**RE: Artificially Induced Wetland Concurrence Request for Noble Energy, Inc.  
Five Rivers K04-32D, K04-20D, K04-21D, K04-25, K09-30D, K09-29D Pad Site,  
Weld County, Colorado**

**NOBLE ENERGY, INC.  
FIVE RIVERS K04-32D, K04-20D, K04-21D, K04-25, K09-30D, K09-29D  
DRILL PAD  
WATERS OF THE UNITED STATES IDENTIFICATION  
AND WETLAND DELINEATION  
WELD COUNTY, COLORADO**

**September 2010**

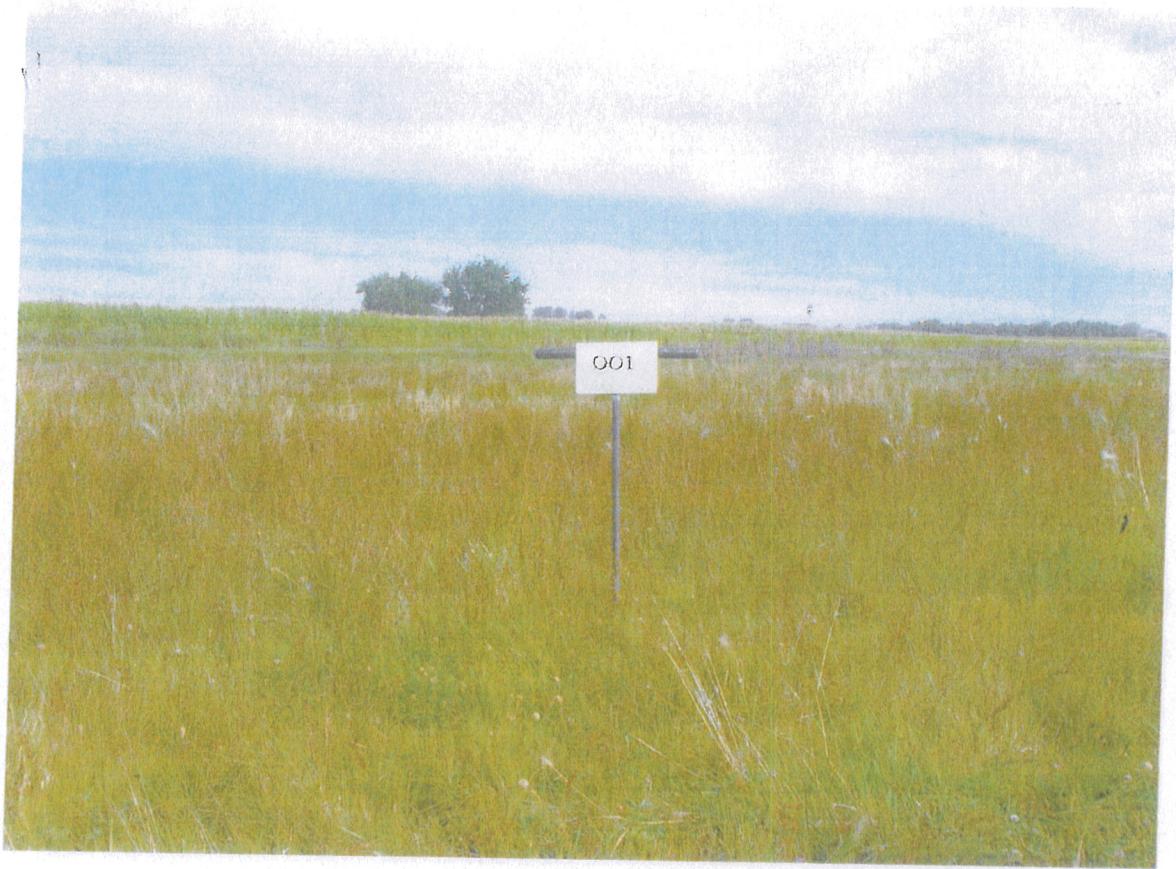
**Figure 2. Sample Point 001 Facing North Toward Agricultural Field**

Vegetation within the site (Sample Points 001 and 002) was dominated by inland saltgrass, Baltic rush, and white clover (Figures 2. and 3.).

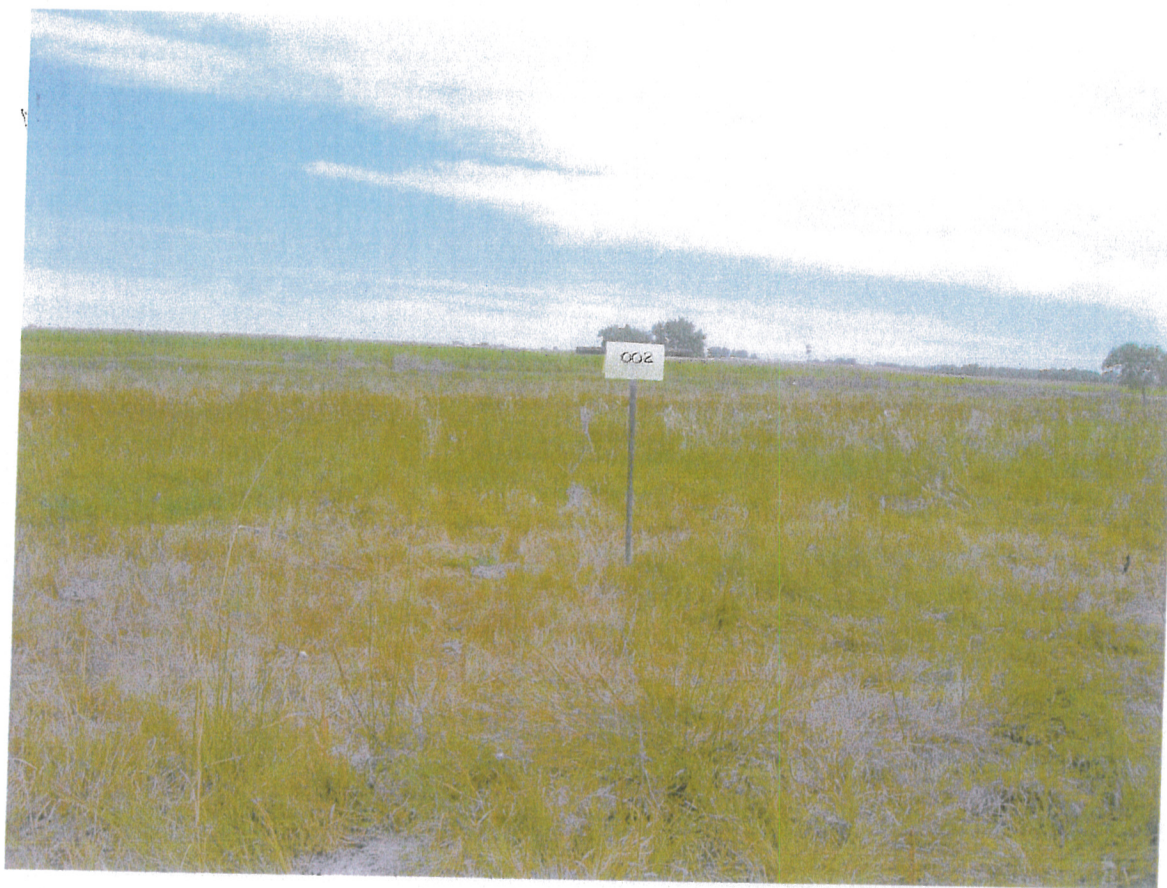
**Figure 3. Sample Point 002 Facing North Toward Agricultural Field**

1987). The soil sample examined at sample point 001 confirmed the presence of the Aquolls and Aquents unit. Sample point 002 contained soil significantly more mesic than that at Sample Point 001 and was not indicative of hydric conditions.

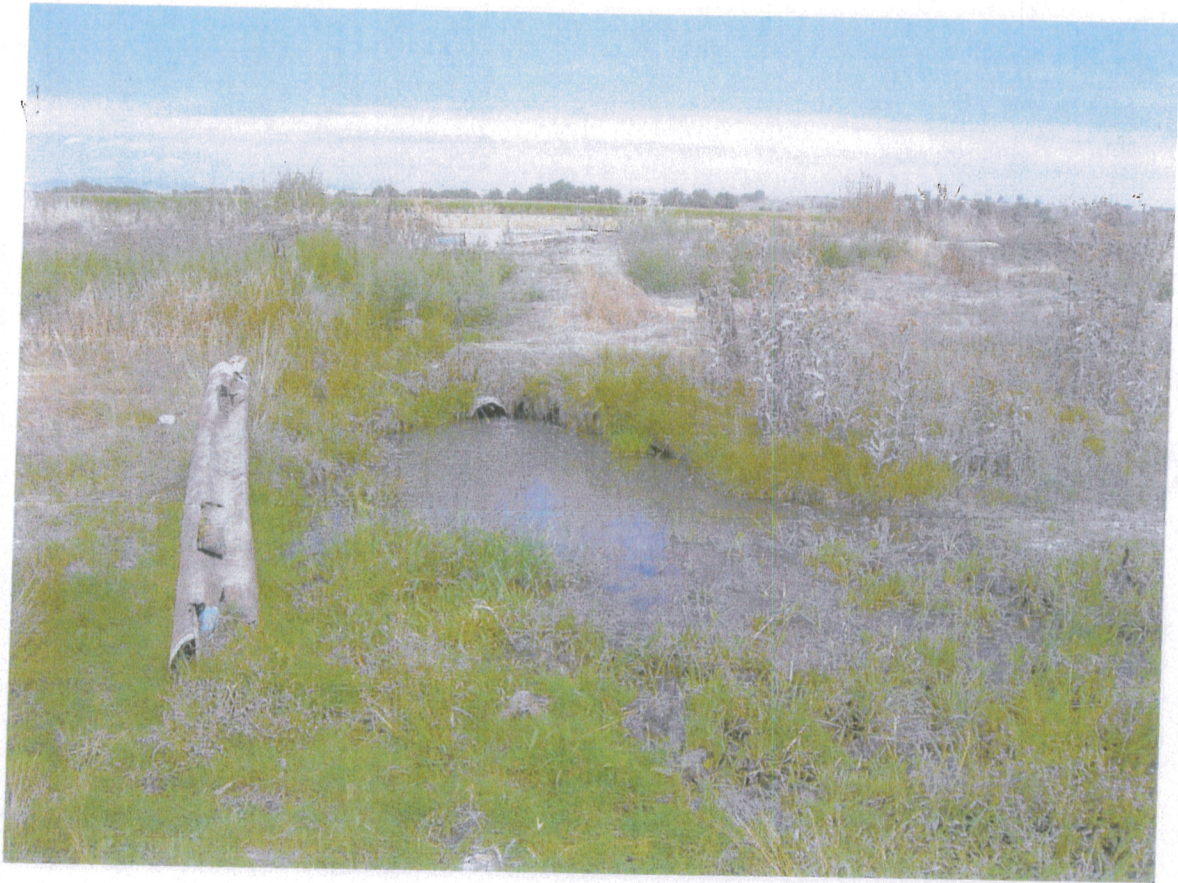
**Figure 4. Agricultural Field with Water Draining from Pipe into Wetland**

Three drain pipes were observed that drain the agricultural fields to the north. Significant amounts of surface water were draining onto the primary terrace where the investigation was conducted.

Savage and Savage conducted a wetland delineation at the proposed Noble Energy, Inc. Five Rivers K04-32D, K04-20D, K04-21D, K04-25, K09-30D, K09-29D well pad site on September 1, 2010. This delineation was conducted in order to determine the presence and extent of wetlands. Wetlands were found to be present within relict alluvial features on the site. We concluded that the wetlands identified during our site investigation were artificially induced due to irrigation from the agricultural fields on the secondary terrace above the proposed project site (Figures 4 and 5).
