From: Kubeczko, Dave
Sent: Thursday, August 30, 2012 12:46 PM
To: Kubeczko, Dave
Subject: FW: Colorado River Cutthroat Trout and Petroleum Resource Managment Corp's Sheehan 2 4-2
Attachments: 2 Duncan irrig ditch, Sheehan, NF Upper end.jpg; 1 Map Duncan irrig ditch, Sheehan drainage map.jpg
Categories: Orange - Operator Correspondence, Dark Green - CDOW Pass

Yesterday Dave Kubecsksko with the COGC and I met and examined the "intermittent trout stream" near the location that has been the subject of the debate with regards to the permitting of our well, the Petroleum Resource Management Sheehan 2 4-2

Page 1 - Map of Duncan Irrigation Ditch and Sheehan Drainage, Secs 1, and 2, 10N-89W, Secs 25 and 36, 11N-89W. Locations of Pictures A-P are shown

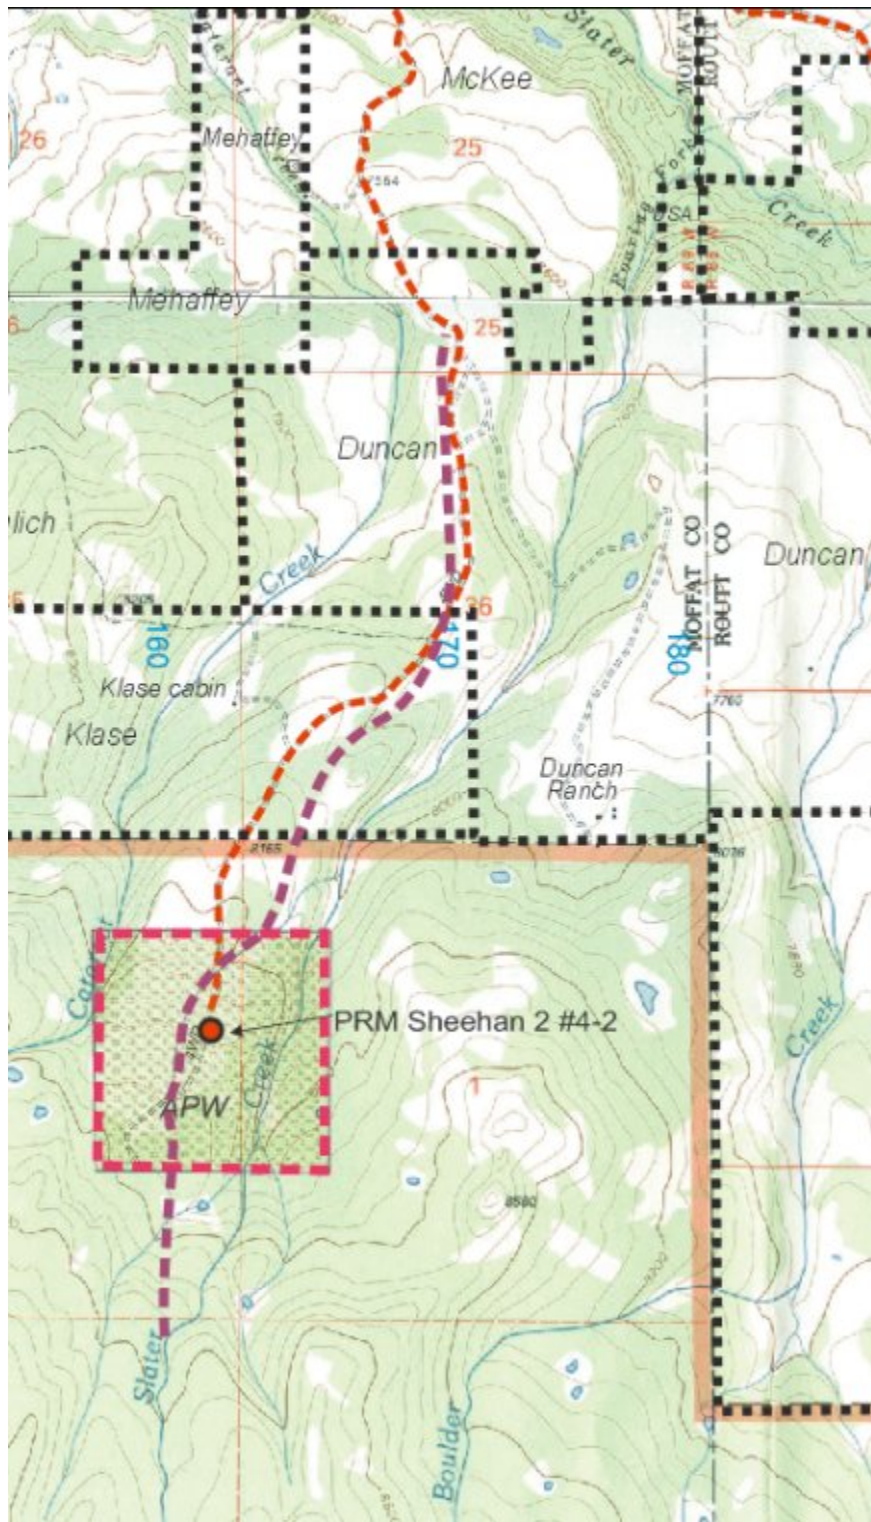
1. We do not believe that the irrigation ditch in question is trout habitat. As per the map shown below and described by Duane Duncan, the rancher who operates the water system, the irrigation ditch runs along the top of the ridge sub-parallel to the access road into the Sheehan (APW) property. The potential trout streams are in the valleys on either side of the ridge. The irrigation ditch irrigates pastures along the road on both sides of the ridge and does not reconnect to either Cataract Creek to the west or Roaring Fork of Slater Creek to the east. Both Duane Duncan and Bobby Stanton, the principal shareholder of APW Corp, have never seen nor believe that trout can live in the irrigation ditch.

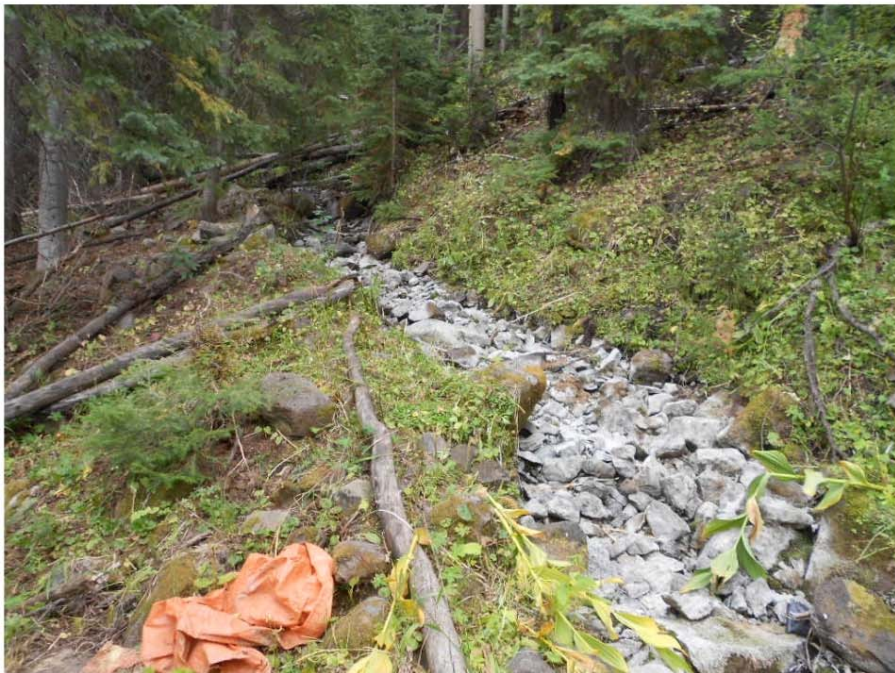
A: Looking East, Irrigation ditch near head gate on Roaring Fork Slater Creek. Original ditch built in late 1800's, diverted to Sheehan tract around 1910.

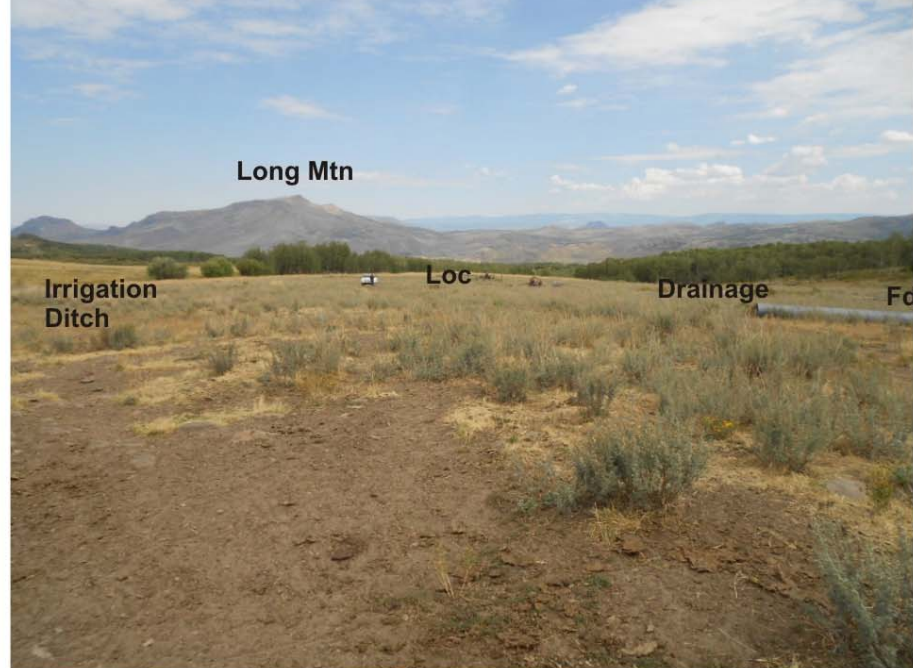
B: Looking ENE. Sheehan Tract, Irrigation ditch to left, Sheehan drainage to right, Location just to right of car in center of photo. Foundation (Fd) just off right of photo.

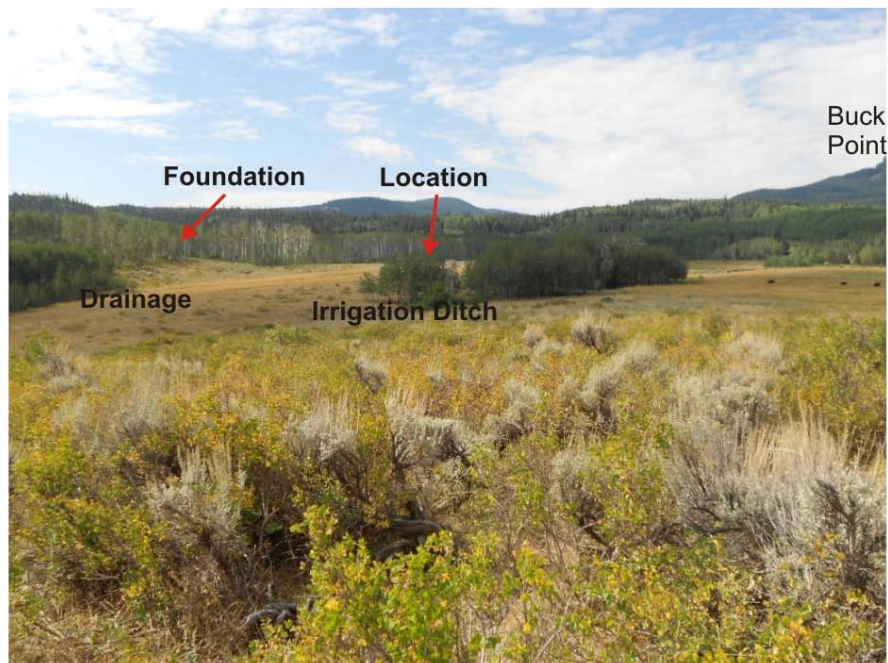
C. Looking South. Sheehan Tract. Shehan drainage and APW house foundation to left, Irrigation ditch and location in center of photo, Buck Point just off right edge.

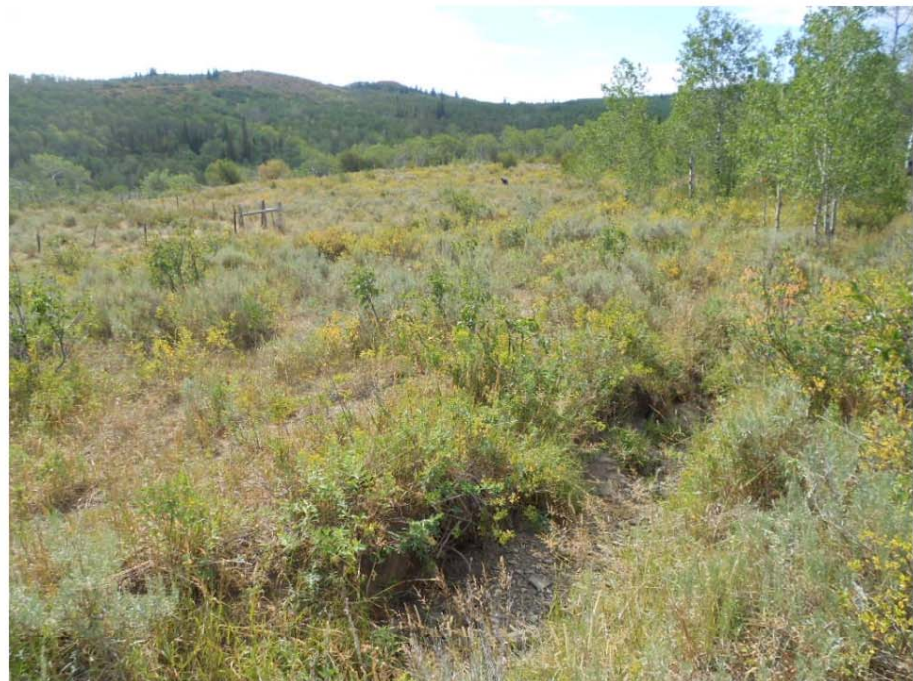
D. Looking South. National Forest strip, NWNW of Section 1, 10N-89W. Irrigation ditch in foreground, Shehan drainage is where Dave is standing (black dot in upper center of photo.)

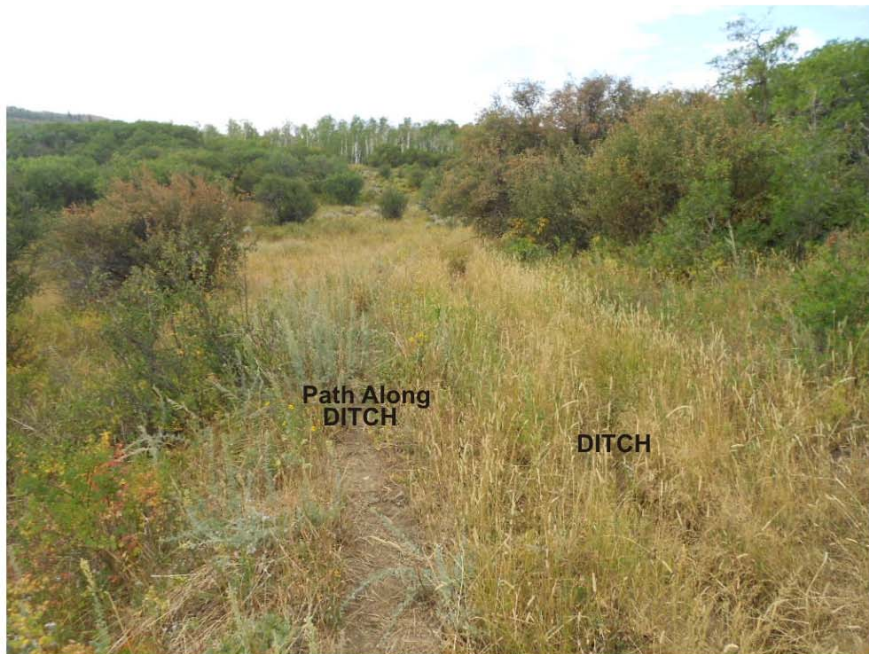
E. Irrigation ditch looking SW, Klase property. National Forest in distance. Roaring Fork Slater Creek drainage downslope to left.

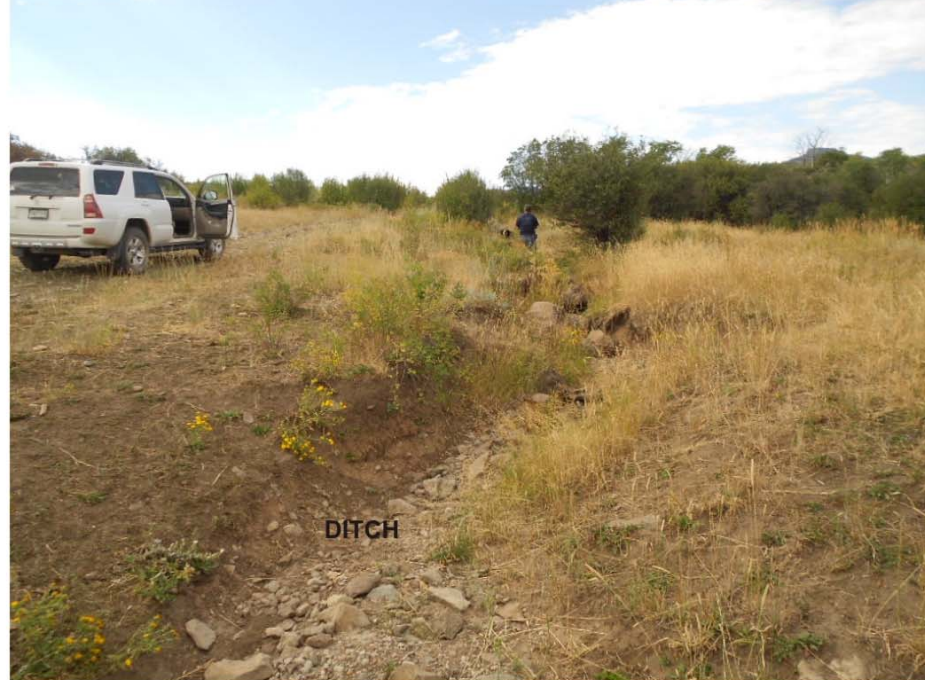
F. Ditch looking SW, Klase property where it crosses road before entering onto the Duncan Ranch near center of Section 36, 11N-89W.

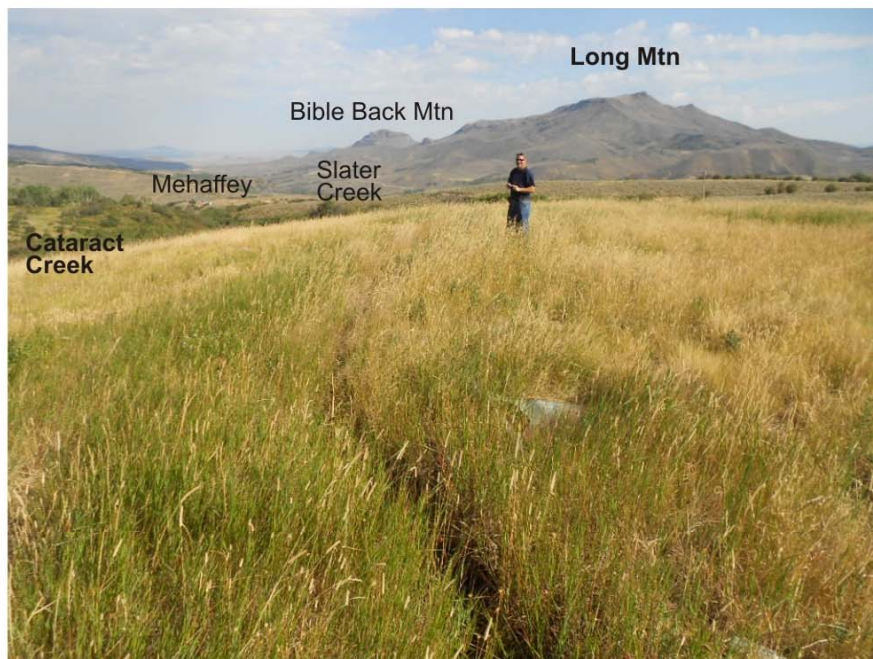
G. Ditch looking N, Duncan Ranch, C N2, Section 36, 11N-89W. Cataract Creek is drainage to the left, Mehaffey house is visible in center left. Long Mtn in distance.

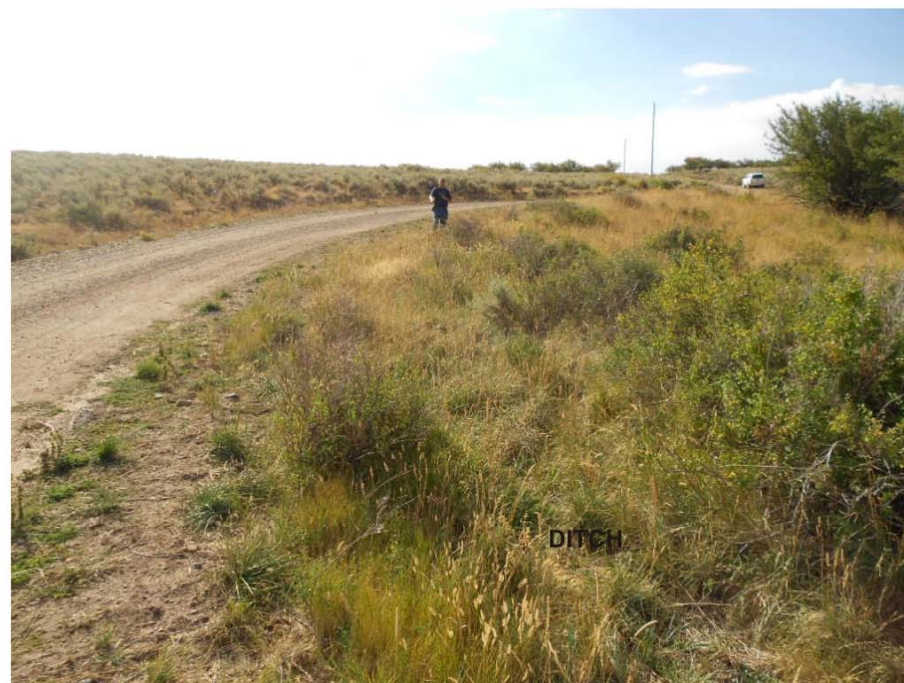
H. Ditch looking SSE. End of ditch near the north line of Duncan Ranch, Sec 25, 11N-89W. Effect of irrigation seen. Sage brush where no water, good grass with water.

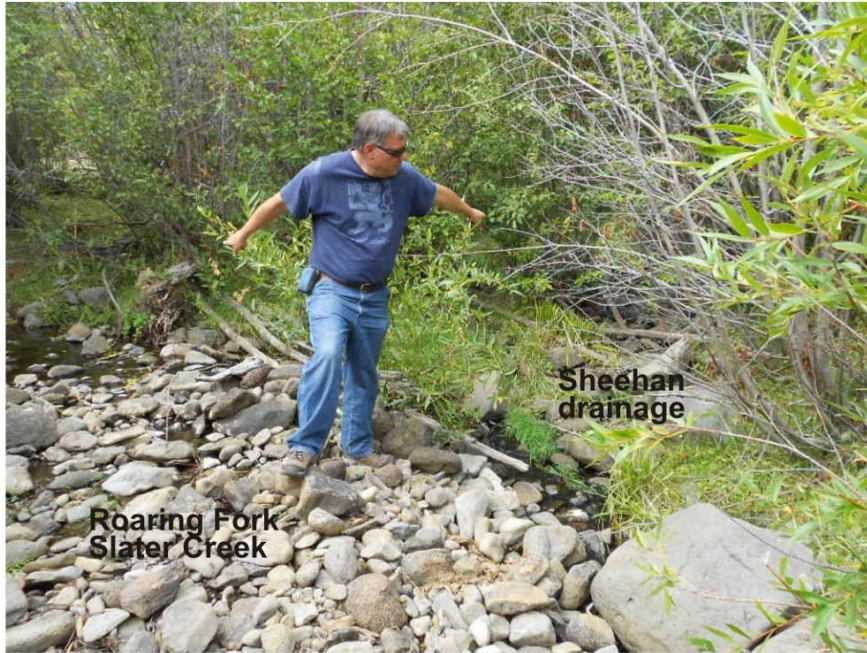
Dave Kubescko and I agreed that there is no possible way that a trout in Roaring Fork Slater Creek could start up the Sheehan drainage (Pic I) where there is only a slight amount of moisture (Pic J), scramble up over the rocks on the steep slope where there is no water (Pic K), then work its way up through the pasture where there is still no water (pic L) and then no channel (Pics M and N) or water, and then find its way up slope into the Duncan irrigation ditch.

I. Junction of drainage from Sheehan with Roaring Fork Slater Creek
NENWNW, Sec 1, 10N-89W. Very small amount of water in Sheehan drainage.

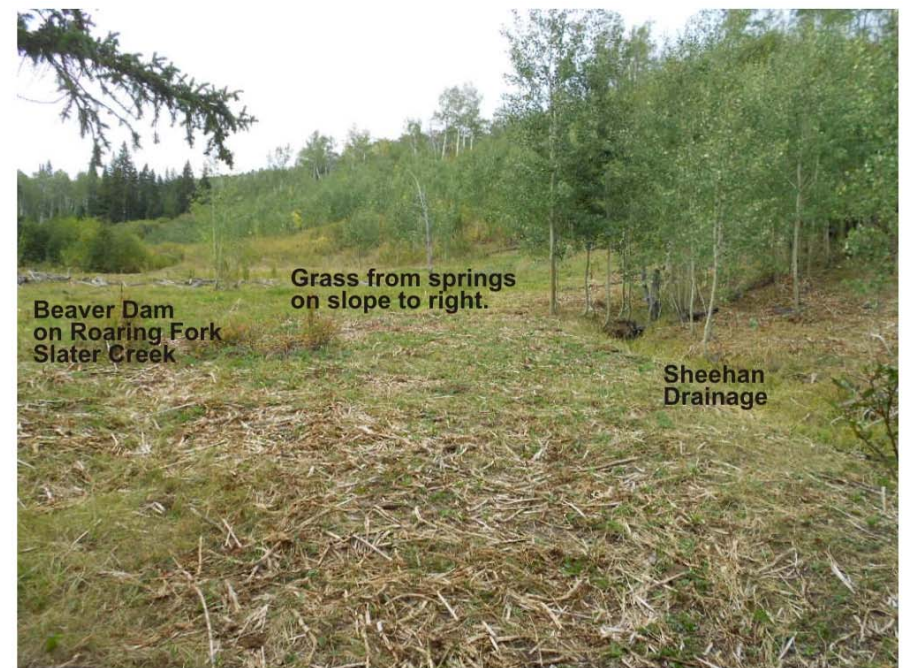
J. Sheehan drainage near Roaring Fork Slater Creek, No visible water here but ground is marshy from springs along the slope which put a small amount of water into the Sheehan drainage and other small drainages. NENWNW, Sec 1, 10N-89W

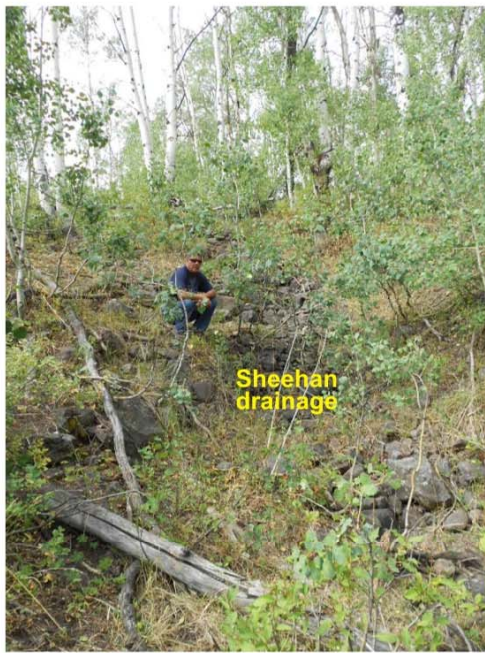
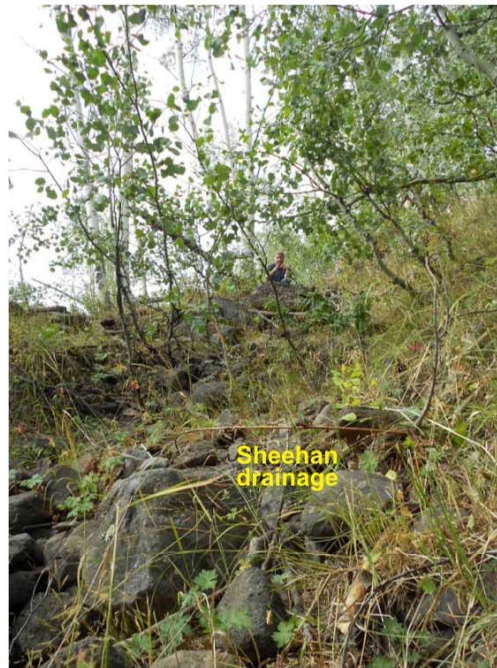
K1 and 2 Looking west. Sheehan Drainage on rocky slope. Drainage climbs 80' in about 250'. The steepest parts of the drainage are shown here. No visible water or significant channel cut other than where spring runoff as scoured off the rocks.

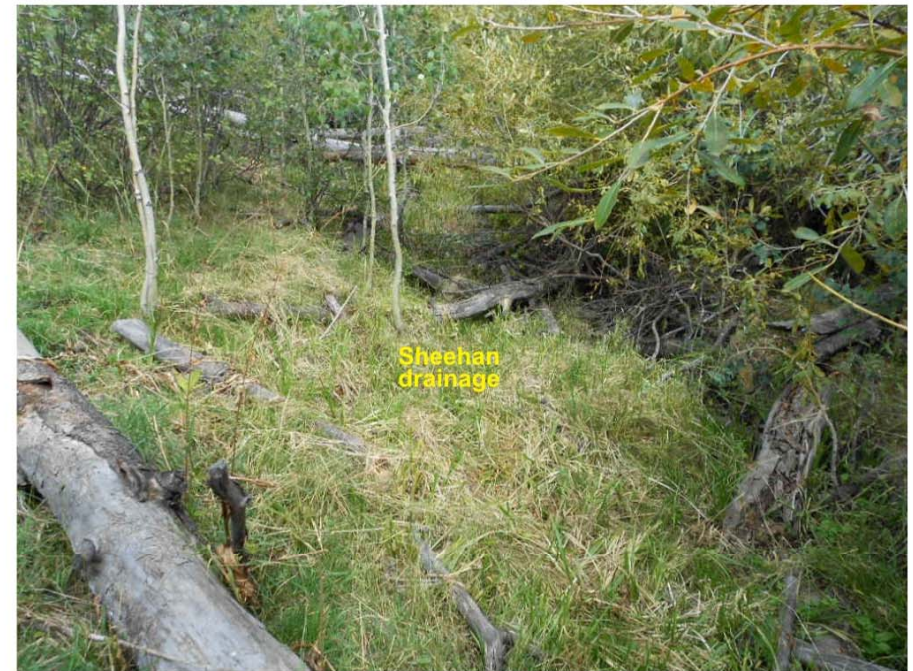
L. Sheehan drainage on slope above Roaring Fork Slater Creek. No visible water or rocky channel at this point.

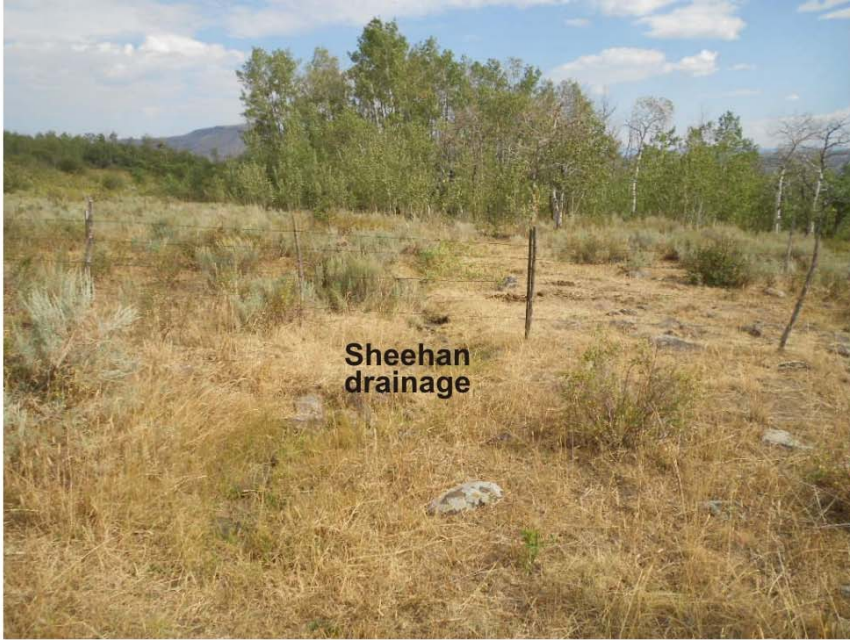
M Looking northeast. Sheehan drainage on National Forest just north of Sheehan (APW) Tract NWNW, Sec 1, 10N-89W. No water or significant channel. Irrigation ditch is about 150' to left. (see picture D)

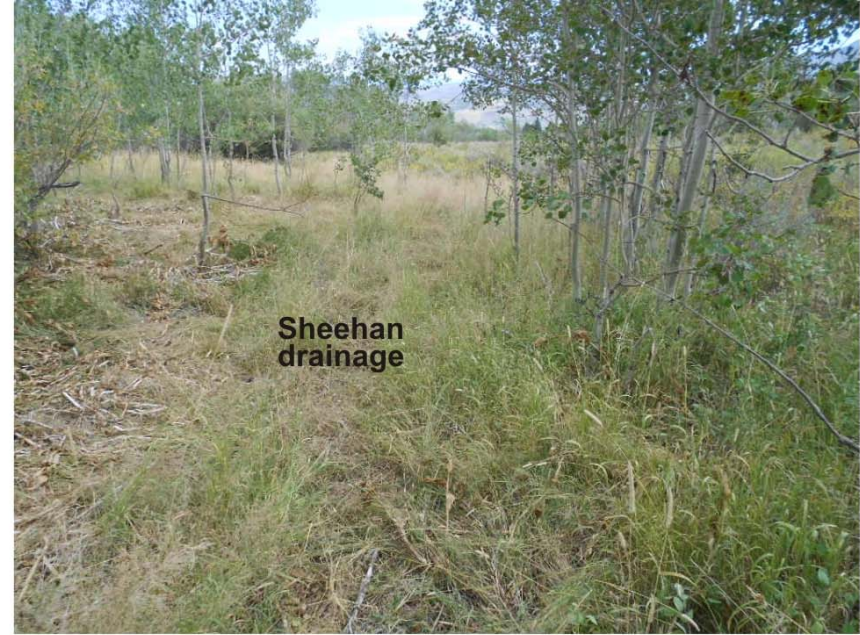
N. Sheehan drainage near north boundary of Sheehan Tract. No visible water or significant channel. Irrigation ditch is about 100' to left. NWNW, Sec 1, 10N-89W

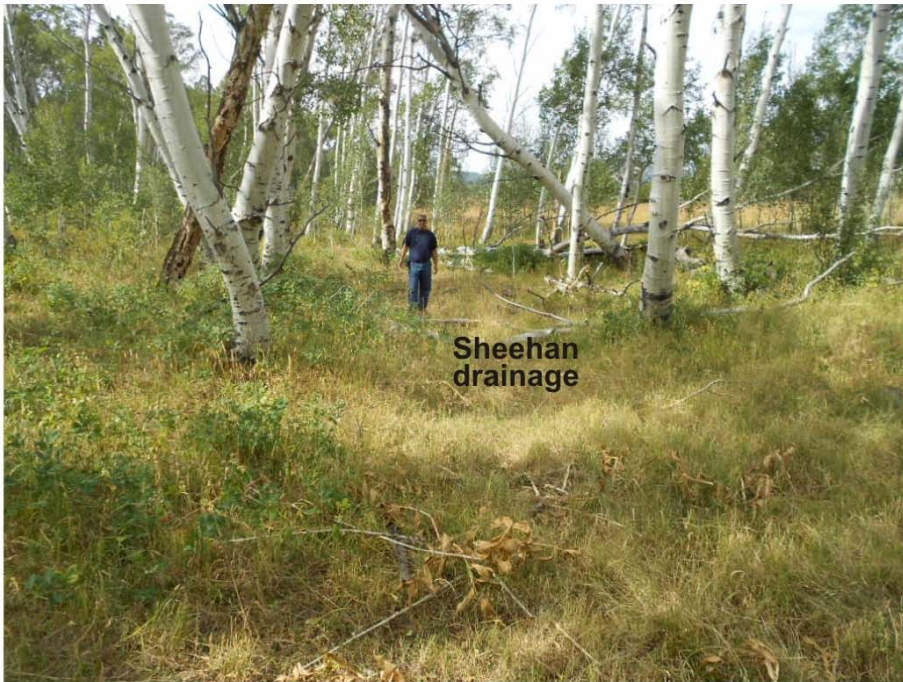
O Sheehan drainage on Sheehan (APW) Tract near west line of Sec 1. No visible water, rocks, or stream channel. Only a slight, discontinuous depression.

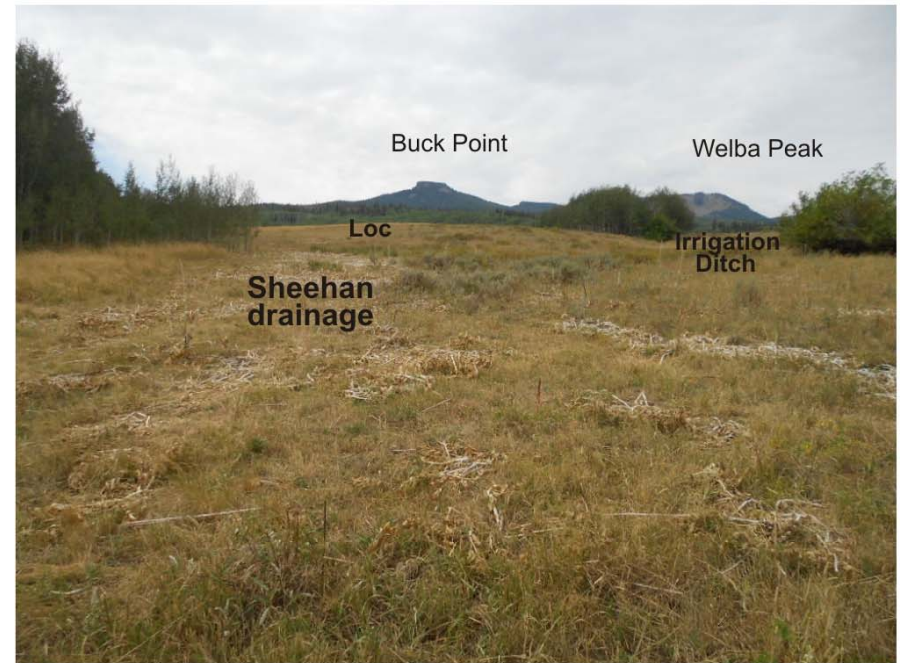
P. Looking SE to Buck Point. Sheehan drainage on Sheehan property. Sheehan drainage to left, Irrigation ditch is to right upslope of the Sheehan drainage. No visible water, rocks, or channel. Cows have trampled the white stalky weeds that apparently grew in the bottom of the drainage. (See left side of Photo C)
