RE: Fuqua 18-15 Well Pad Separator Release Remediation and Confirmation Sample Results for COGCC Spill Tracking #2222753, Location ID# 324766, Rem #6938 Olsson Project #012-0225

Site Map Showing Impact Area and Site Characterization Soil Sample Locations
 Fuqua 18-15
 Jackson County, Colorado

Confirmation Soil Sample Results
 Fuqua 18-15
 Jackson County, Colorado

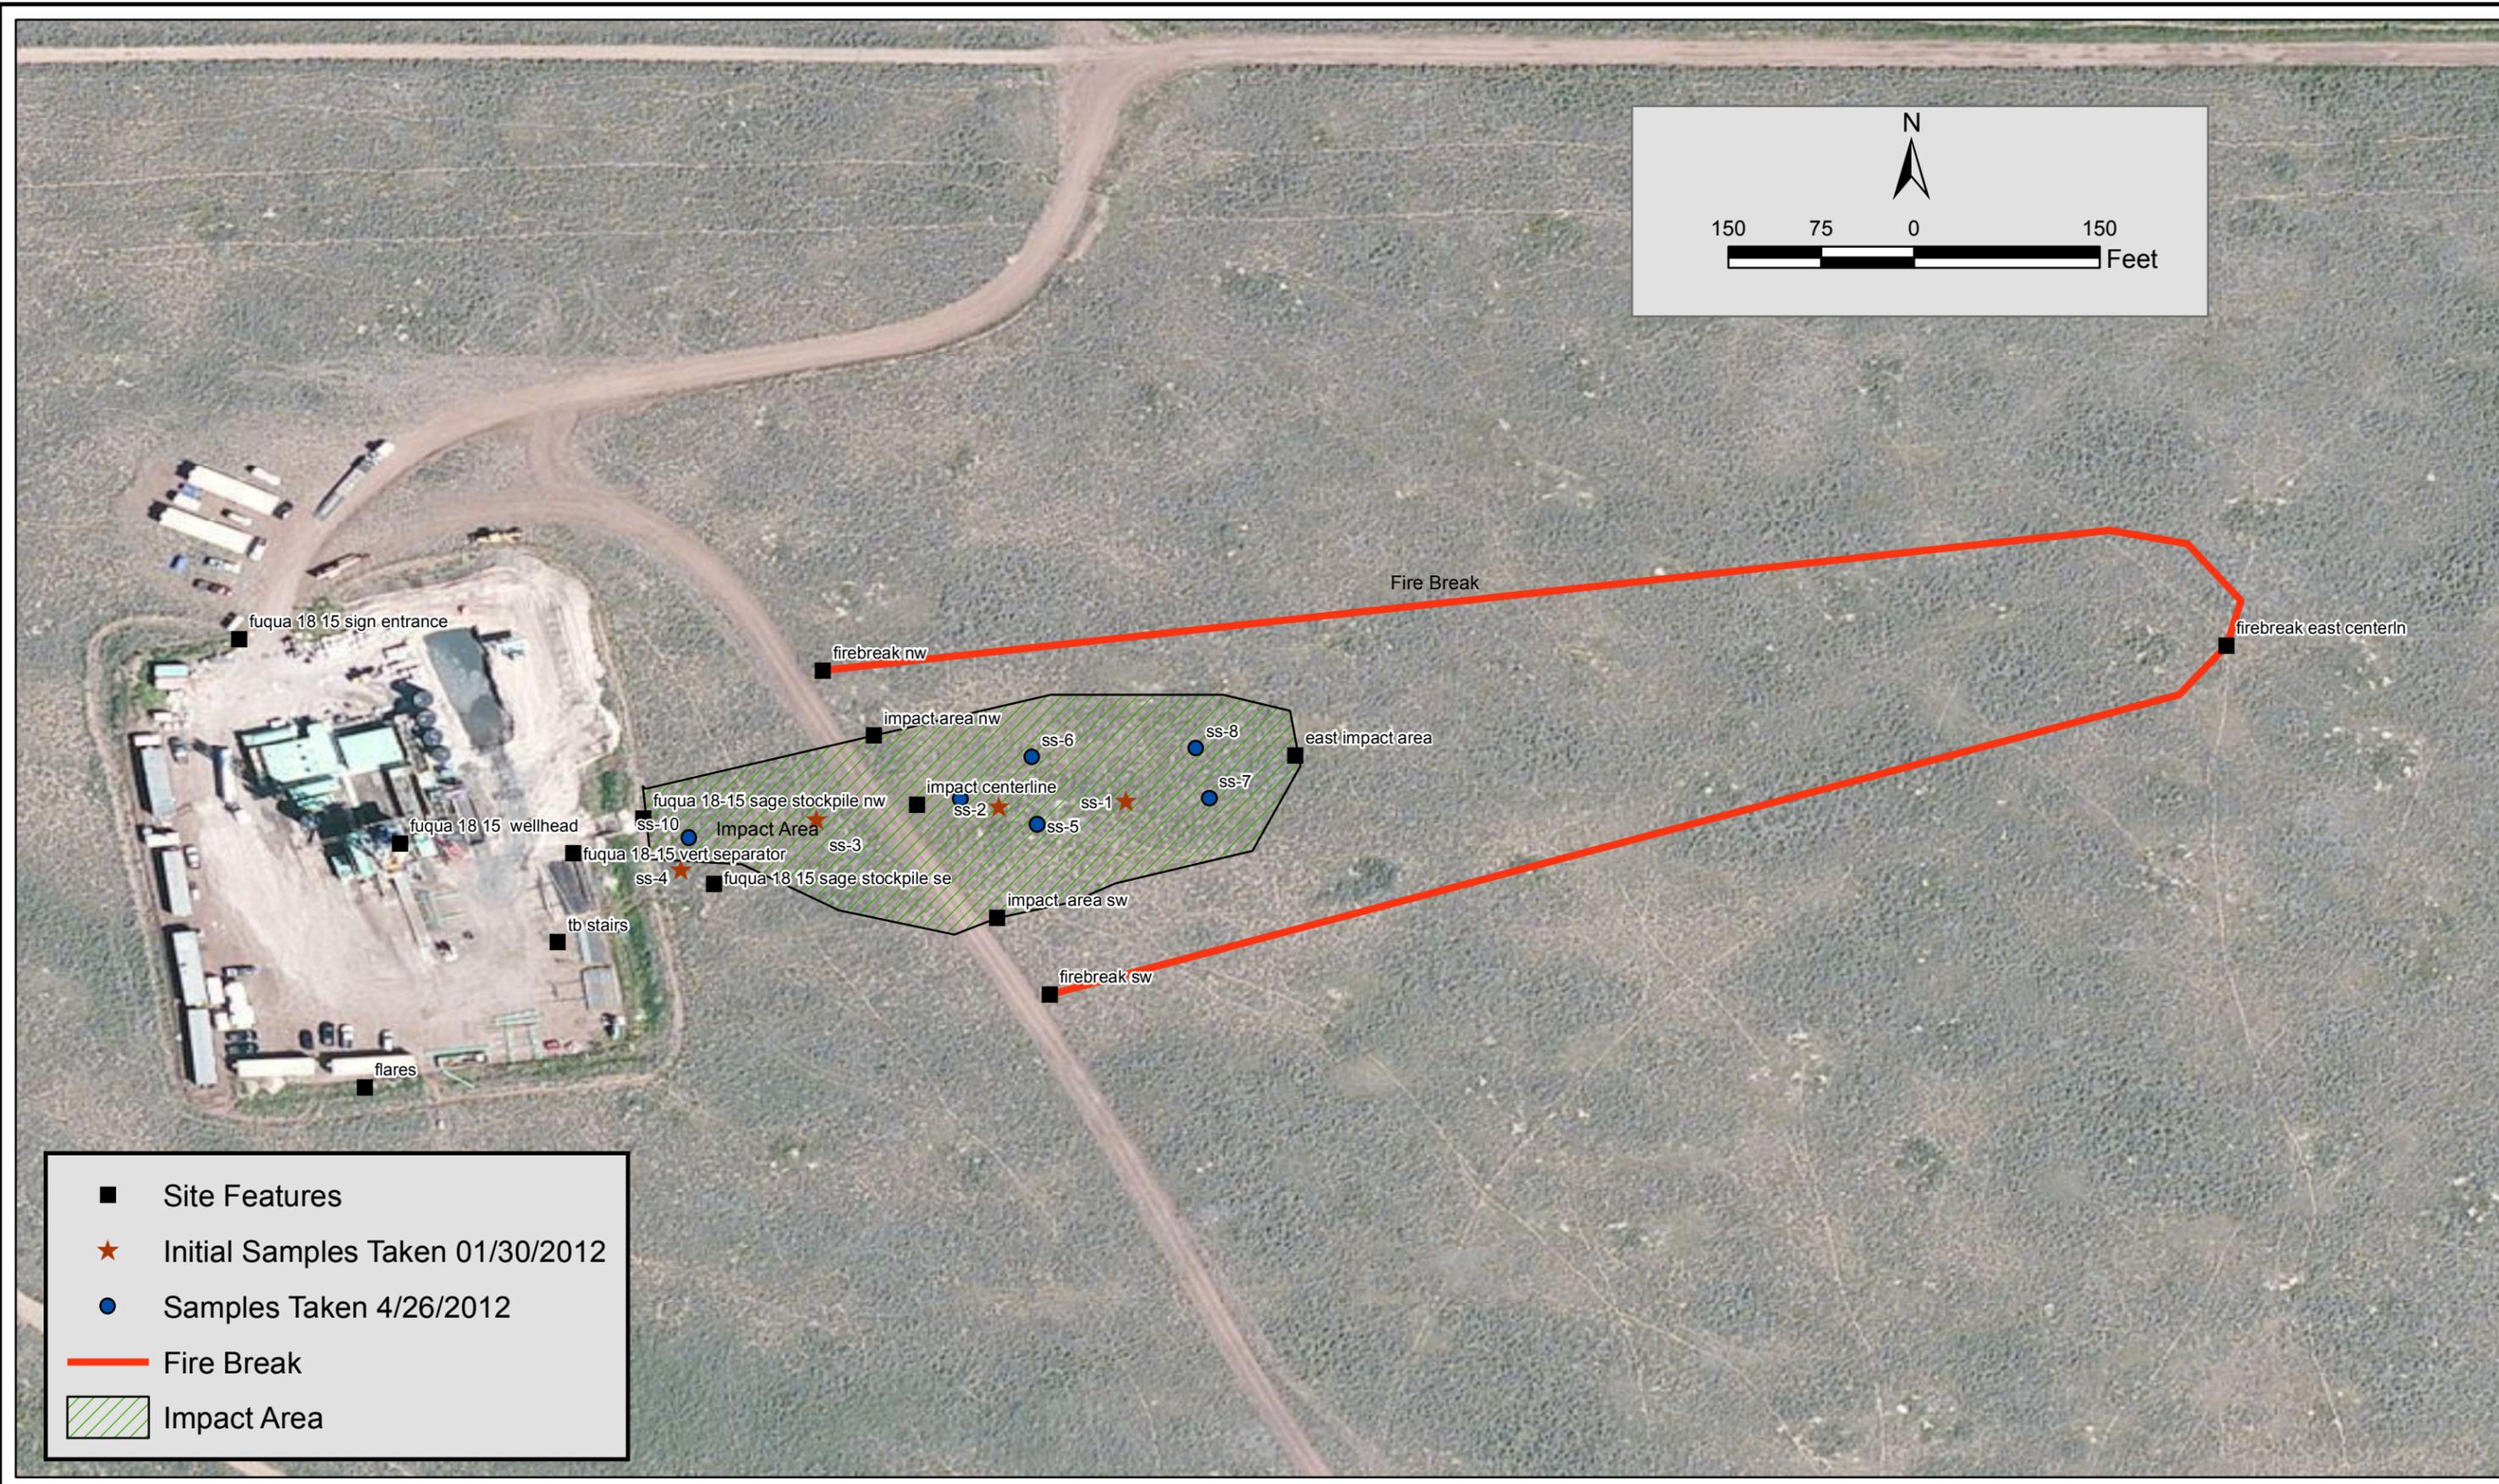
It appeared that the wind had carried the release more to the southeast at approximately 450 feet from the separator; however, the majority of the impacted vegetation was within this impact area as shown on **Figure 3**. The width of the impact area “fanned out” from the vertical separator and ranged from 160 feet to 200 feet at its widest aperture. “Fingers” and localized spots of impacted vegetation were noted where the wind had carried the petroleum hydrocarbons further out, but were more isolated. Petroleum hydrocarbon impacts were not noted out along the eastern extent of the fire break. New vegetation growth and wildflowers were noted in bloom during the April 26, 2012 site characterization activities.

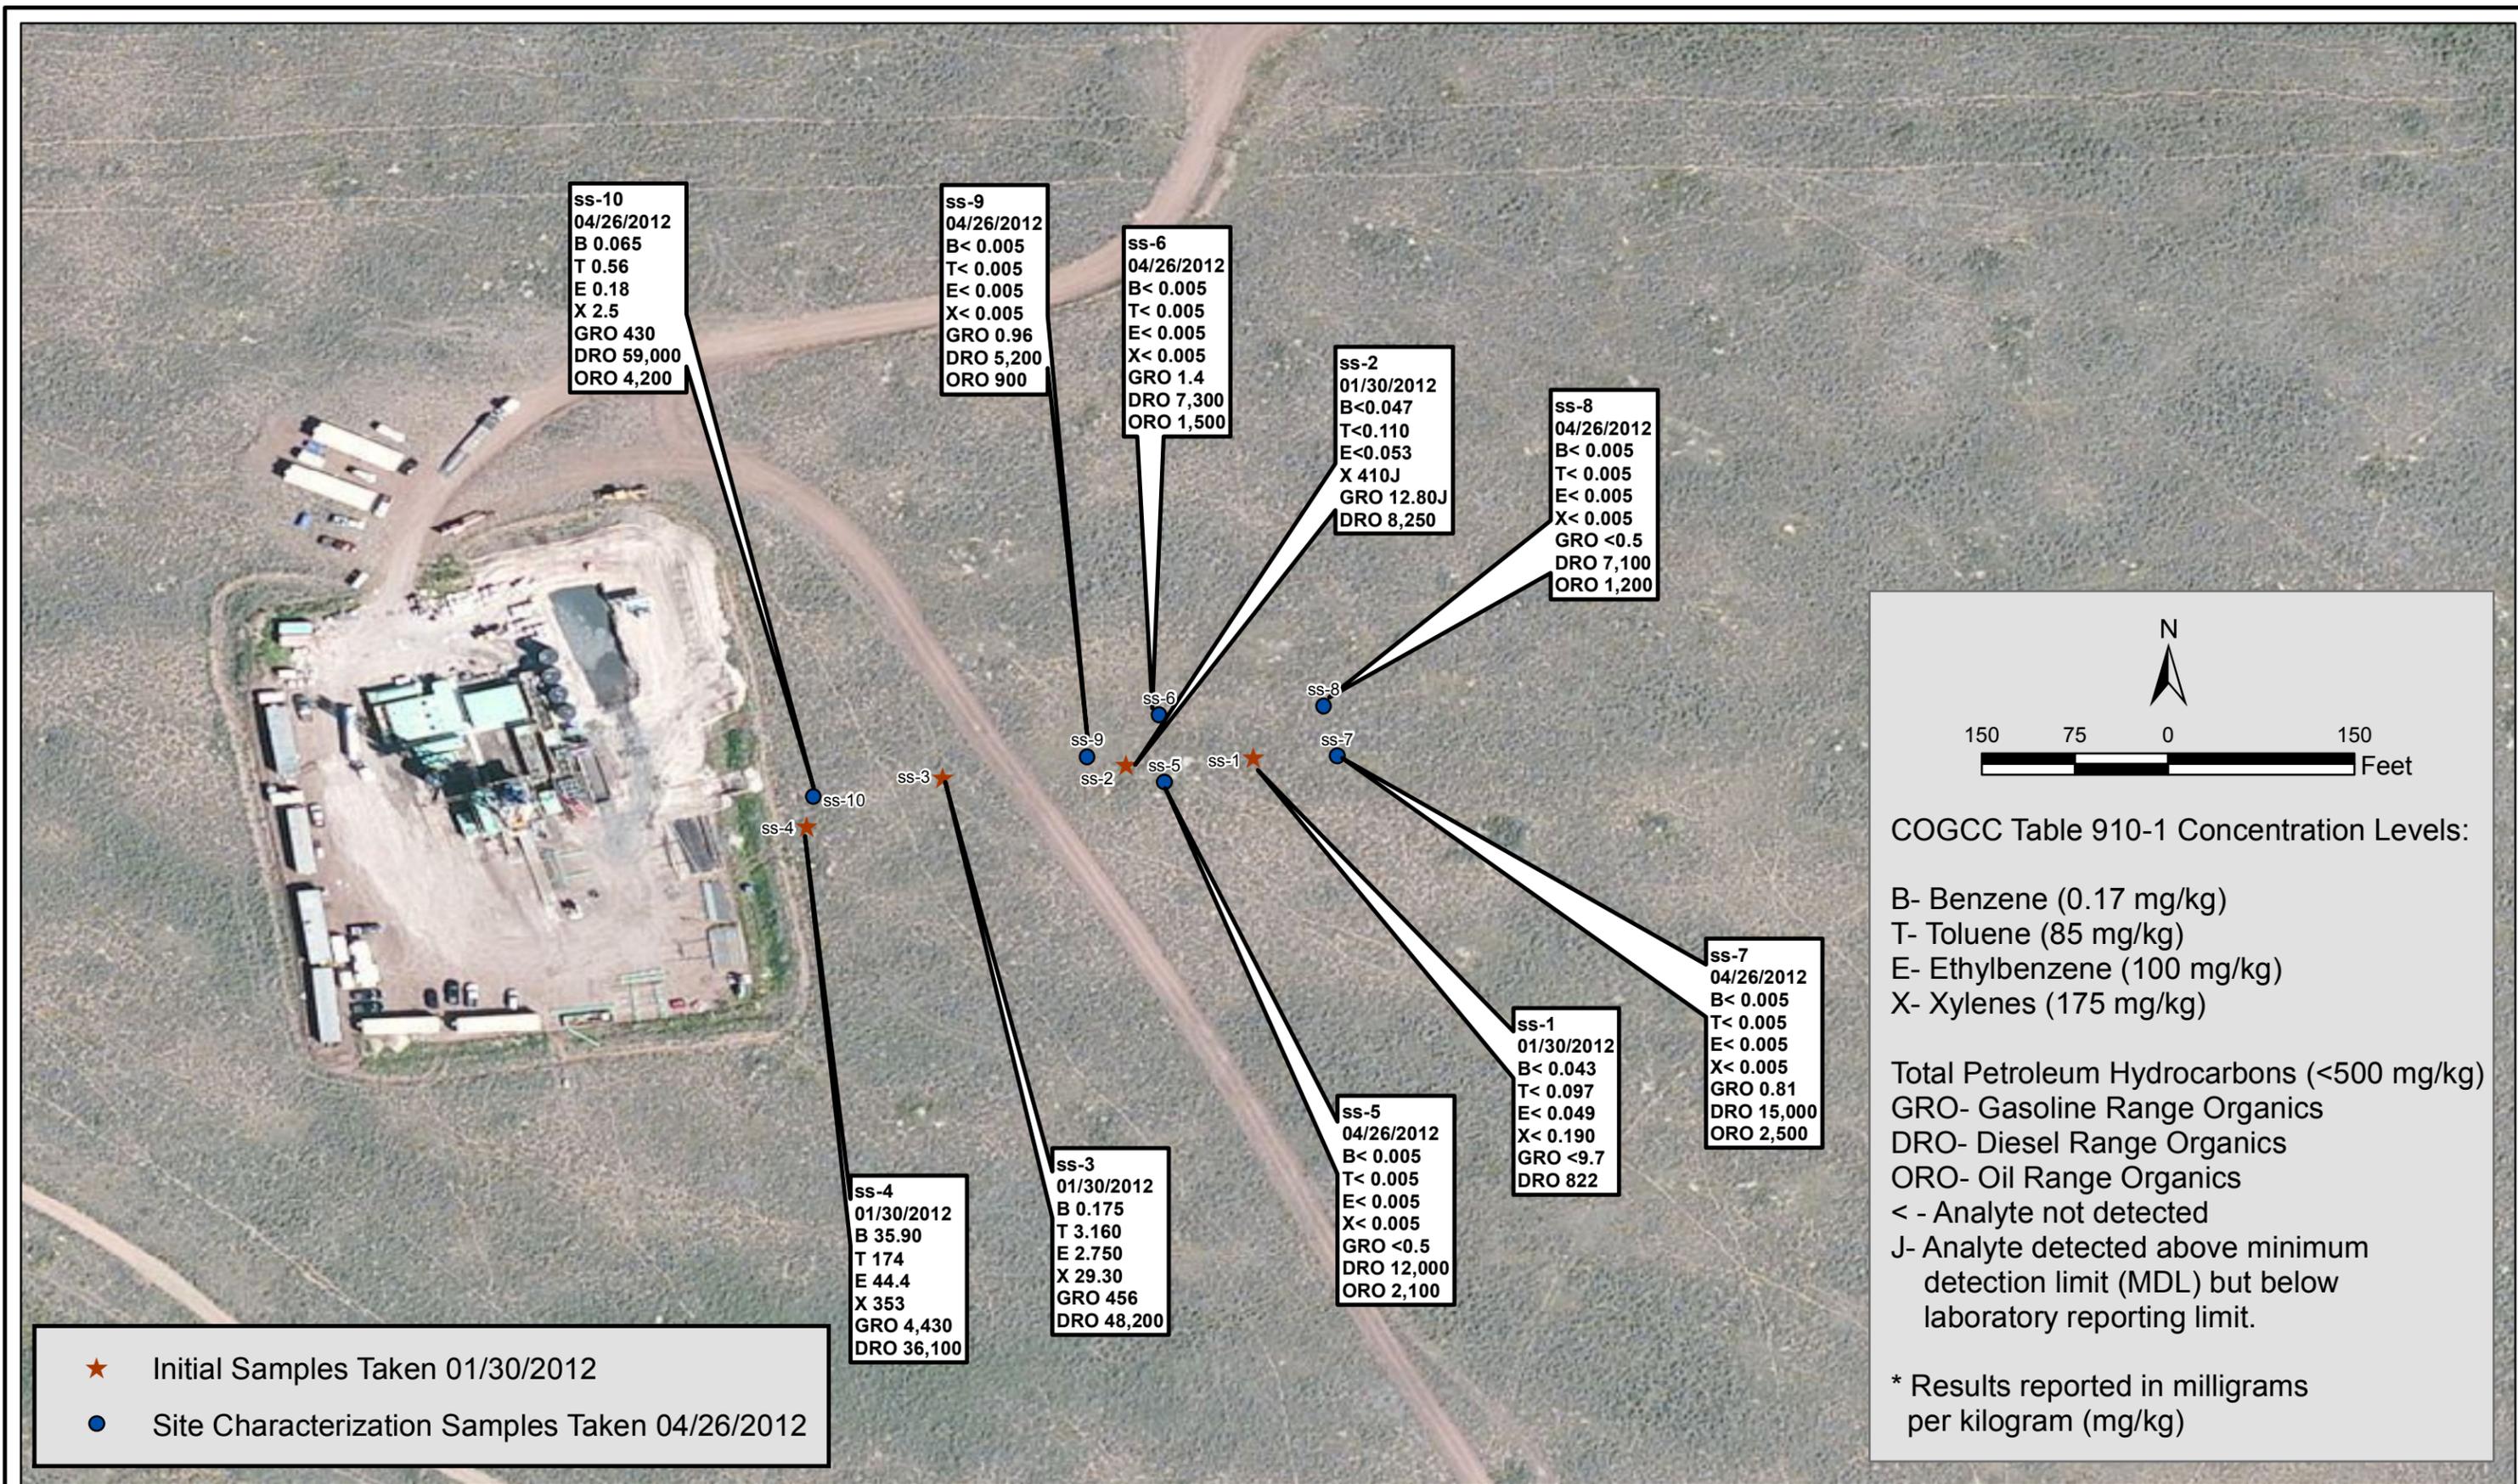
Site Characterization Soil Analytical Results
 Fuqua 18-15
 Jackson County, Colorado

The April 26, 2012 soil samples showed elevated DRO concentrations, and the BTEX and GRO concentrations were limited to the stockpiled vegetation that had been cleared from the area closest to the vertical separator. Concentrations of BTEX and GRO were either not detected or did not exceed COGCC Table 910-1 concentration levels in samples collected outside the stockpile. Confirmation soil samples SS16 and SS17 collected on November 1, 2012 were from 35 feet along, and from 110 feet, respectively, along the center line from the well pad. These locations were marked with pin flags during the April 2012 additional site characterization.

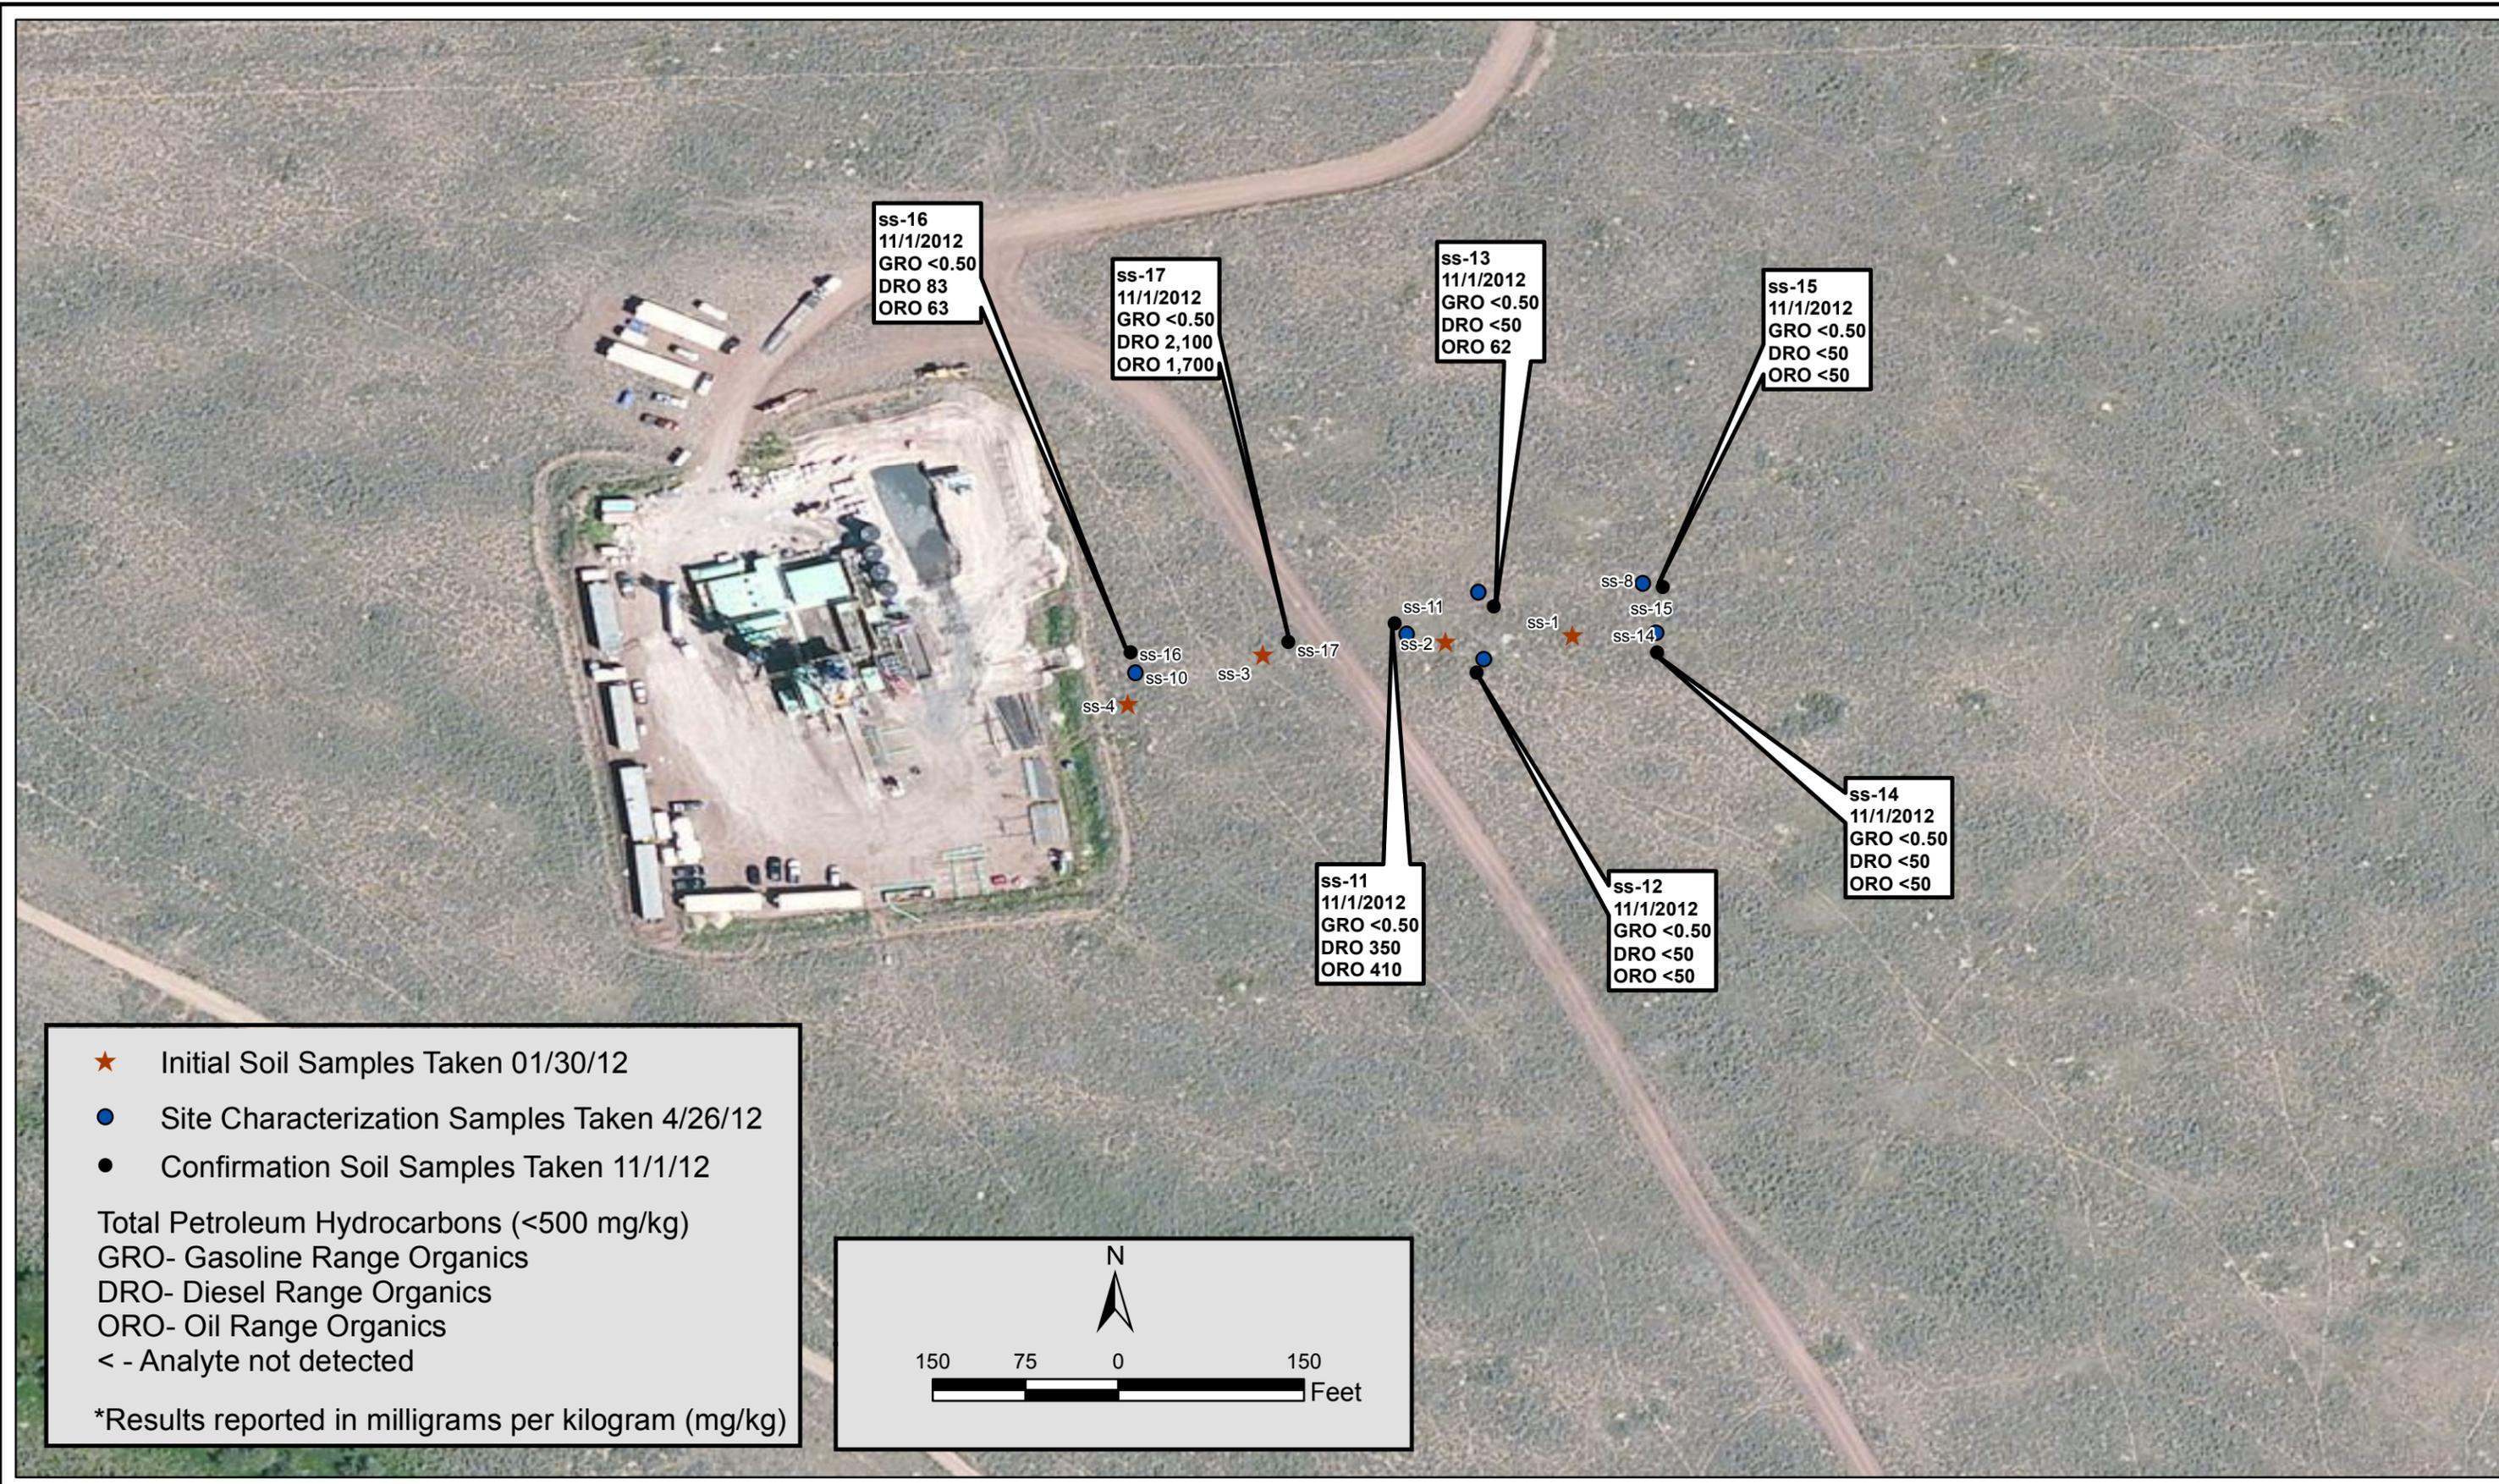
The analytical results for the November 1, 2012 sample results are plotted on **Figure 4**. A summary of the previous site characterization sample results are shown in **Table 1** as compared to the COGCC Table 910-1 concentration levels and **Table 2** presents the November 1, 2012 soil confirmation samples following remediation.

Concentrations of GRO were not detected in any of the November 1, 2012 confirmation soil samples SS11, SS12, SS13, SS14, SS15, SS16, or SS17. The samples were submitted for analysis of the total petroleum hydrocarbon (TPH), or GRO, DRO, and ORO, and were not analyzed for BTEX since the characterization soil sample results showed that BTEX compounds were not detected in the site characterization samples.

The laboratory results show that concentrations of DRO and ORO were not detected at or above the method detection limit in the confirmation soil samples SS12, SS14, or SS15. Confirmation soil sample SS12 was located near soil sample SS5, approximately 300 feet east of the well pad, and 25 feet south of the centerline of the release. Confirmation sample SS14 was collected near soil sample SS7, approximately 400 feet east of the well pad and 25 feet south of the centerline of the release. Confirmation soil sample SS15 was collected near soil sample SS8, approximately 400 feet east and 15 feet north of the centerline of the release.

The laboratory reported a DRO concentration of 350 mg/Kg and an ORO concentration of 410 mg/Kg in confirmation soil sample SS-11. Combining both the DRO and ORO TPH ranges, these results show that TPH concentrations are greater than the COGCC Table 910-1 concentration level of 500 mg/Kg. Hydrocarbons in the DRO and ORO ranges are typically less mobile than in the GRO range. Confirmation soil sample SS-11 was collected near the SS-9 site characterization soil sample, or approximately 250 feet along the centerline of the release.

The laboratory analytical results for confirmation soil sample SS17 collected 110 feet along the centerline measured from the fence surrounding the well pad, show that concentrations of DRO were reported at 2,100 mg/Kg, and that ORO were reported at 1,700 mg/Kg. These concentrations are above the COGCC Table 910-1 concentration level of 500 mg/Kg for total petroleum hydrocarbons. Confirmation soil sample SS17 was collected near the impacted materials and debris stockpile located close to the Fuqua 18-15 well pad.

Additional treatment may be necessary for the impacted soils near SS17, and the stock pile of impacted materials, and the total petroleum hydrocarbon (TPH) concentrations near confirmation soil sample SS11. Although the individual ranges for DRO and ORO are less than 500 mg/Kg, the combined concentrations are above the COGCC Table 910-1 TPH concentration level of 500 mg/Kg. Treatment options may include mulching the impacted materials or additional spraying of the hydrocarbon degrader solution over this area in June 2013.

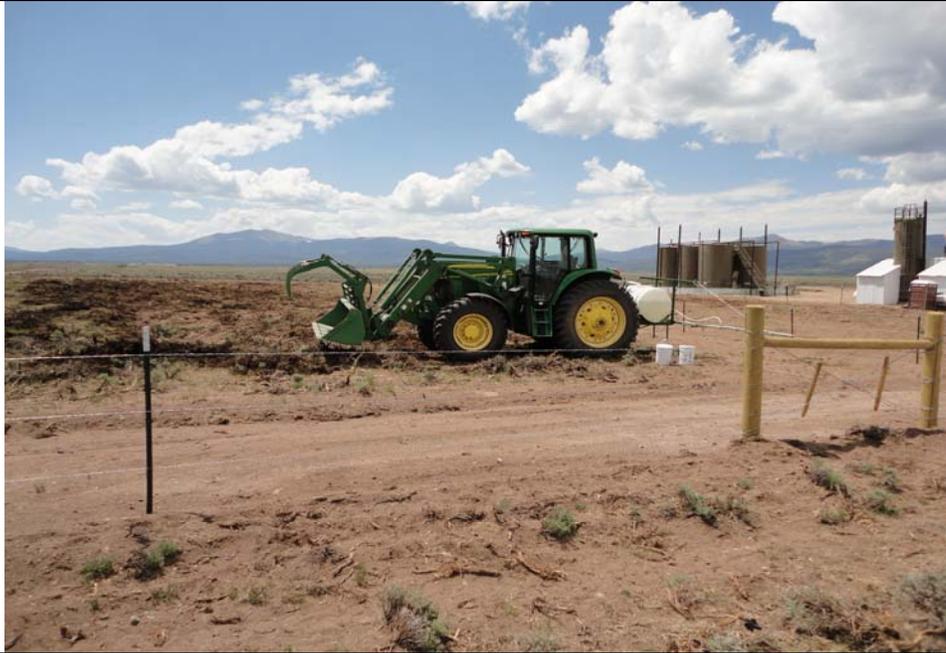
Subject: A John Deere 741 tractor with a 150-gallon capacity polytank and a sprayer boom was used to apply the EarthSmart hydrocarbon cleaner over the impacted area. The vertical separator is shown at the right hand side of the photo. A three-strand wire fence had been constructed to keep cattle out of the area.

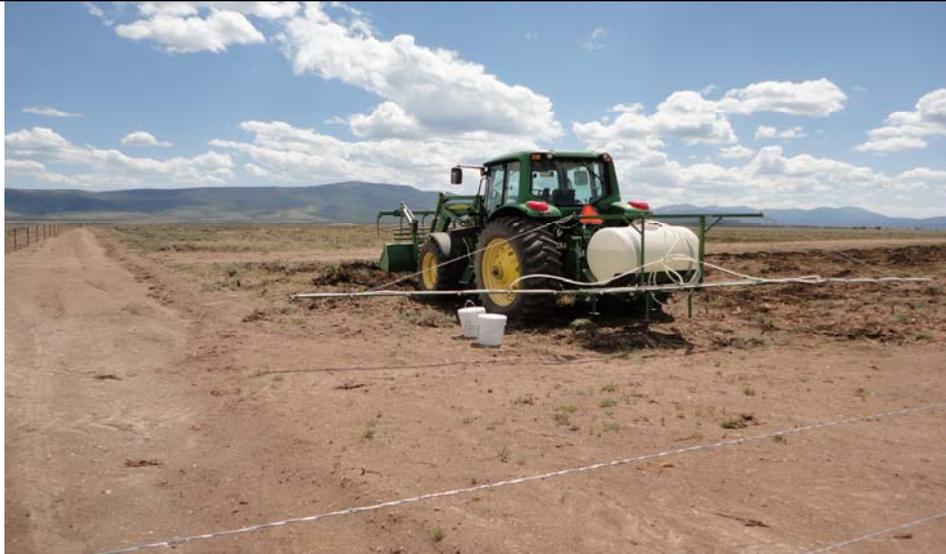
Subject: The concentrated Earth Smart hydrocarbon cleaner was delivered in 5-gallon containers. The area was treated twice using a ratio of one 5-gallon bucket of the concentrate to approximately 100 gallons of water.

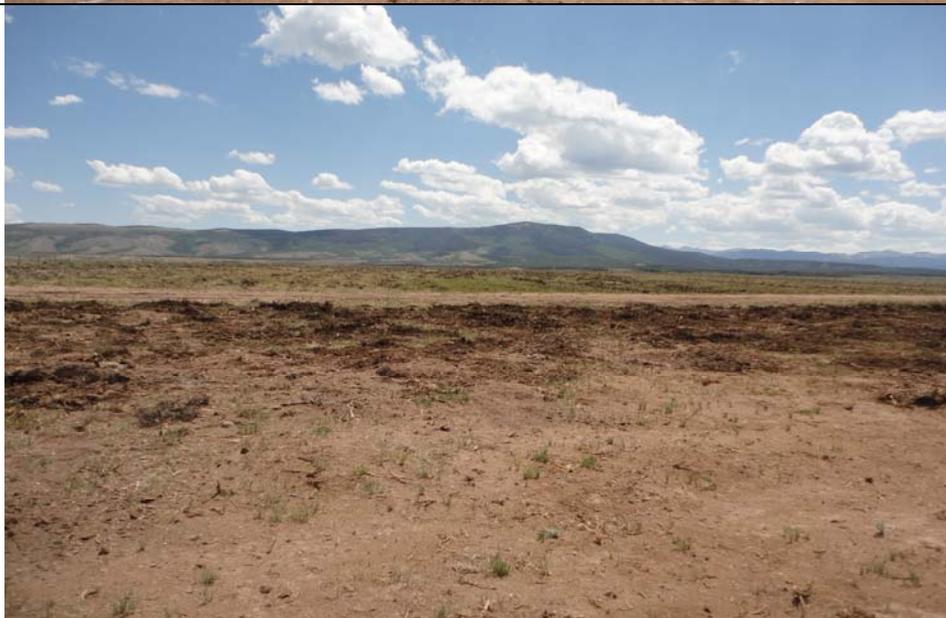
Subject: Stained soil and vegetation had been stockpile on the east side of the well pad near an access road.

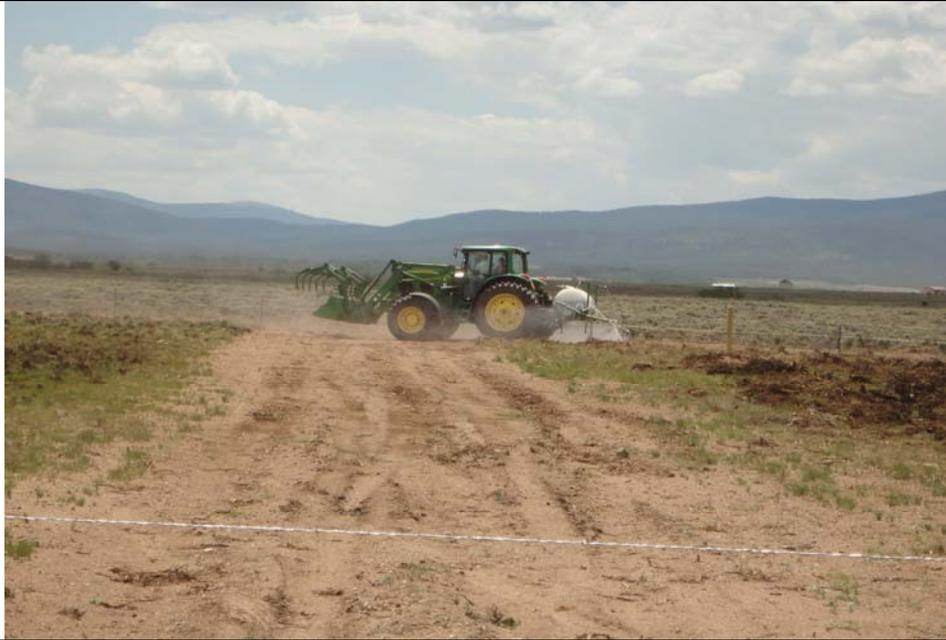
Subject: Photograph shows the treatment in progress near the stockpile on the south side of the release area. A fire break had been cleared around the release area since the original treatment plan was to burn the impacted vegetation. However, Jackson County implemented a fire ban due to a lack of precipitation and high fire danger.

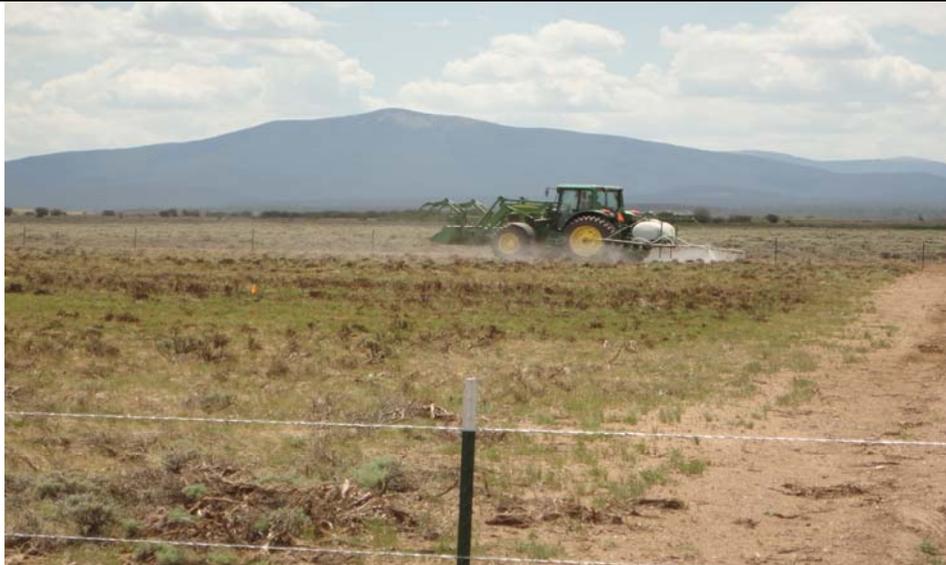
Subject: An orange pin flag marks the approximate centerline of the release area. Impacted brush and new vegetation growth can be seen in the photograph. The EarthSmarth hydrocarbon cleaner was used to aid in breaking down and reducing hydrocarbon concentrations.

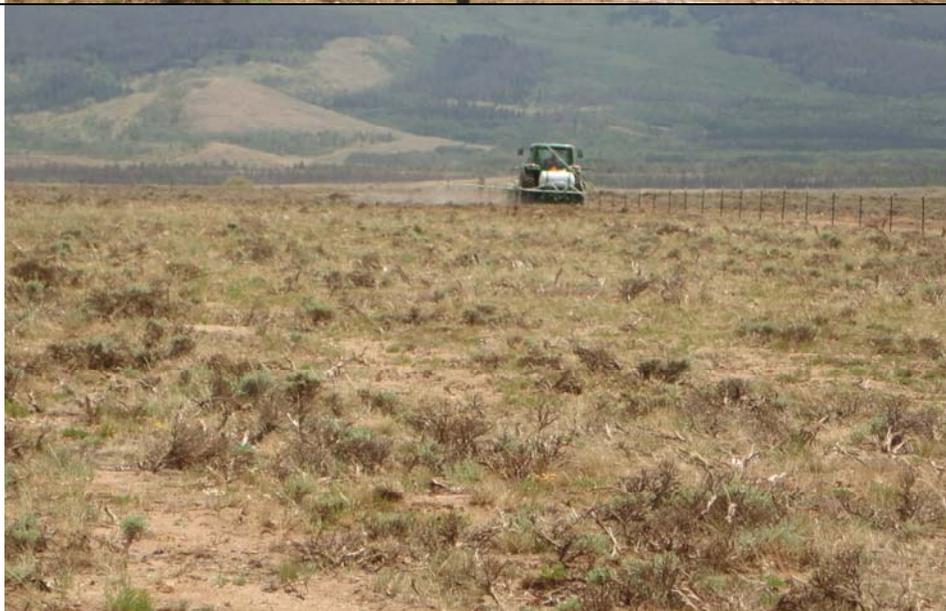
Subject: Photograph shows treatment of the south side of the release area and new growth of grasses and brush.

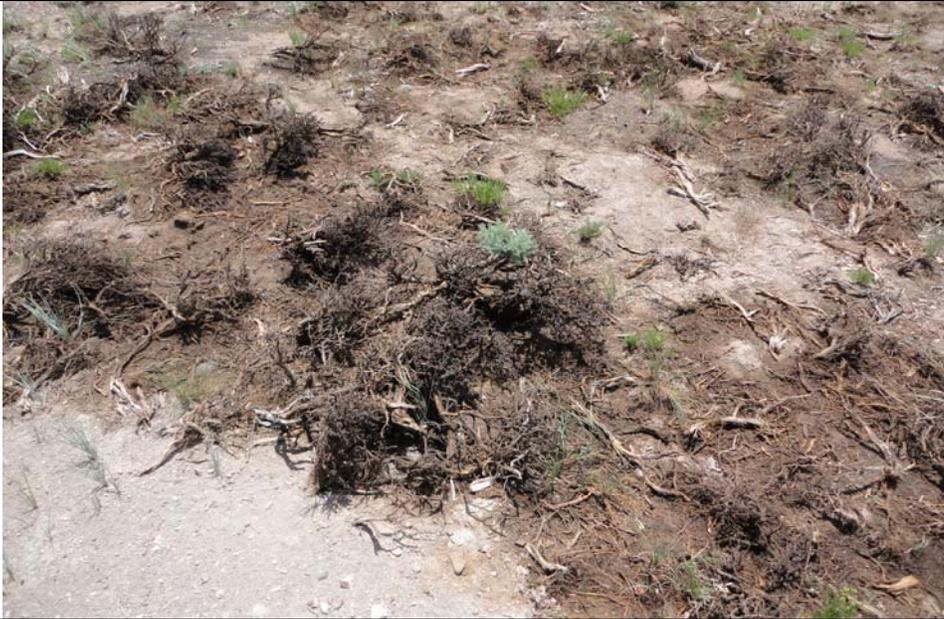
Subject: Stained soils were observed in the release area with the heaviest impact closest to the well pad. However, new vegetation growth was also observed.

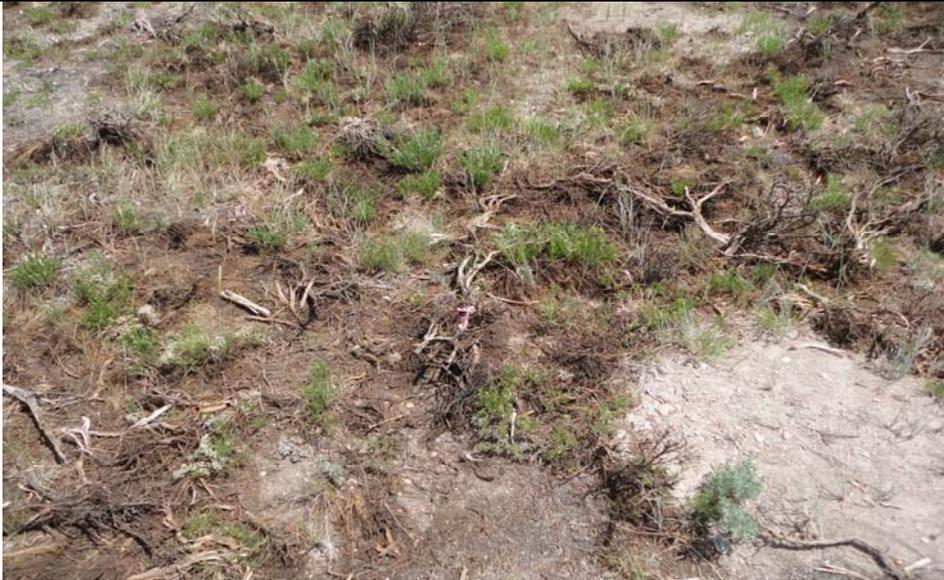
Subject: Photograph shows new vegetation growth in the vicinity of one of the April 2012 site characterization soil sample locations marked with flagging tape near the center of the photograph.

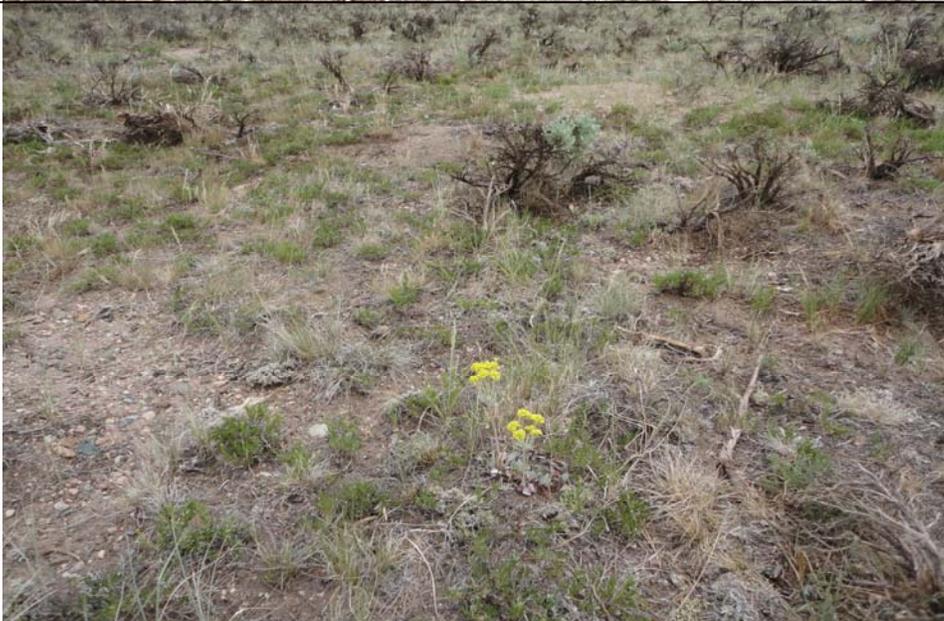
Subject: New vegetation growth and flowering plants were observed within the release area.

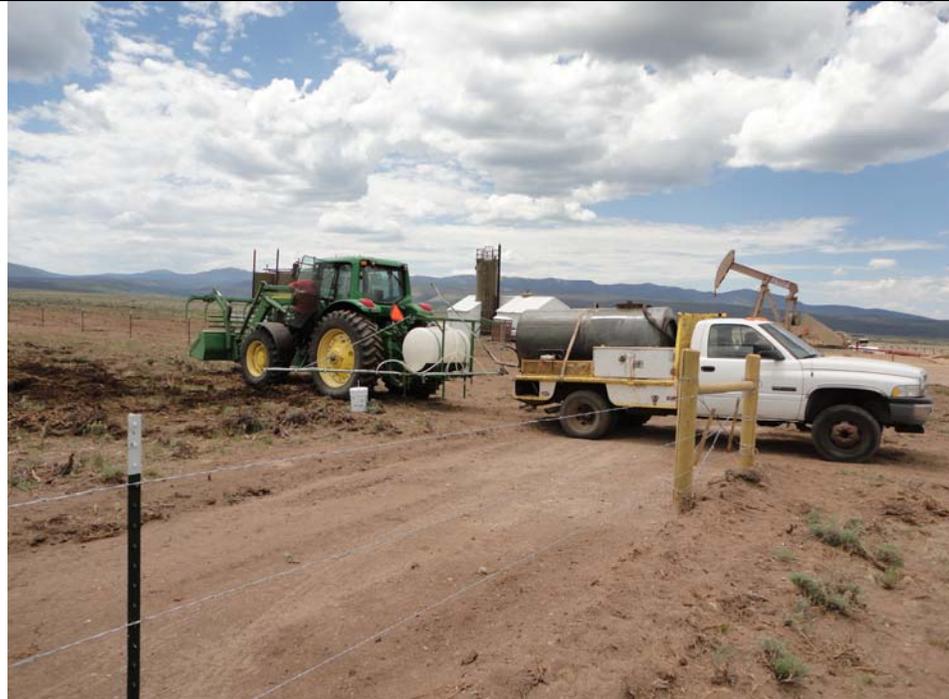
Subject: Water was obtained from a pond on the Fuqua Ranch and brought to the site in a 1,000-gallon capacity tank. The 150-gallon capacity polytank on the tractor was filled using one 5-gallon bucket and approximately 100-gallons of water for each mixture. The area was treated using two applications of the EarthSmart hydrocarbon cleaner solution.

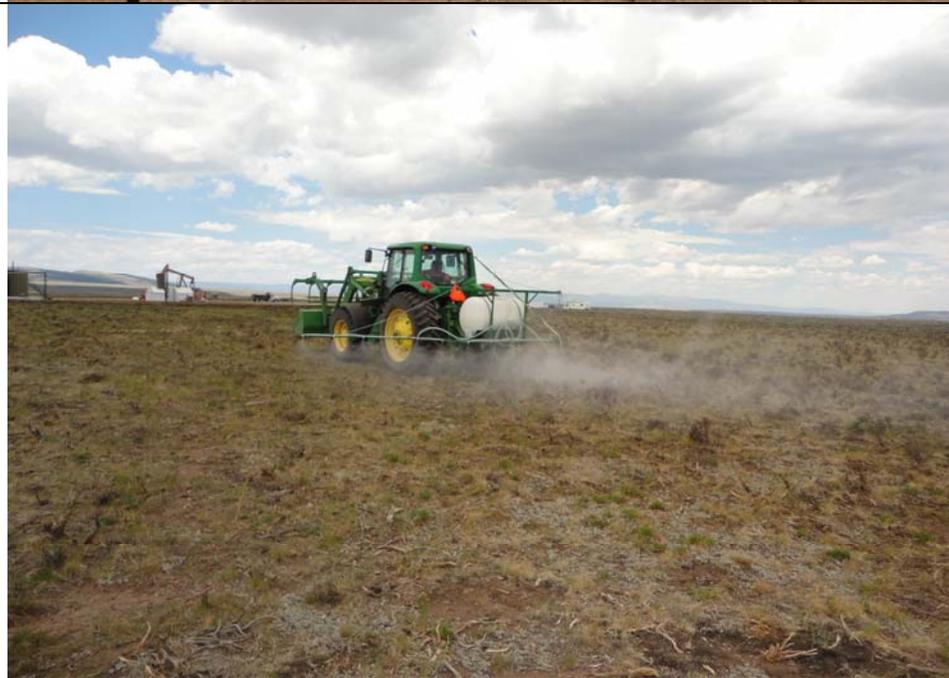
Subject: Photograph shows treatment of the release impact area.

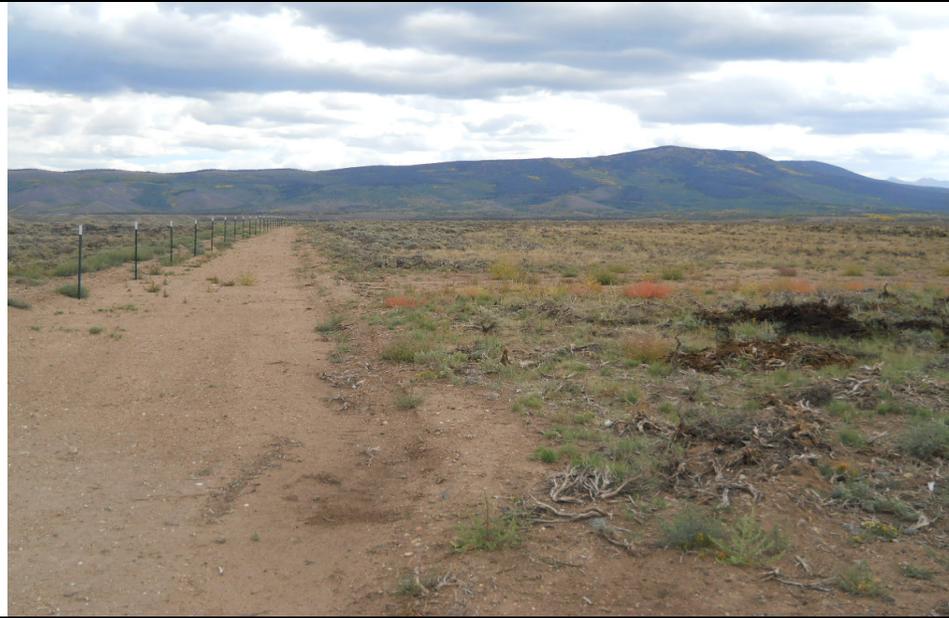
Subject: Laramie Energy II – Fuqua 18-15 photograph shows the January 29, 2012 separator release area and vegetation recovery and residual staining in September 2012 from the fire break and access road near the well pad.

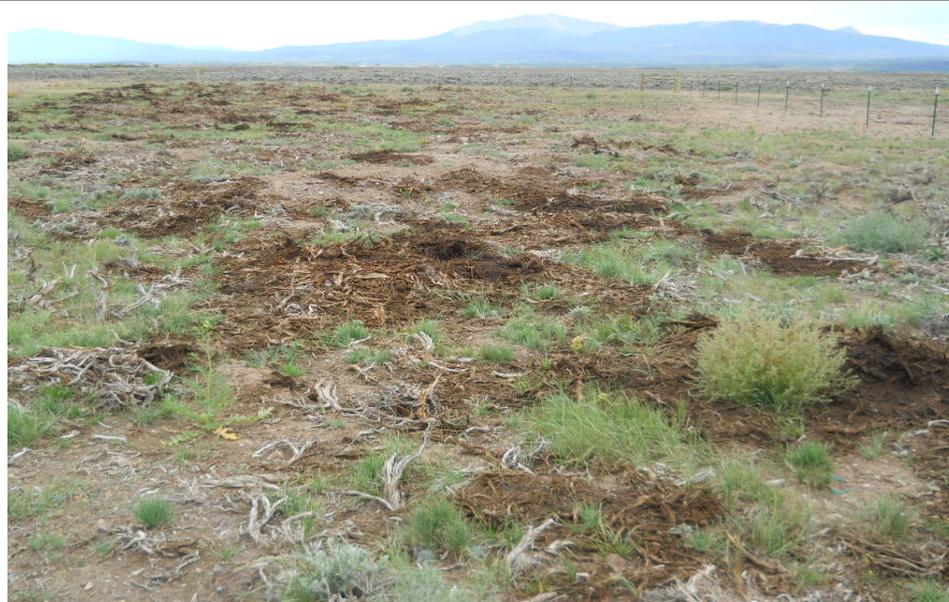
Subject: Laramie Energy II – Fuqua 18-15 separator release site photograph shows the release area with residual staining and vegetation recovery.

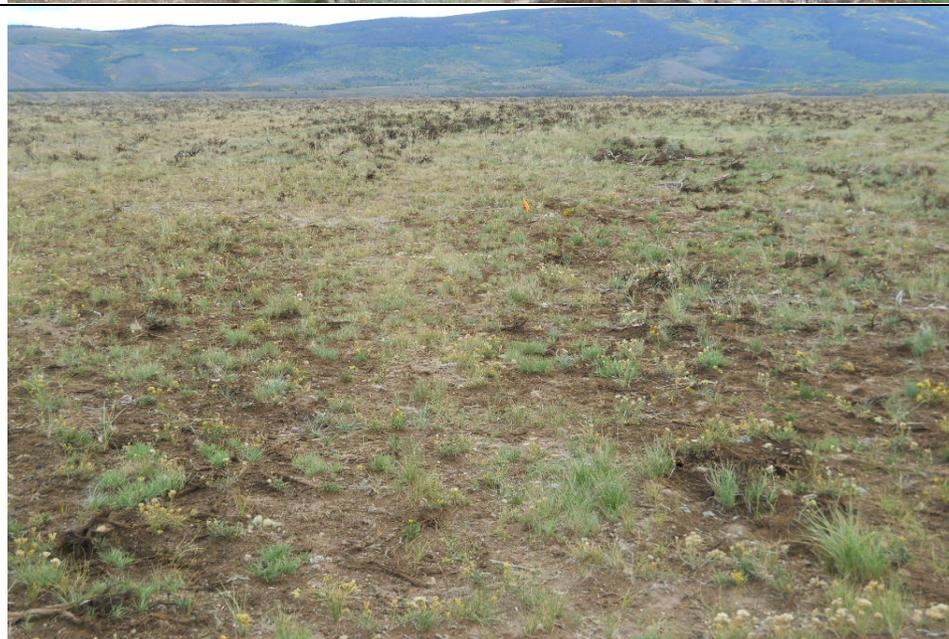
Subject: Laramie Energy II – Fuqua 18-15 separator release site photograph shows pin flag marking the approximate center line of the release following the June 26, 2012 biosurfactant treatment solution.

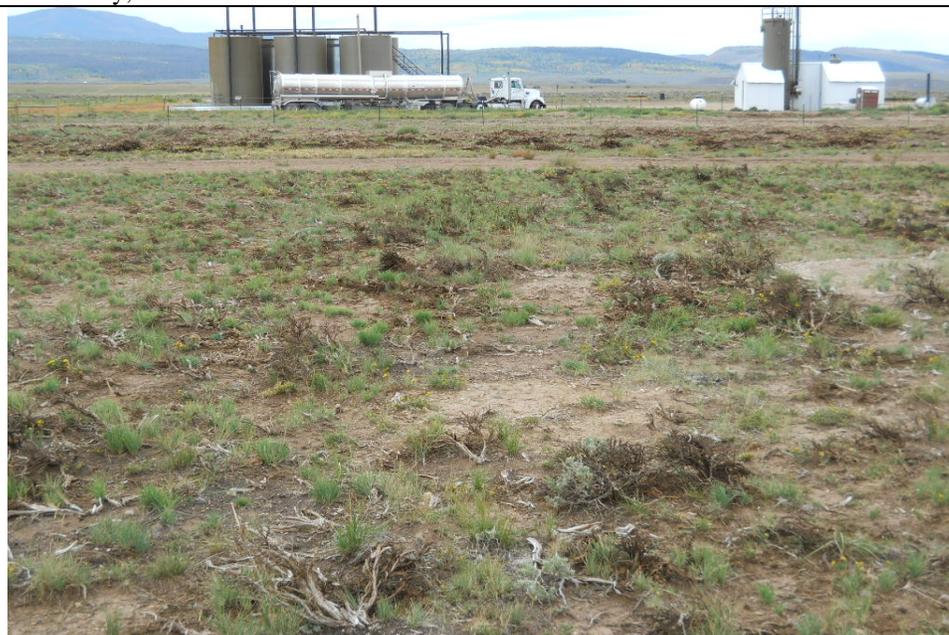
Subject: Laramie Energy II – Fuqua 18-15 Well pad January 29, 2012 release area showing the vertical separator in the upper right hand corner of the photograph. The area was treated with a water and biosurfactant solution on June 26, 2012.

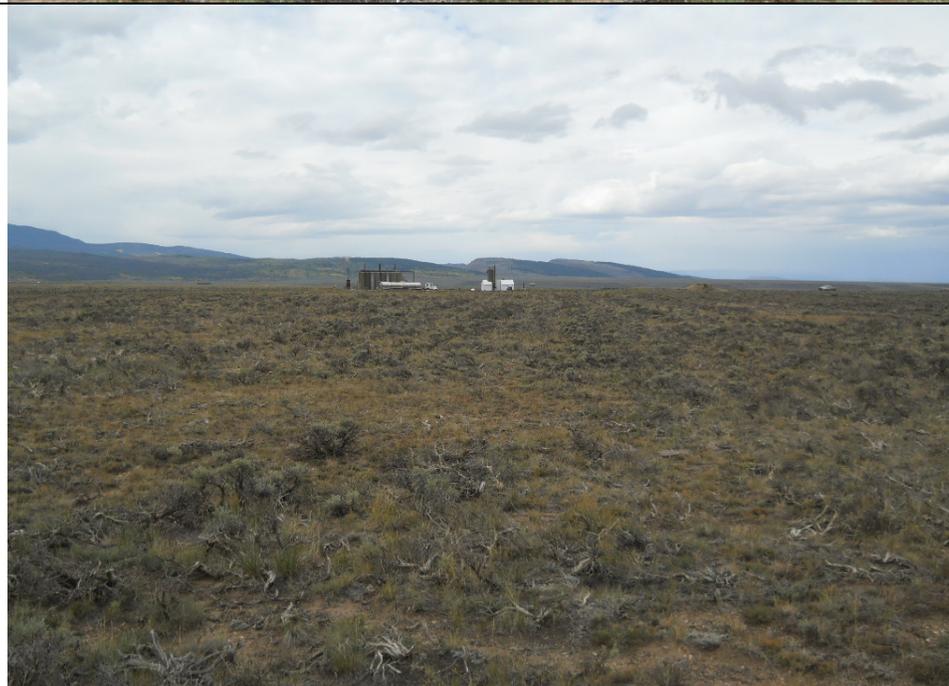
Subject: Laramie Energy II – Fuqua 18-15 Well pad January 29, 2012 release area showing the Fuqua 18-15 well pad in the background of the photograph.
