On Friday May 17, 2013, Kerry Guy, US Environmental Protection Agency, met Alex Fischer, Colorado Oil and Gas Conservation Commission, at the Lone Pine Gas, Inc. facility near Walden, CO., to inspect the petroleum contaminated soil piles stockpiled at the site. The soil piles are a result of historic pits that were recently excavated (within the last year) by Lone Pine under the oversight of COGCC. To a much lesser extent, some contaminated soil and vegetation were caused by removal activities associated with a December 15, 2011, discharge of crude oil from the Lone Pine battery and treatment facility.

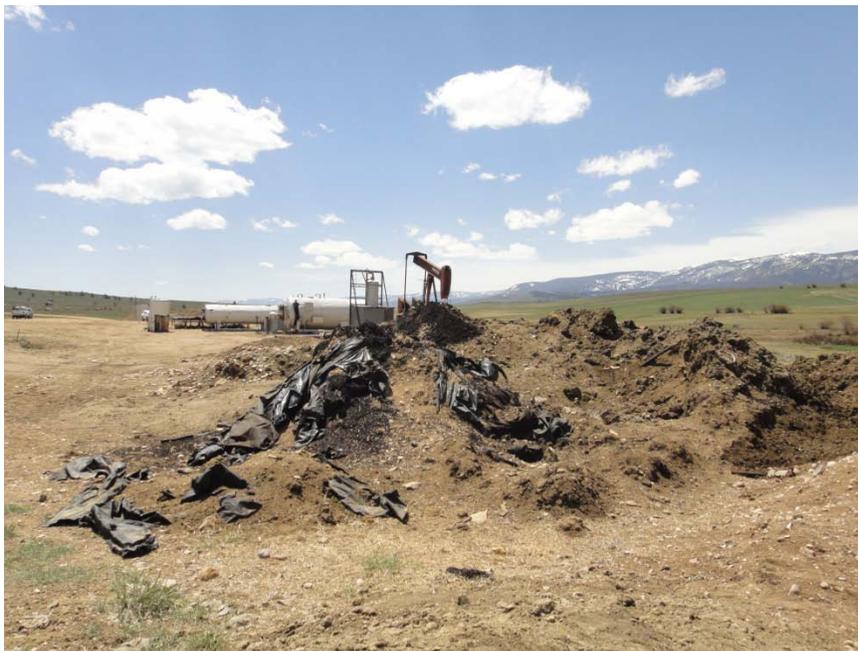
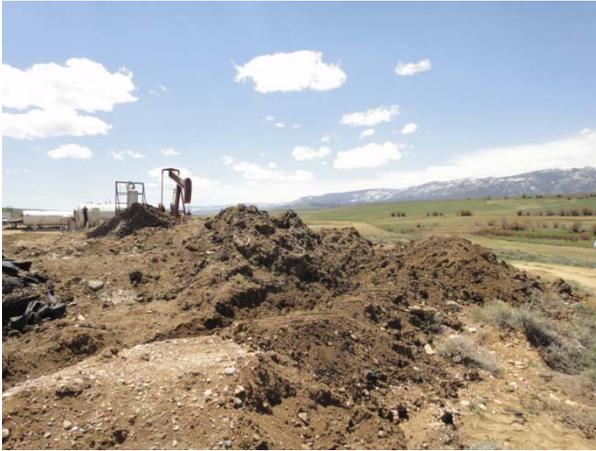
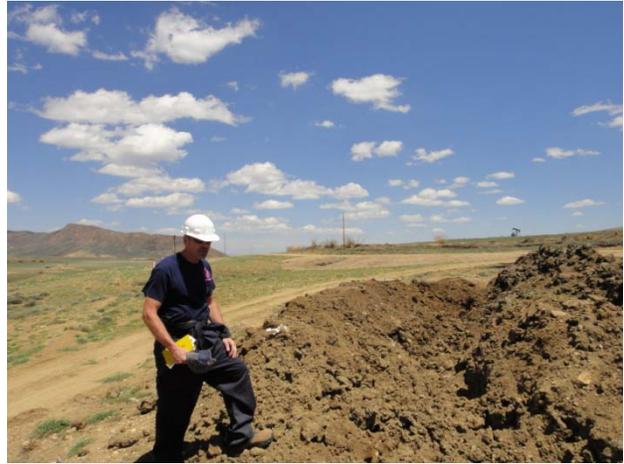
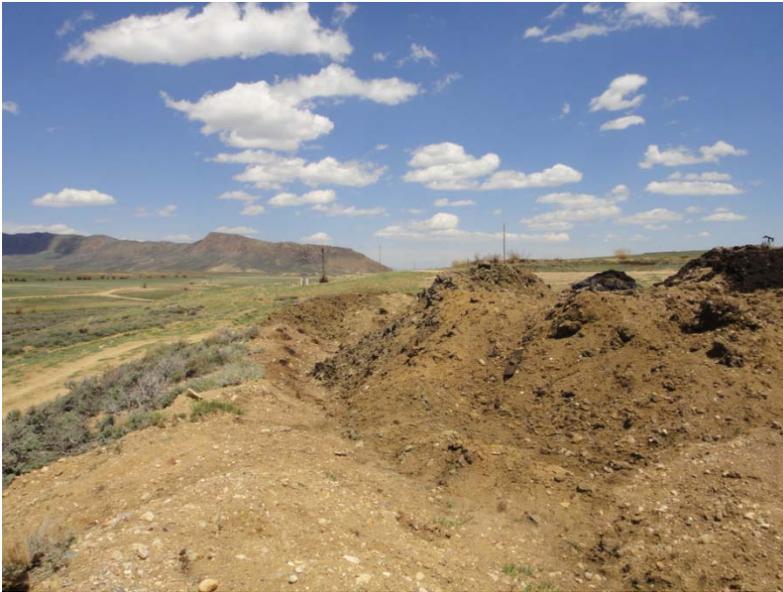
Soil Pile 1 (looking from the north, the berm terminates on the north side of the pile---bottom of picture)

Soil Pile 1 encroaches onto the northwest side of the berm. As seen in the inspection photographs, contaminated soil lies on the outside slope of the berm--most pronounced on the northwest corner. The pile needs to be pulled back from the berm, consolidated and shaped, and contaminated soil scrapped off the inside and outside slopes of the berm and placed within the re-shaped soil pile. Sufficient freeboard (recommended 3 feet) above the pad needs to be created to retain large precipitation event runoff... A minimum three to five foot corridor between the berm and the pile

should be created for this purpose. The berm itself requires buildup in several locations where it is low. The entire berm needs to be cleared of vegetation, built up as necessary-both height and sidewalls, extended sufficiently around the north side of the soil pile, and sufficiently compacted. There is approximately 150-200 linear feet of berm requiring restoration as described above for Soil Pile 1.

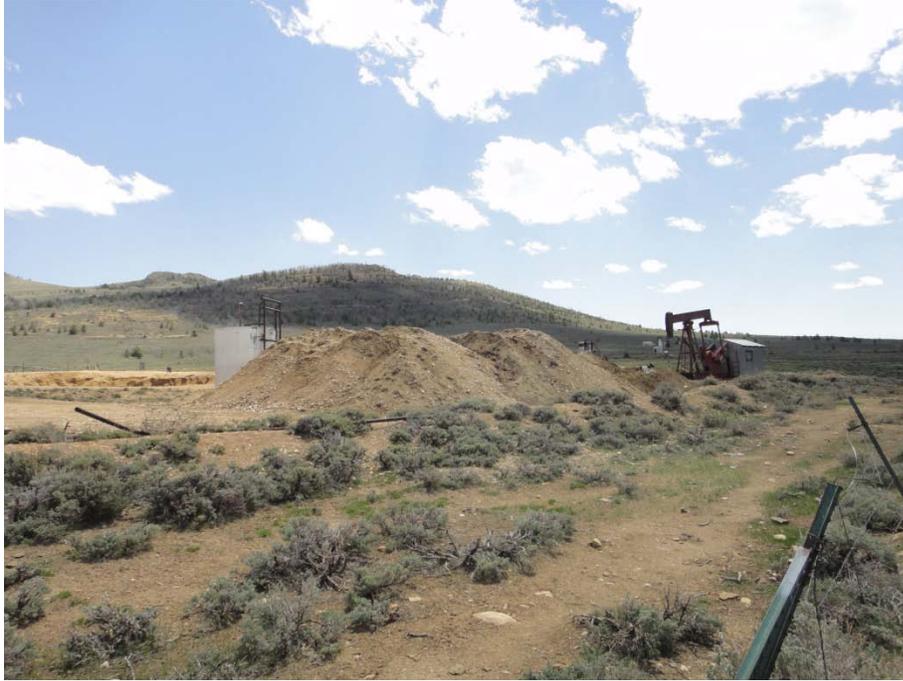
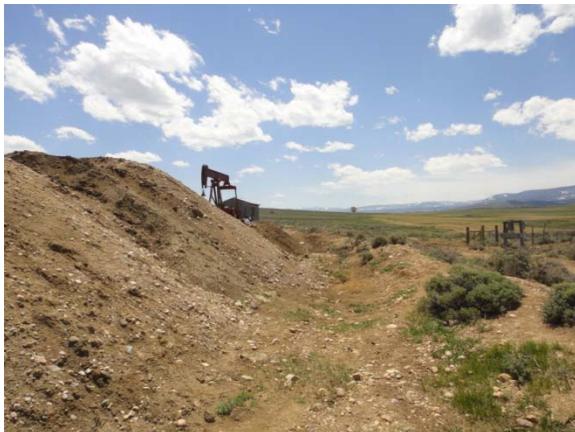
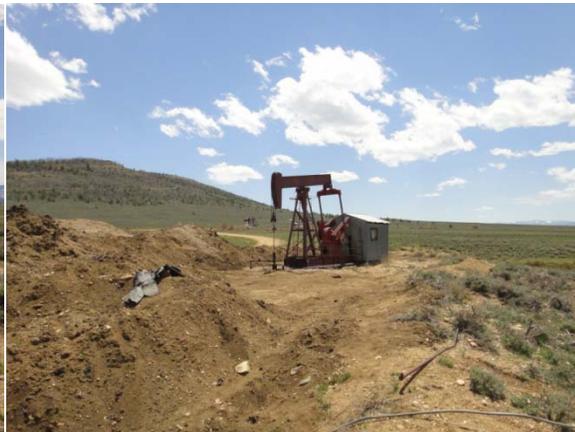
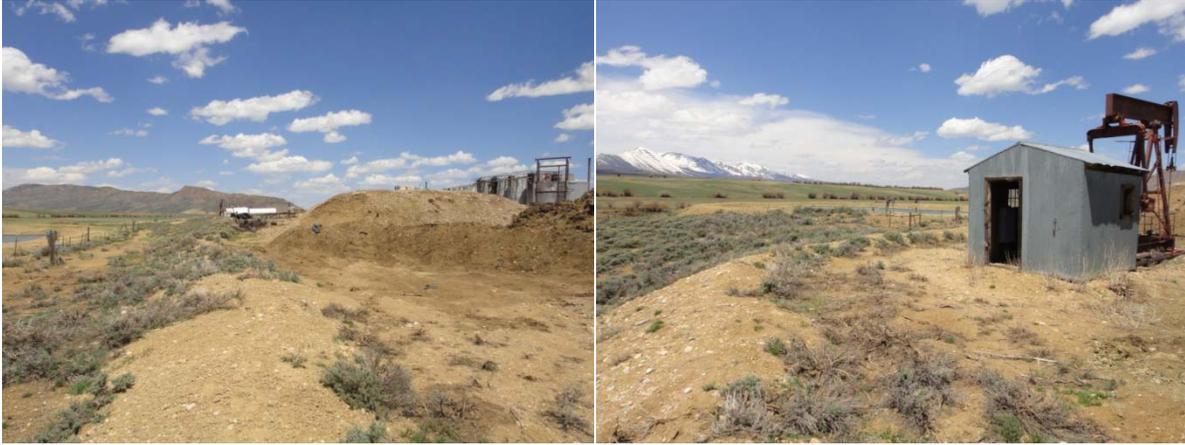
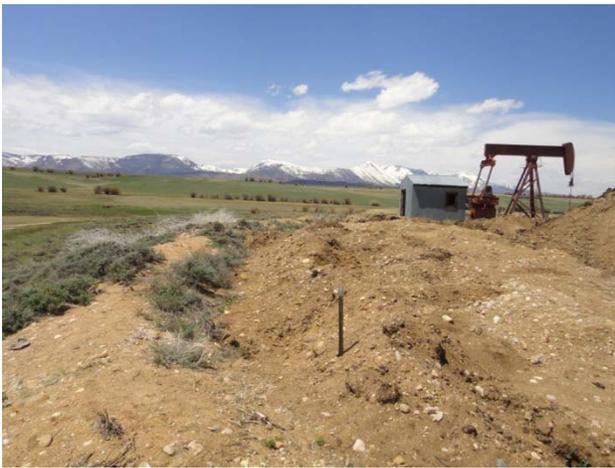
Soil Pile 2 (looking east from the west side of pad)

Soil Pile 2 does not encroach upon the berm to the extent as Soil Pile 1; however, it needs to be pulled back in places and sufficient space provided for water retention/ponding between the berm and pile. The berm is low in several locations and also has significant vegetation and animal burrow holes. Contaminated soil from the pile should be pulled away from the berm. The berm should be cleared of vegetation, built up to minimum height of 3 feet above the pad, extended to cover the south side of the soil pile, and compacted appropriately. There is approximately 225-250 linear feet of berm involved in the above berm restoration maintenance work.

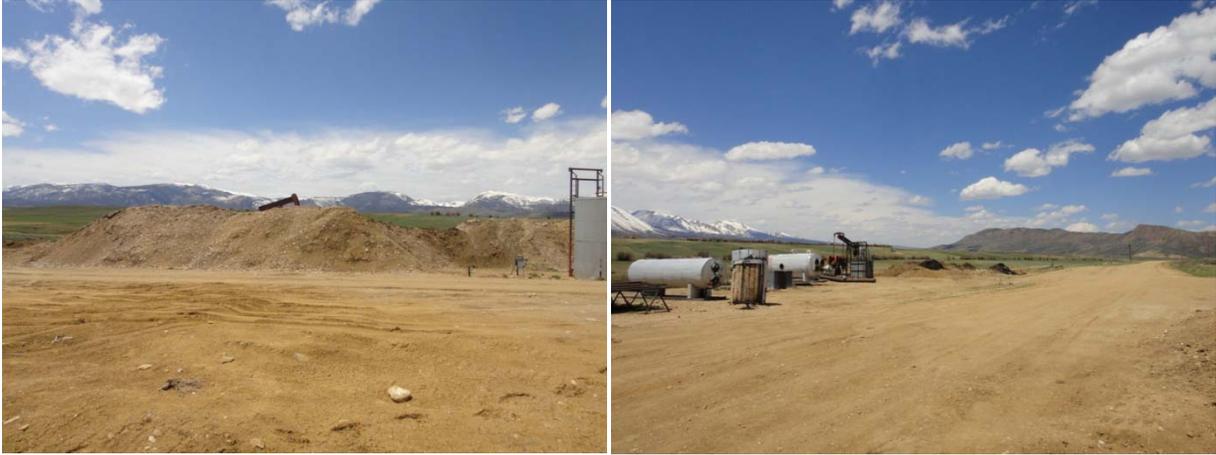
Up-gradient (east of the piles)

Looking west from upslope of the piles on the pad (note: the access road goes through middle of pad).
