Subject: **Excavation Report**
 Prebish #2
 SWNW Sec 20, T4N, R64W
 API # 05-123-12068
 Weld County, Colorado
 Fremont Project No. C013-029
 Facility ID# 322794

EXCAVATION REPORT
NOBLE ENERGY INC.
PREBISH #2
WELD COUNTY, COLORADO
FREMONT PROJECT NO. C013-029

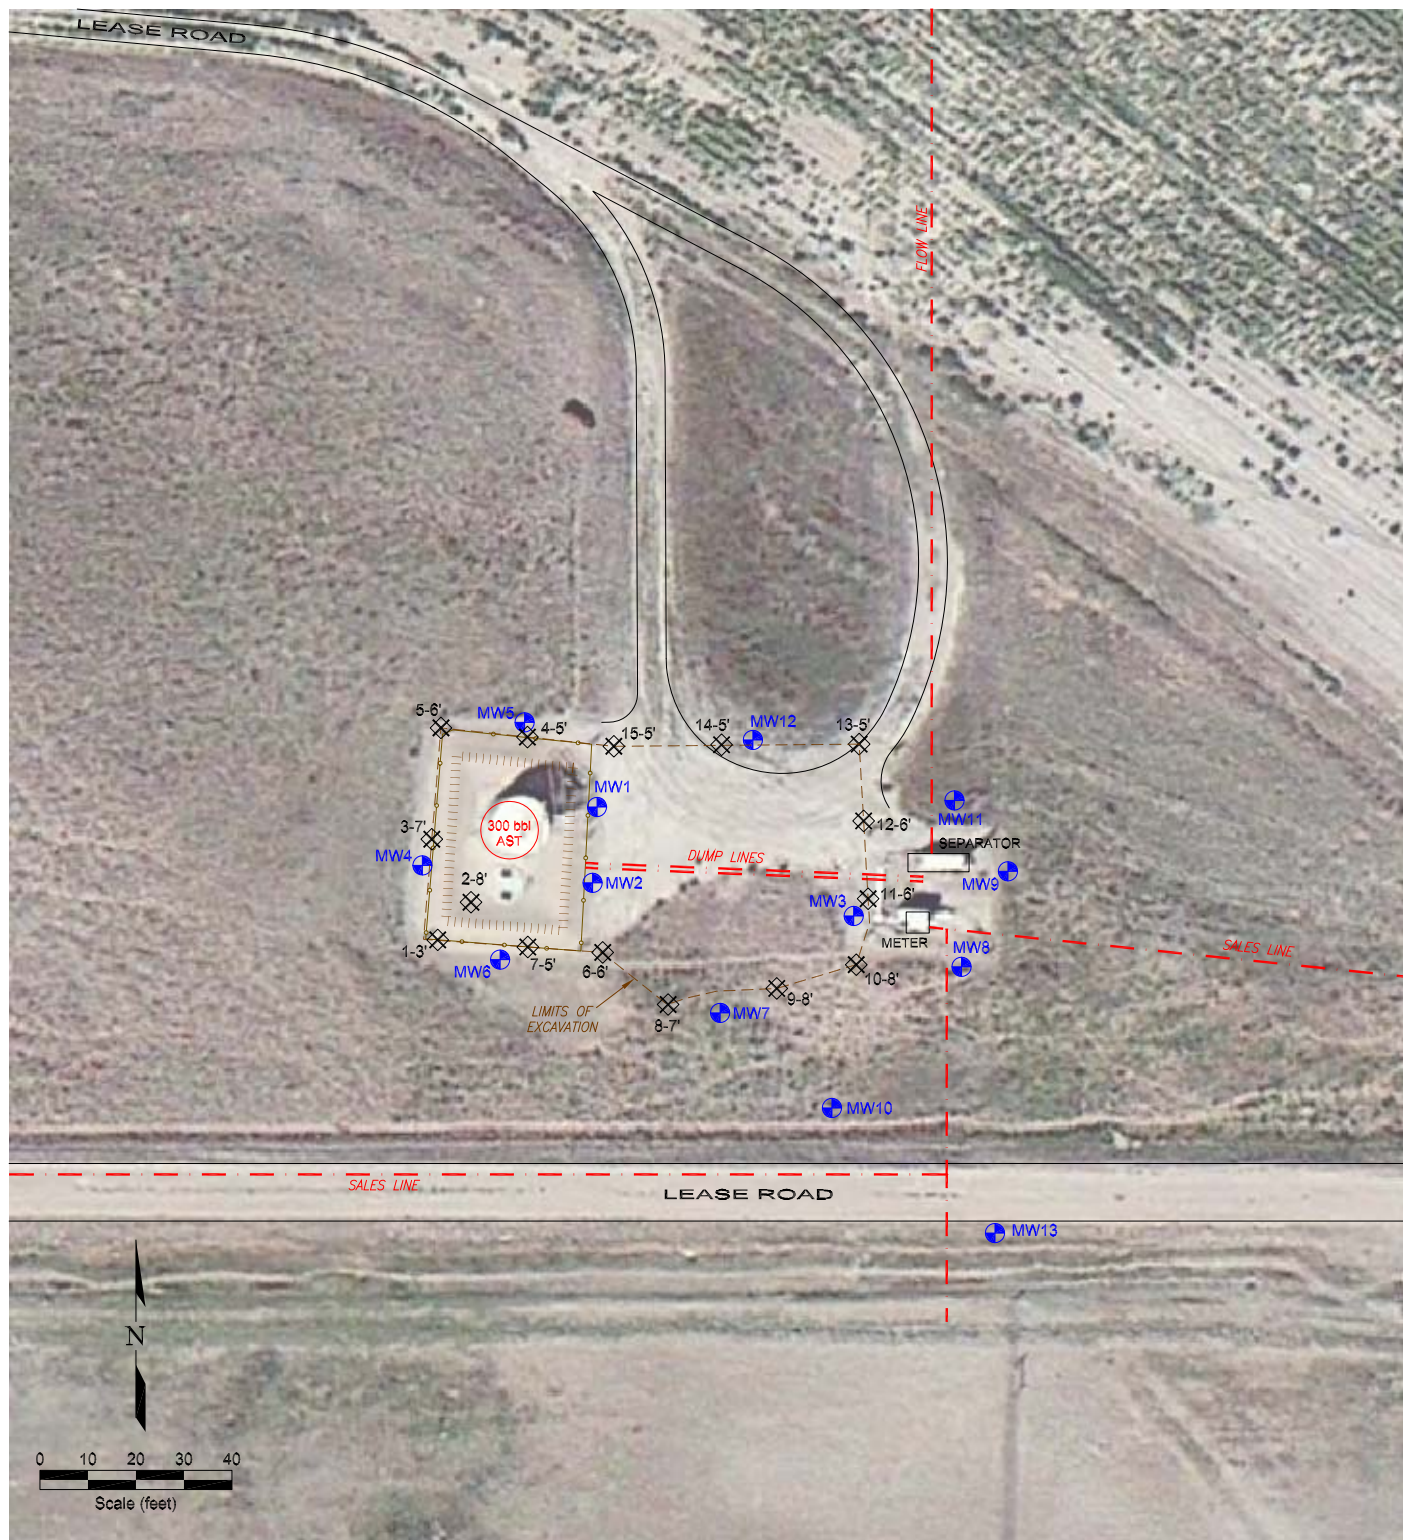
Figure 2

The facility is located in an agricultural area 0.4 miles south of County Road 44 and 0.1 miles southeast of County Road 51. The location is further described as the SW $\frac{1}{4}$ of the NW $\frac{1}{4}$ of section 20, township 4N, range 64W. A Site Map is included as Figure 2.

Between September 20 and September 26, 2013, remediation efforts at the site consisted of the excavation of petroleum-impacted soil. Although ground water was present in the monitoring wells, the flow into the open excavation was very limited. As a result, the excavation was able to proceed to a maximum depth of eight feet where clean soil was encountered near the former water vault. The excavated area is shown on Figures 2 and 3.

SITE MAP

September 20, 2013 (Day 1) – Excavation of the site was initiated near the location of the former concrete water pit and remained within the bermed area as shown on Figure 2. Soil removal was conducted to the north and the south of the former pit. Four wall samples (1-7’, 3-7’, 4-5’, and 5-6’) and one floor sample (2-8’) were collected and submitted to the laboratory during the first day of excavation. Approximately 470 cubic yards of impacted soil were removed and transported to the landfill. Monitoring wells MW-1 and MW-2 were destroyed during the excavation work.
