**SITE INVESTIGATION AND REMEDIATION WORKPLAN**

# **EXCAVATION REPORT**

Orr E 19-05  
Weld County, Colorado

Subject:       **Excavation Report**  
                  Orr E 19-05  
                  API # 05-123-26397, Release Tracking # 2148159  
                  Weld County, Colorado

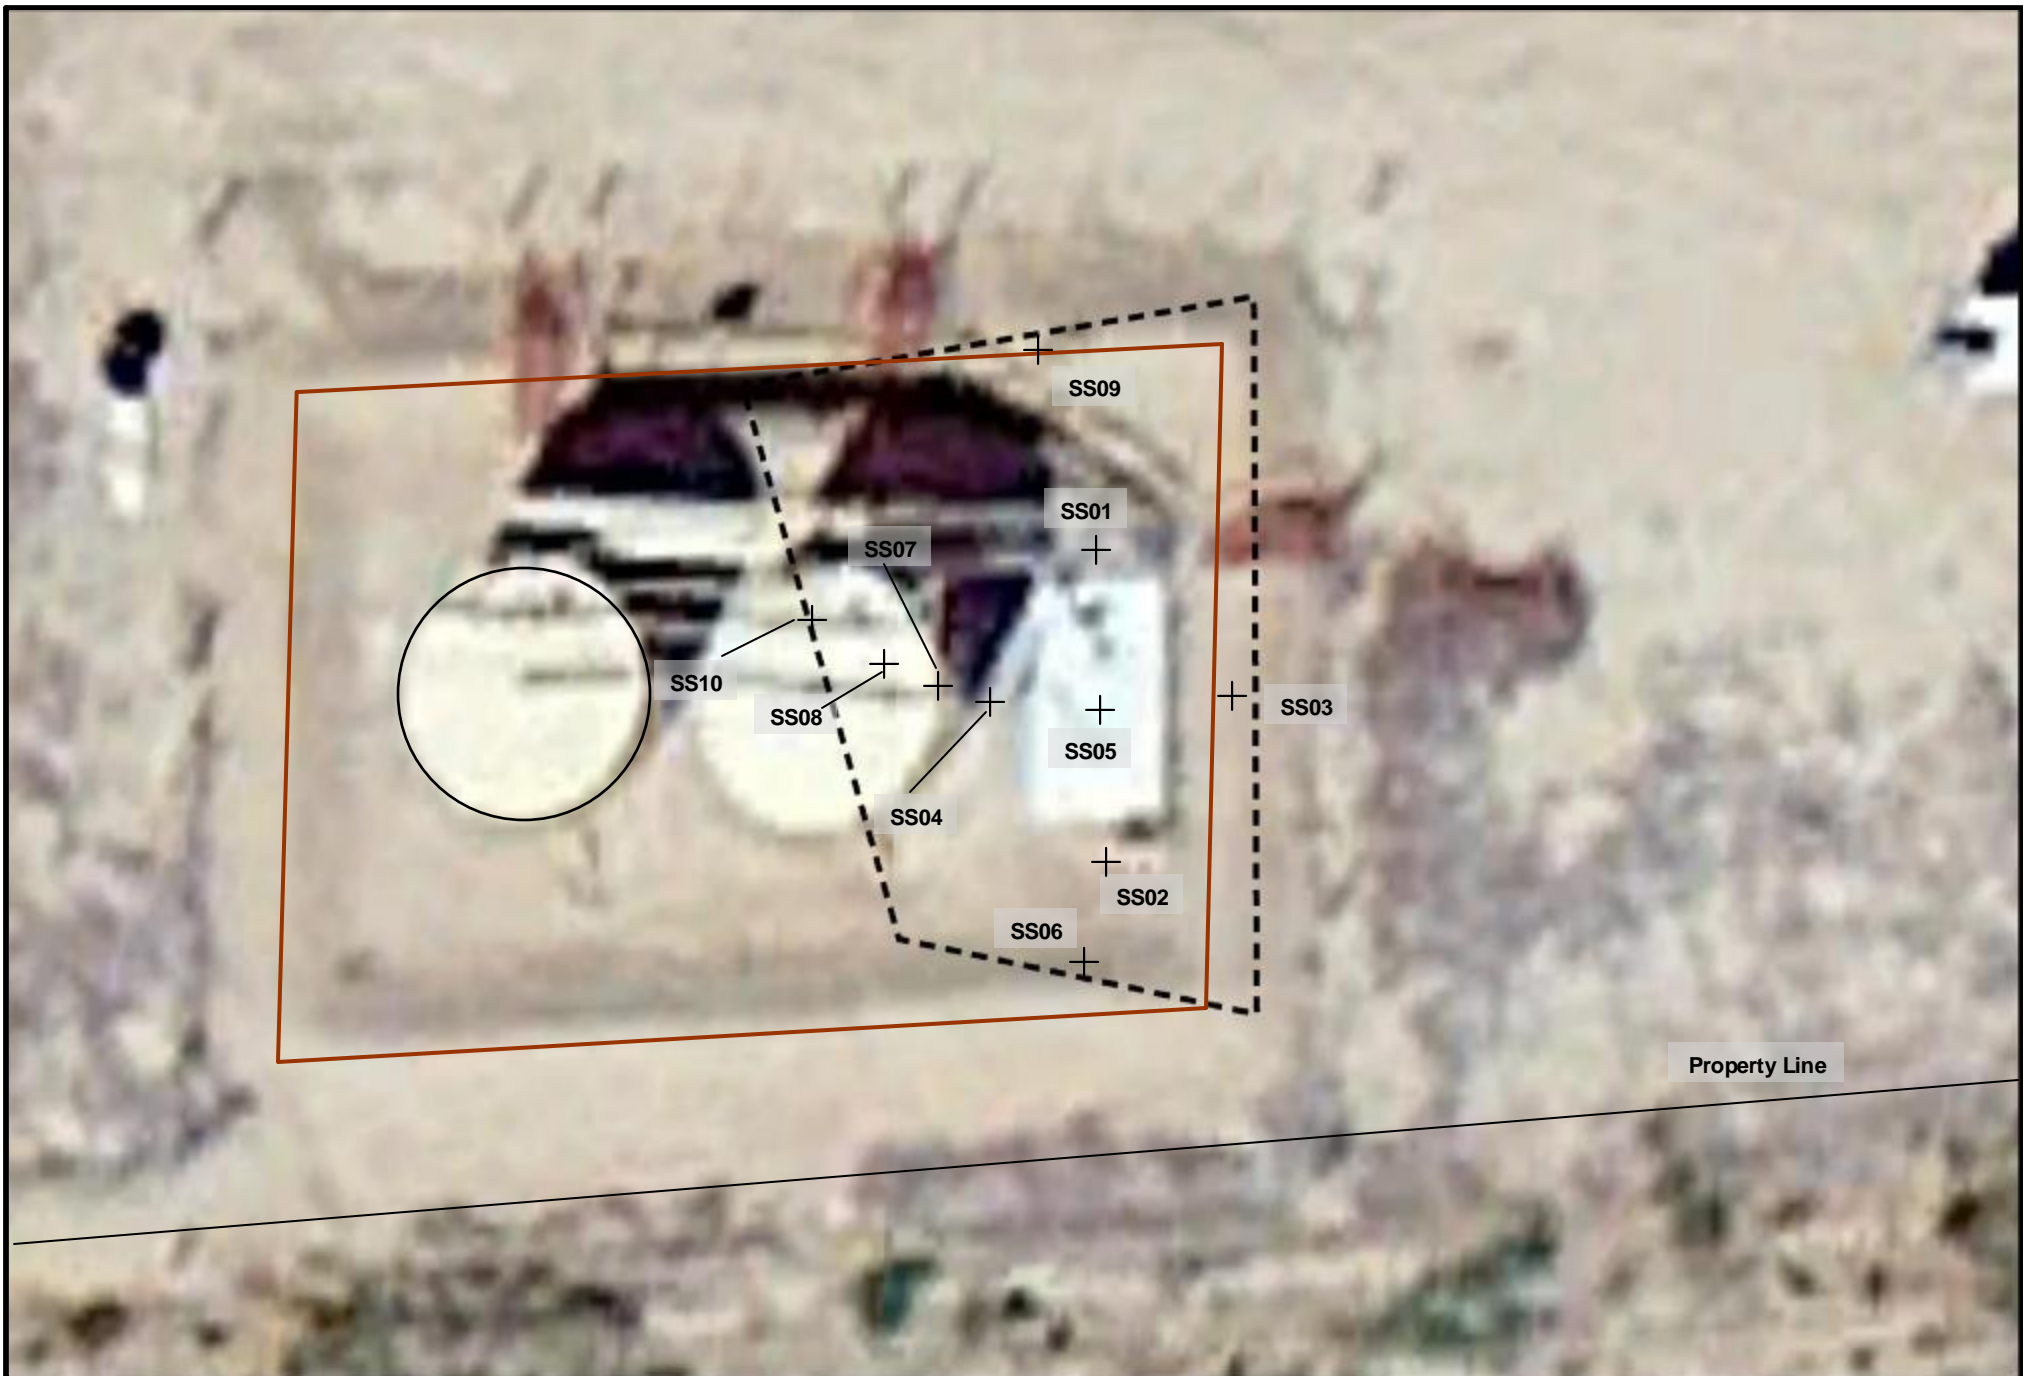
Excavation Extent & Soil Sample Locations  
 Figure 2

Excavation activities were initiated on March 31, 2014 and continued through April 1, 2014. Soil removal activities produced an excavation with final dimensions of approximately 18 feet (ft.) by 30 ft. by 13 ft. below ground surface (bgs) (Figure 2). Approximately 260 cubic yards of impacted soil was removed from the Site and taken to North Weld Landfill for disposal, and clean fill soil was then returned to the site. Sixteen soil samples were collected from the sidewalls of the excavation and one soil sample was taken from the base of the excavation at 13 feet bgs. Samples were field screened with a photoionization detector (PID), and four perimeter and one base sample with PID values ranging between 3.4 ppm and 19.6 ppm were retained for laboratory confirmation analysis. Samples were submitted to eAnalytics Laboratory in Loveland, Colorado, for analysis of BTEX, naphthalene, TPH-GRO, and TPH-DRO.

**Facility Diagram**  
 Noble Energy  
 Orr E 19-05  
 Weld County, CO

Excavation Extent (Surveyed Via Trimble Unit)

Soil confirmation sample analysis indicated that confirmation samples collected from the final extent of the excavation were below applicable Colorado Oil and Gas Conservation Commission (COGCC) standards. These data are presented in Table 1. Groundwater was not encountered during excavation activities.

Laboratory data indicate that BTEX, naphthalene, TPH-GRO, and TPH-DRO concentrations are below the applicable COGCC Table 910-1 standards for soil samples collected from the final extent of the excavation. Based on field observations and laboratory analytical confirmation, impacted media with constituent concentrations above the applicable standards was successfully removed from the Site. As such, a no further action designation for the Site is appropriate.
