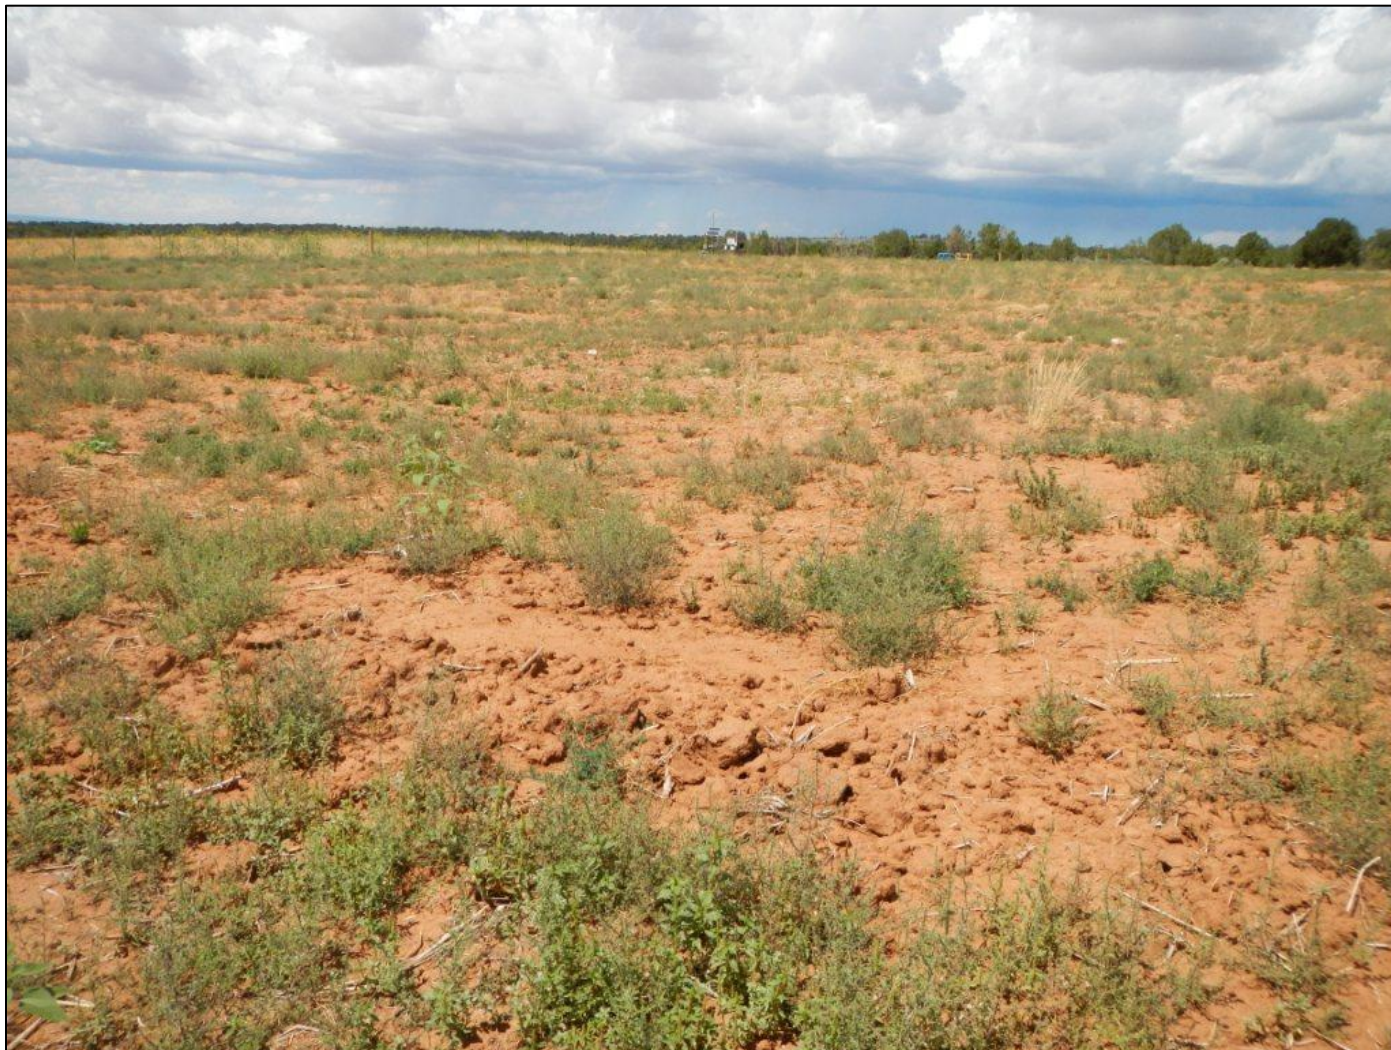
Photo 1. View from southeastern corner of well pad toward center. Vegetation is largely redroot pigweed and Russian thistle.

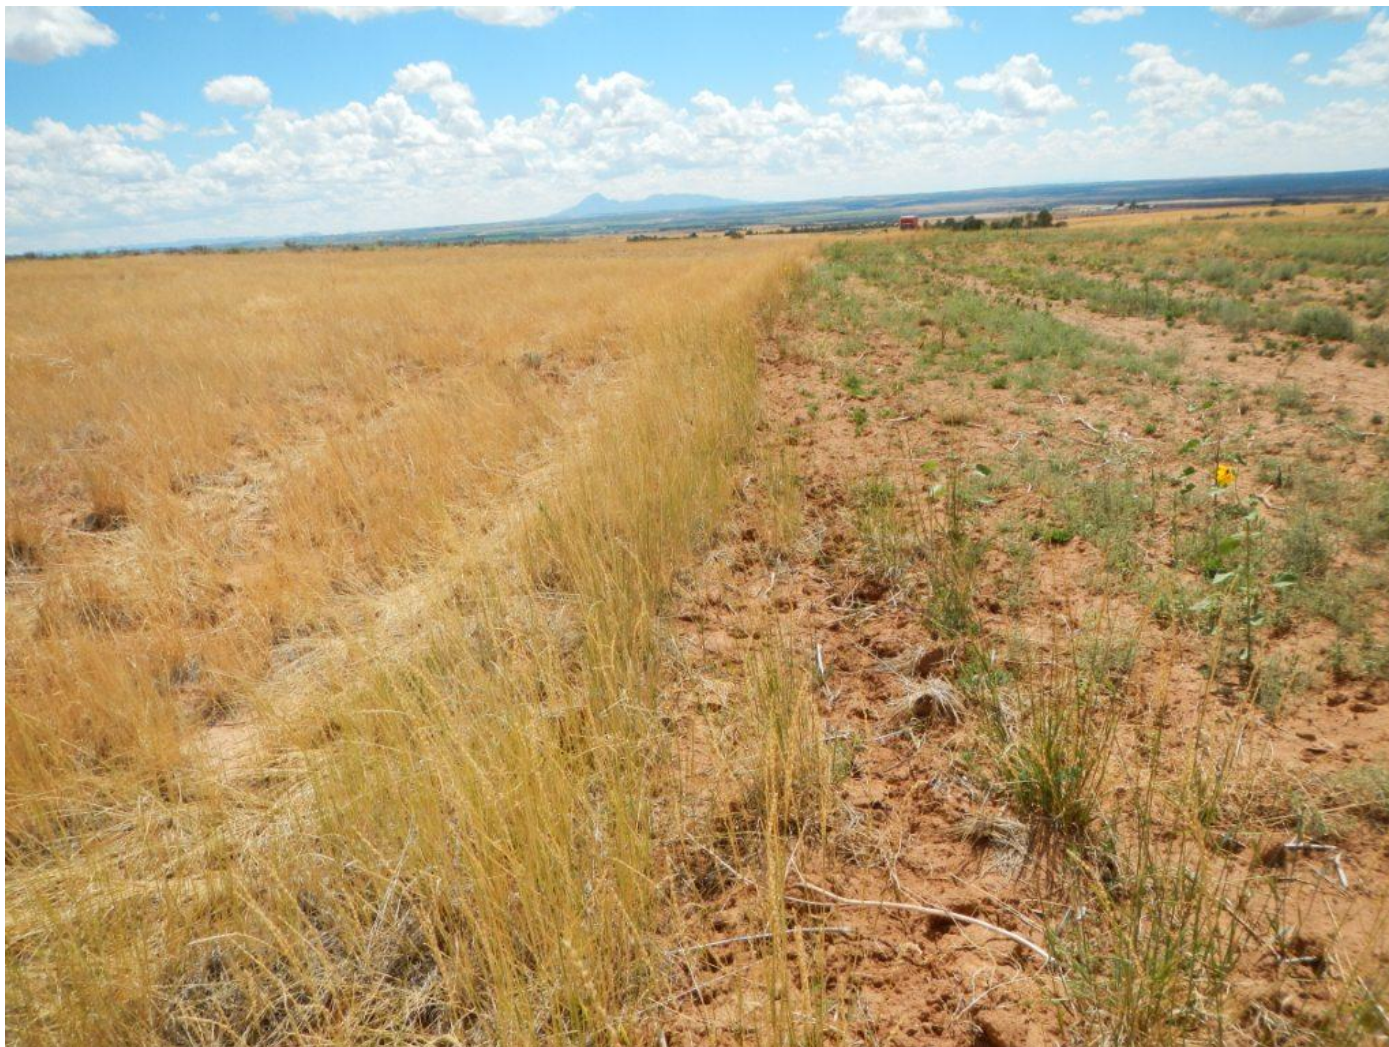
Photo 2. View of eastern edge of well pad with grassy pasture off of well pad, on left ,and weedy vegetation on well pad, on right.

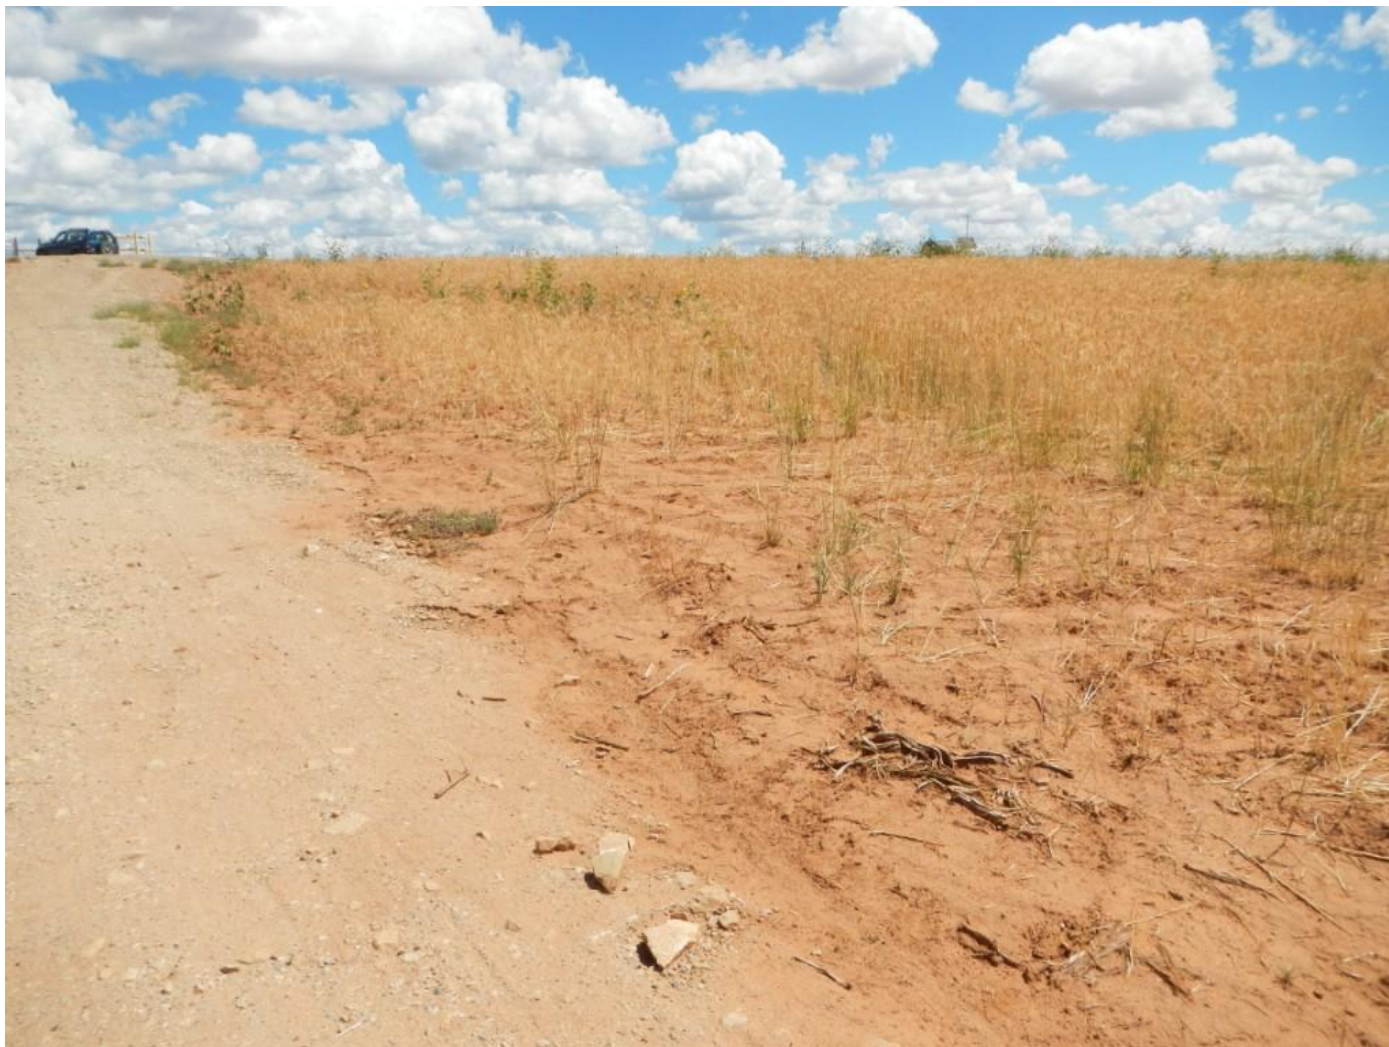
Photo 3. View from northwestern corner of well pad toward center. Revegetation on western side of interim reclamation area is largely wheat and sunflower.

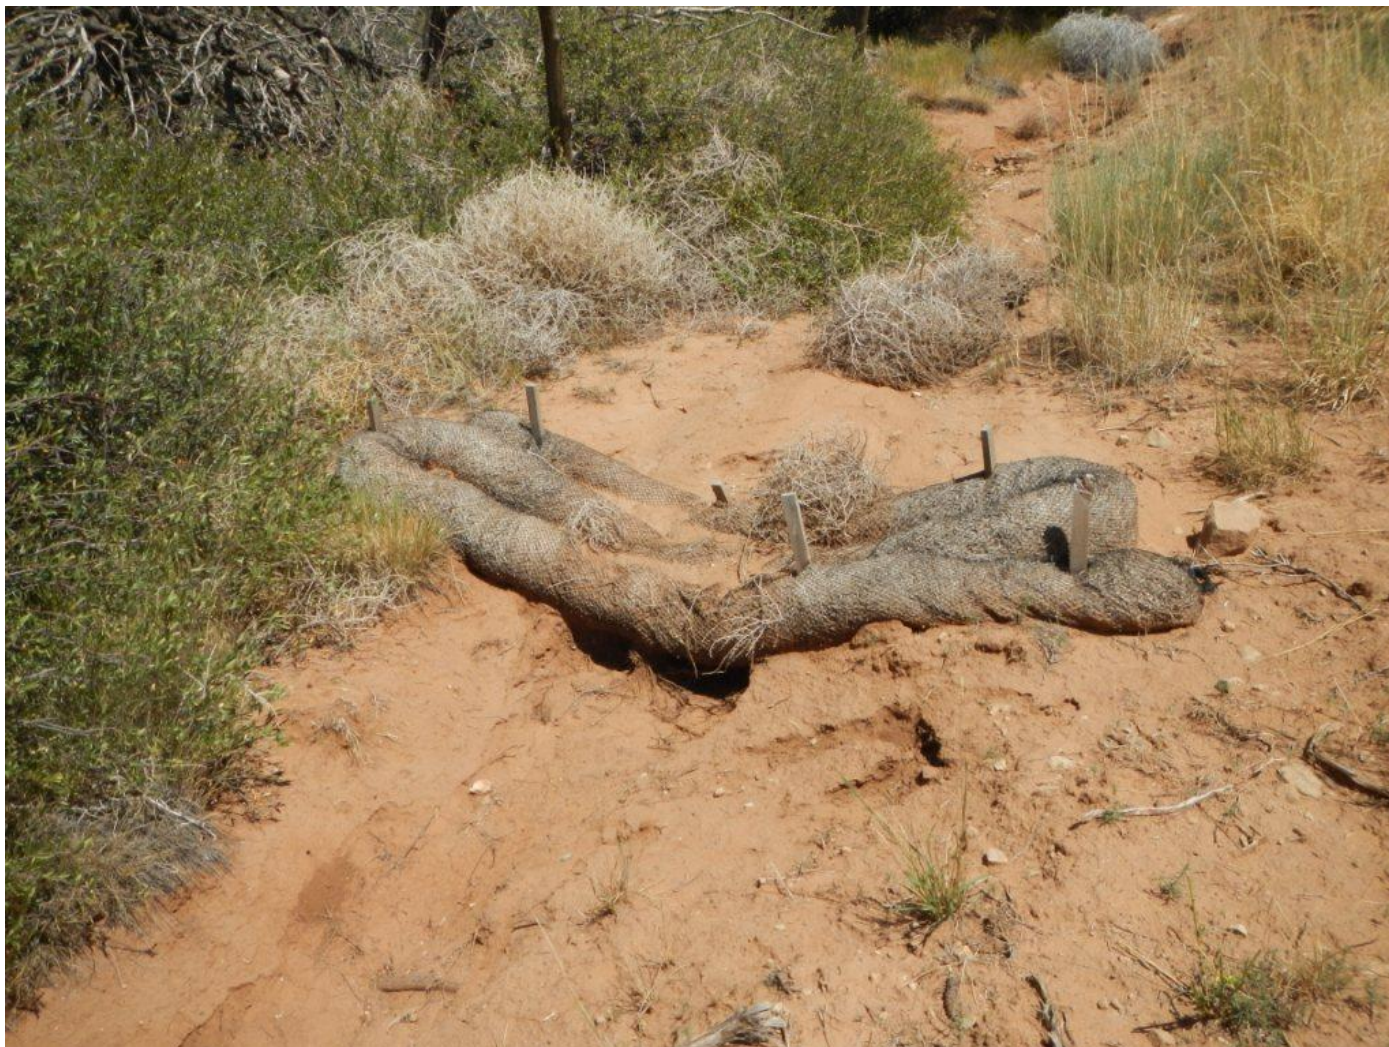
Photo 4. View of failed straw wattle on northern side of access road, downstream of well pad and rock check dams.

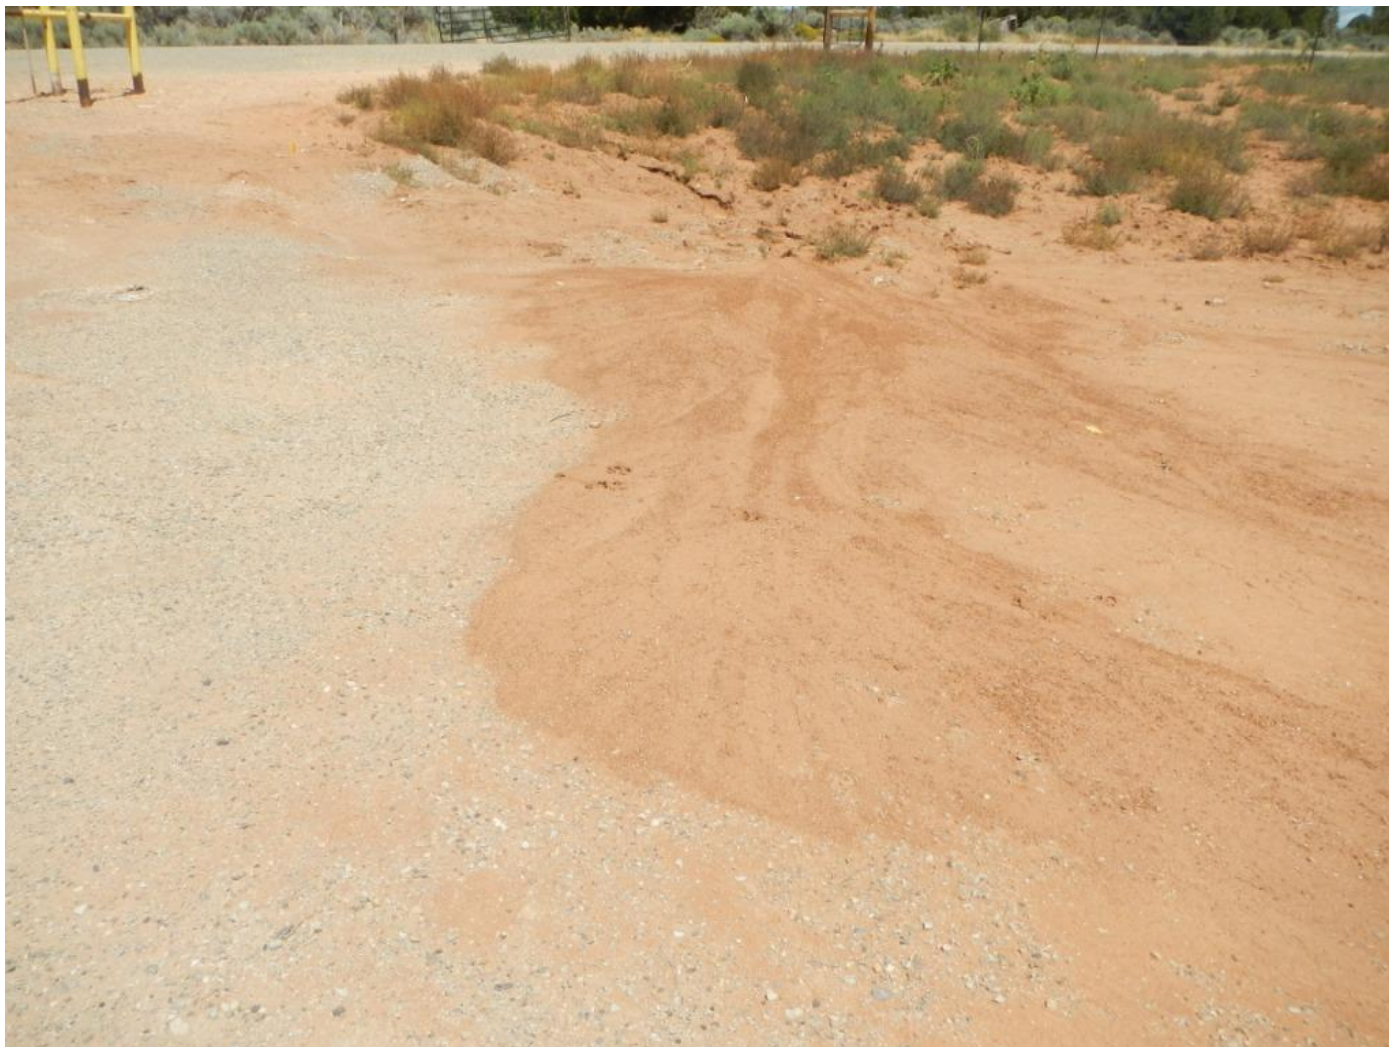
Photo 5. View of sediment discharge onto the well pad adjacent to the access road at the entrance to the well pad.
