**Field Assessment and Excavation Report
Pergola #1-15 – Water Vault Release
NE $\frac{1}{4}$ SE $\frac{1}{4}$ SEC.15 T1S R68W 6PM
39.963000/-104.981439
Adams County, Colorado
API # 05-001-08797**

Eagle Environmental Consulting, Inc. (EAGLE) is pleased to present this Field Assessment and Excavation Report for the above referenced site.

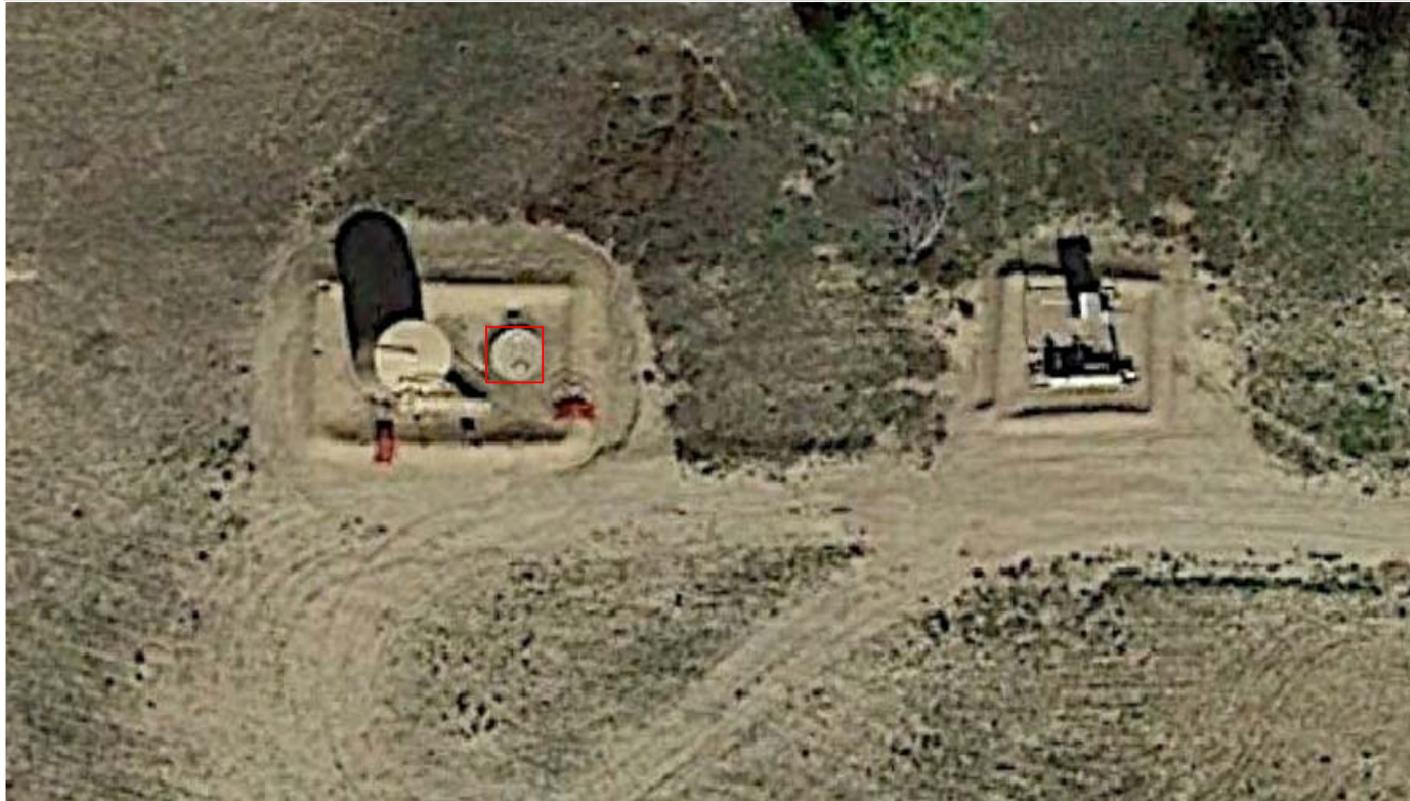
FIG. NO. 2
 DRAWN BY: amn

APPROXIMATE LOCATION OF REMOVED WATER VAULT

AERIAL SITE LOCATION MAP
 PERGOLA #1-15 - WATER VAULT RELEASE
 39.963000/-104.981439
 NE1/4 SE1/4 SEC.15 T1S R68W 6PM
 ADAMS COUNTY, COLORADO
 API # 05-001-08797

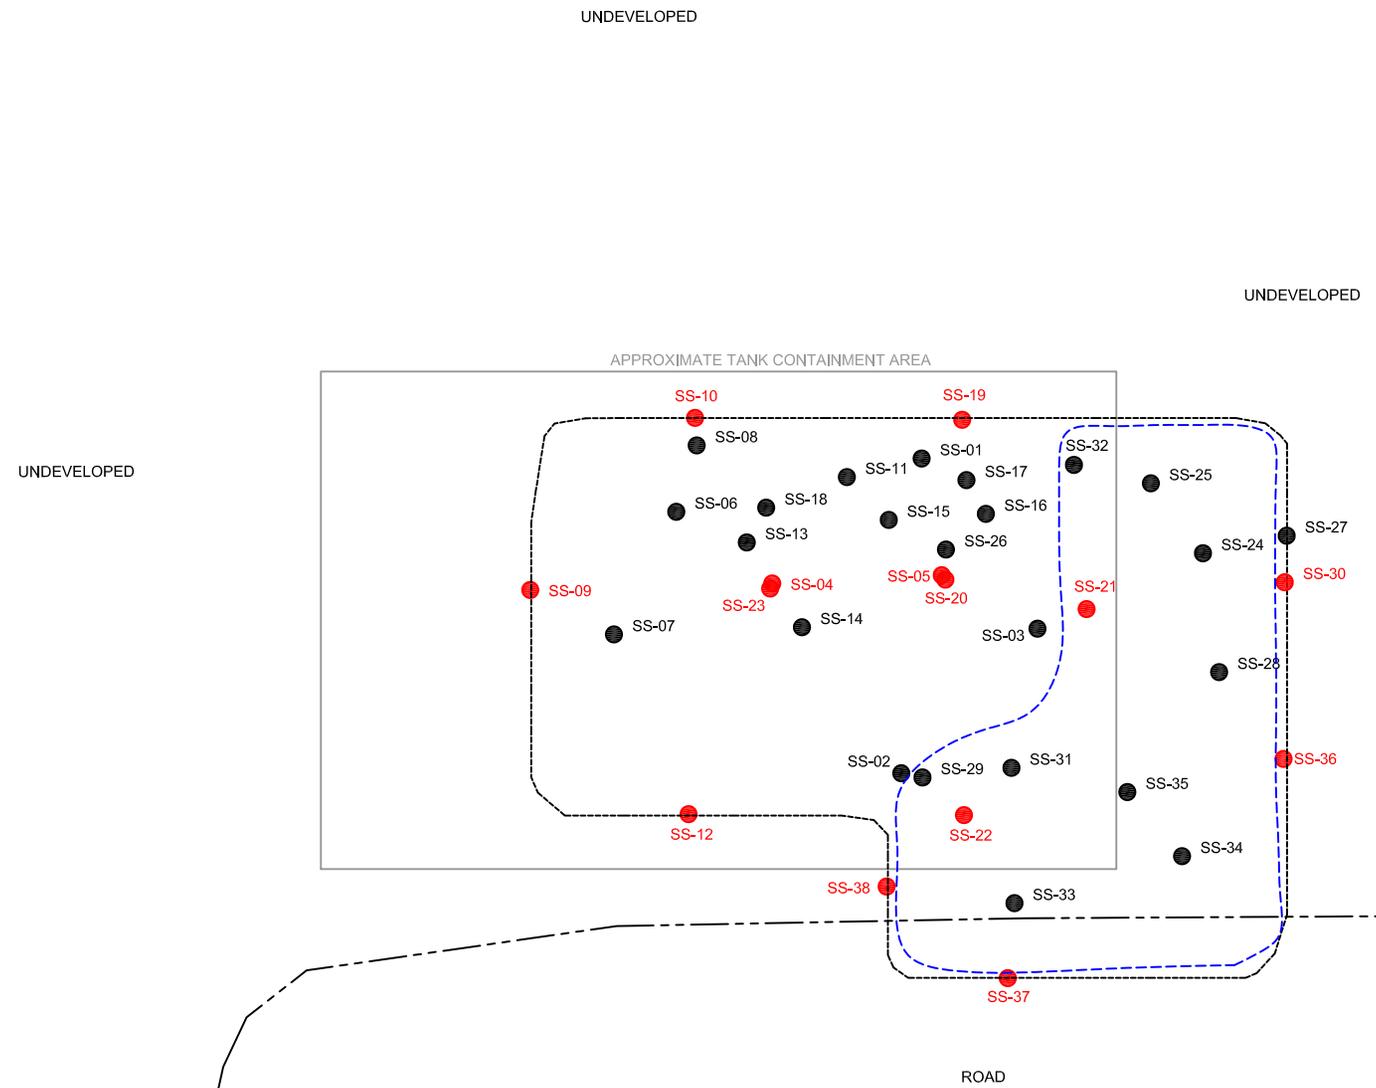
DATE:	07/11/14
FIG. NO.	DRAWN BY:
3	amn

A total of twelve (12) confirmation soil samples (SS-09@6', SS-10@6', SS-12@7', SS-19@8', SS-20@19', SS-21@9', SS-22@9', SS-23@17', SS-30@12', SS-36@12', SS-37@12', and SS-38@12') were submitted for laboratory analysis. Soil samples, SS-09@7', SS-10@7', SS-12@7', SS-19@8', SS-21@9', SS-22@9', SS-30@12', SS-36@12', SS-37@12', and SS-38@12' were collected from the sidewalls of the excavation, while soil samples, SS-20@19' and SS-23@17', were collected from the floor of the excavation. Spatial location of each soil sample was recorded using a Trimble GeoXT 6000 series instrument. PID readings are summarized in Table 1. A site map presenting the limits of the excavation, as well as soil sample locations, is included as Figure 3.

The final limits of the Pergola #1-15 excavation extended approximately 28 feet north to south, and 38 feet east to west. The excavation was advanced to a depth of approximately 17 feet bgs on the west side of the excavation, and approximately 19 feet bgs on the east side of the excavation. The eastern portion of the excavation was extended to approximately 19 feet bgs due to observed staining and elevated PID readings. Approximately 910 cubic yards of soil was removed during excavation activities. Soil was transported offsite for disposal at an appropriately permitted facility.

SOIL SAMPLE LOCATION MAP
 PERGOLA #1-15 - WATER VAULT RELEASE
 39.963000/-104.981439
 NE1/4 SE1/4 SEC.15 T1S R68W 6PM
 ADAMS COUNTY, COLORADO
 API # 05-001-08797

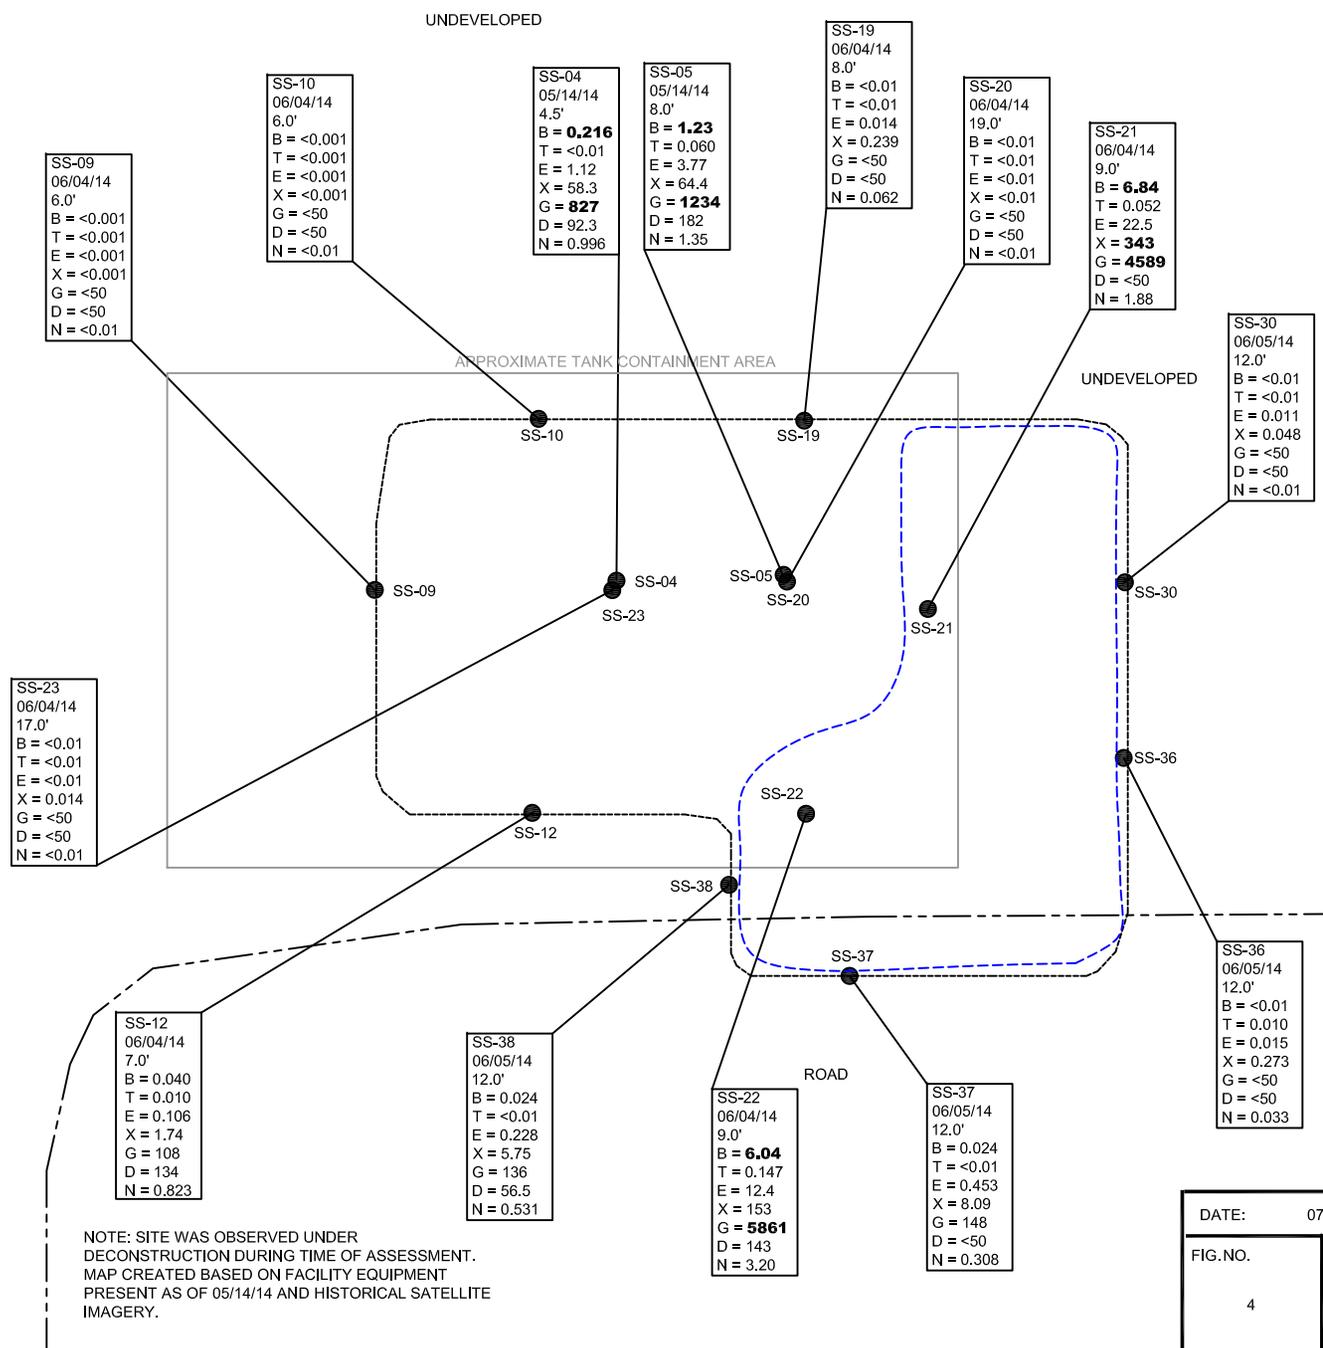
DATE:	07/11/14
FIG. NO.	4
DRAWN BY:	amn

Based on soil laboratory analytical results, confirmation soil samples SS-09@6', SS-10@6', SS-12@7', SS-19@8', SS-20@19', SS-23@17', SS-30@12', SS-36@12', SS-37@12', and SS-38@12' collected from the Pergola #1-15 excavation did not contain concentrations of BTEX, naphthalene, TPH-GRO, or TPH-DRO exceeding their respective COGCC Table 910-1 regulatory limits.

Soil samples SS-21@9' and SS-22@9', collected from the then sidewall of the excavation, contained concentrations of benzene and TPH exceeding their respective COGCC Table 910-1 regulatory limits. Based on the laboratory analytical results, the excavation was extended to the east and south, and vertically to a total depth of 19 feet bgs. Groundwater was observed at approximately 18 feet bgs, and therefore, soil samples were not collected within the saturated zone. A groundwater sample (GW-01) was collected to determine if petroleum hydrocarbon impacts had migrated to the groundwater table. Based on groundwater laboratory analytical results, confirmation groundwater sample, GW-01, did not contain concentrations of BTEX exceeding their respective COGCC Table 910-1 regulatory limits.

Soil analytical results are summarized in Table 2 and are presented in Figure 4. The laboratory analytical reports for the soil samples collected during source removal activities at the Pergola #1-15 site are included in Attachment A.

SOIL SAMPLE ANALYTICAL MAP
 PERGOLA #1-15 - WATER VAULT PULL
 39.963000/-104.981439
 NE1/4 SE1/4 SEC.15 T1S R68W 6PM
 ADAMS COUNTY, COLORADO
 API # 05-001-08797

- No further assessment or remediation is warranted for the Pergola #1-15 water vault release site at this time.
