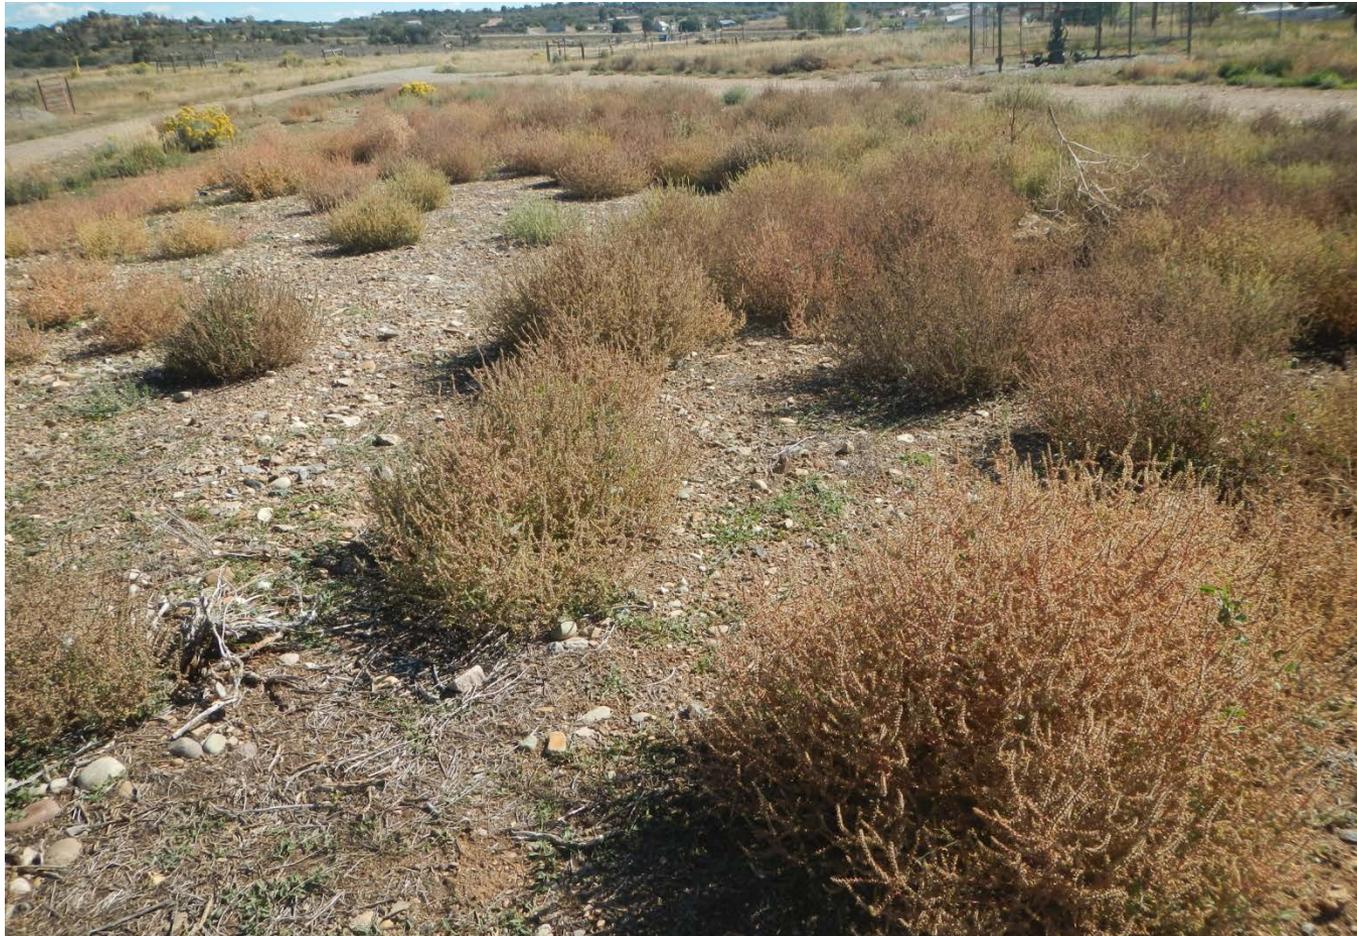
Photo 1. View of dense population of Russian thistle plants within an unused portion of the working area. These plants need to be removed from the location and disposed of properly.

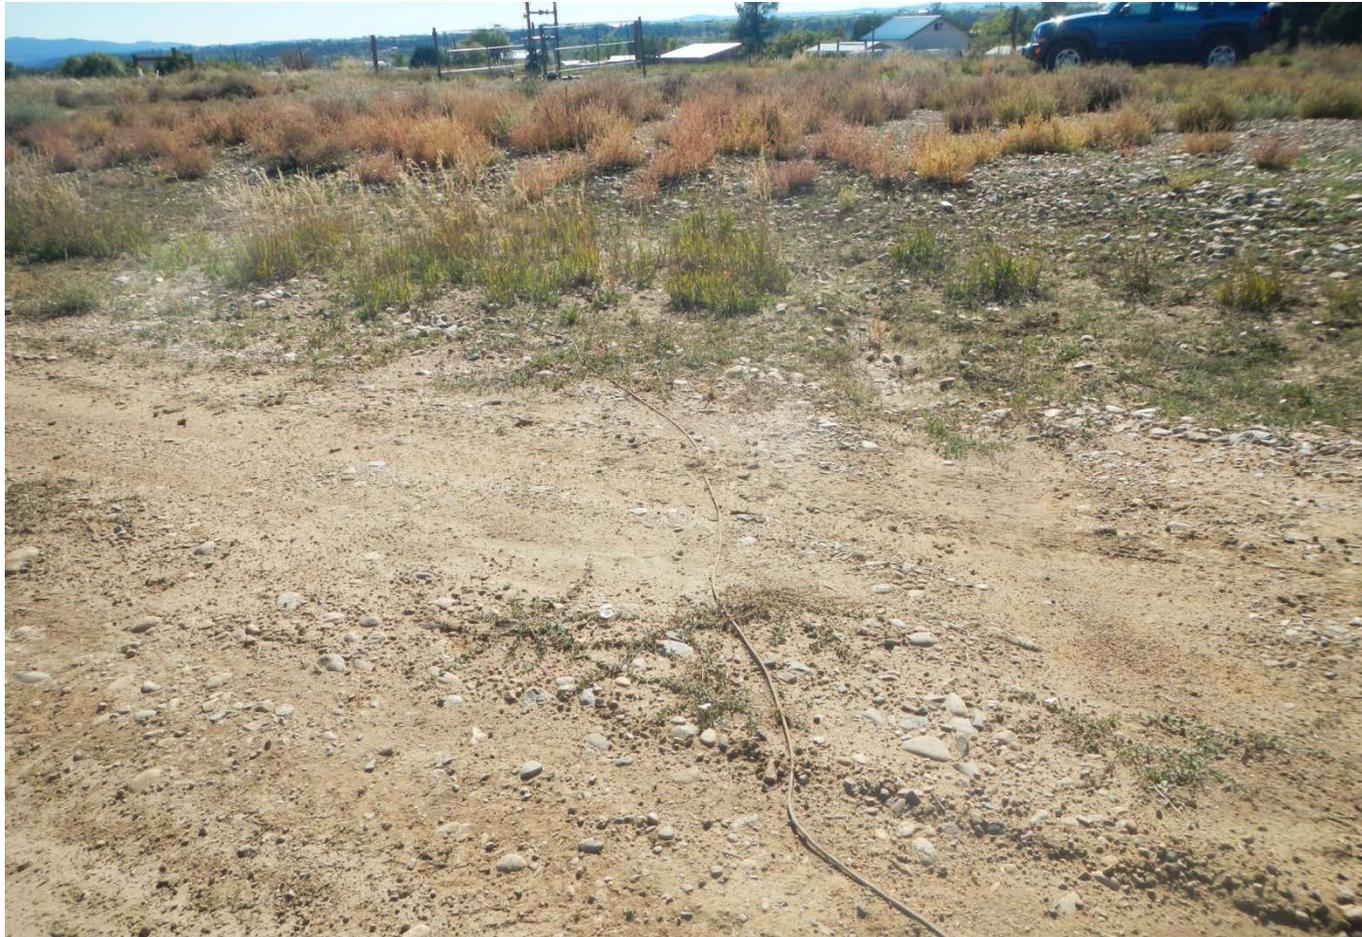
Photo 2. View of Russian thistle plants (in background) within the western portion of the interim reclamation area. These plants need to be removed and disposed of properly.

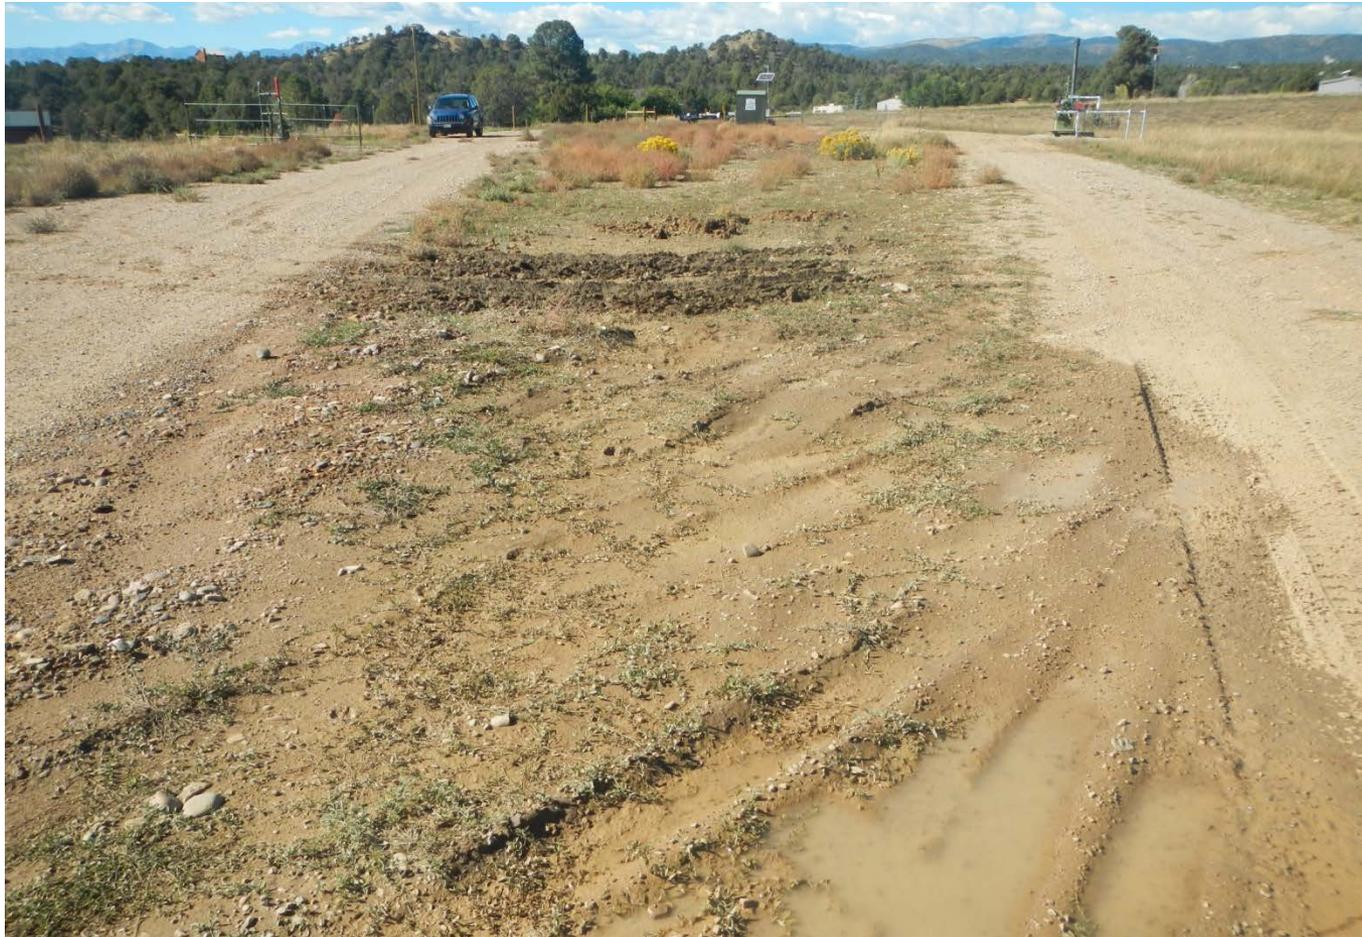
Photo 3. View of area with mud and weedy vegetation within unused portion of working area that needs to be revegetated.

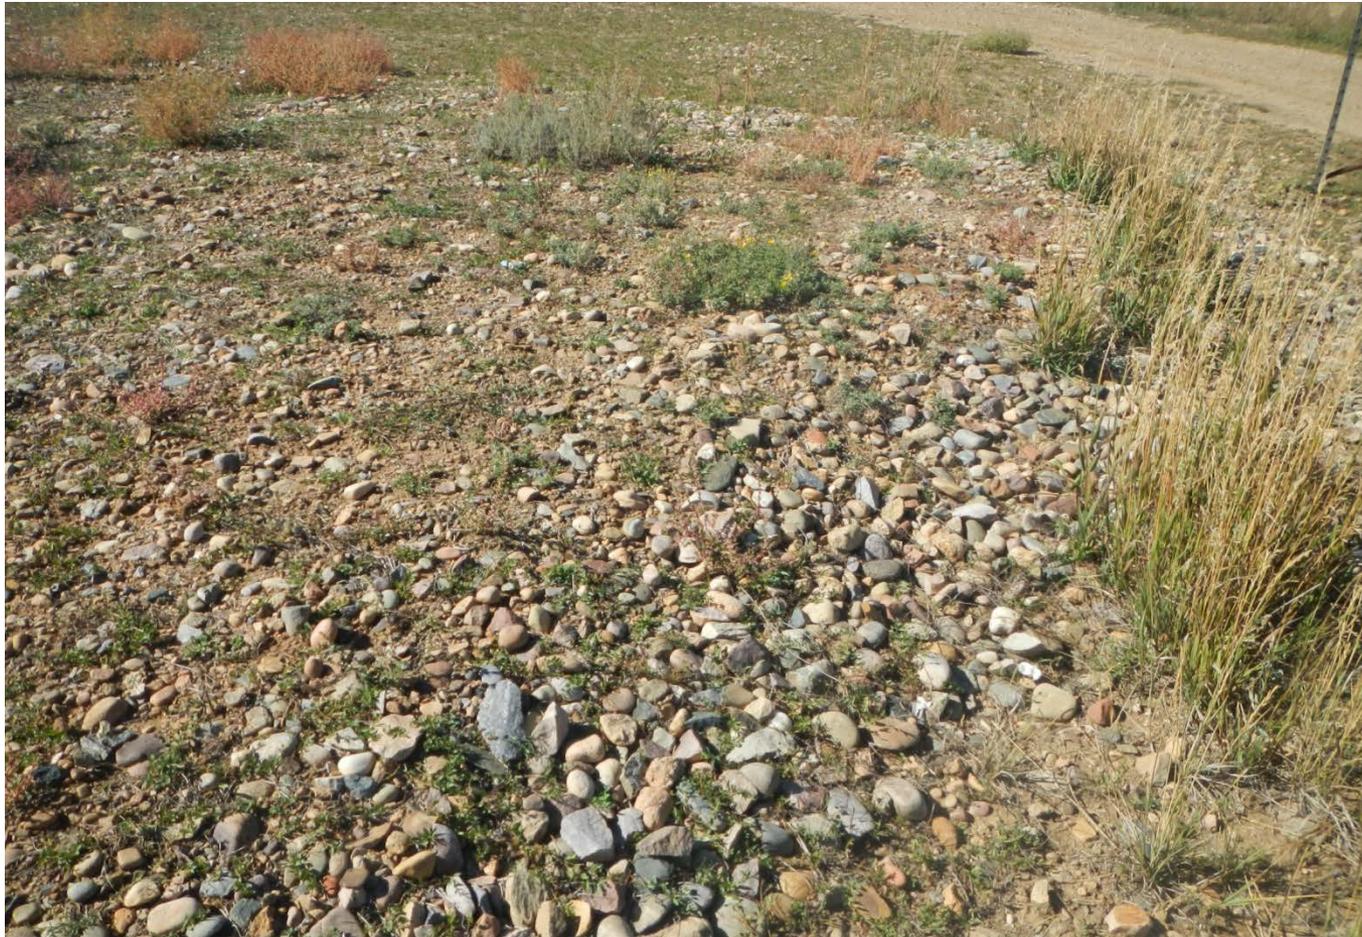
Photo 4. View of cobble on soil surface within unused portion of the center of the working area. It may be necessary to remove cobble and incorporate topsoil to revegetate this area.
