#### Form 2A - Attachment E

Hydrology Map

#### Watson Ranch B

Sections 17, Township 7 South, Range 95 West

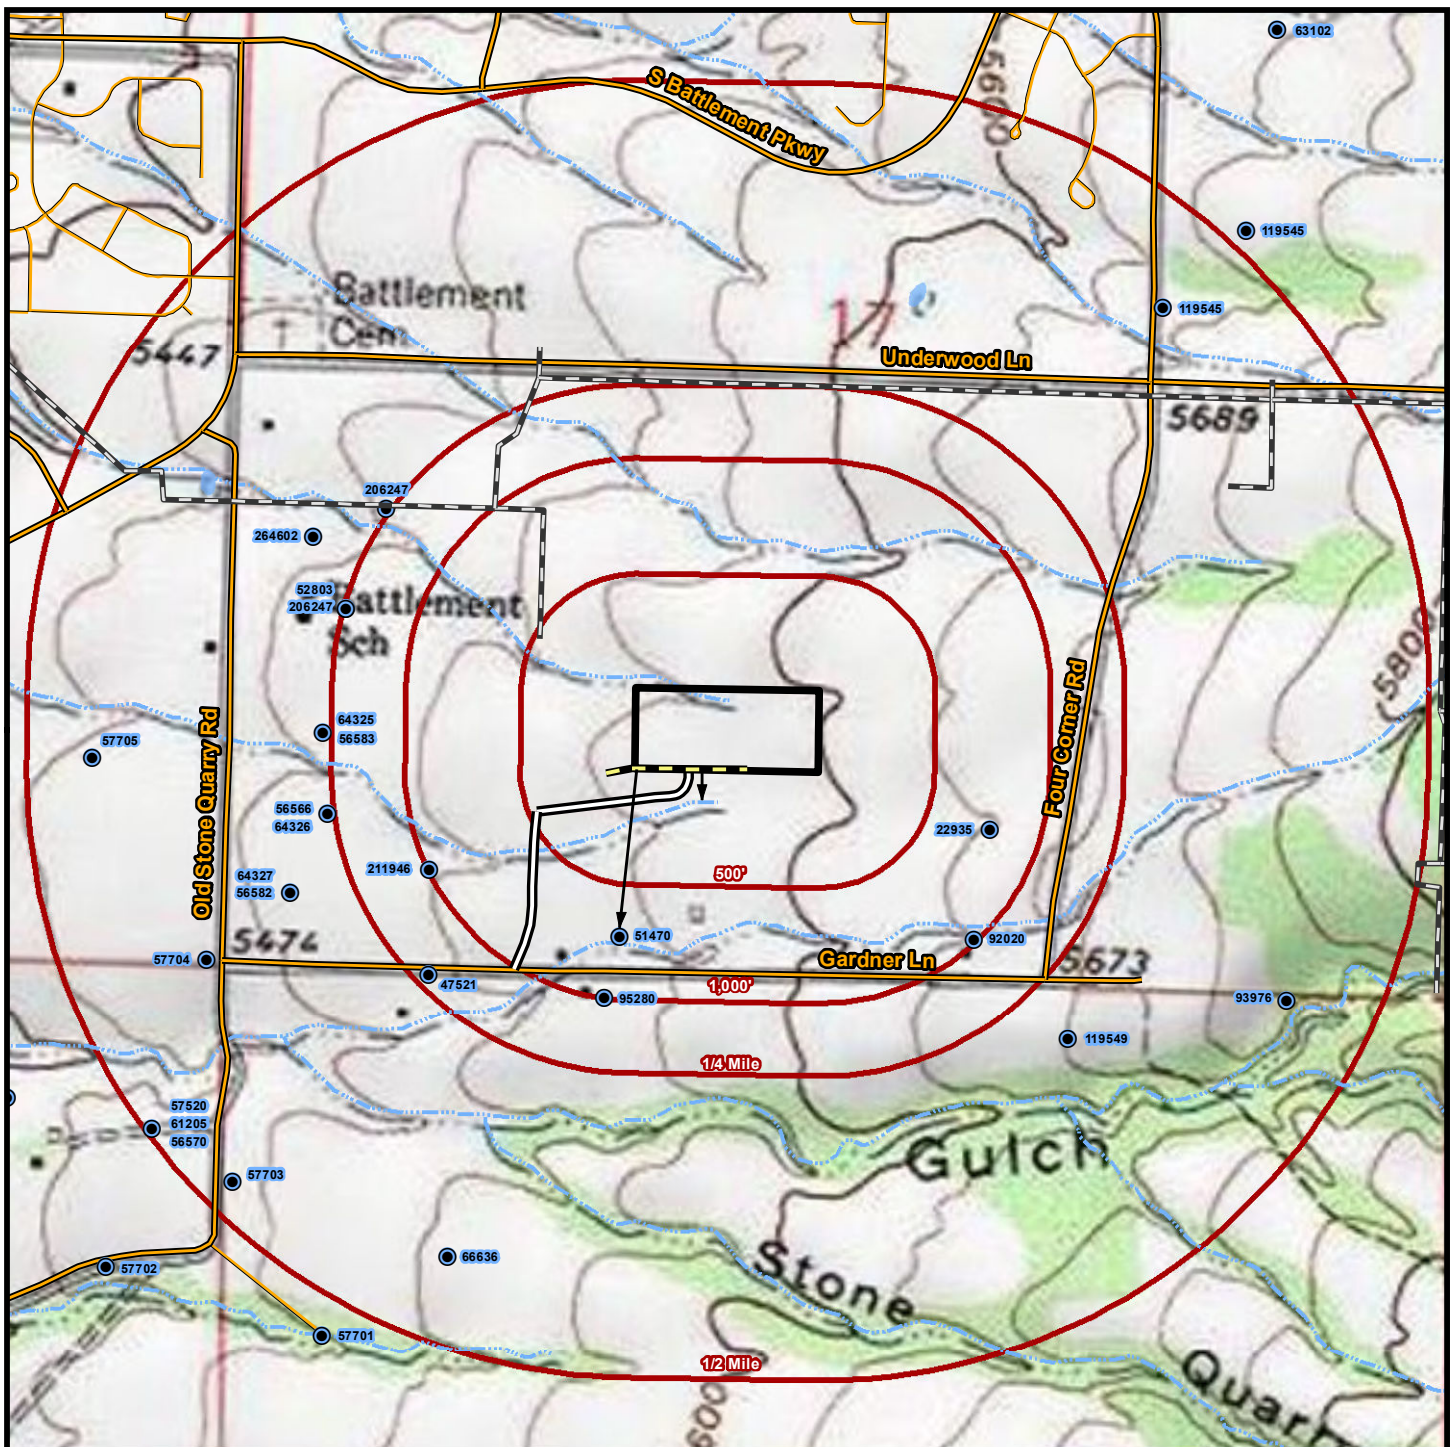
FEATURE	PRESENT WITHIN 1,000 ft
Ditch	*Yes

Groundwater Depth	Approx. 90'
Intermittent Stream	Yes - 139'

Water Well	Yes - 729'

\*Irrigation ditches present on-site; absent from USGS National Hydrography Dataset.
