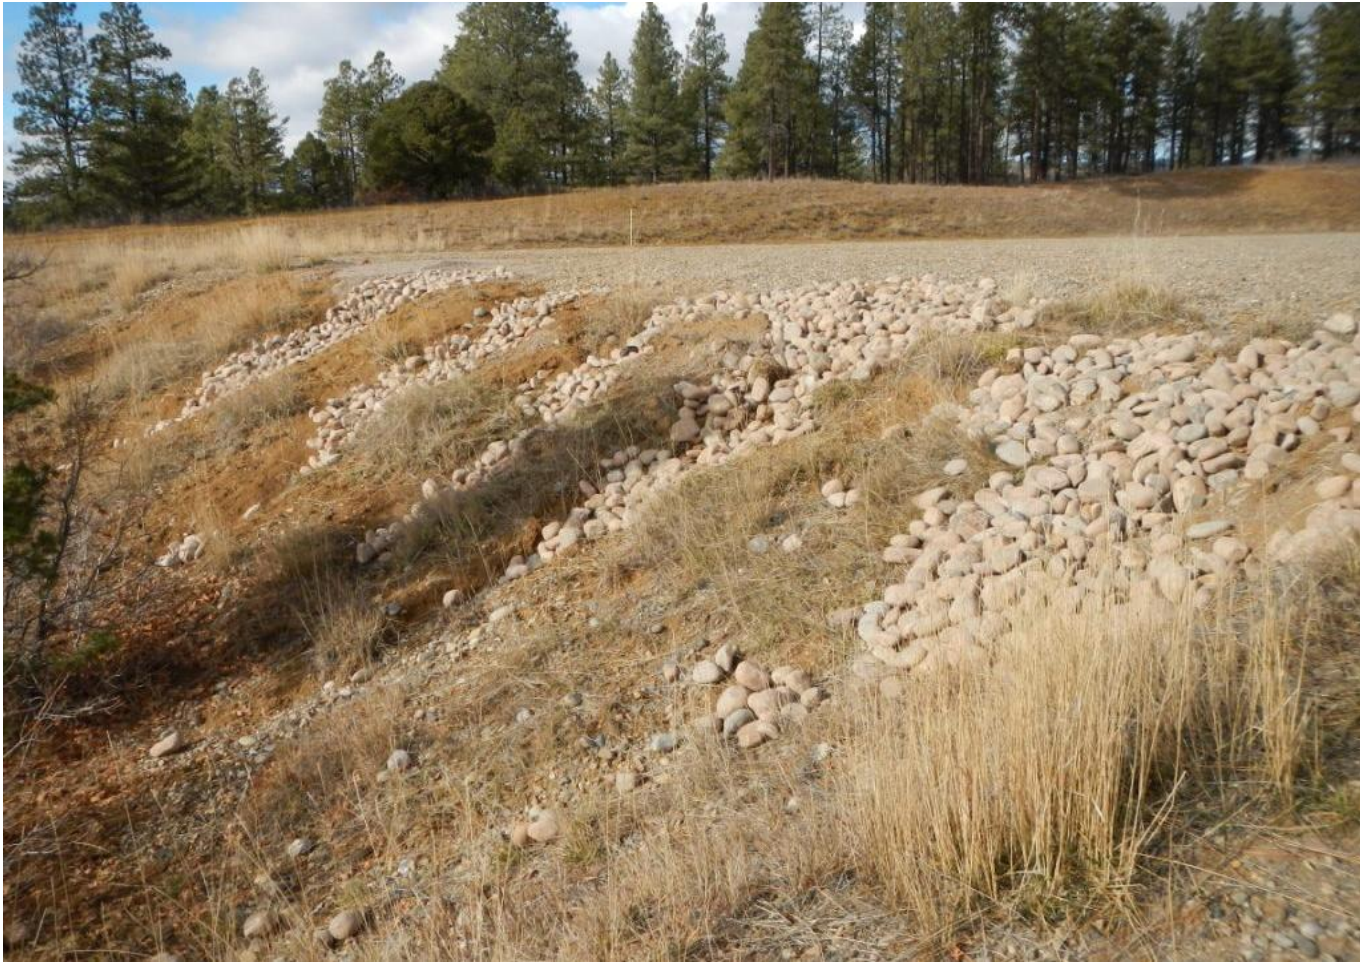
Photo 1. View of cobble placed in erosional channels in southern portion of project area.

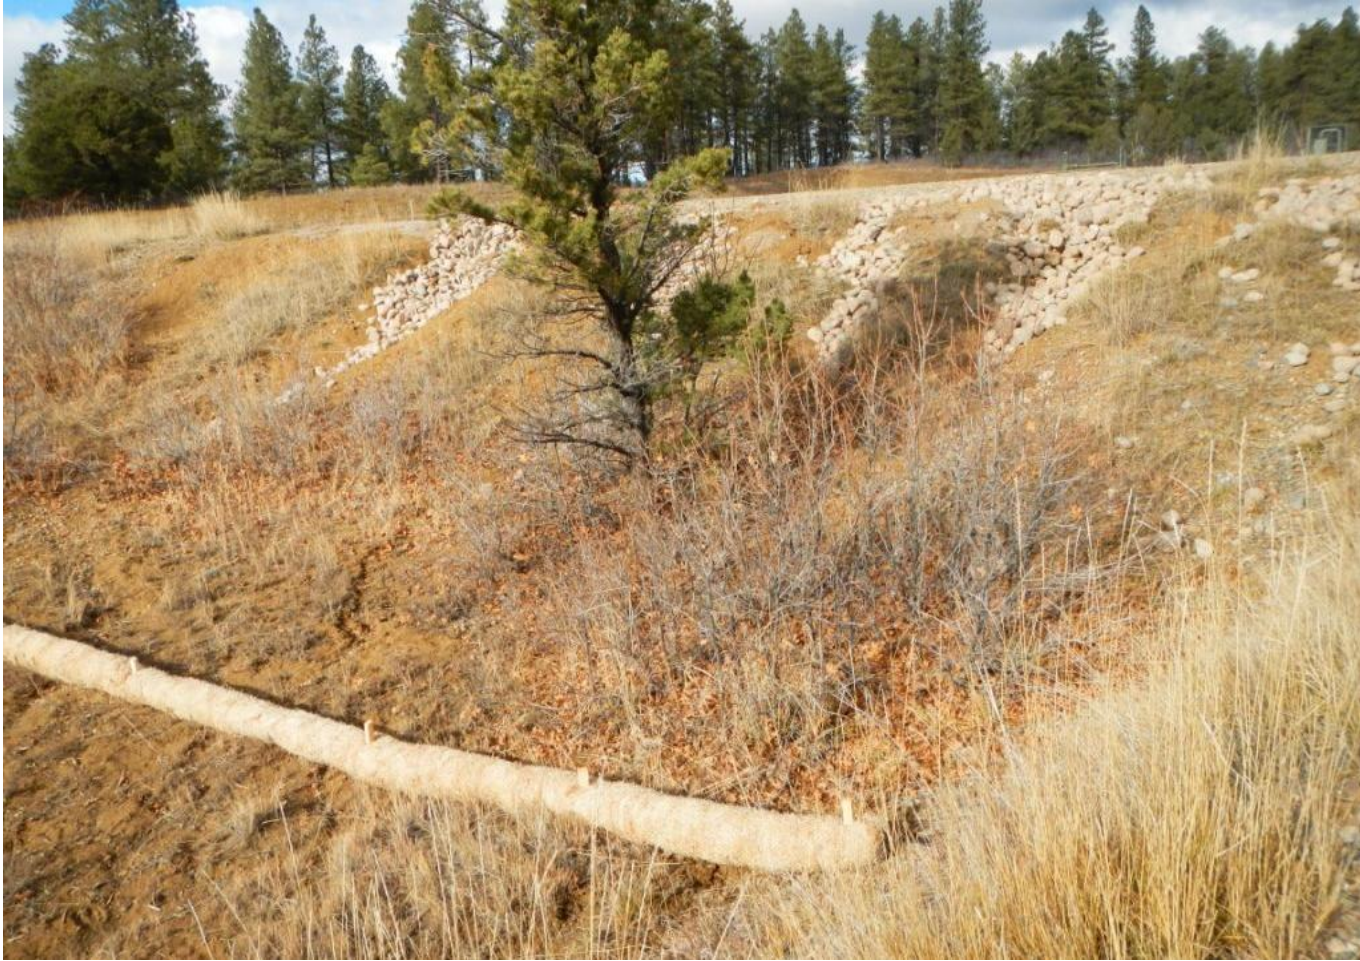
Photo 2. View of straw wattle placed below cobble in southern portion of project area.

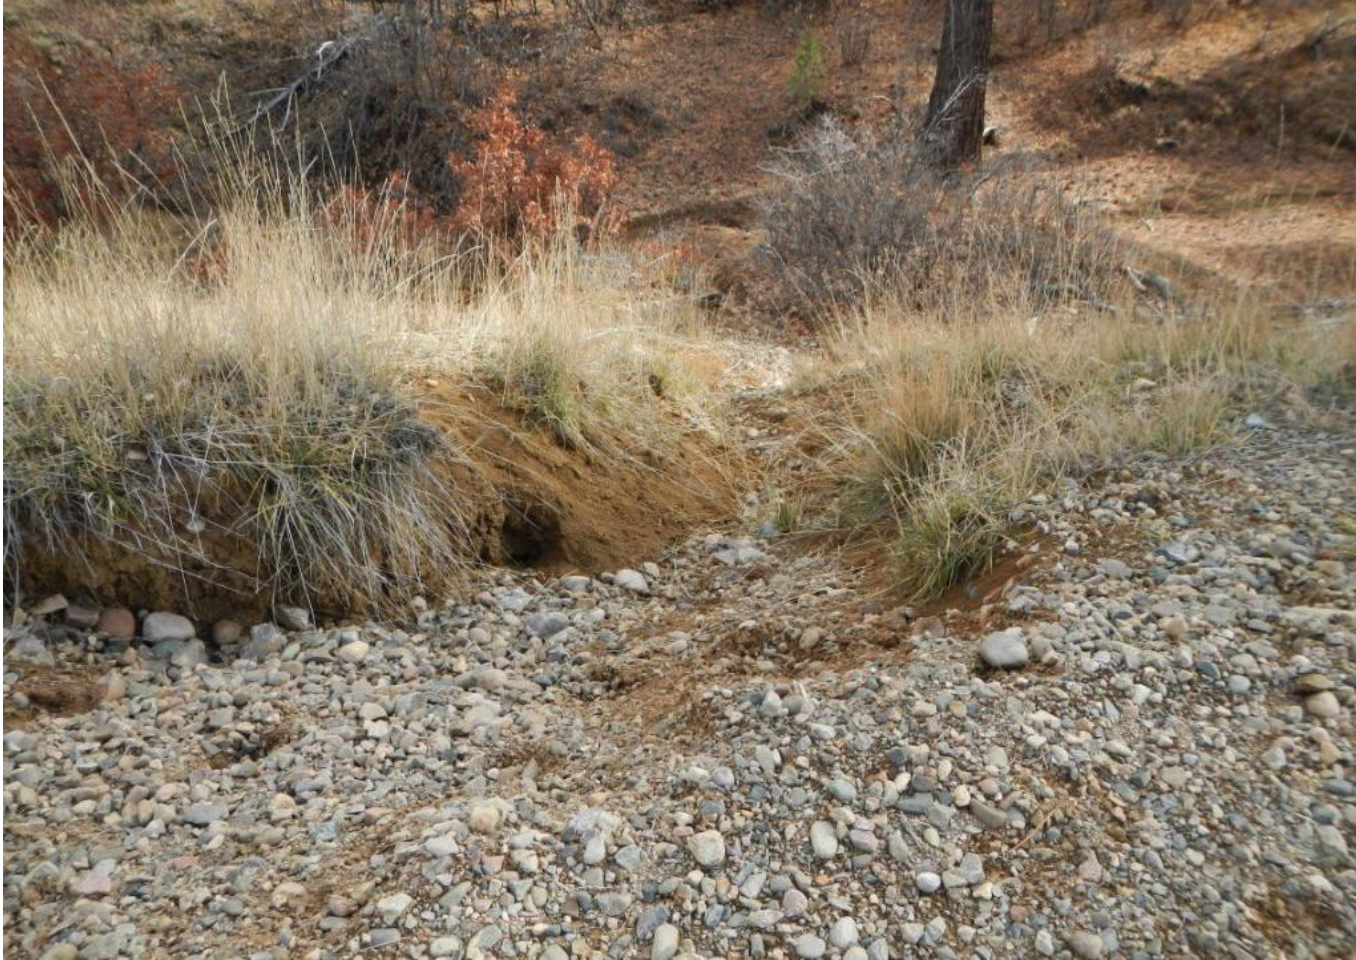
Photo 3. View of erosional channel on eastern side of access road near well pad entrance. Small amount of cobble may not be sufficient to prevent erosion here.

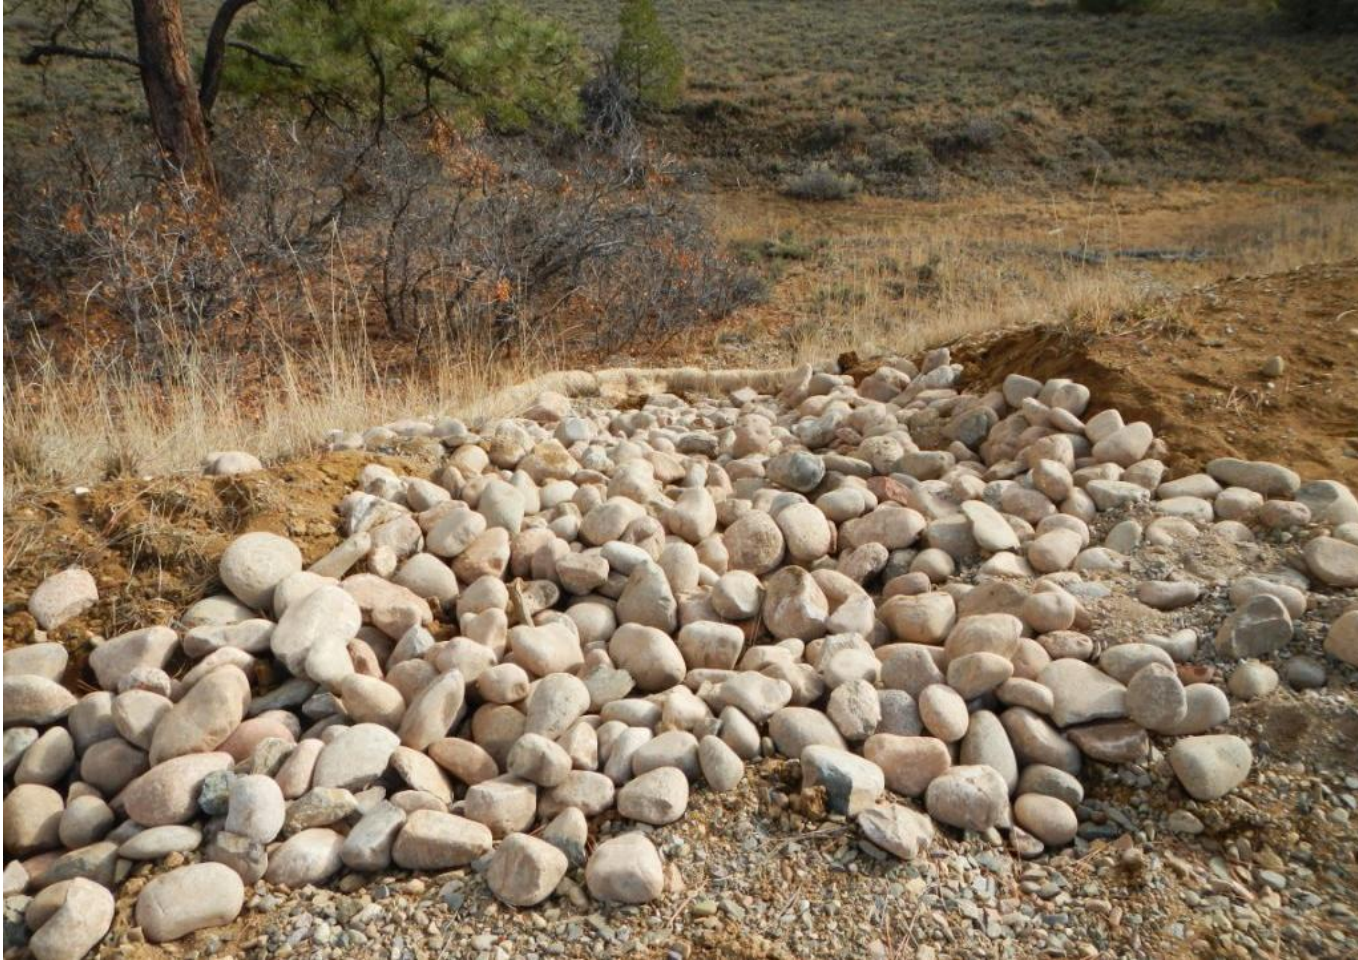
Photo 4. View of new BMP in eastern portion of project area with cobble in erosional gully and straw wattle placed below.
