Form 2A - Attachment H

NRCS Map

Yater

Attachment H – NRCS Soil Survey, Rifle Area

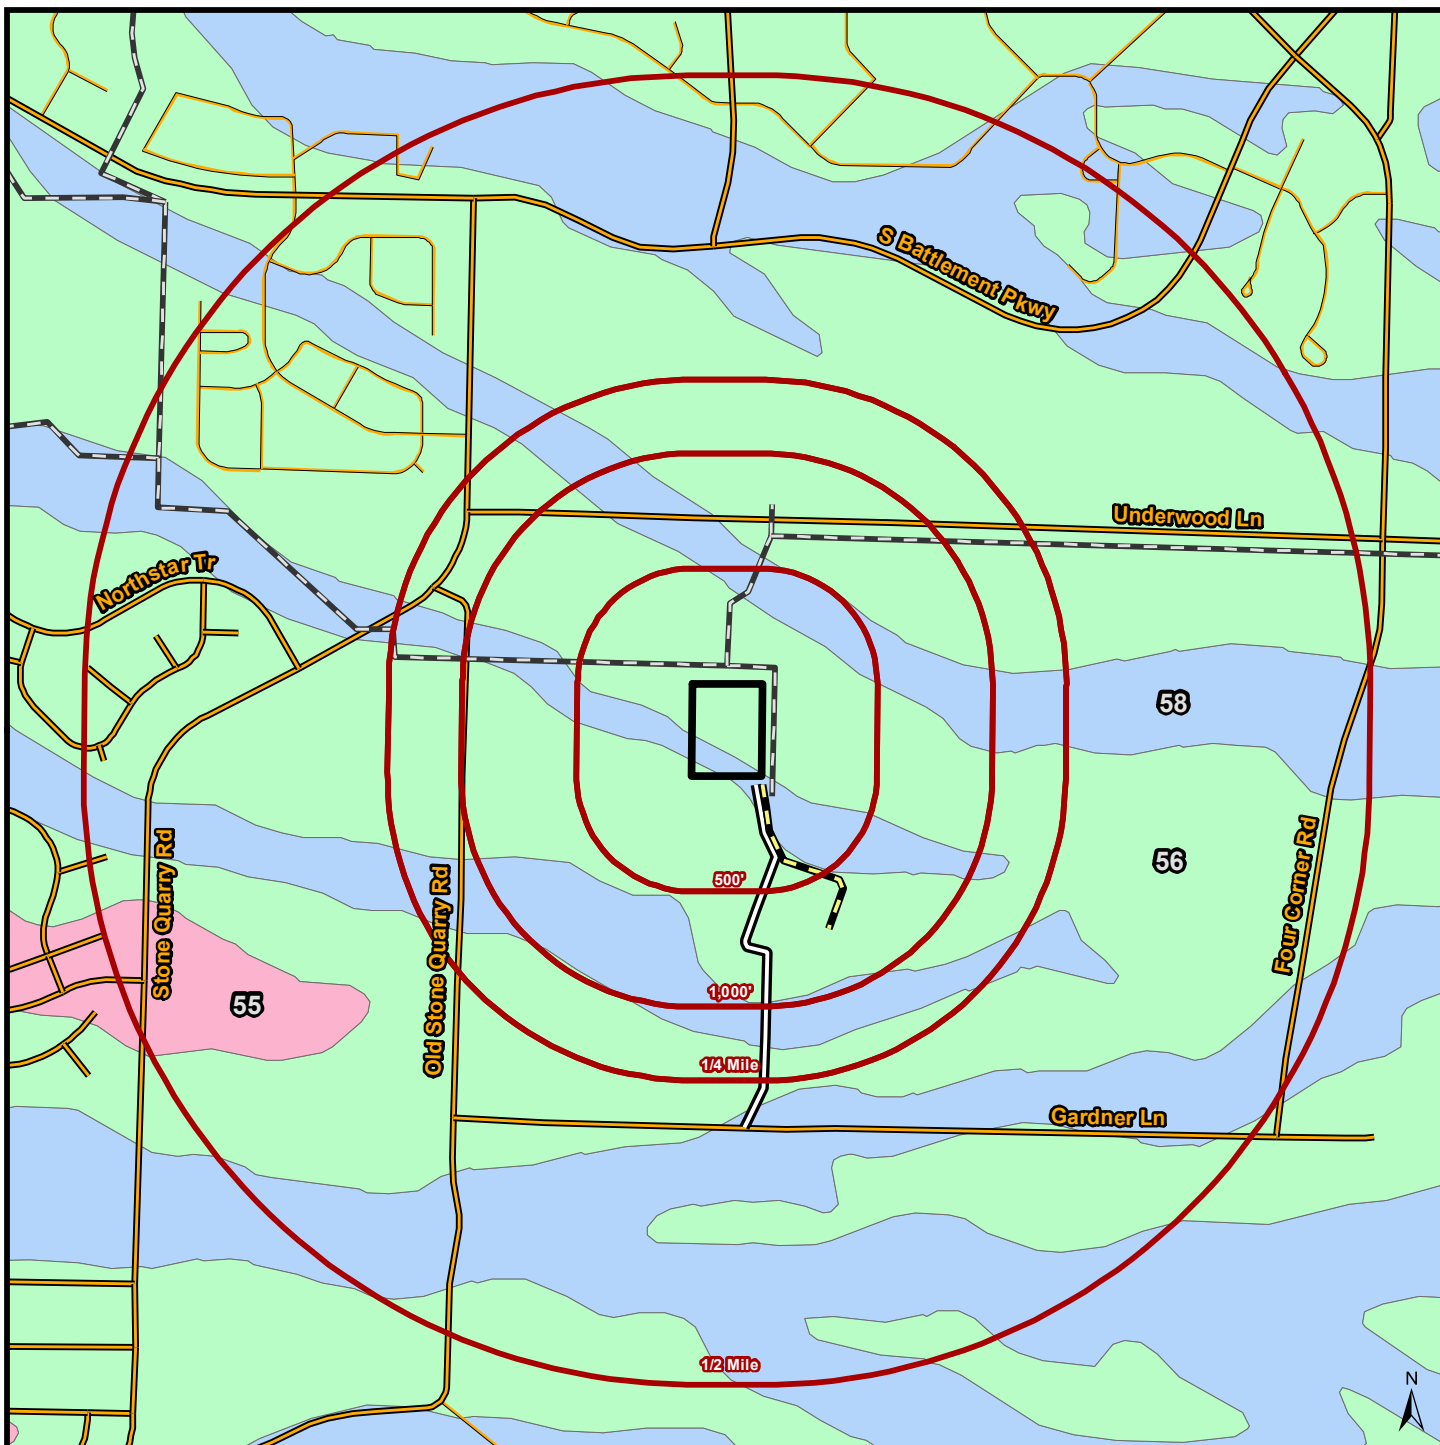
MAP SYMBOL	SERIES NAME (Slope)
55	Potts loam (3-6% slopes)
56	Potts loam (6-12% slopes)
58	Potts-Ildefonso complex (12-25%)

- Proposed Development
- Proposed Access
- Proposed Pipeline

- Pipeline Tie-in
- County Roads
- Local Roads

Map Symbol 56 – Potts loam (6-12% slopes)	
Deep, well drained, moderately sloping soils found on mesas, benches and sides of valleys.	
Elevation	5,000 to 7,000 feet
Average Annual Precipitation	Approximately 14 inches
Average Annual Air Temp	Approximately 46 degrees F
Frost Free Days	Approximately 120 days
Permeability	Moderate
Available Water Capacity	High
Effective Rooting Depth	60+ inches
Surface Runoff	Slow
Erosion Hazard	Moderate
Native Vegetation: Mainly wheatgrass, needleandthread, and sagebrush.	
Development is limited by low strength and shrink-swell potential. This soil is in capability subclasses IIIe, irrigated and IVe, nonirrigated.

Map Symbol 58 – Potts-Ildefonso complex (12-25% slopes)	
Strongly sloping to hilly soils found on mesas, alluvial fans, and sides of valleys.	
Elevation	5,000 to 6,500 feet
Average Annual Precipitation	Approximately 14 inches
Average Annual Air Temp	Approximately 46 degrees F
Frost Free Days	Approximately 120 days
Permeability	Moderate
Available Water Capacity	High
Effective Rooting Depth	60+ inches
Surface Runoff	Medium
Erosion Hazard	Moderate
Native Vegetation: Mainly wheatgrass, needleandthread, and sagebrush with additional pinyon, juniper, ricegrass, serviceberry, bitterbrush, and junegrass.	
Development is limited by steep slopes, runoff, gullyng, and erosion. This complex is in capability subclass Vie, nonirrigated.
