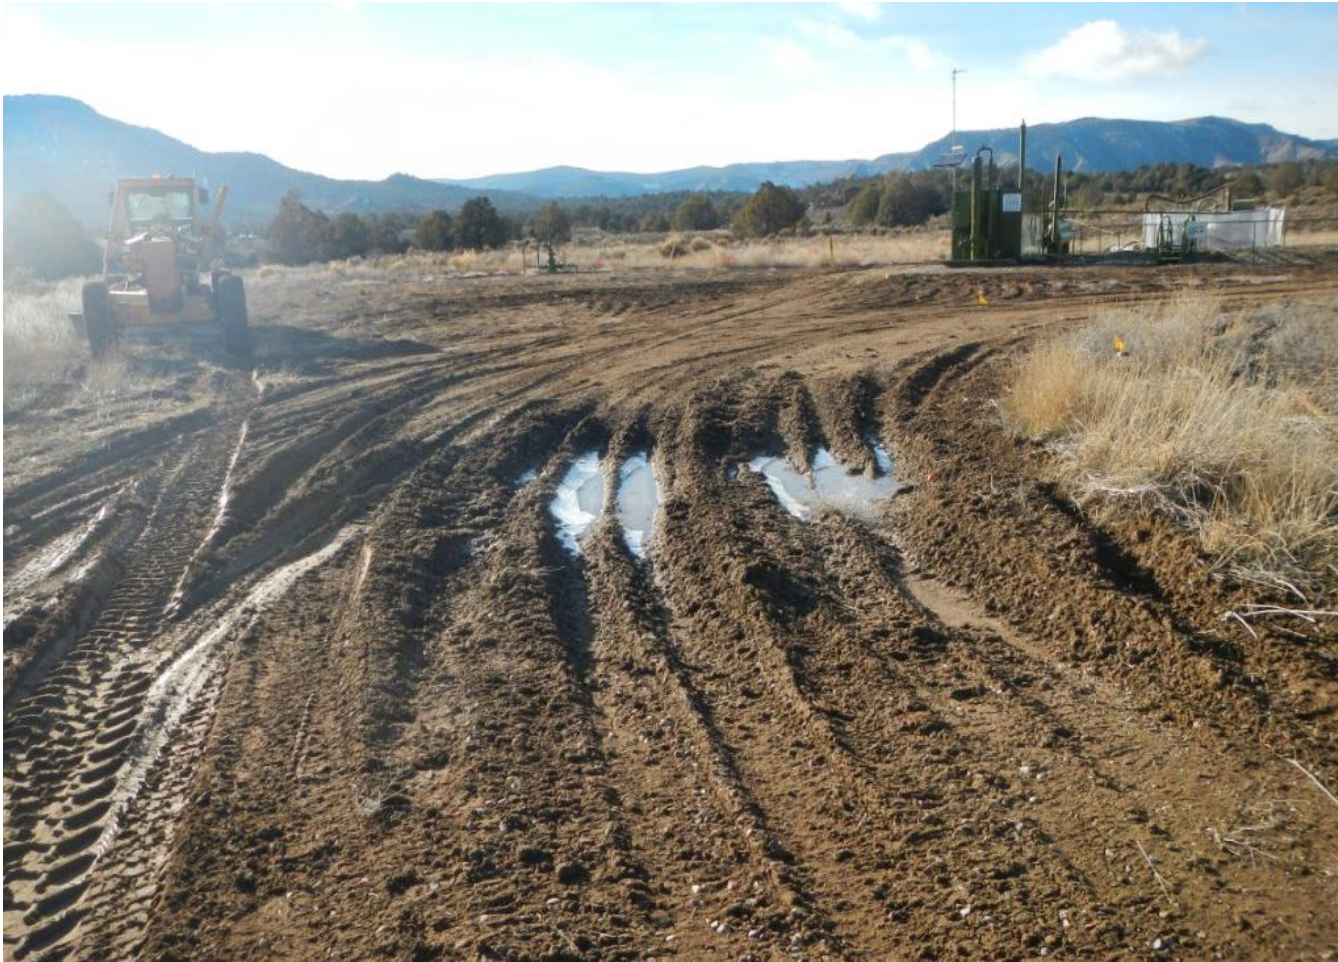
Photo 1. Deep ruts and ponding at the entrance to the well pad.

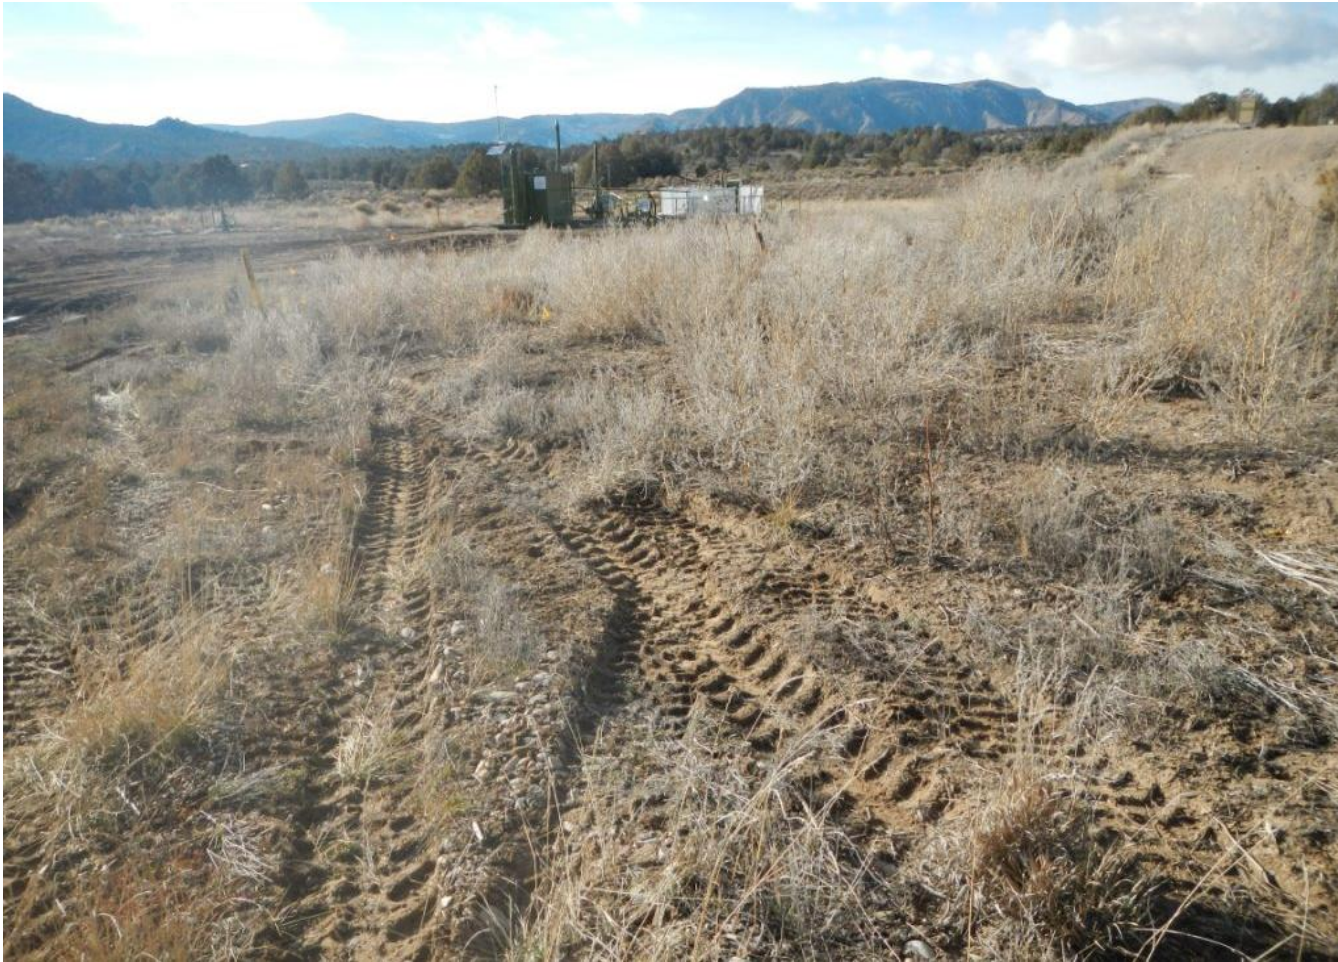
Photo 2. View of dense kochia (*Kochia scoparia*) patch approximately 125 feet by 75 feet long, in northeastern corner of project area. Tire tracks appear to be caused by vehicles avoiding muddy pool at well pad entrance.

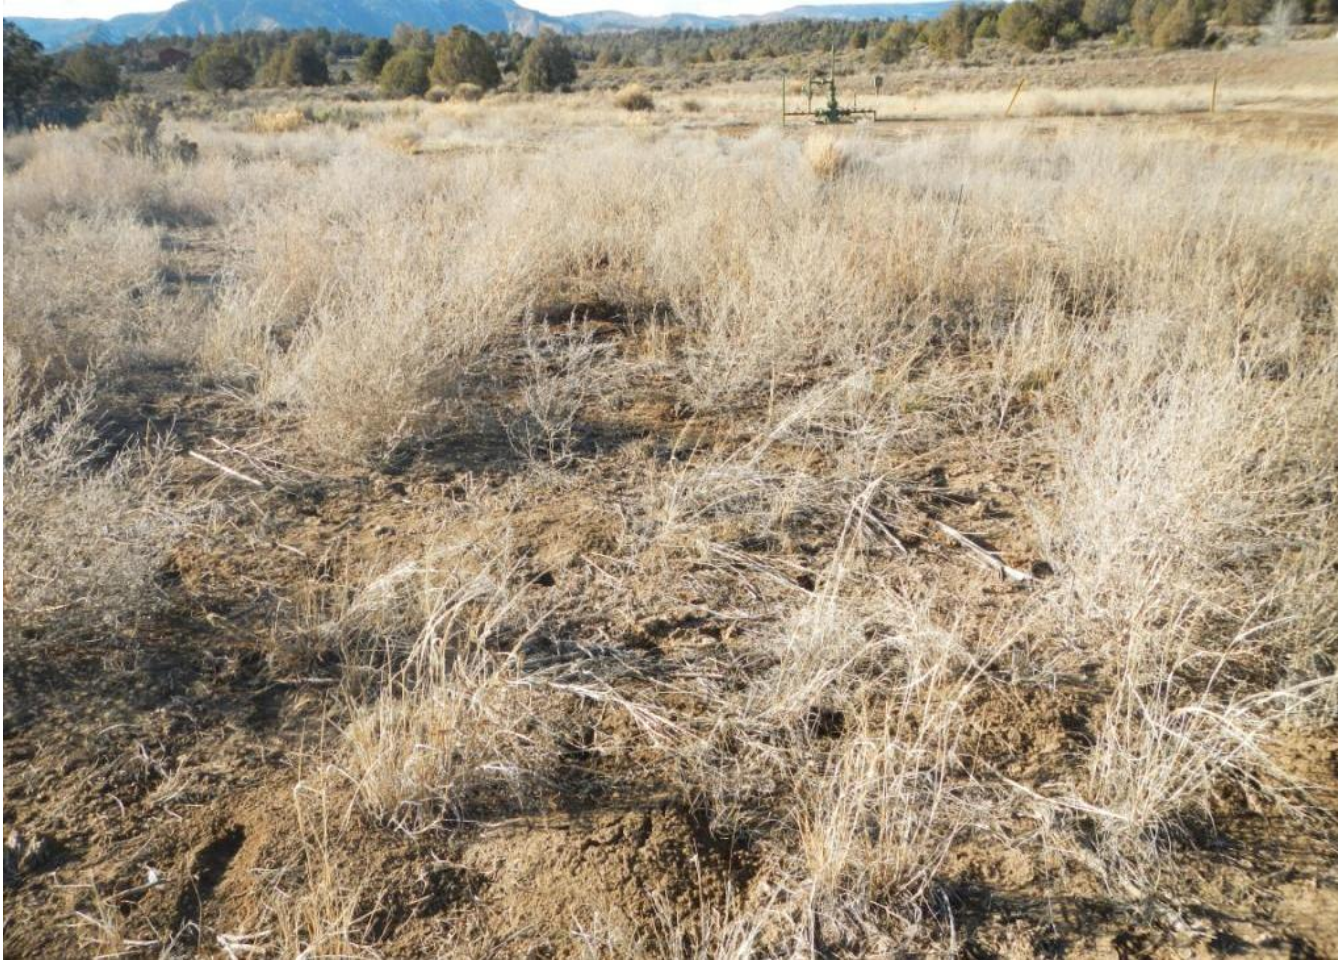
Photo 3. View of dense kochia (*Kochia scoparia*) patch approximately 150 feet by 150 feet long, in southern portion of project area.

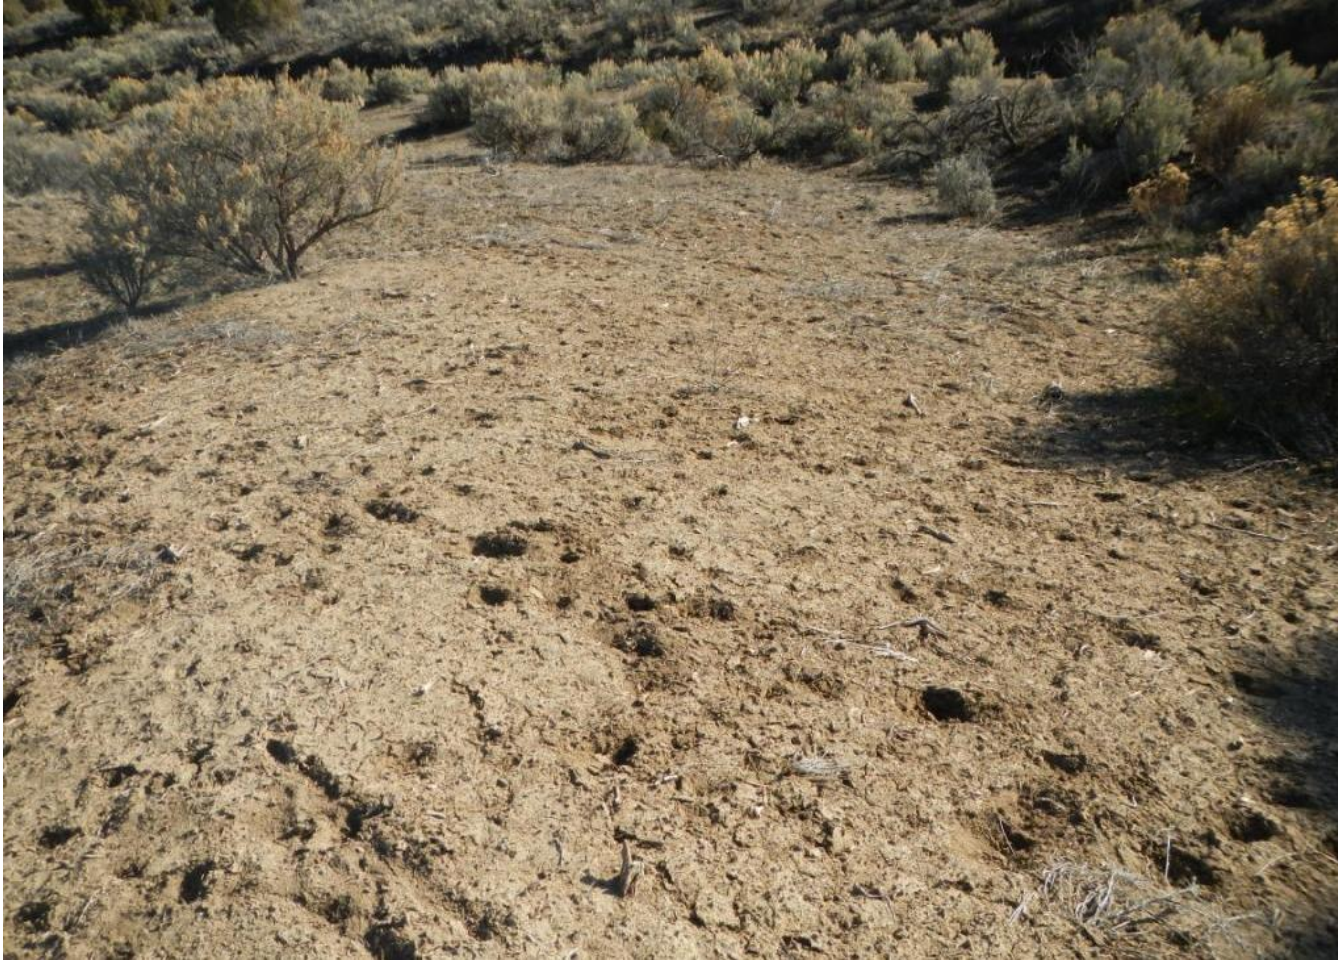
Photo 4. Little vegetation established on southern fill slope.

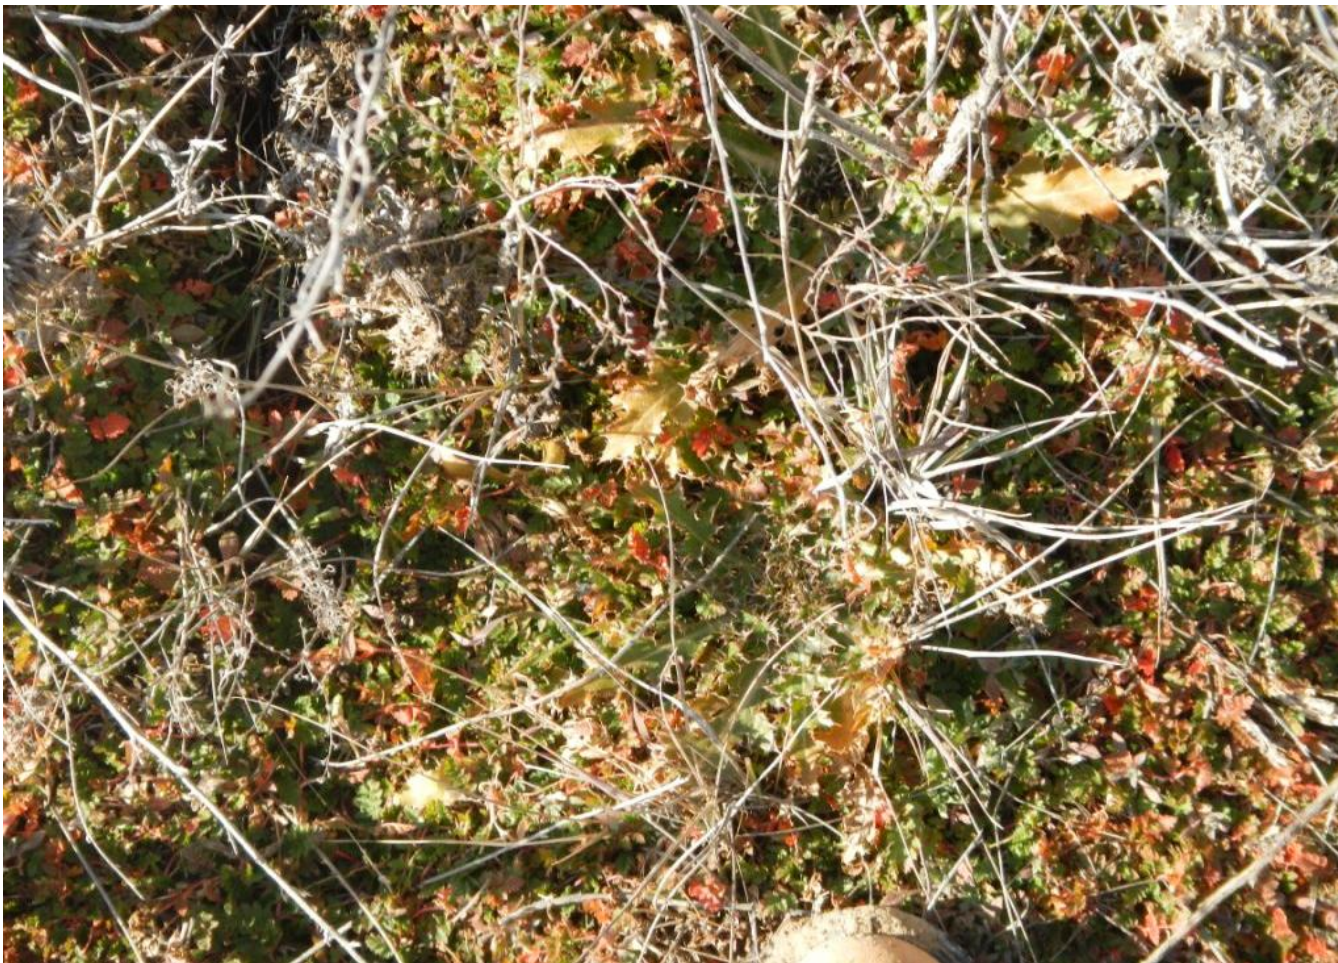
Photo 5. Birdseye view of Scotch thistle (*Onopordum acanthium*) rosettes within interim reclamation area.

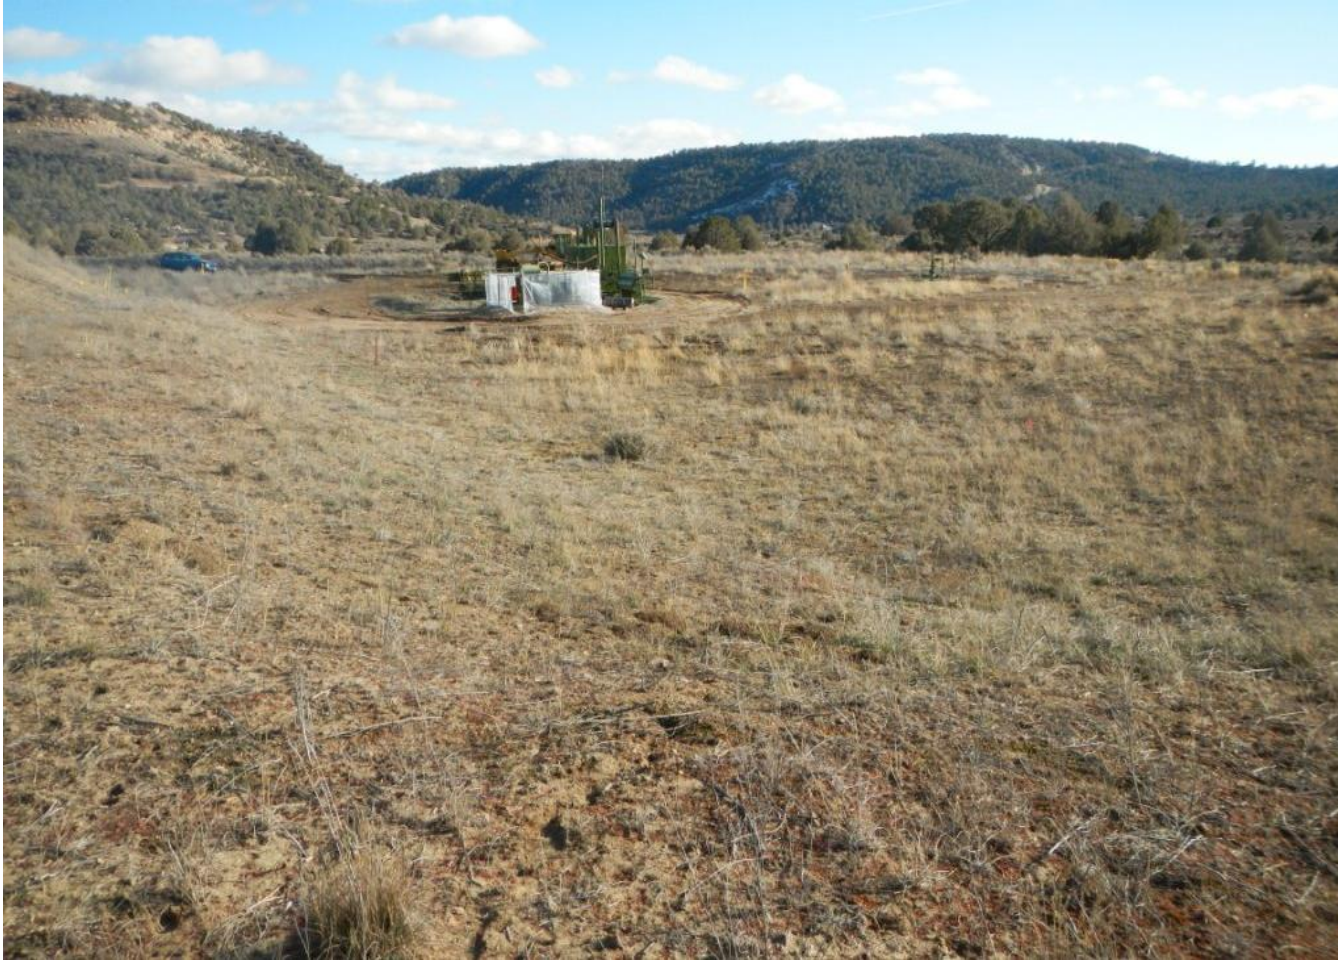
Photo 6. View from northwestern corner of project area facing center. Vegetation appears to be progressing in the western portion of the project area.
