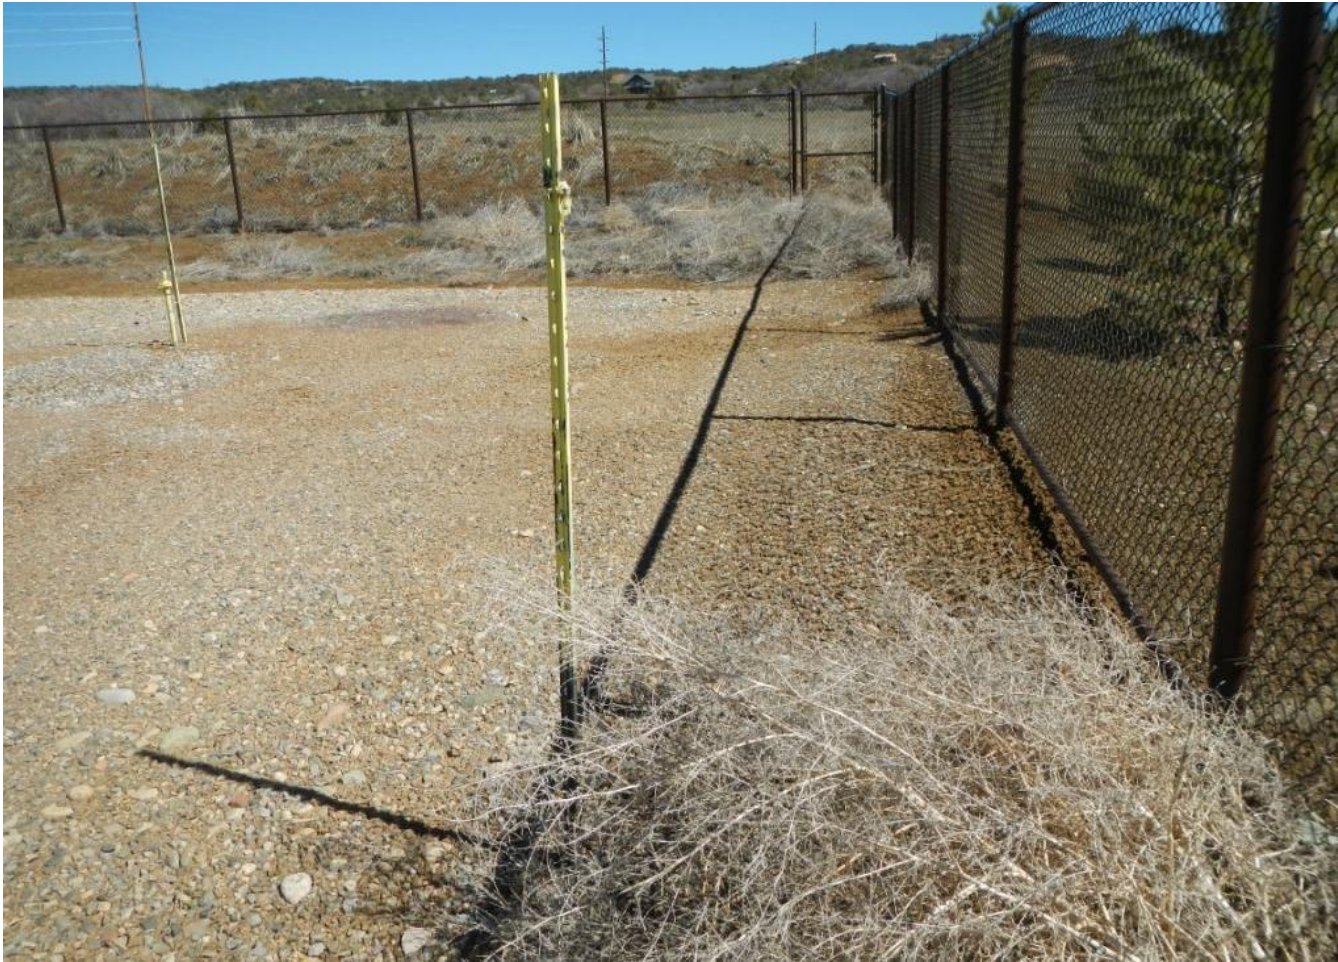
Photo 1. View of kochia debris along southern fenceline facing eastward.

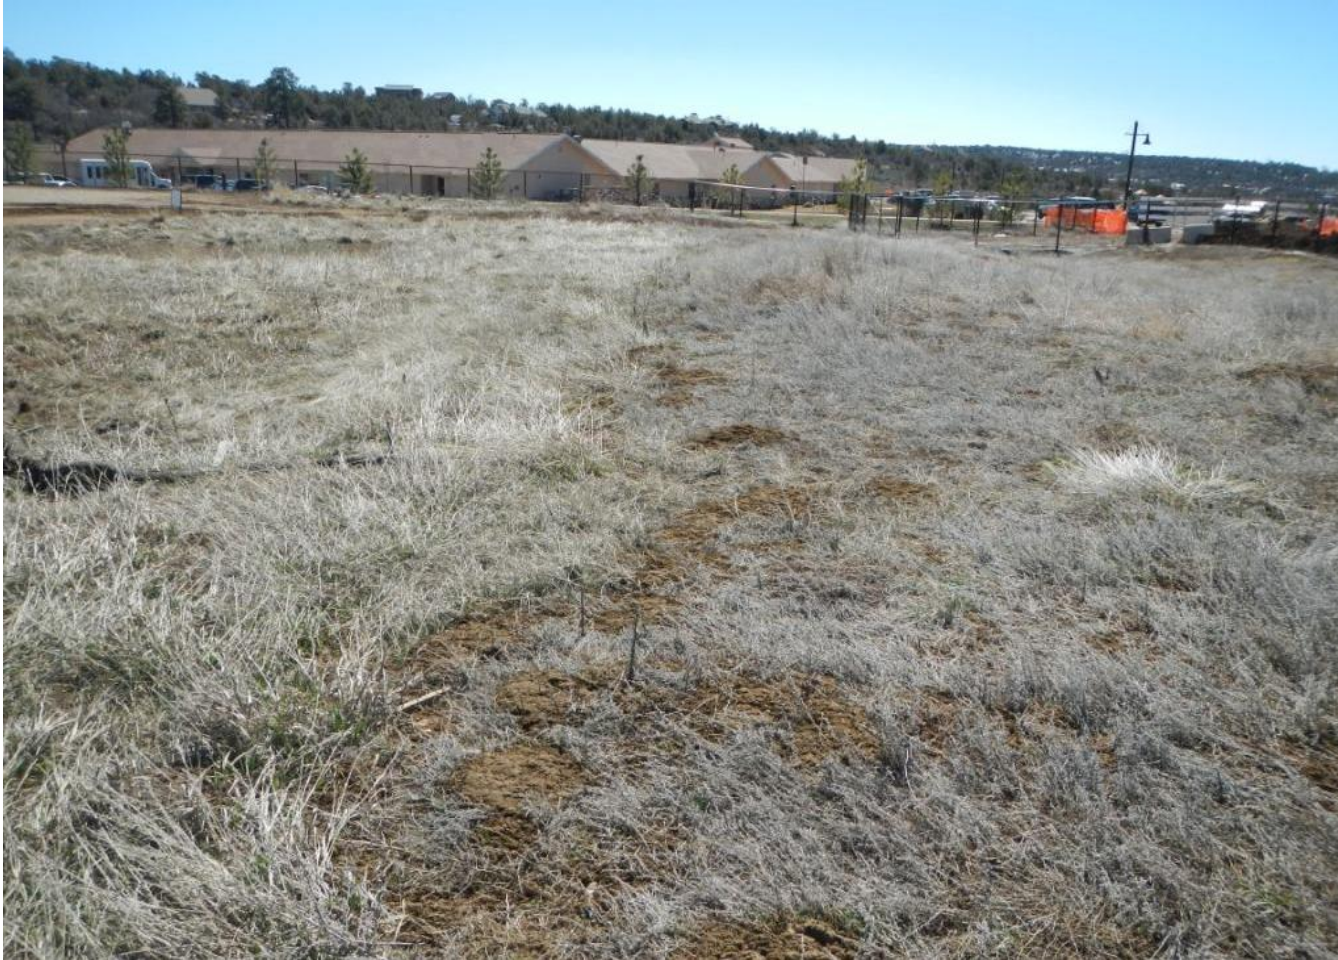
Photo 2. View of boundary between vegetated (on left) and unvegetated (on right) areas within the western portion of the interim reclamation area. Grey vegetation on right is a dense population of kochia.

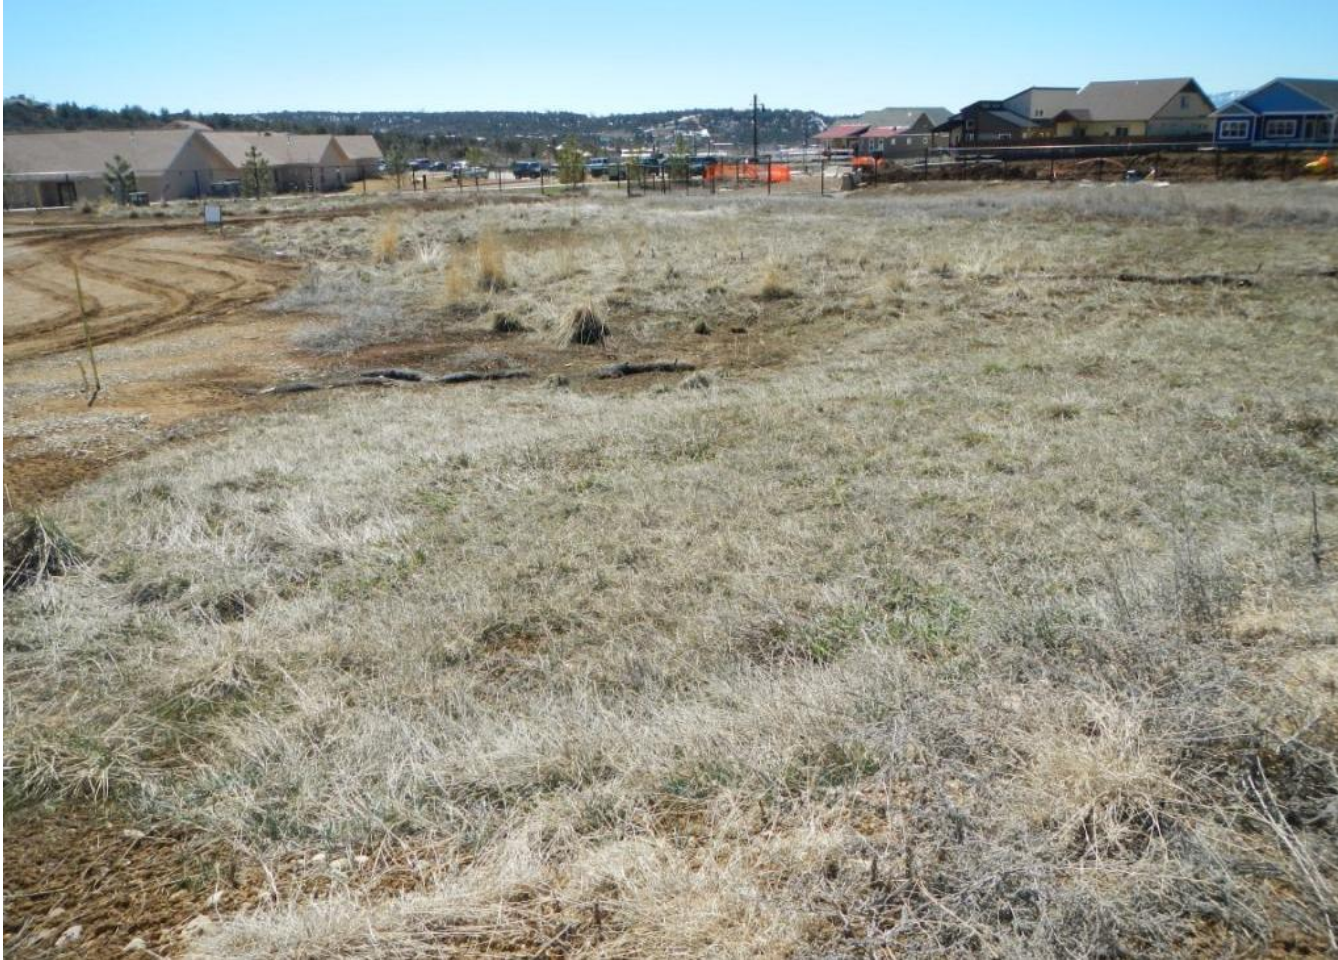
Photo 3. View of two patches of killed vegetation (in mid ground and back ground) adjacent to the western edge of the working area of the well pad.

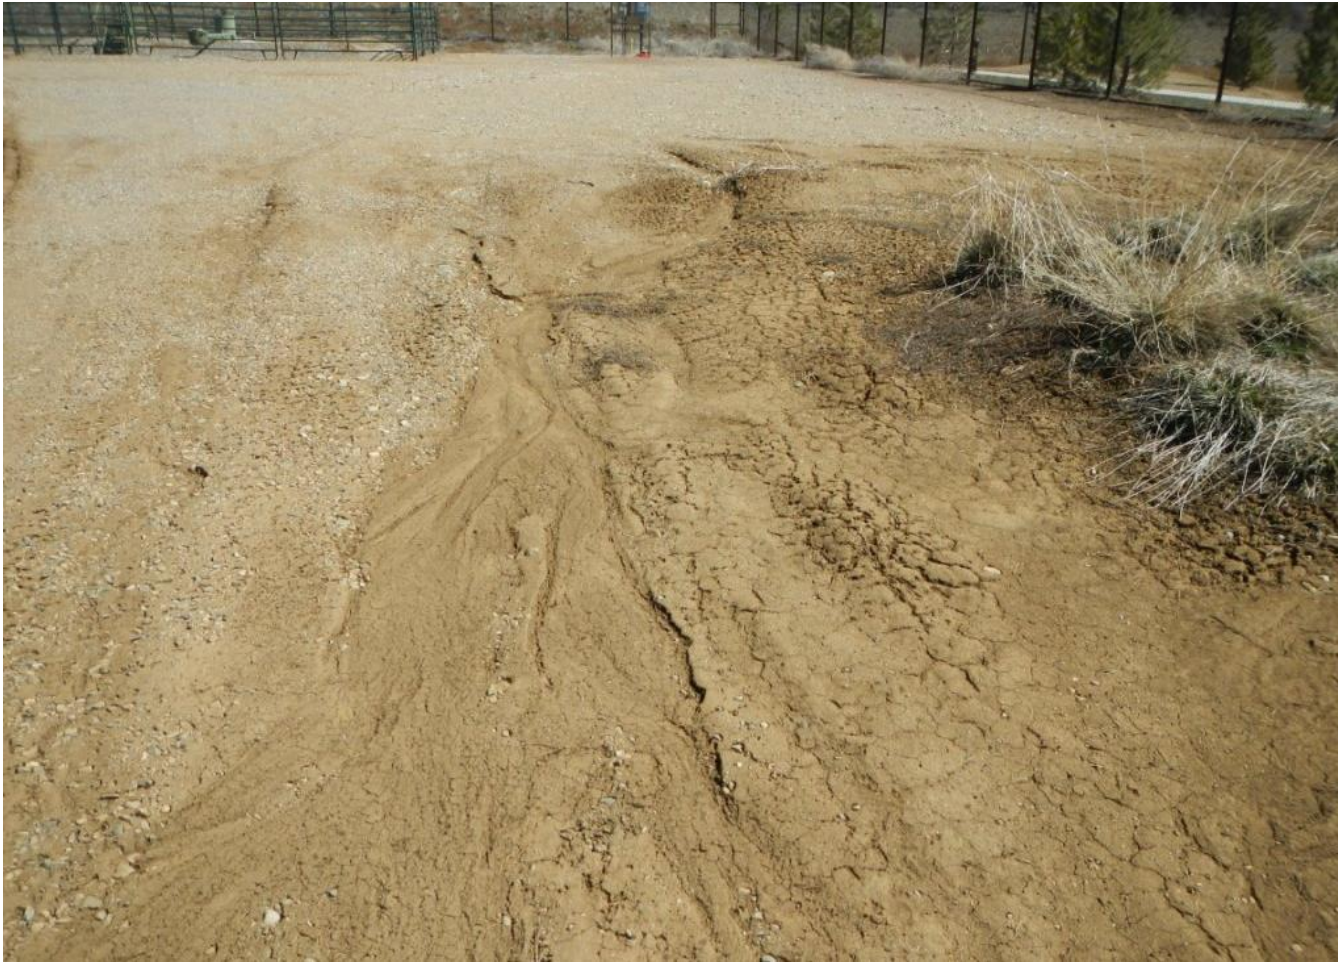
Photo 4. View of stormwater erosion on southwestern corner of working area of well pad.
