Monument Global Resources, Inc.

Cache Unit Investigations

April 6, 2015

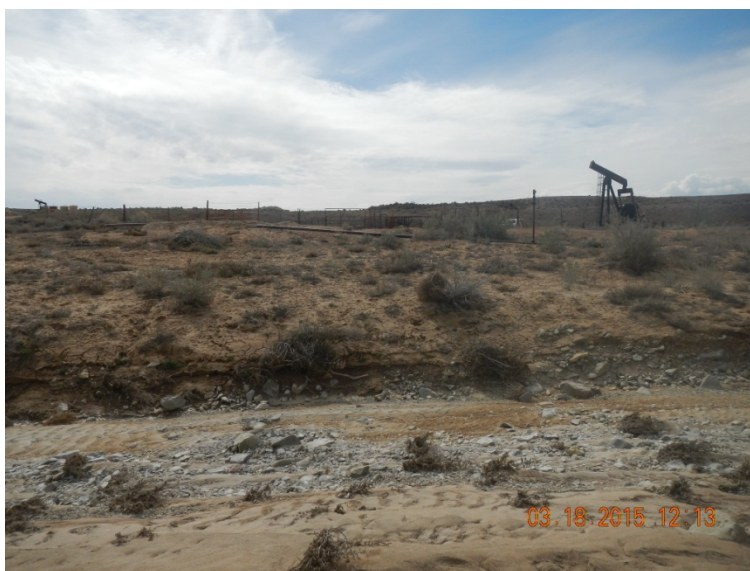
Approximate location where produced fluids entered the East Fork of McElmo Creek, from an underground flow line that had corroded. The East Fork of McElmo Creek is an intermittent stream. The streambed indicates that high energy flows occur during storm events. The Monument Global Cache Unit #9 pump jack is visible in the background. Remediation project #7786 indicates that contaminated soils were treated with Simple Green and high nitrogen content fertilizer.

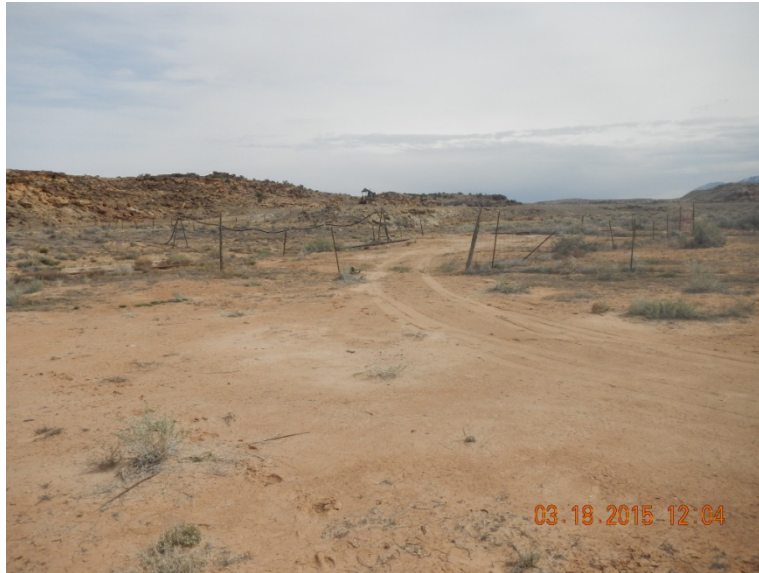
Site of historic AST associated with Cache Unit #9 API #05-083-05148. Poly flow line on risers has replaced underground flow line where spill was generated from. Landowner, Corey Veach met COGCC SW EPS on March 24, 2015 to walk location and extent of releases.

3/27/15 - Phone conversation and site visit between landowner Corey Veach and SW EPS Jim Hughes. Mr. Veach and COGCC staff walked the area of the releases. Mr. Veach verbally gave Monument Global access to his land to complete remediation work. Mr. Veach expressed concerns about potentially impacted material at the site of the historic AST associated with the Cache Unit #9.

Phone conversation with Monument Global representative Tom Fox regarding remediation plan for historic AST location near the Cache Unit #9. Mr. Fox stated that equipment will be brought in to excavate and remove impacted material. Mr. Fox was made aware of the landowner’s recently granted access for remediation efforts.

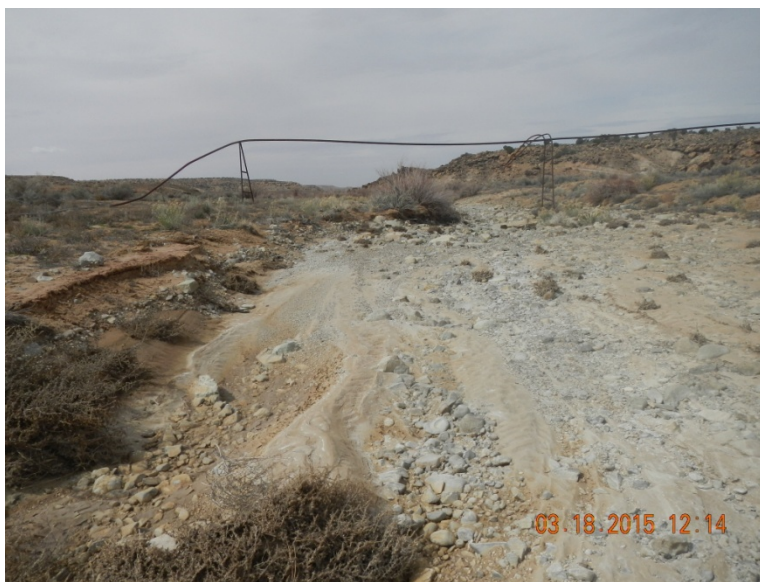
View facing downstream (west) of Spill #1 in streambed of the East Fork of McElmo Creek. Cache Unit #9 is directly south of this location. No evidence of a release remains in the streambed or along the banks.

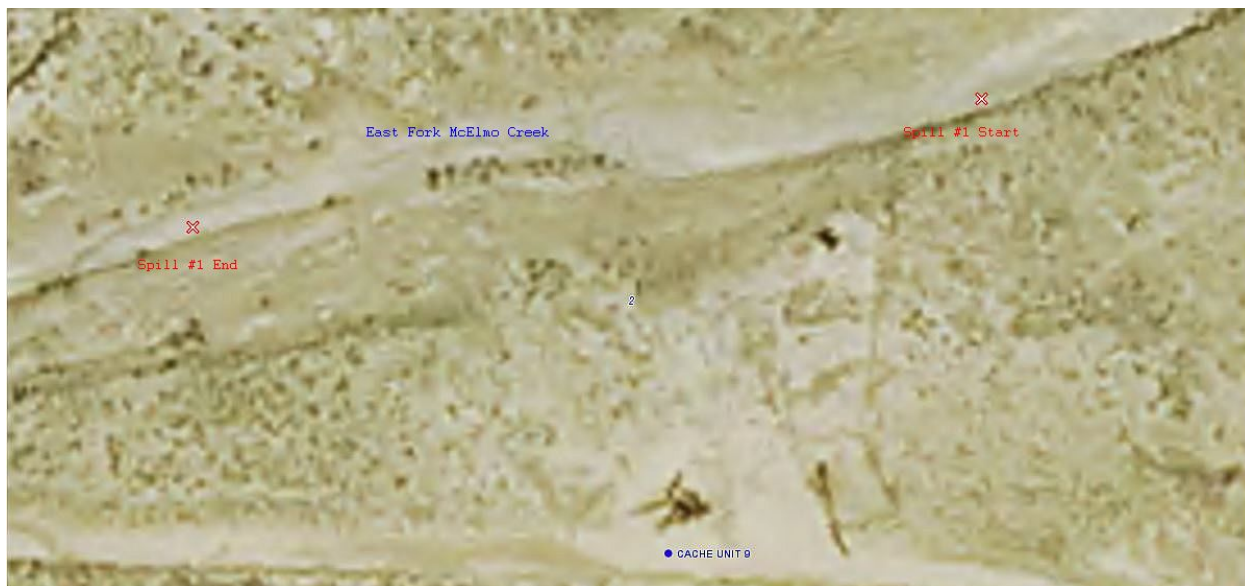
Aerial map showing extent of release. Coordinates were taken from field notes of Karen Spray's site inspection on 4/26/13. The East Fork of McElmo Creek flows from right to left.

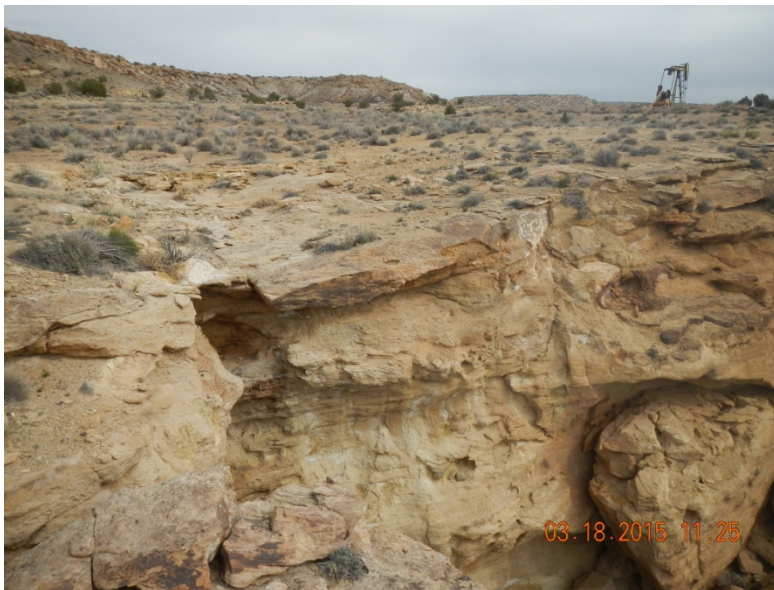
View from cliff face looking north towards Monument Global Cache Unit #6. Area impacted by Spill #2. A historic release from a corroded flow line was documented as the cause of this release. Remediation project #7787 indicates that the flow line was repaired and the impacted materials were treated with Simple Green and high nitrogen content fertilizer.

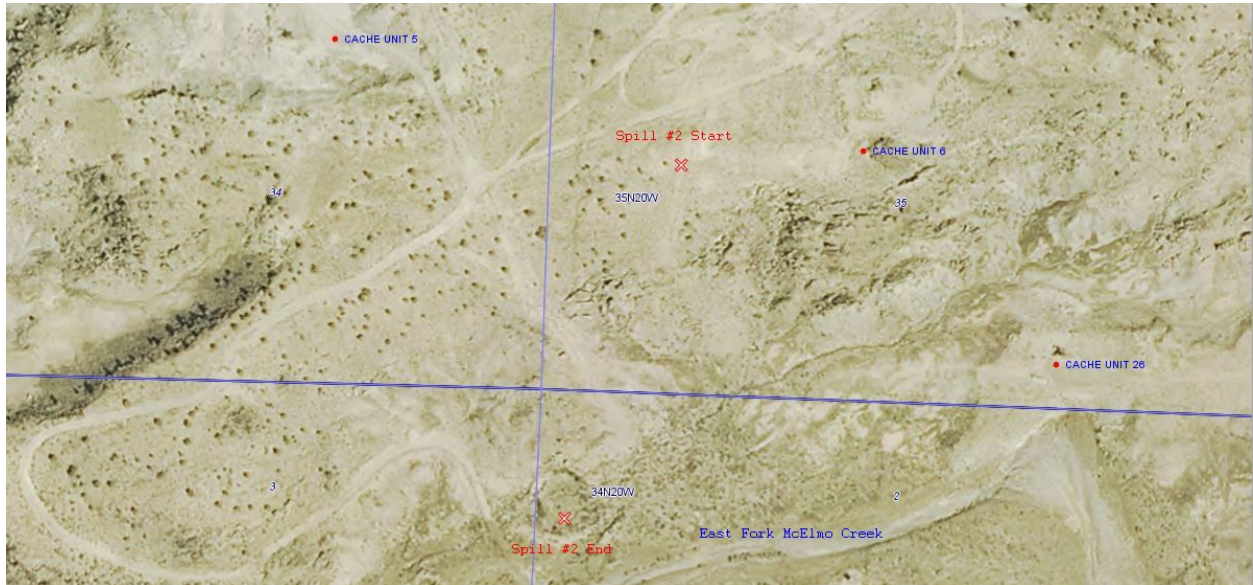
Aerial map showing extent of release. Produced fluids from spill #2 reportedly did not reach the East Fork of McElmo Creek.

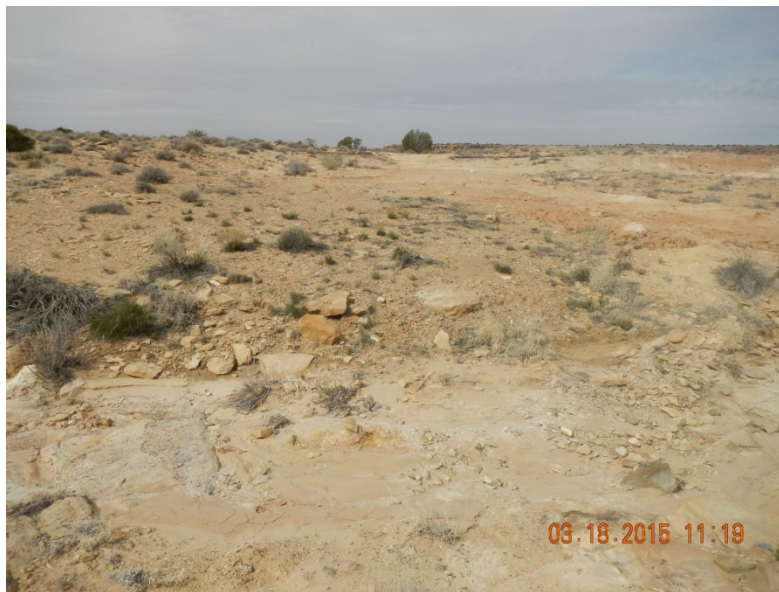
Area where produced fluids ran over the cliff face. This area has had some surface disturbance.

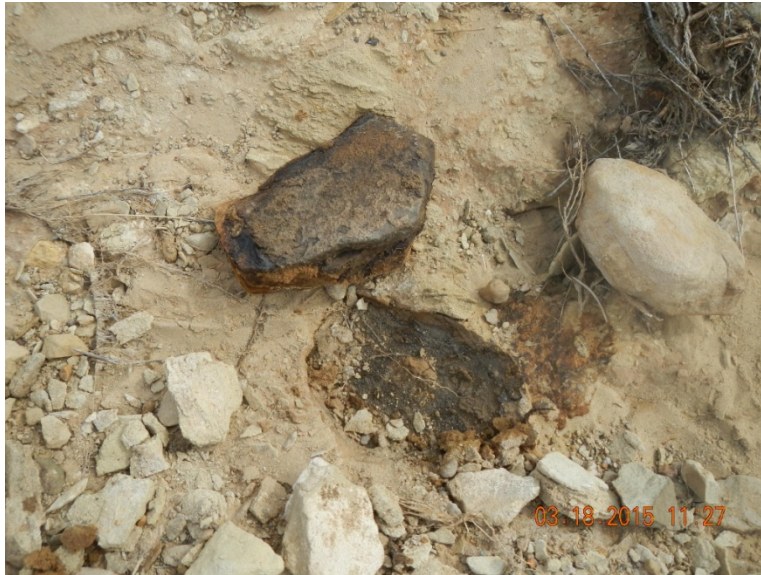
Overturned rocks near edge of cliff are oil stained.

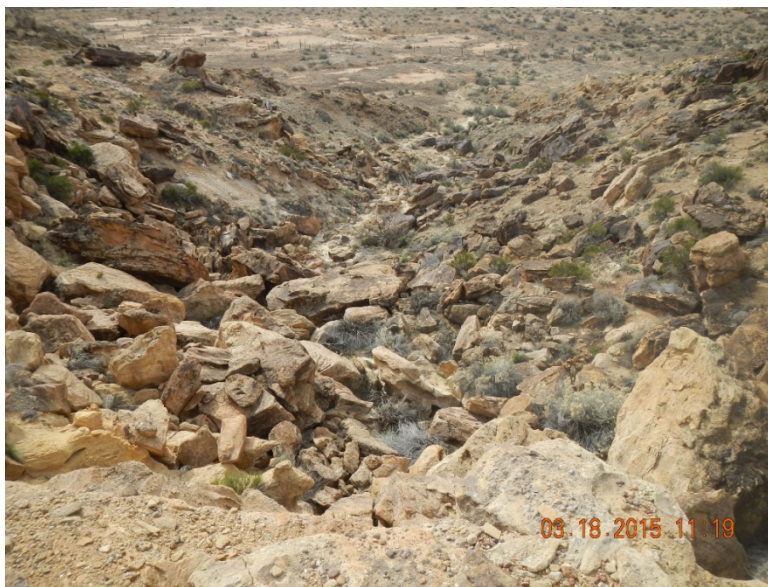
View to the south of impacted drainage and terrain where produced fluids flowed off of bluff.
Impacted material is visible in streambed, as well as on top of the bluff.

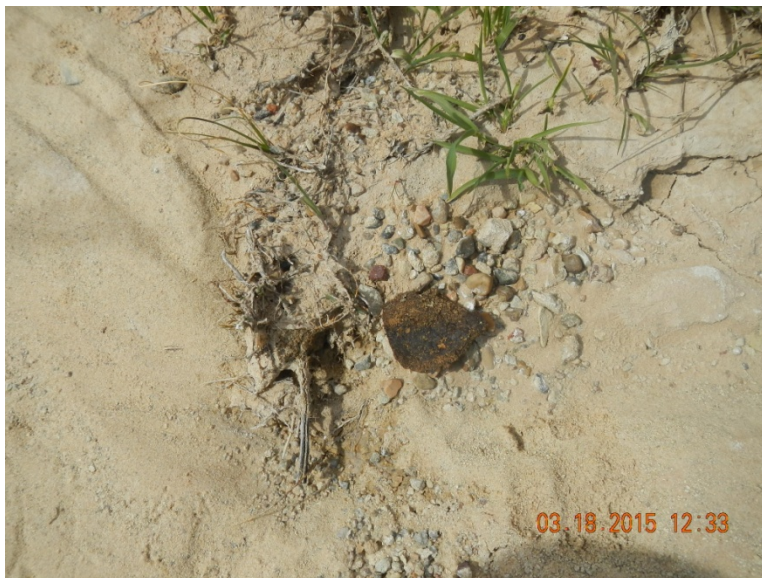
Impacted rocks and soil in streambed of tributary drainage to the East Fork of McElmo Creek.

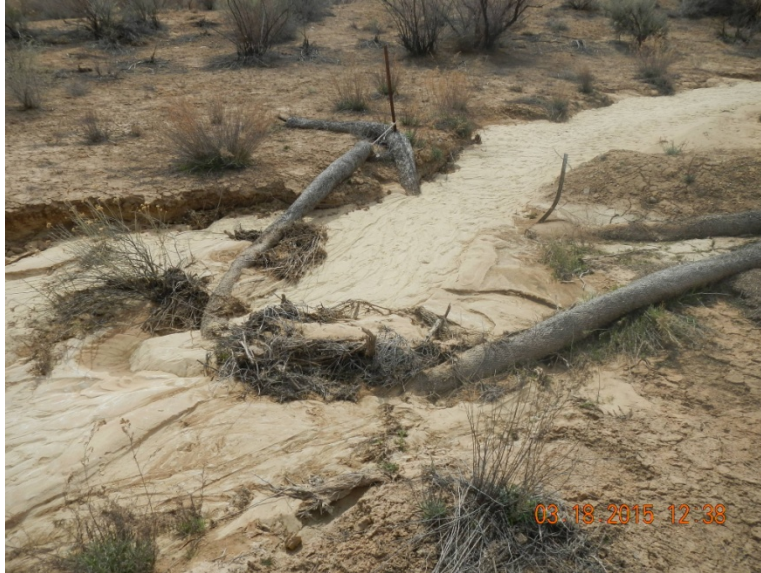
Wattles anchored across tributary drainage of the East Fork of McElmo Creek. This is the furthest extent reported for spill #2. Impacts from spill #2 are still present on top of the bluff and in the drainage below.

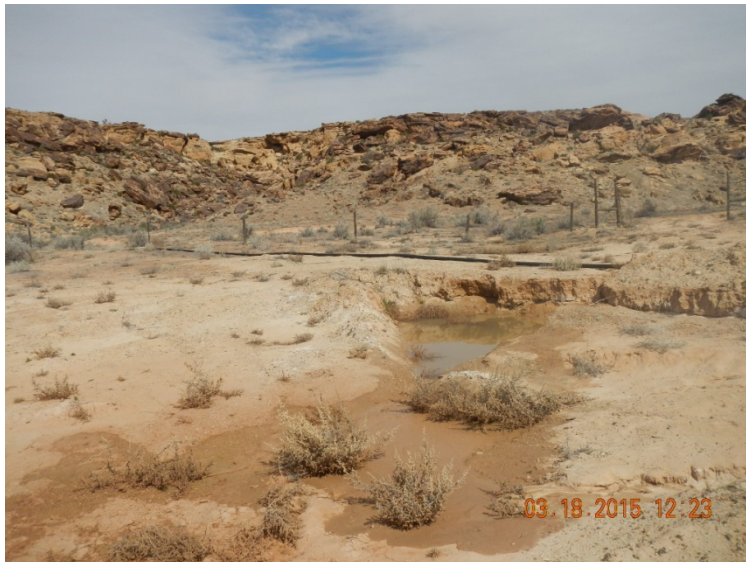
An underground flow line was discovered to be leaking on June 10, 2013.

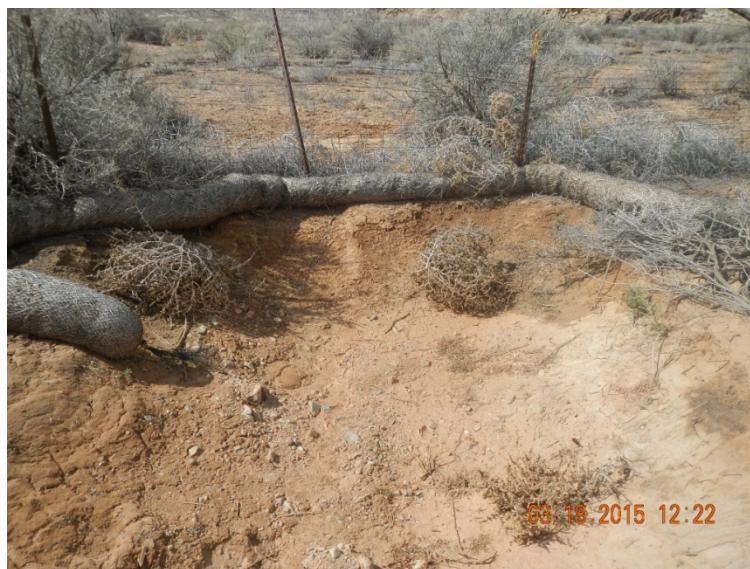
Furthest extent of spill #3 and excavated material. Material was stock piled on Monument Global Cache Unit #26 location. Per conversation with Tom Fox, material has been moved to tank battery across the valley to be land farmed.

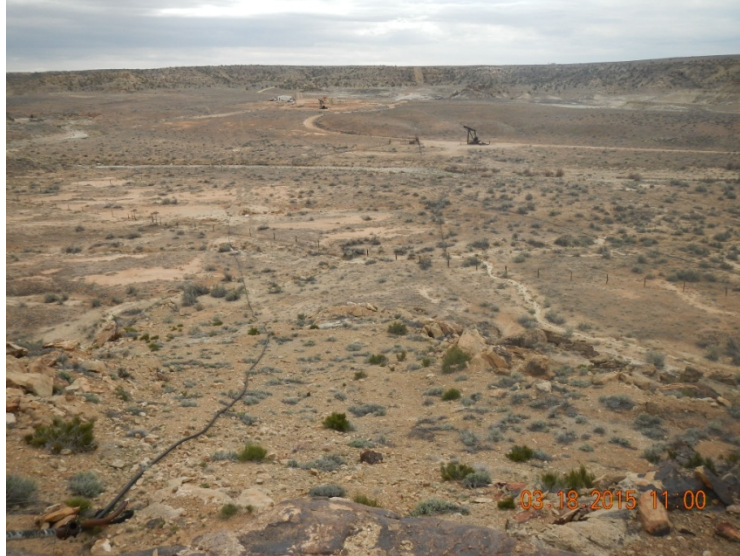
View to the south showing location of spill #3 in relation to the East Fork of McElmo Creek and the Cache Unit #9. Facility where impacted material has been transported to can be seen left of the pump jack in this photo.
