## **WARNING LETTER Document Number 2533889**

Spill 1: Cache Unit 9, NWNW Sec 2 T34N R20W, Montezuma County, Colorado  
Spill 2: Cache Unit 6, SWSW Sec 35 T35N R20W, Montezuma County, Colorado  
Spill 3: Cache Unit 9, NWNW Sec 2 T34N R20 W, Montezuma County, Colorado  
Spill 4: Cache Unit 9 NWNW Sec 2 T34N R20 W, Montezuma County, Colorado

## Cache Unit Investigations

April 6, 2015

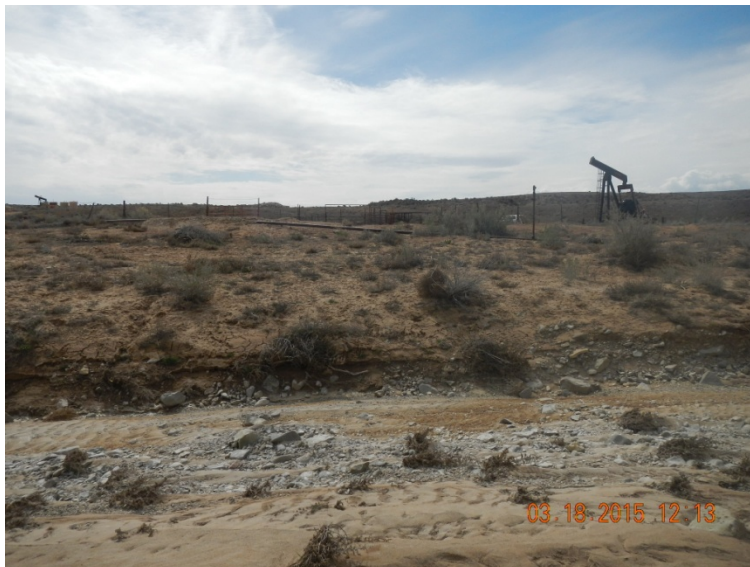
Approximate location where produced fluids entered the East Fork of McElmo Creek, from an underground flow line that had corroded. The East Fork of McElmo Creek is an intermittent stream. The streambed indicates that high energy flows occur during storm events. The Monument Global Cache Unit #9 pump jack is visible in the background. Remediation project #7786 indicates that contaminated soils were treated with Simple Green and high nitrogen content fertilizer.

- Submit a supplemental report to remediation project #7786 detailing work performed to date, corrective actions taken (including type and quantity of product(s) used for remediation), and any future work plans. **Corrective Action Deadline Date: June 8, 2015.**
- Request “No Further Action”. **Corrective Action Deadline Date: June 8, 2015.**

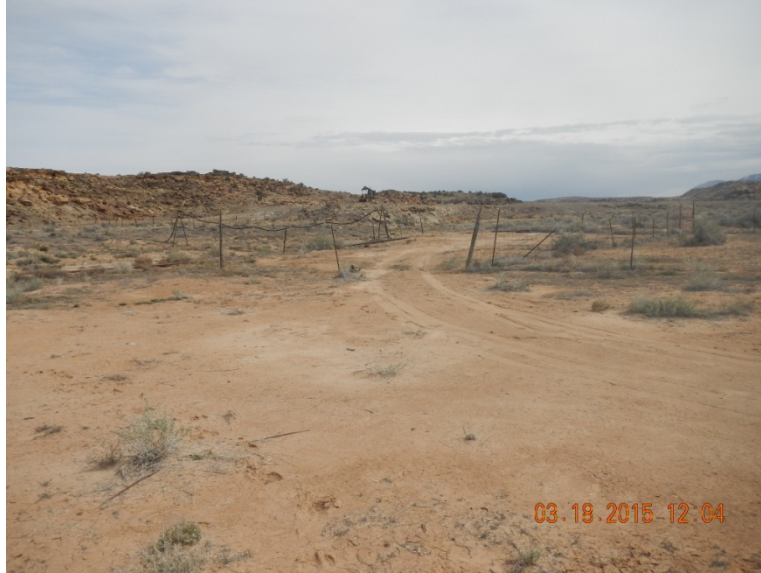
On March 18, 2015, COGCC Staff observed staining on the ground surface in the area where a former aboveground storage tank (AST) at the Cache Unit #9 Well was located. This spill/release was not reported to COGCC or remediated.

Site of historic AST associated with Cache Unit #9 API #05-083-05148. Poly flow line on risers has replaced underground flow line where spill was generated from. Landowner, Corey Veach met COGCC SW EPS on March 24, 2015 to walk location and extent of releases.

- Submit a Form 19 to report historic release in the area where the former above ground storage tank (AST) was located. **Corrective Action Deadline Date: 10-days of receipt of this letter.**
- Submit a Form 27 to address extent of impact and subsequent remediation of this location. **Corrective Action Deadline Date: Within 30-days of receipt of this letter.**

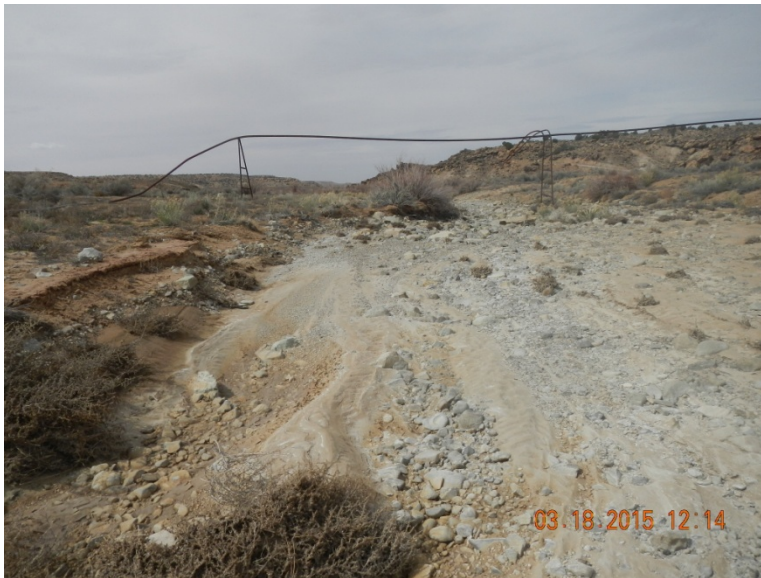
View facing downstream (west) of Spill #1 in streambed of the East Fork of McElmo Creek. Cache Unit #9 is directly south of this location. No evidence of a release remains in the streambed or along the banks.

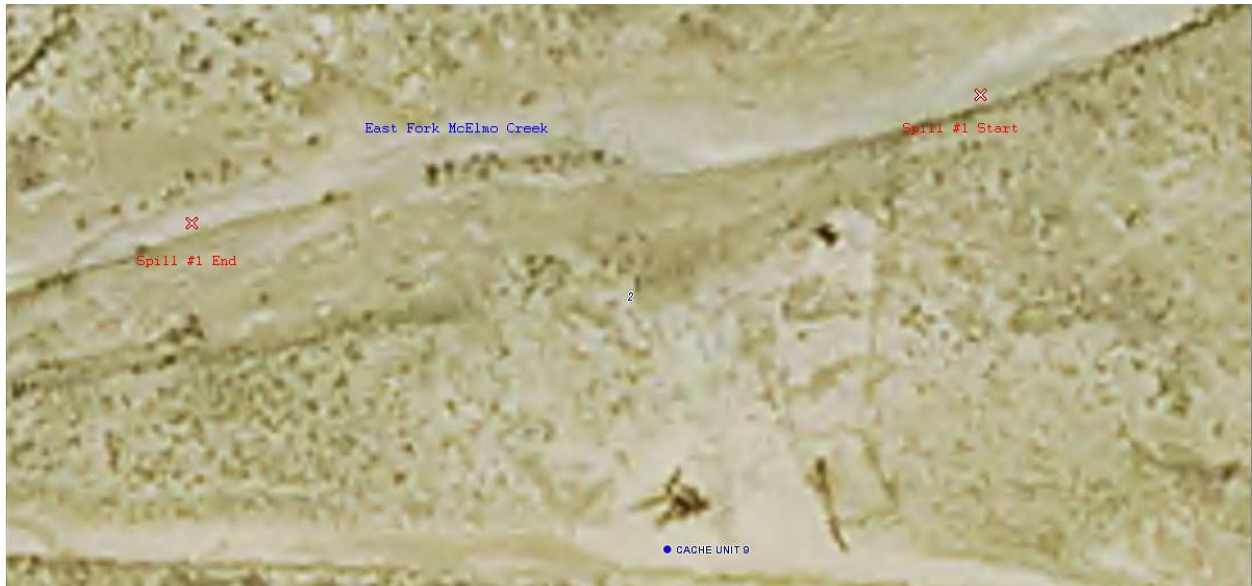
Aerial map showing extent of release. Coordinates were taken from field notes of Karen Spray's site inspection on 4/26/13. The East Fork of McElmo Creek flows from right to left.

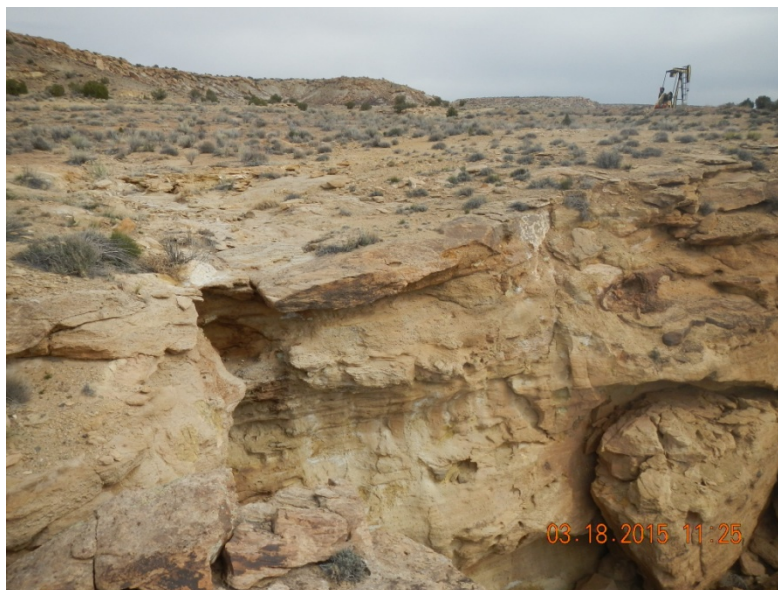
View from cliff face looking north towards Monument Global Cache Unit #6. Area impacted by Spill #2. A historic release from a corroded flow line was documented as the cause of this release. Remediation project #7787 indicates that the flow line was repaired and the impacted materials were treated with Simple Green and high nitrogen content fertilizer.

- Further remediation is necessary to address contamination still on location. Landowner’s verbal permission to access property has been granted. **Corrective Action Deadline Date: June 8, 2015.**
- Submit a supplemental report to remediation project #7787 to address activities performed to date, products and quantities used, and any future work plans. **Corrective Action Deadline Date: June 8, 2015.**

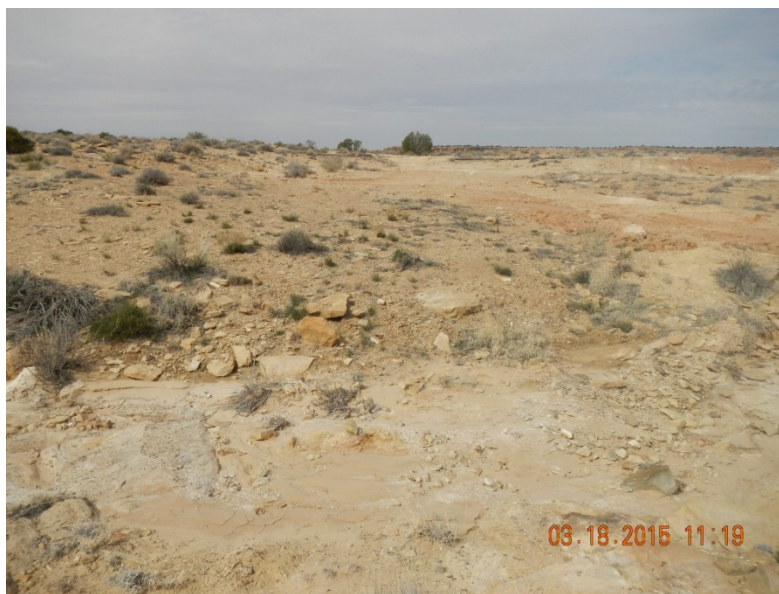
Area where produced fluids ran over the cliff face. This area has had some surface disturbance.

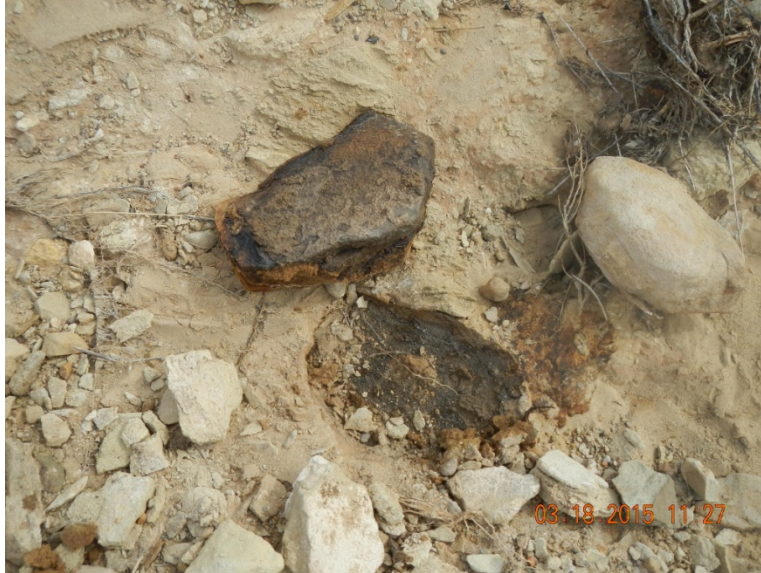
Overturned rocks near edge of cliff are oil stained.

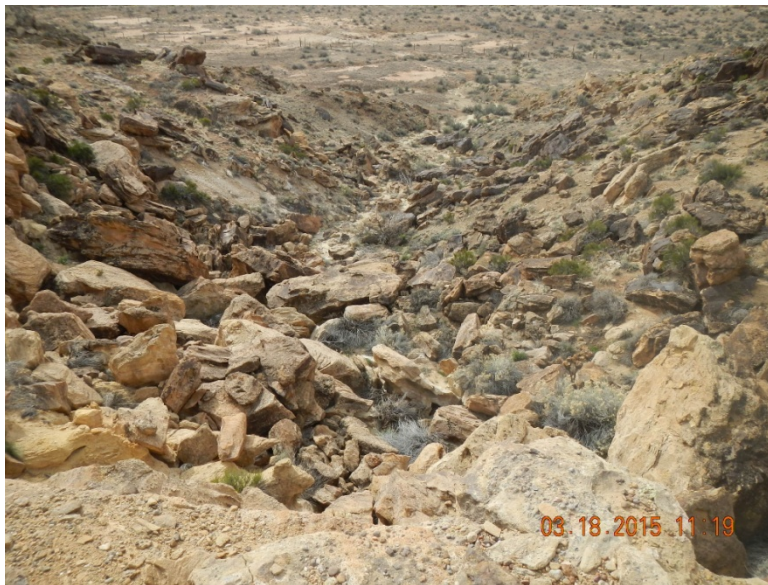
View to the south of impacted drainage and terrain where produced fluids flowed off of bluff.  
Impacted material is visible in streambed, as well as on top of the bluff.

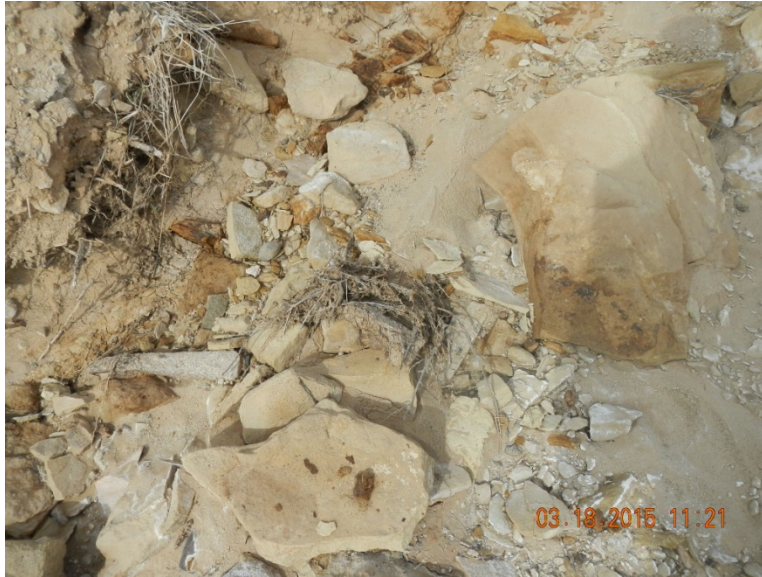
Impacted material from Spill #2 remains on top of the bluff west of the Monument Global Cache Unit #6.

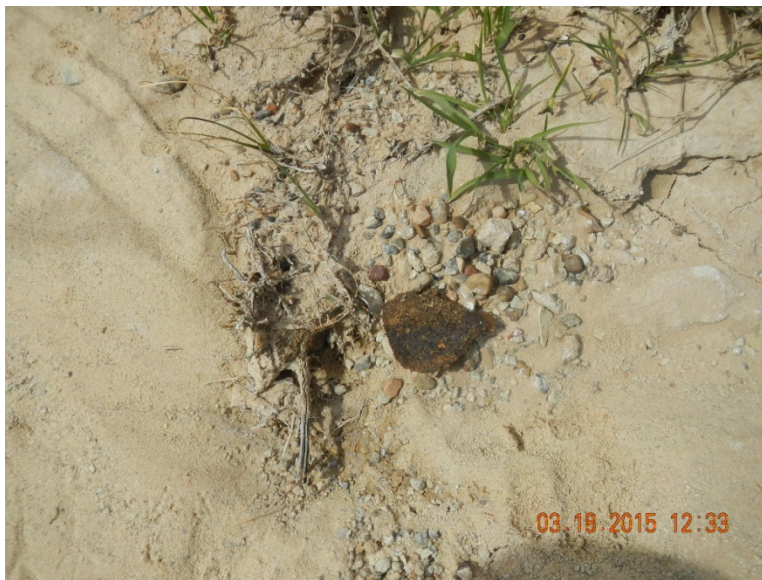
Impacted rocks and soil in streambed of tributary drainage to the East Fork of McElmo Creek.

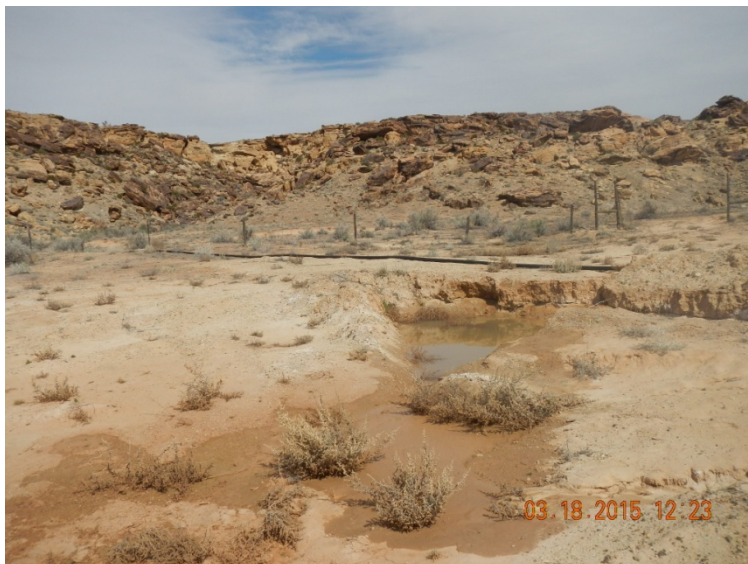
An underground flow line was discovered to be leaking on June 10, 2013.

- Collect confirmation samples and provide analytical results to COGCC. Results from 2013 sampling event indicate TPH, BTEX, PAH, inorganics, and boron levels in excess of Table 910-1 standards. **Corrective Action Deadline Date: June 8, 2015.**
- Remove decommissioned flow line to prevent future impacts. **Corrective Action Deadline Date: June 8, 2015.**

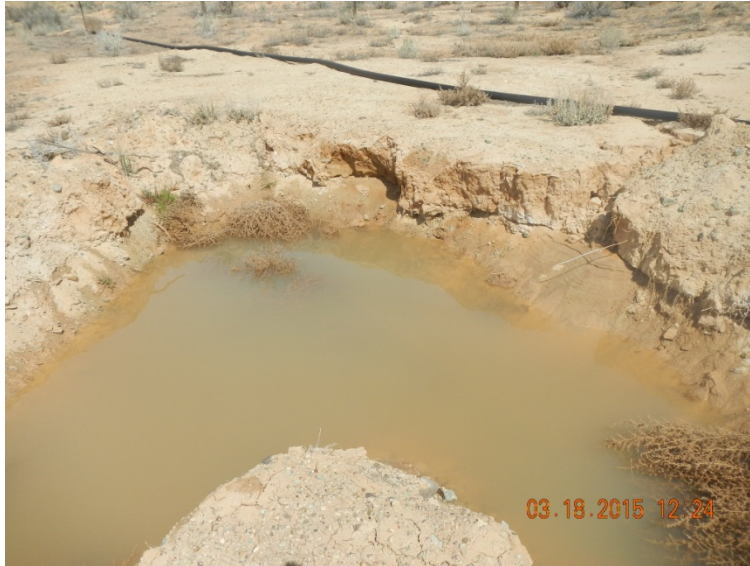
Open excavation from Spill #3 in East Fork McElmo Creek valley. Underground flow line can be seen in pool of standing water. No sheen or odor noted during this inspection. Replacement poly flow line can be seen behind excavation.

- Once confirmation samples are in accordance with Table 910-1, backfill the excavation with clean fill dirt. **Corrective Action Deadline Date: June 30, 2015.**
- Submit a supplemental report to remediation project #7906 detailing work performed, corrective actions taken, volume and disposition of material removed, and any future work plans. **Corrective Action Deadline Date: July 15, 2015.**
- Document how soil stock pile was treated, where it was stored, and disposed, and future remediation plans, if any. **Corrective Action Deadline Date: July 15, 2015.**
- Request “No Further Action”. **Corrective Action Deadline Date: July 15, 2015.**

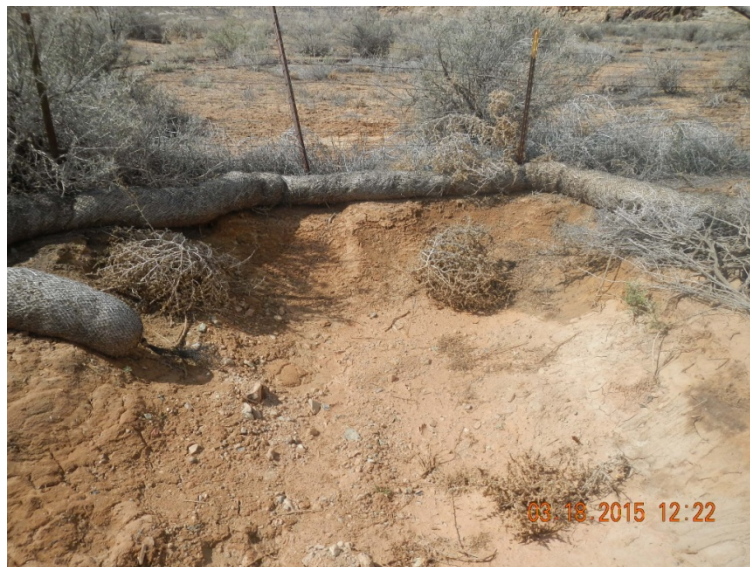
Furthest extent of spill #3 and excavated material. Material was stock piled on Monument Global Cache Unit #26 location. Per conversation with Tom Fox, material has been moved to tank battery across the valley to be land farmed.
