## Assessment of P&A Wells Within 1/4 Mile of Proposed CBM Well

June 2, 2015

**Proposed Well:** Rhodes 1 (API Pending)

**Well Name:** State Gas Com “MZ” 1 (API 05-067-07989)

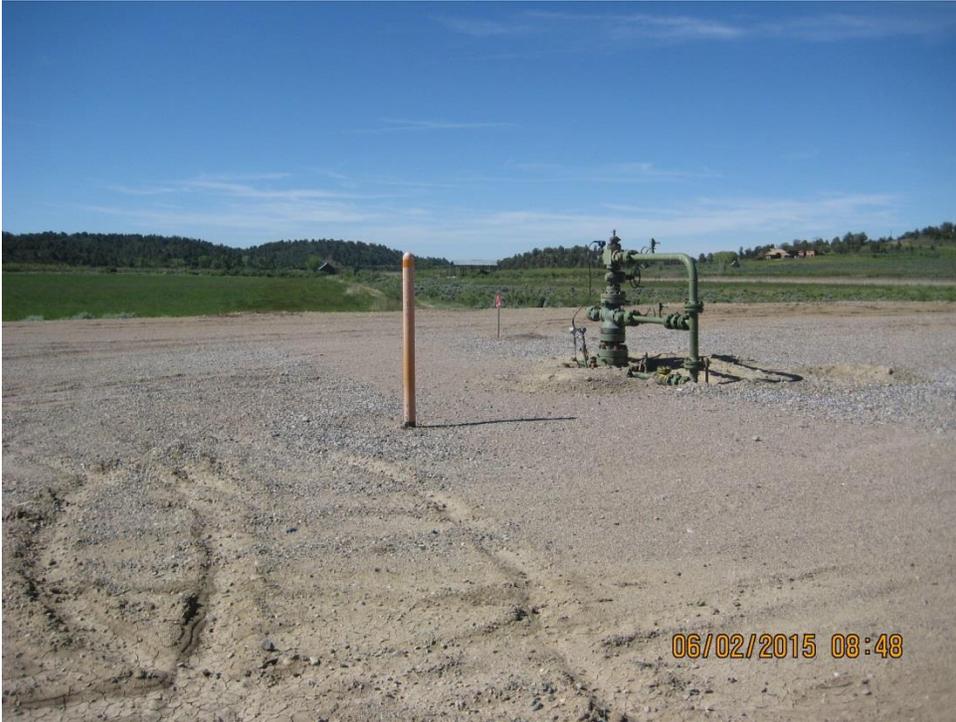
Figure 1 – State MZ 1 Location

In addition, a visual inspection of the State MZ 1 PA was conducted by BP personnel on June 2, 2015. The location was properly marked with a steel pipe (Photo 1). The PA was located within an existing well pad and the surrounding area was graveled. There were no bare spots or signs of stressed vegetation off of the well pad. The area around the pipe was saturated with water to test for bubbles, but no bubbles were observed. There were no odors or soil discoloration (Photo 2).
