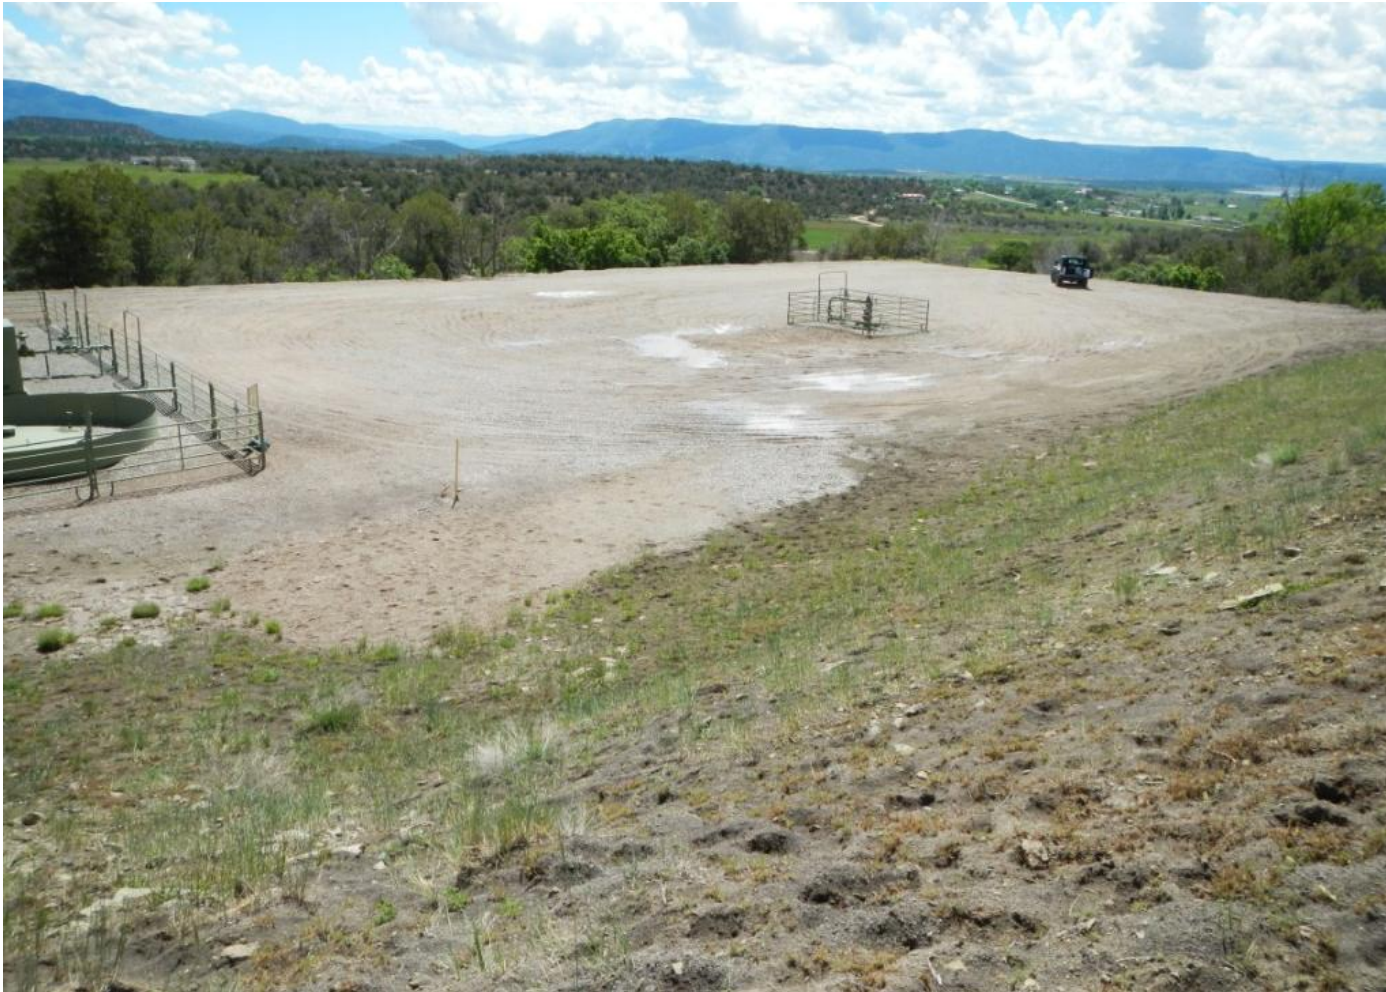
Photo 1. View from northwestern corner of well pad facing center. Sparse western wheatgrass (*Pascopyron smithii*) and cranesbill (*Erodium cicutarium*) are growing in the cut-slope.

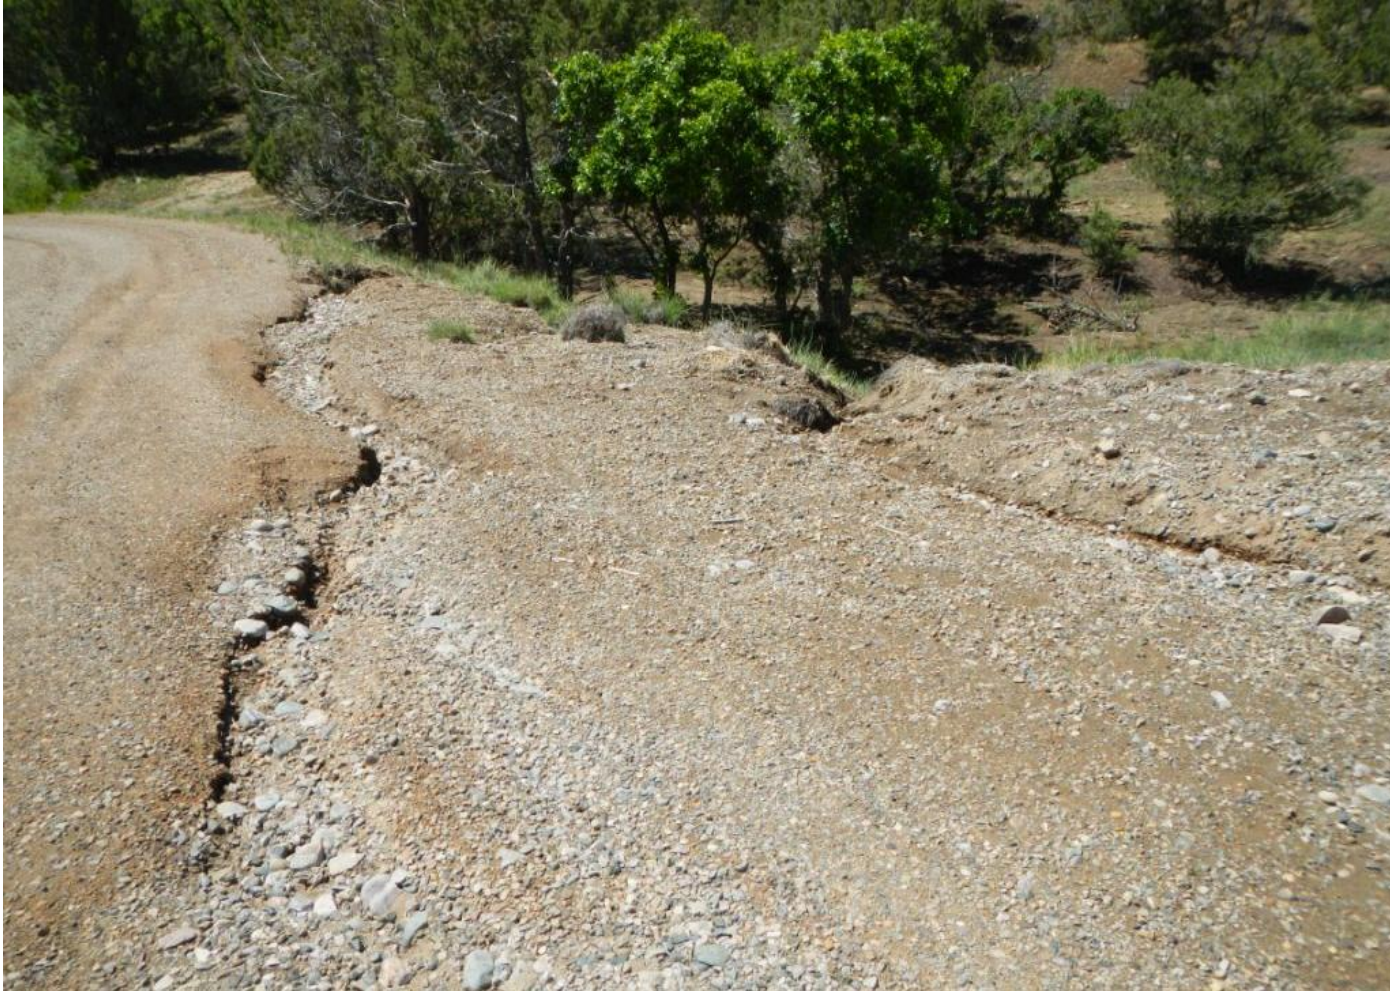
Photo 2. View of erosional channels approximately 1 to 2 feet wide and 1 to 2 feet deep in western edge of access road and southern portion of well pad.

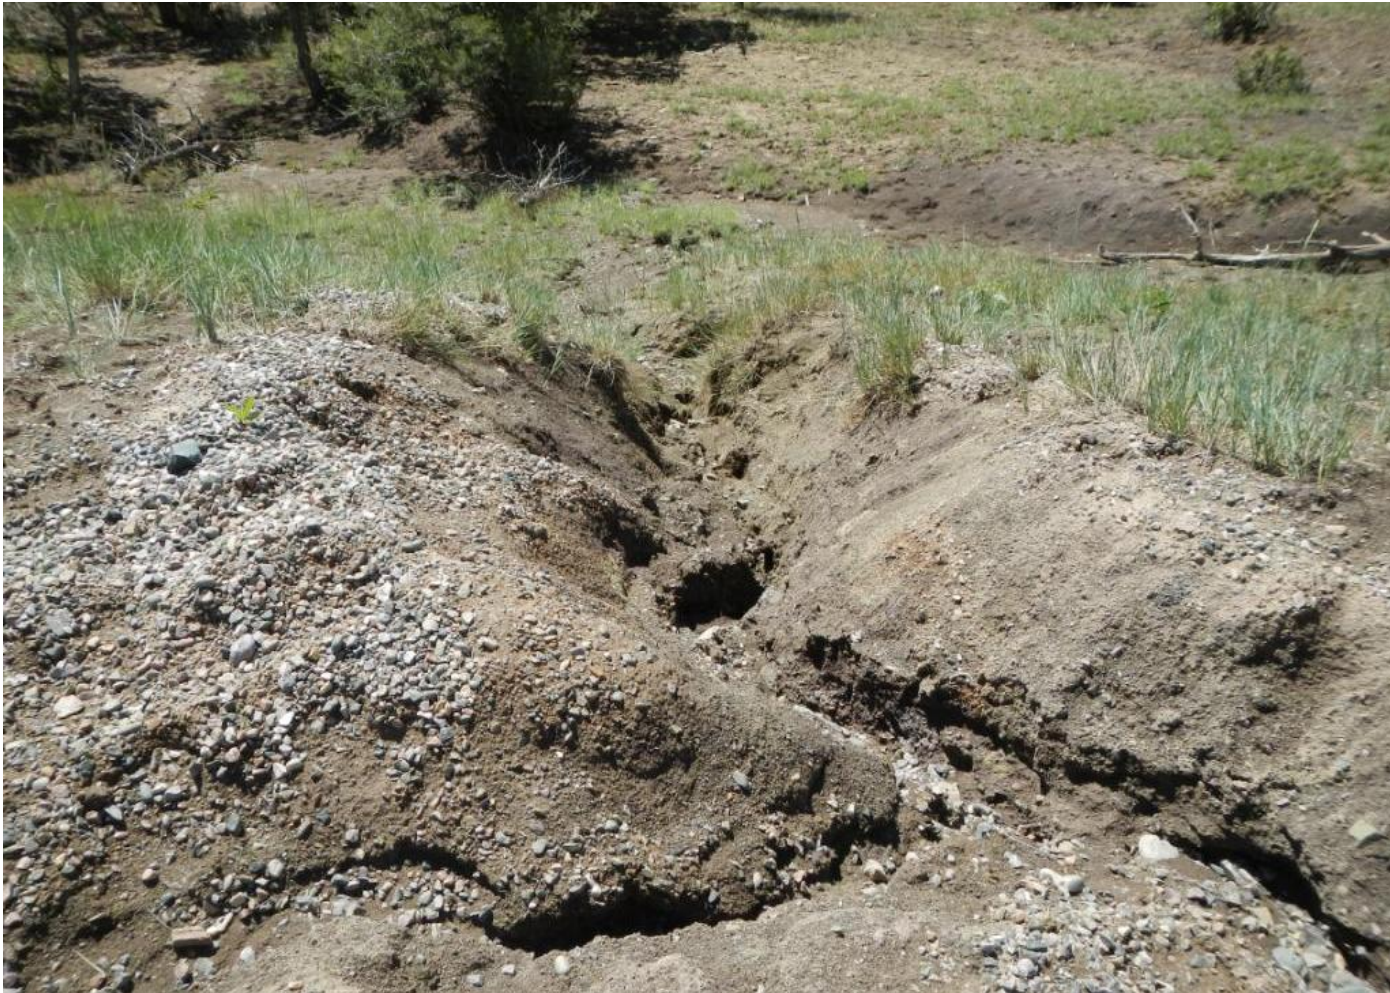
Photo 3. View of erosional channel approximately 3 feet wide and 3 feet deep within the southern portion of the project area.

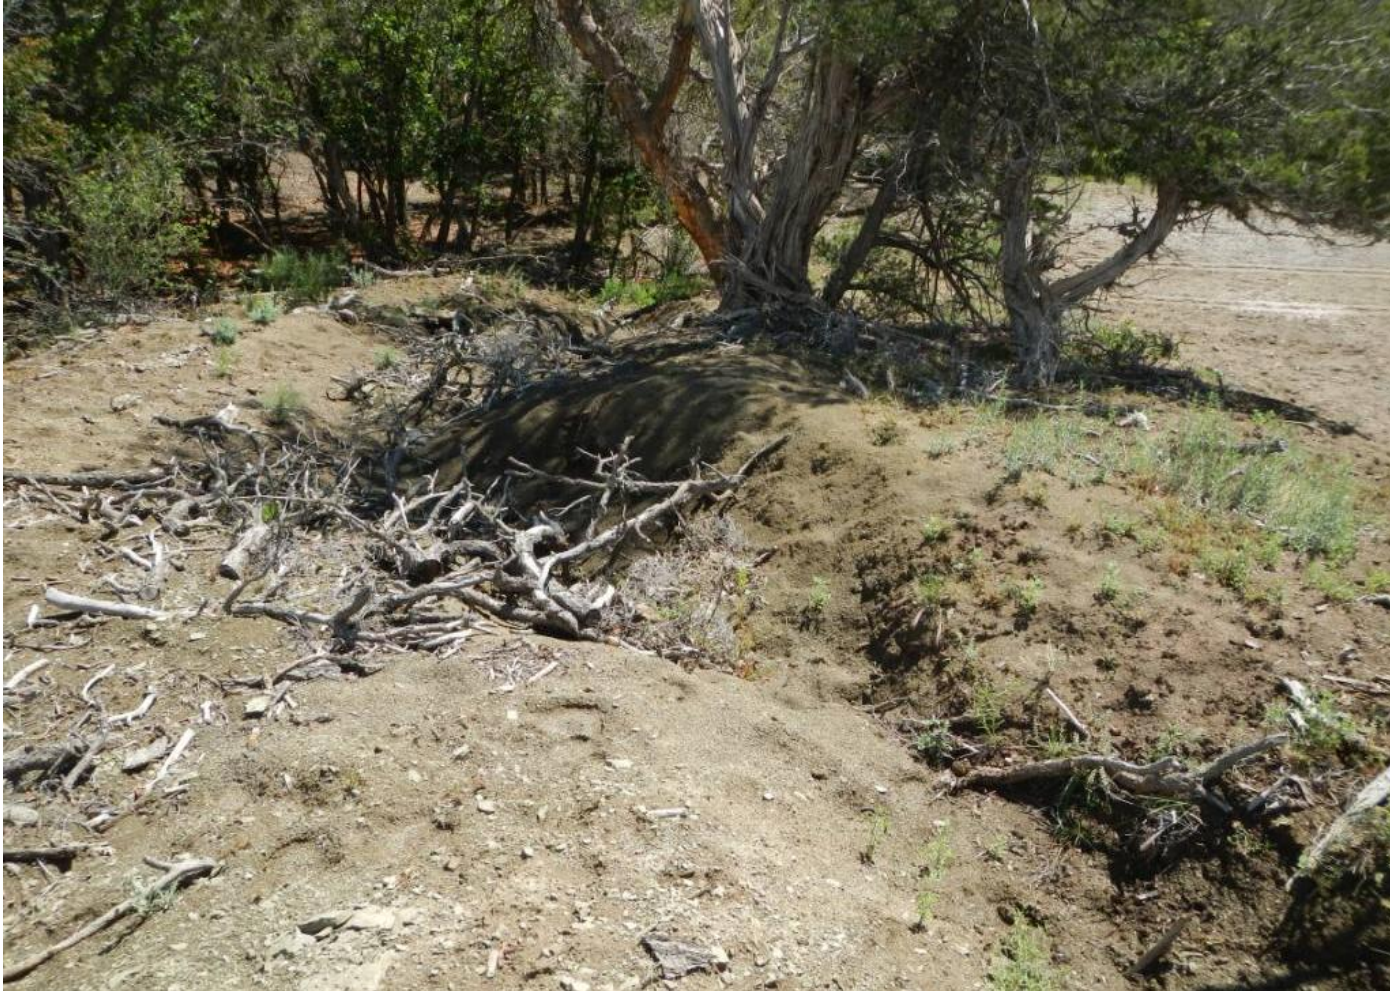
Photo 4. View of northern diversion channel facing downslope (eastward) toward the irrigation ditch. Stormwater BMPs are needed here to de-energize flows and filter sediment.

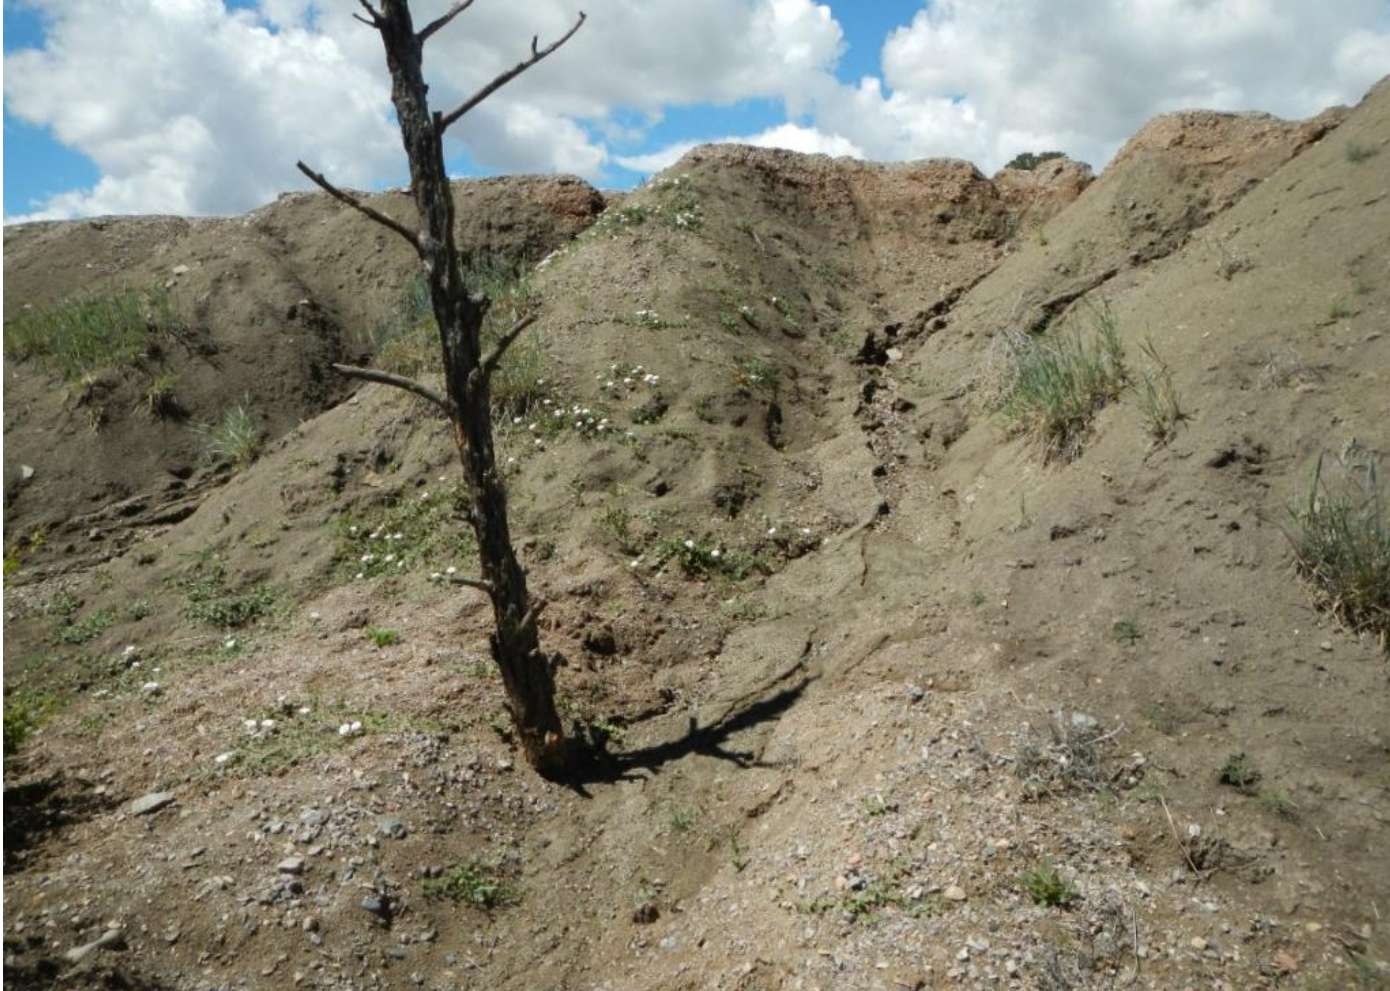
Photo 5. View of stormwater erosional channels within the eastern portion of the project area.

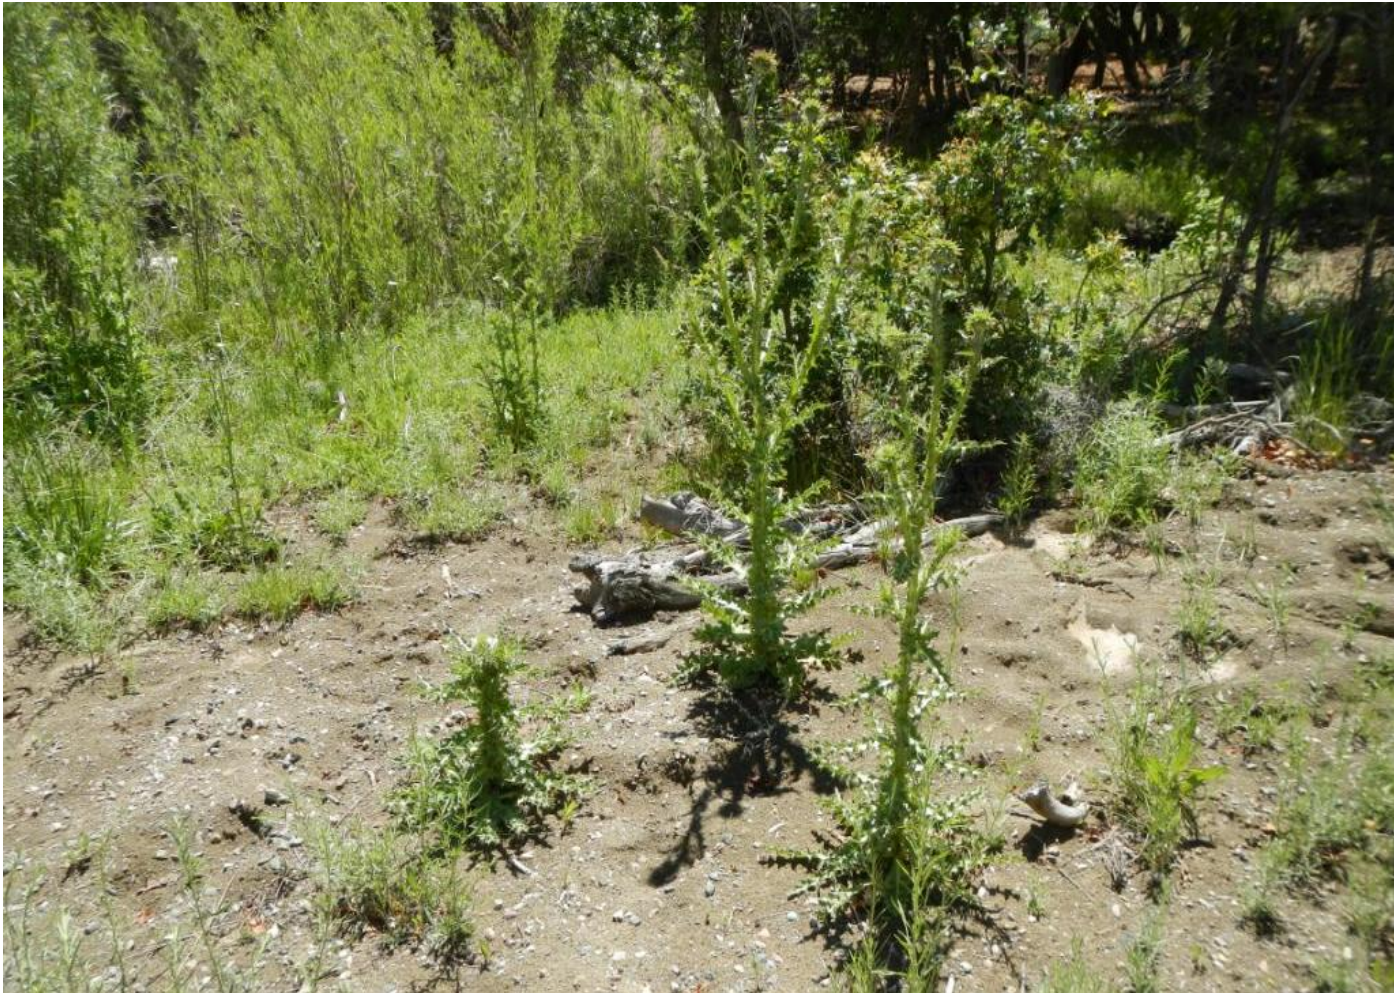
Photo 6. View of musk thistle (*Carduus nutans*) plants at the toe of the eastern fill slope.

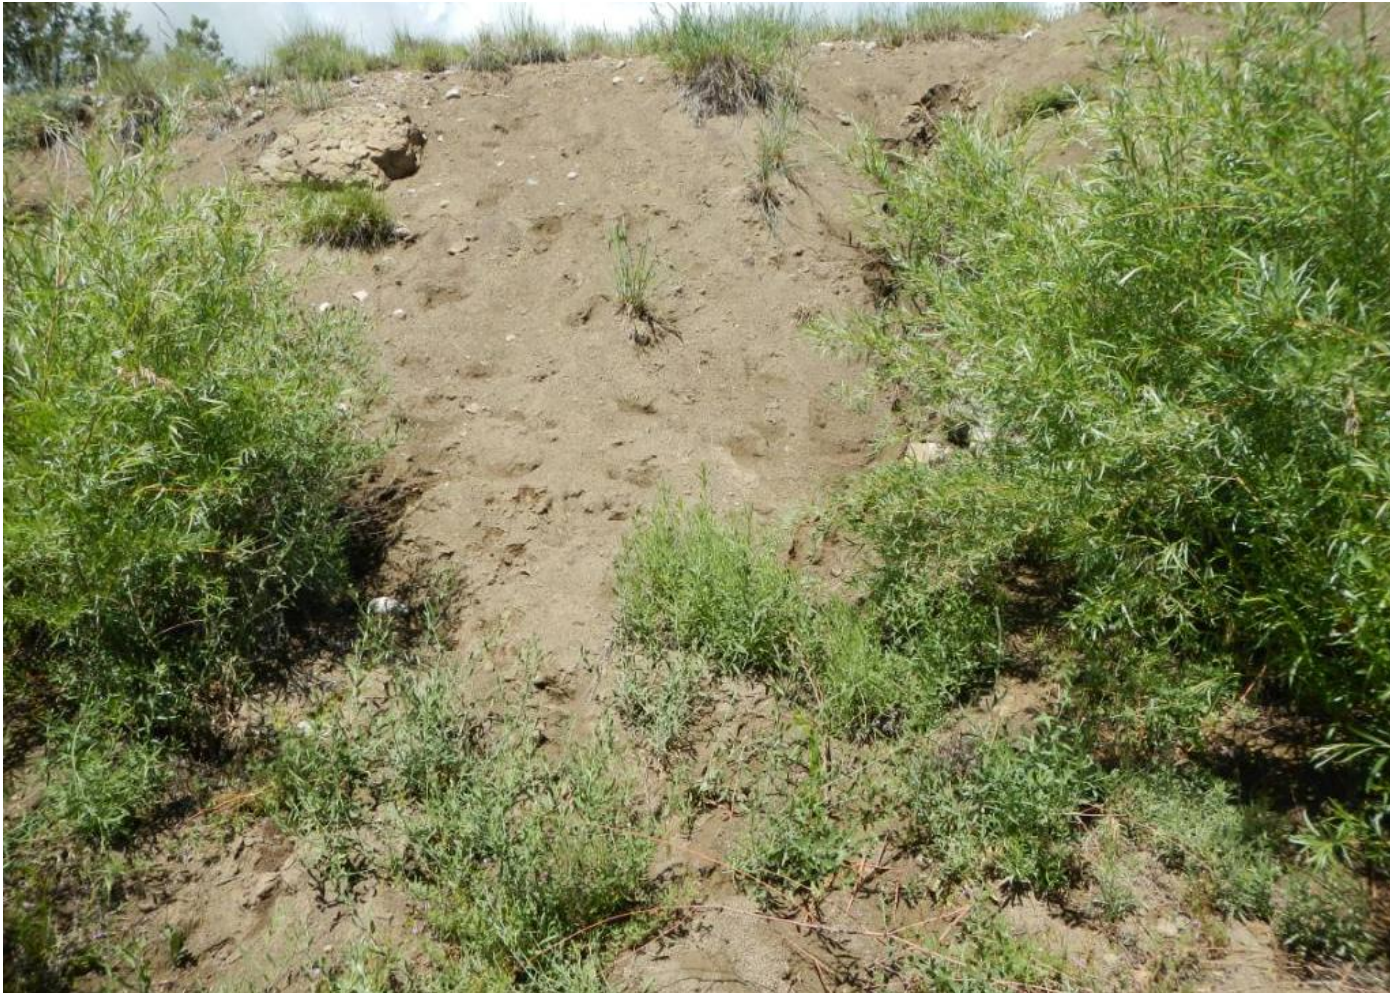
Photo 7. View of Russian knapweed (*Acroptilon repens*) growing in the toe of the eastern fill slope of the well pad.
