#34-10 #28-2 FC Pipeline Spill August 10, 2015

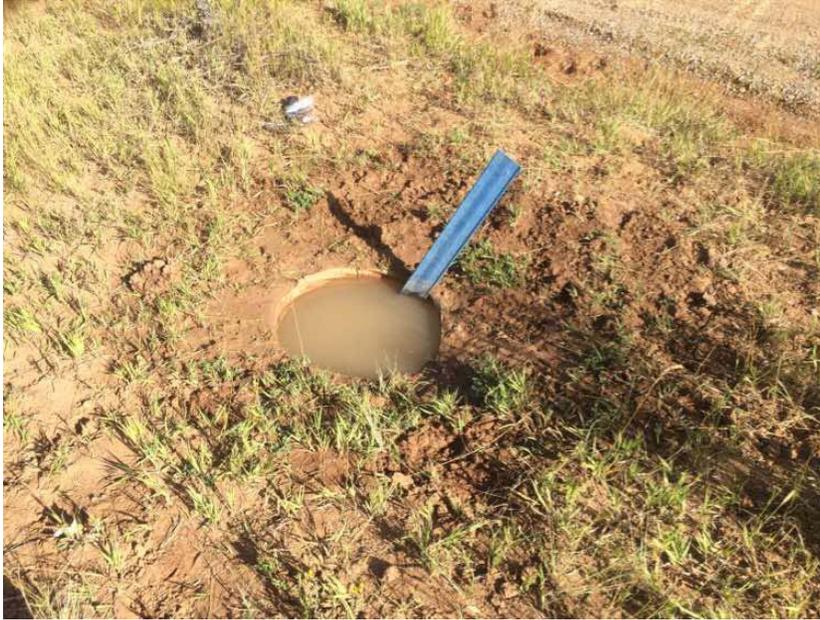
Figure 1. Valve can that overflowed due to a gas eliminator failure causing 1 bbl of produced water to spill onto the pipeline ROW. A vac truck pulled standing water from the valve can. Spill area is 7' x 7'.

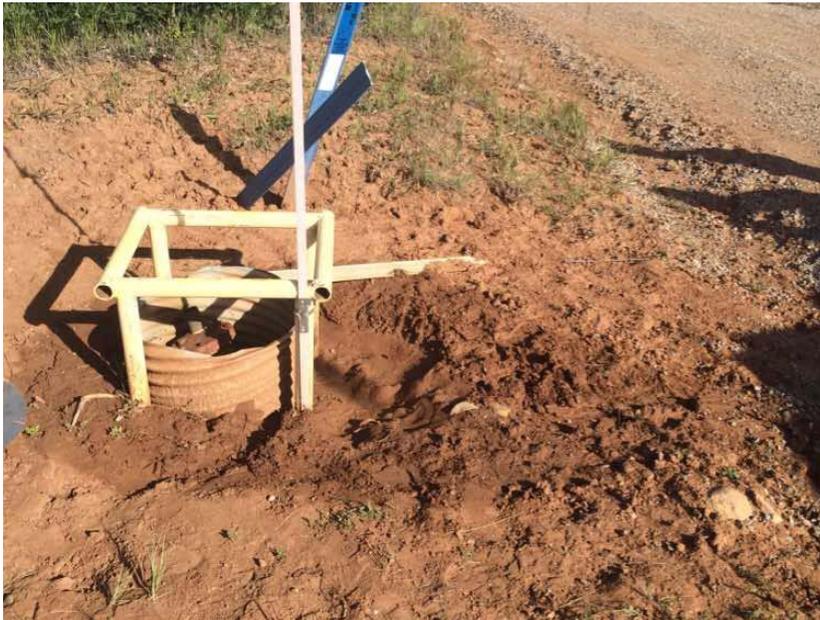
Figure 2. Valve can that overflowed due to a gas eliminator failure causing 2 bbls to spill onto the pipeline ROW and borrow ditch. Spill area is 15' x 5'.
