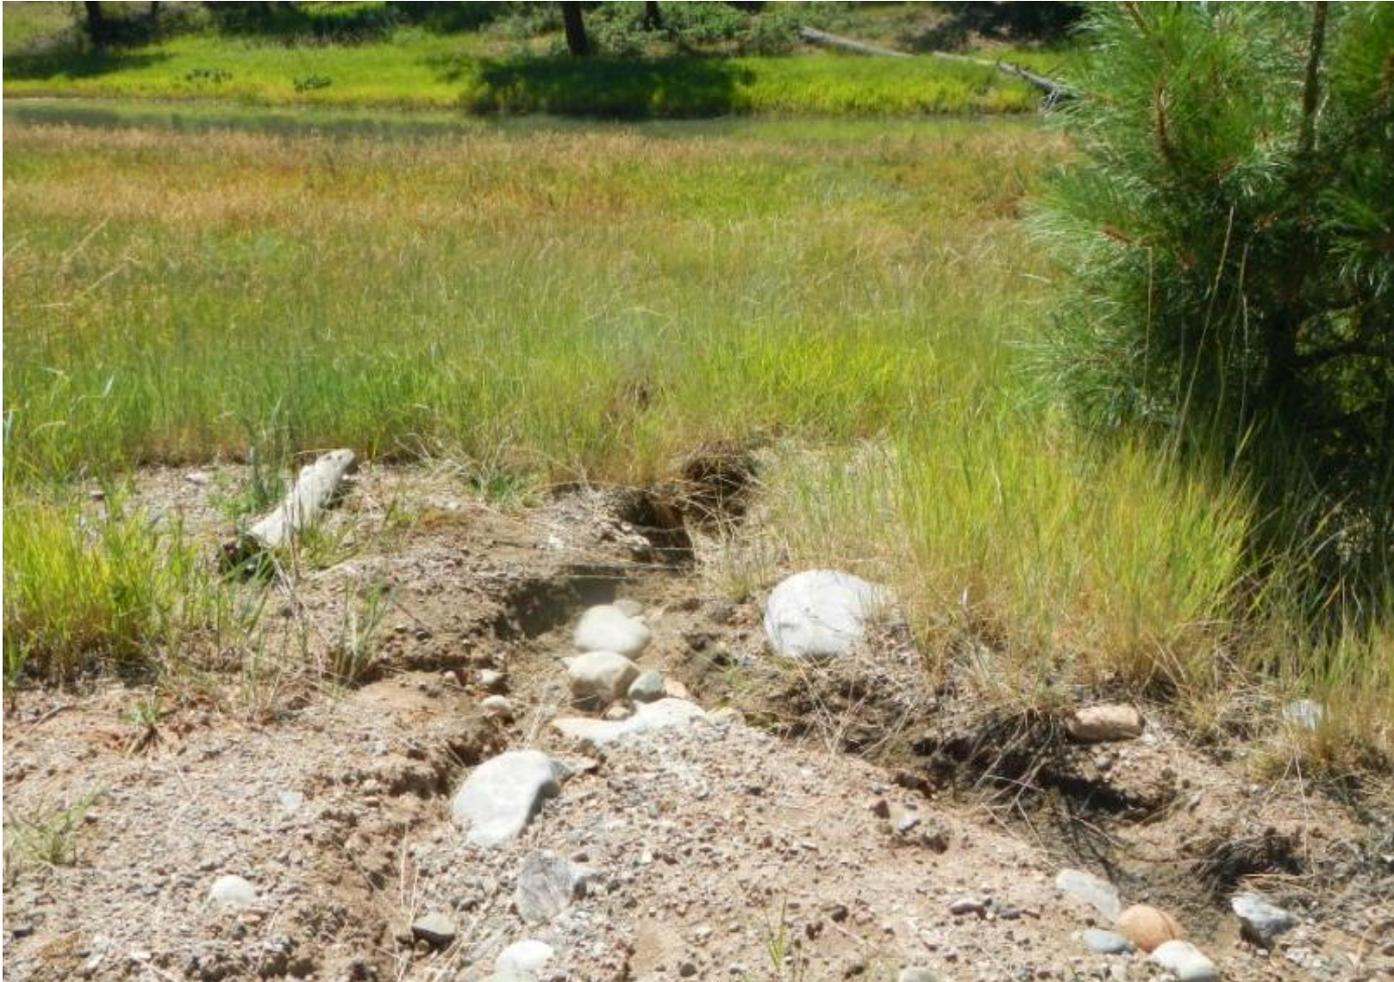
Photo 1. View of erosional channel (approximately 2 feet wide and 1.5 feet deep) within southern portion of project area. Erosional channel is flowing toward nearby open water (in background of photo).

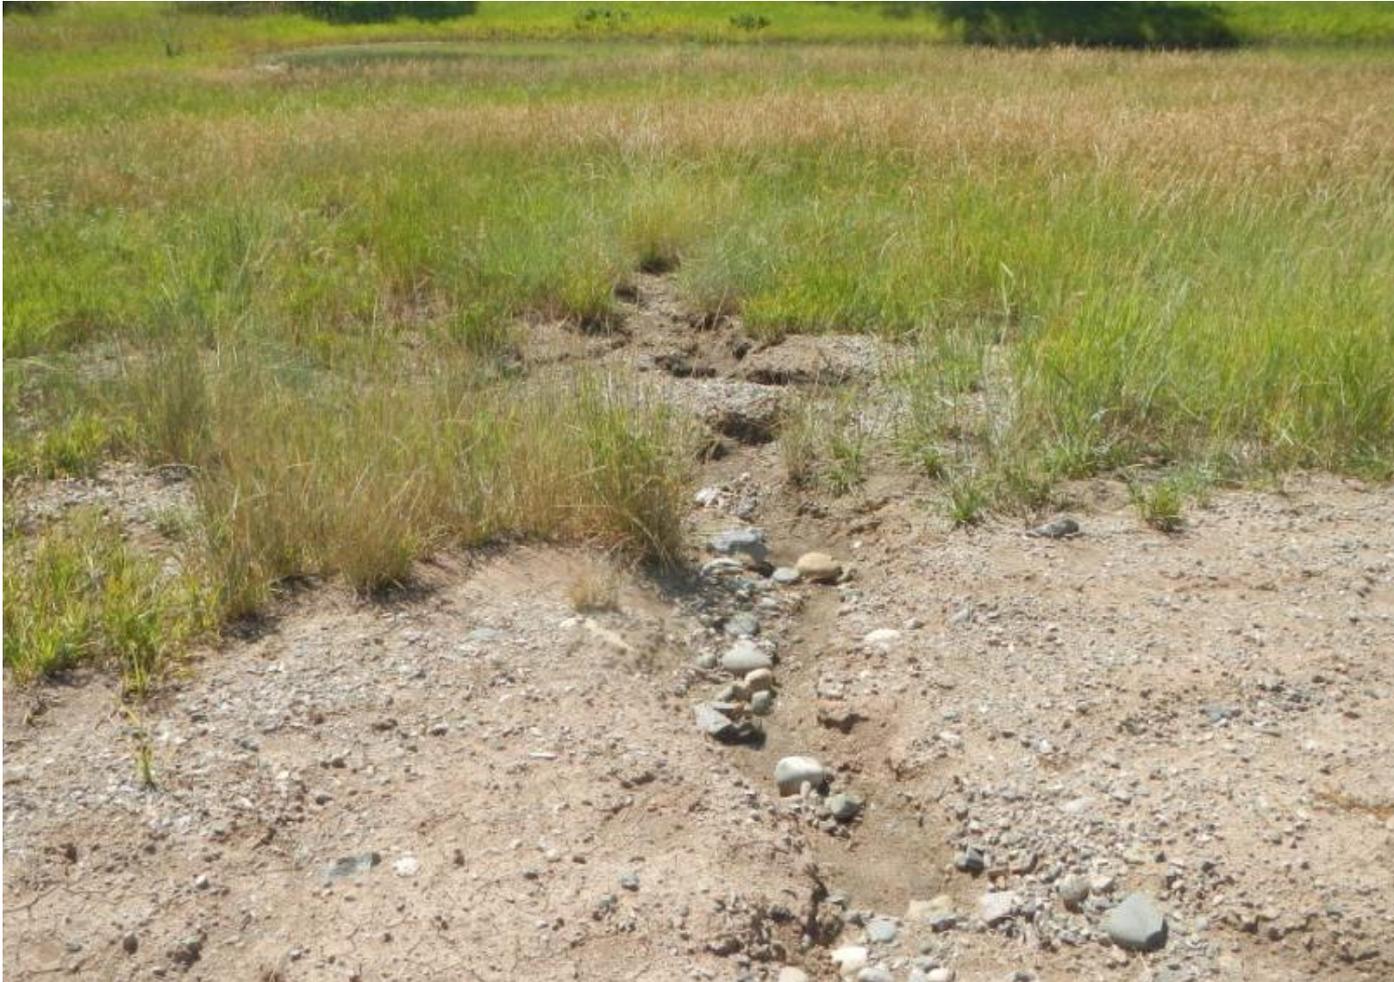
Photo 2. View of another erosional channel (approximately 12 inches wide and 10 inches deep) within southern portion of project area. Erosional channel is flowing toward nearby open water (in background of photo).

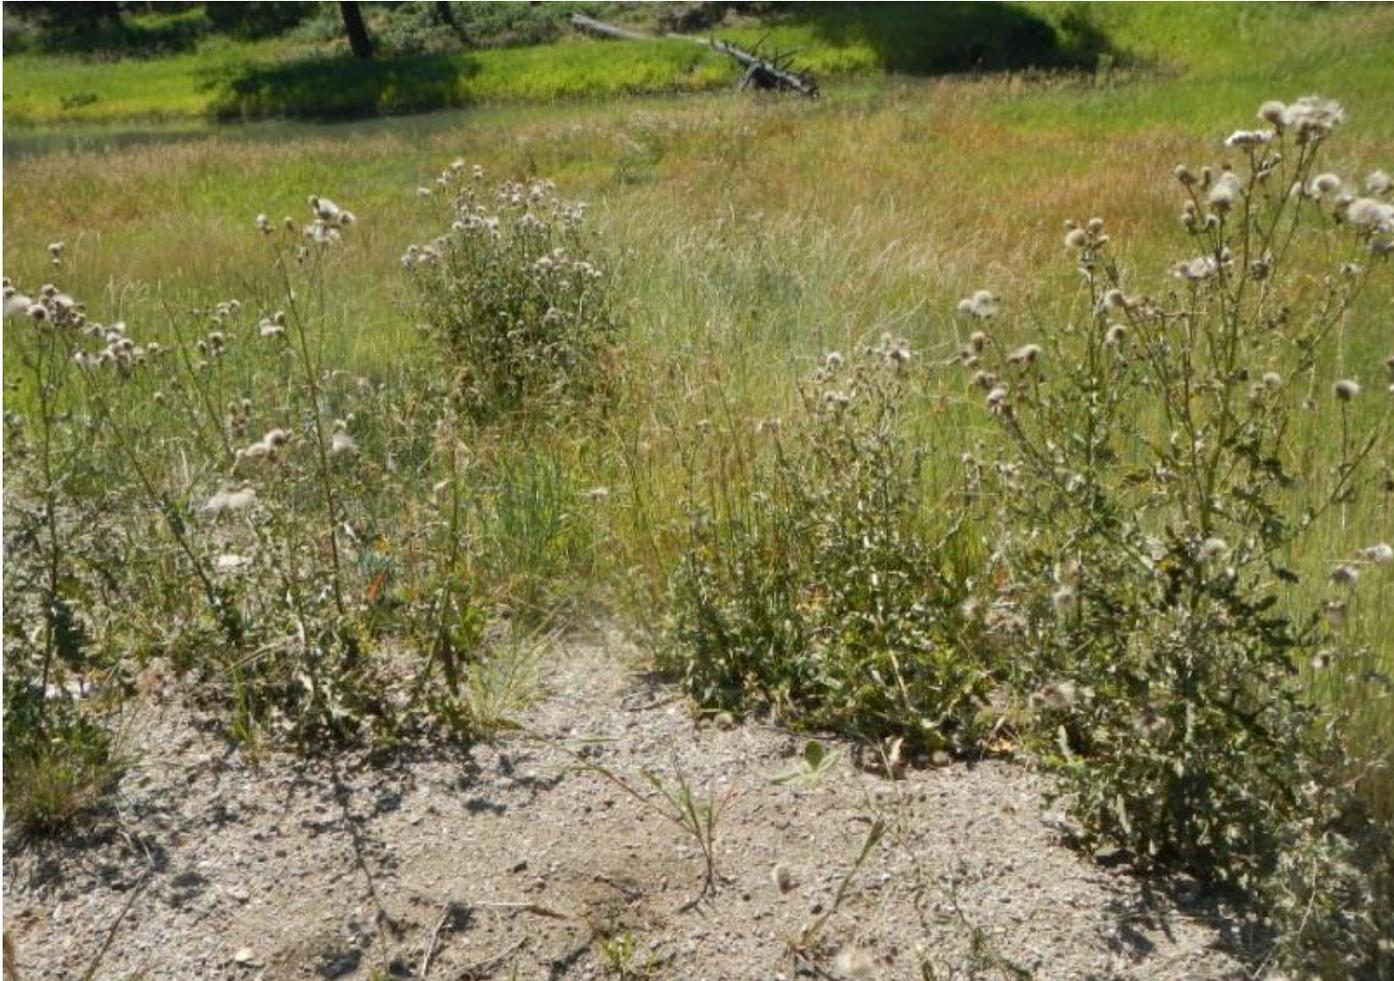
Photo 3. View of Canada thistle (*Cirsium arvense*) plants in southern portion of project area that need to be physically removed.
