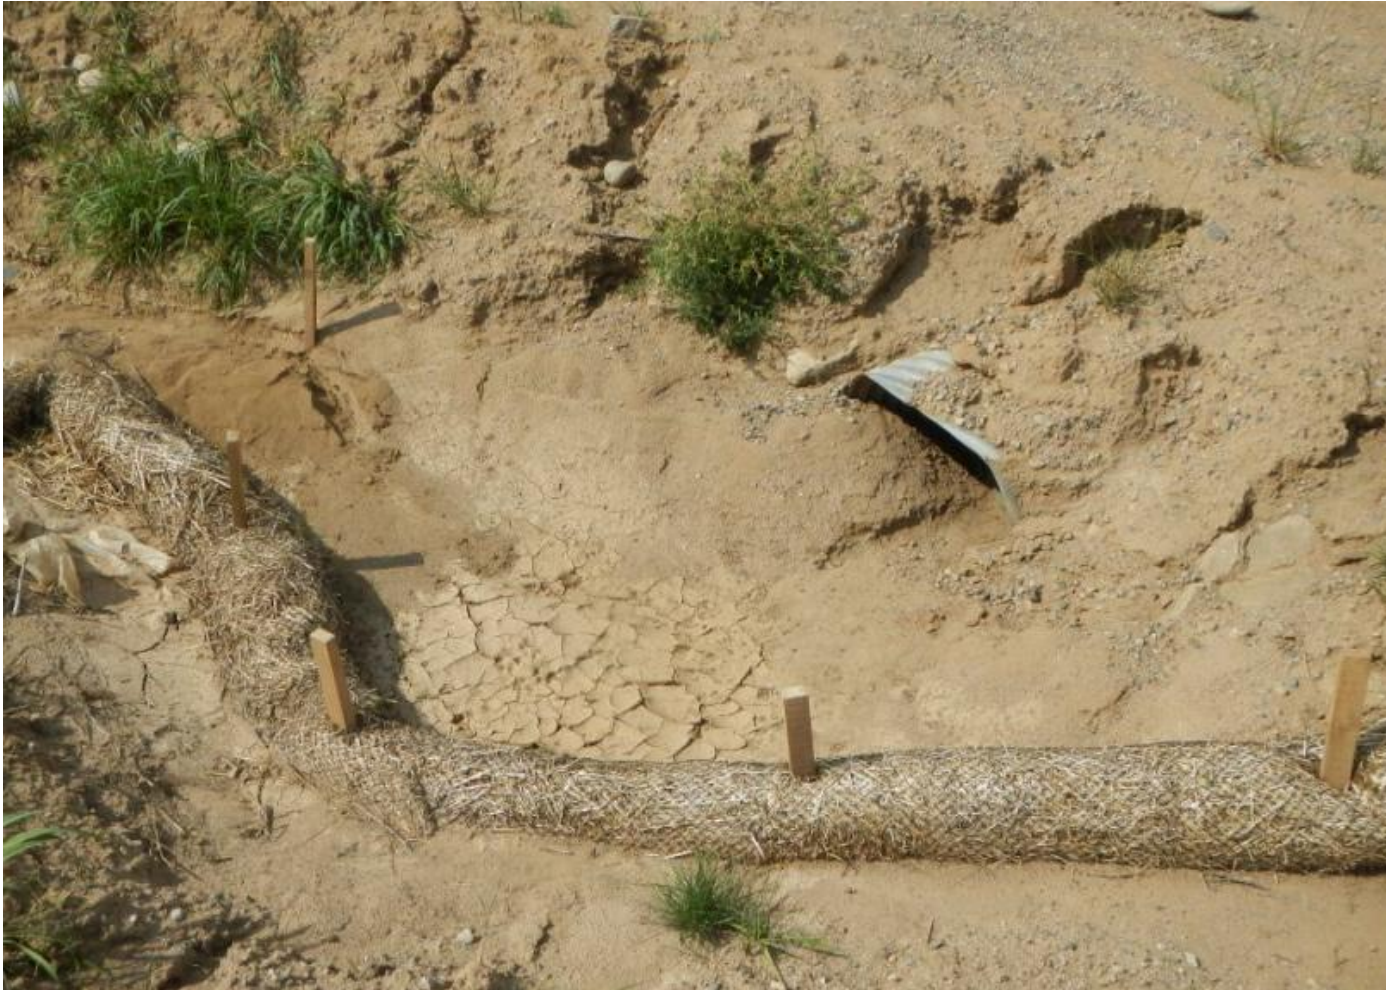
Photo 1. View of sediment filled silt trap and wattle at culvert near well pad entrance. This area needs stabilization and maintenance.

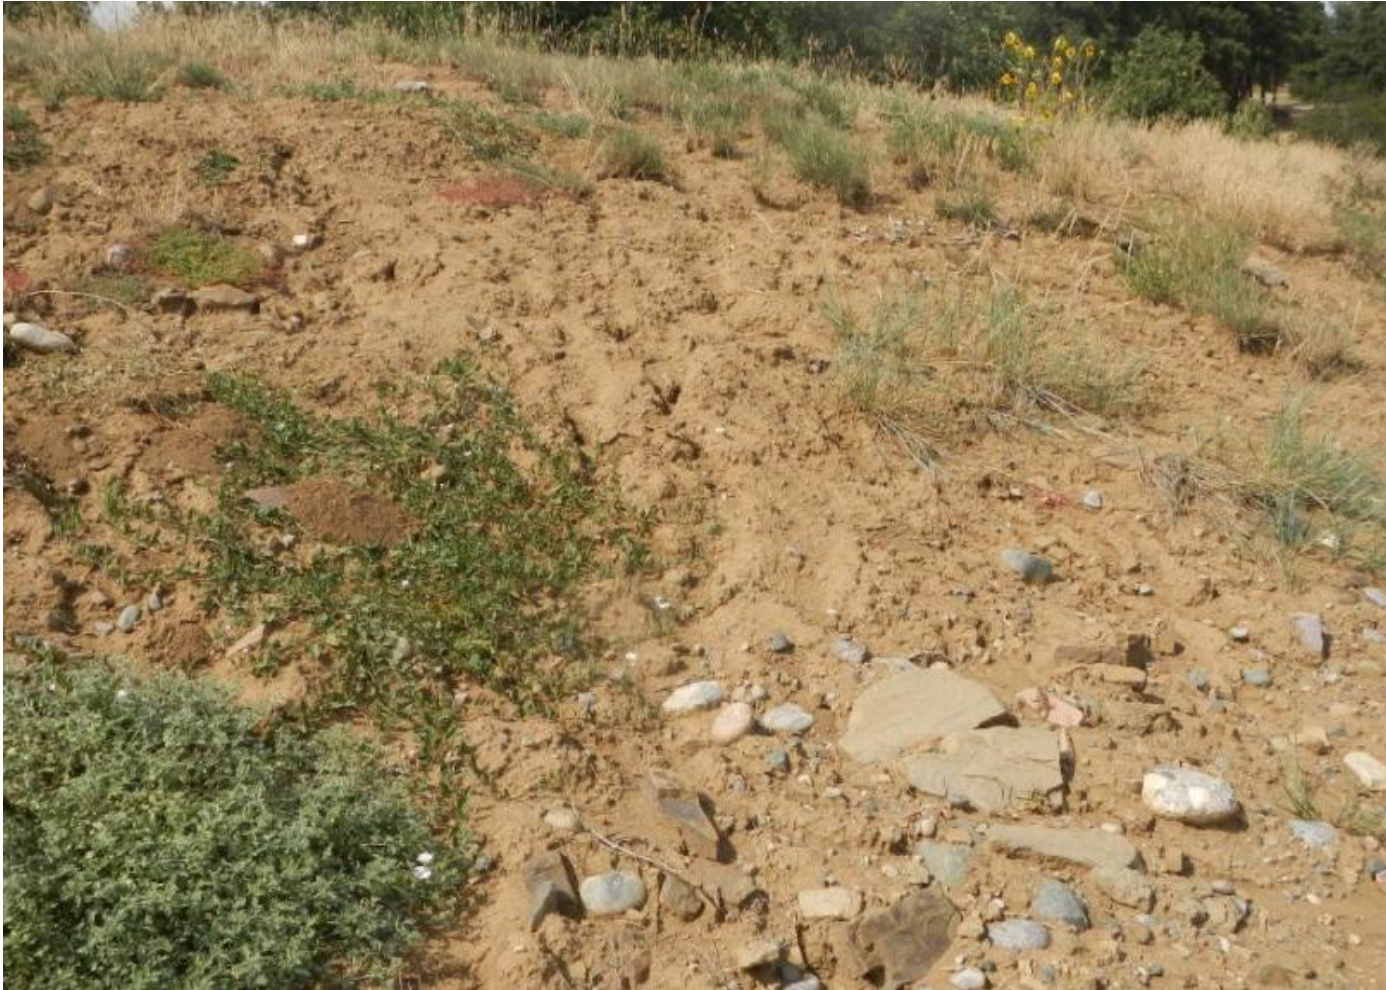
Photo 2. View of weedy and sparse vegetation within western portion of project area. Field bindweed (*Convolvulus arvensis*) and cutleaf nightshade (*Solanum triflorum*) are weeds that are established on the slope.

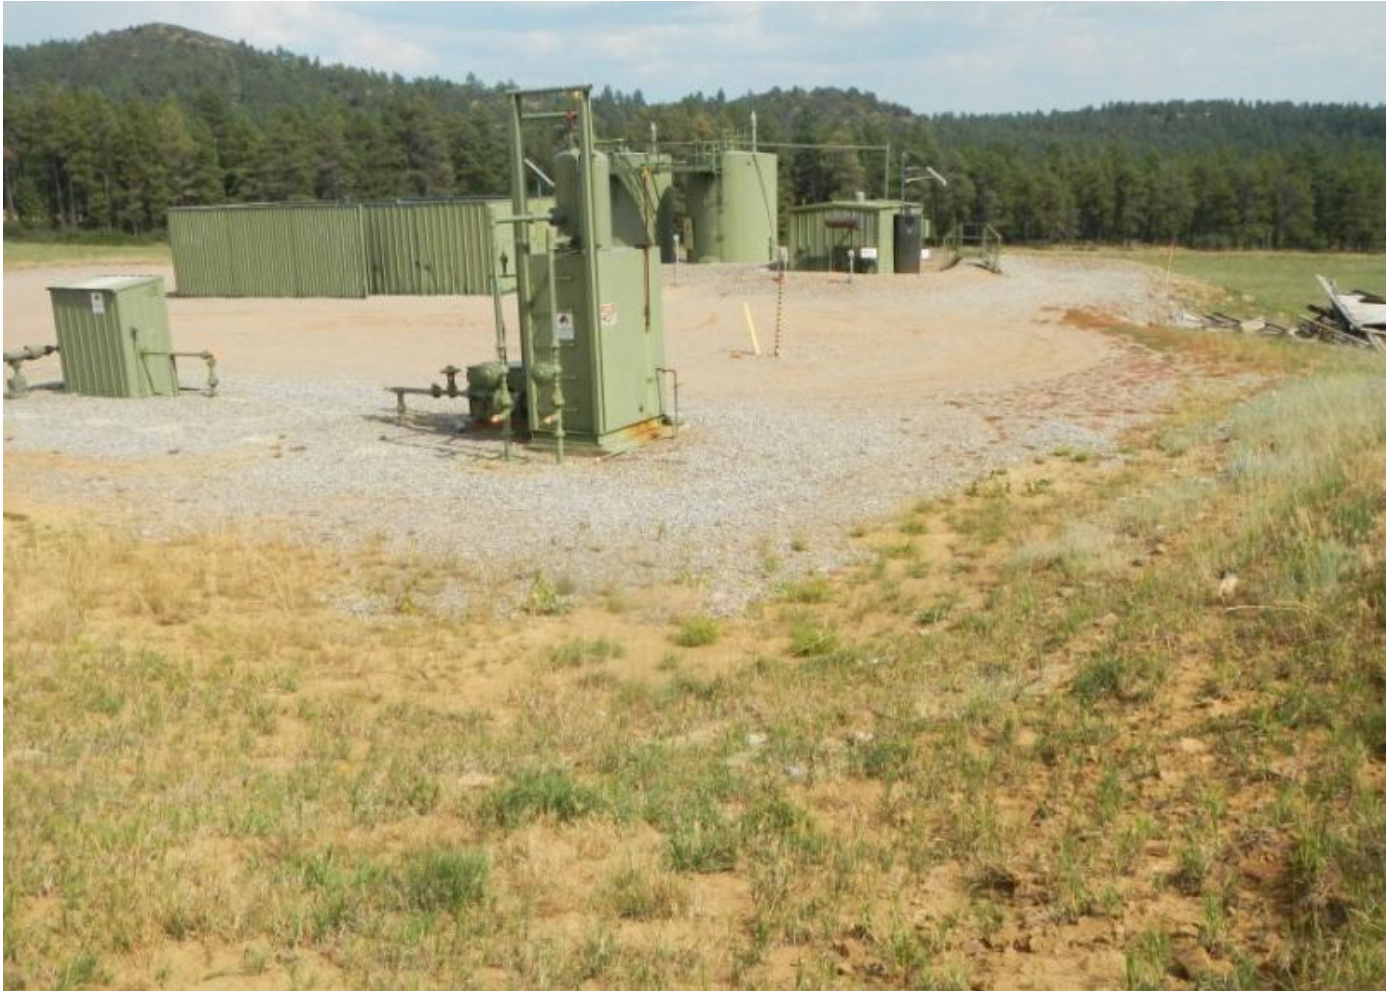
Photo 3. View from southwestern corner of well pad facing center. Smooth brome (*Bromus inermis*) and western wheatgrass (*Pascopyrum smithii*) are becoming established here.
