RE: Sensitive Receptor Information
Ward Property
Bayfield, Colorado

LT Environmental, Inc. (LTE) is pleased to provide you with this letter summarizing the results of the methane survey at the Ward property located near Bayfield, Colorado on September 17 and September 21, 2005. The work was conducted as part of the Fruitland Formation outcrop monitoring program in La Plata County on behalf of The Group, which consists of the Colorado Oil and Gas Conservation Commission (COGCC), La Plata County, Bureau of Land Management (BLM), BP America, Inc. (BP), XTO Energy, Inc. (XTO), Pure Resources, Inc. (Pure), and ChevronTexaco Production Company (Chevron). LTE has prepared this site-specific summary in advance of the full report given the sensitive nature of the data.

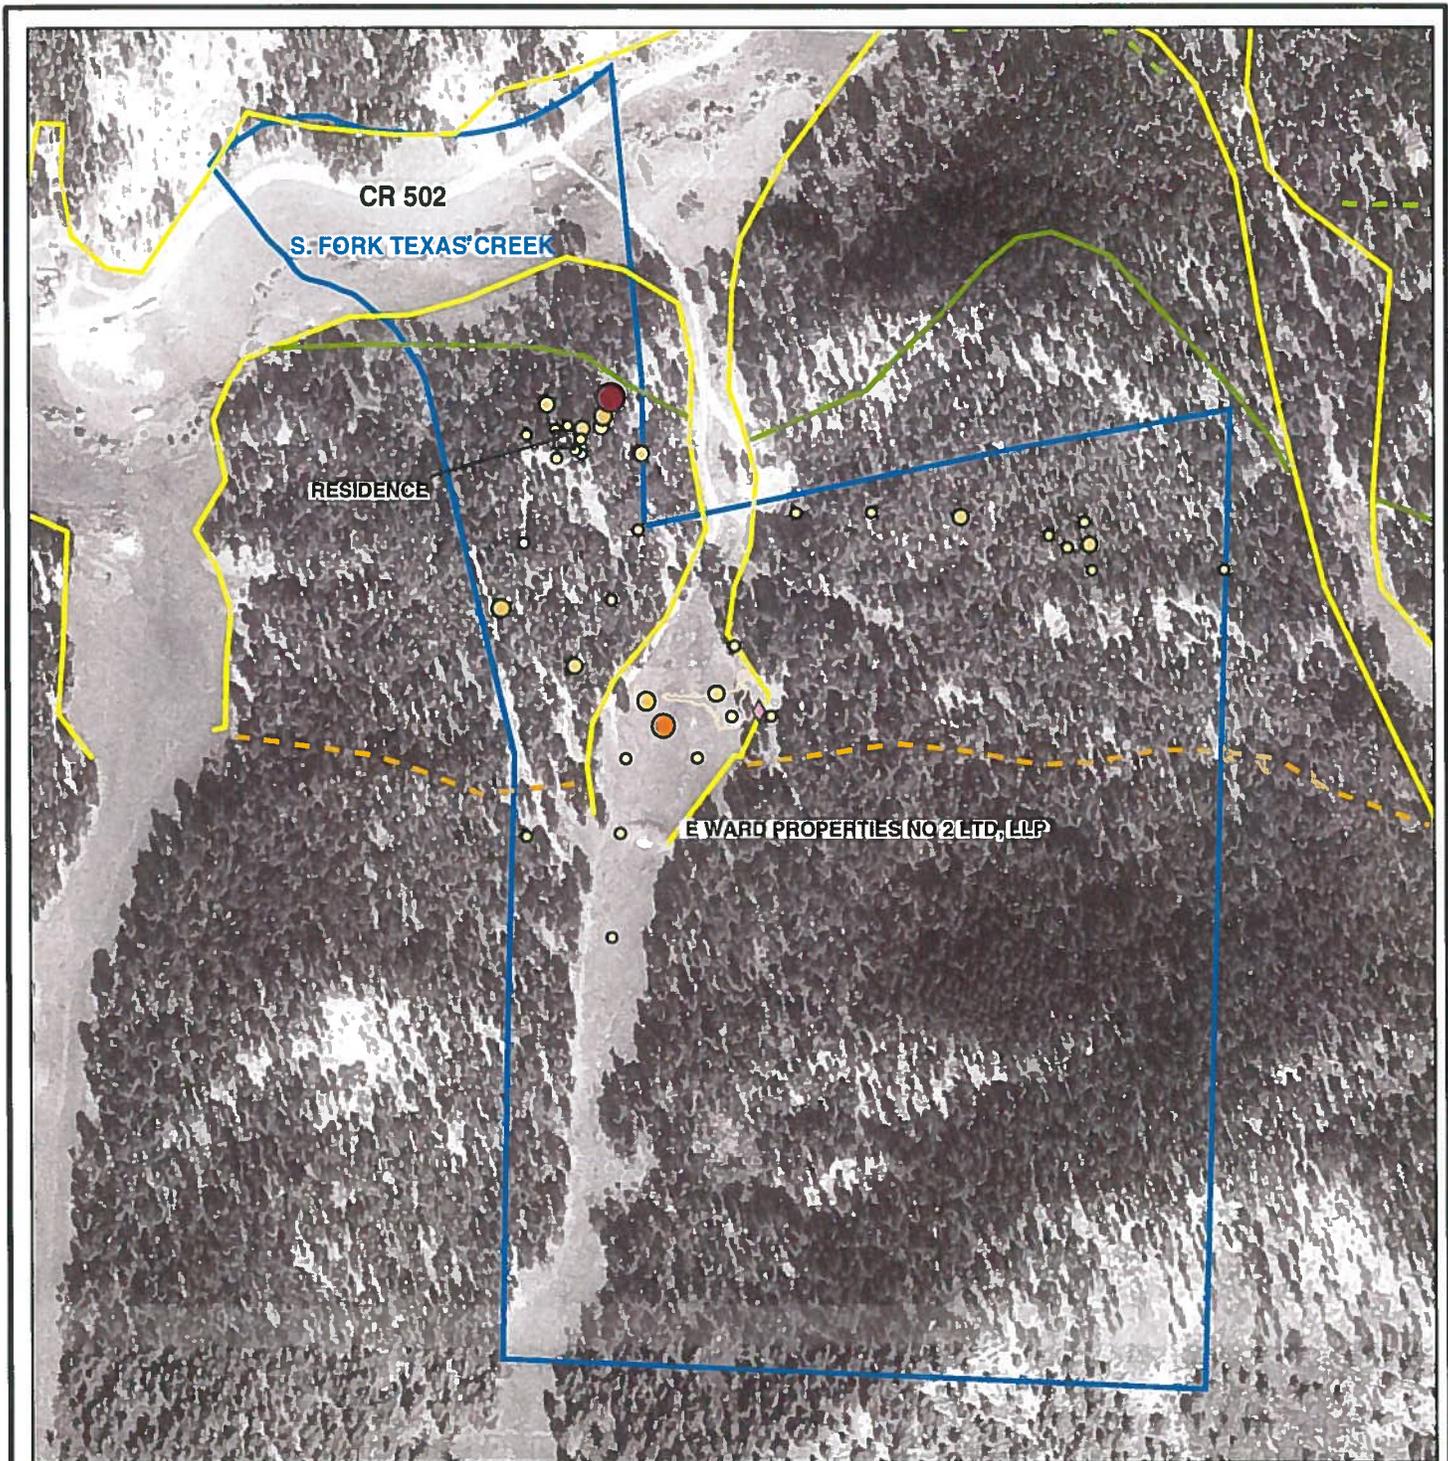
FIGURE 1
SUBSURFACE METHANE MEASUREMENTS
SEPTEMBER 2005
E. WARD PROPERTIES NO 2 LTD, LLP
BAYFIELD, COLORADO

LTE advanced a total of 38 soil probes on the Ward property in order to collect subsurface methane gas measurements. Methane was detected at concentrations ranging from 3,500 ppm (0.35%) to 100%. Methane concentrations of 8,000 ppm (0.80%), 9%, and 100% were recorded at distances from the Ward residence of approximately 20 feet (ft), 75 ft, and 110 ft, respectively.

The results of the recent investigation indicate that methane seep activity is occurring on the Ward property and in close proximity of the Ward residence. Due to the high concentrations of methane detected near the residence, there is a potential for methane to enter the Ward residence and create a hazardous condition. LTE recommends that an interior methane survey of the Ward residence be conducted as soon as possible in order to confirm or deny the presence of methane gas in the house. In addition, the property owner should be informed of the potential dangers associated with methane gas in confined structures and what precautions should be taken prior to entering these structures until a full assessment of the potential risks can be made.

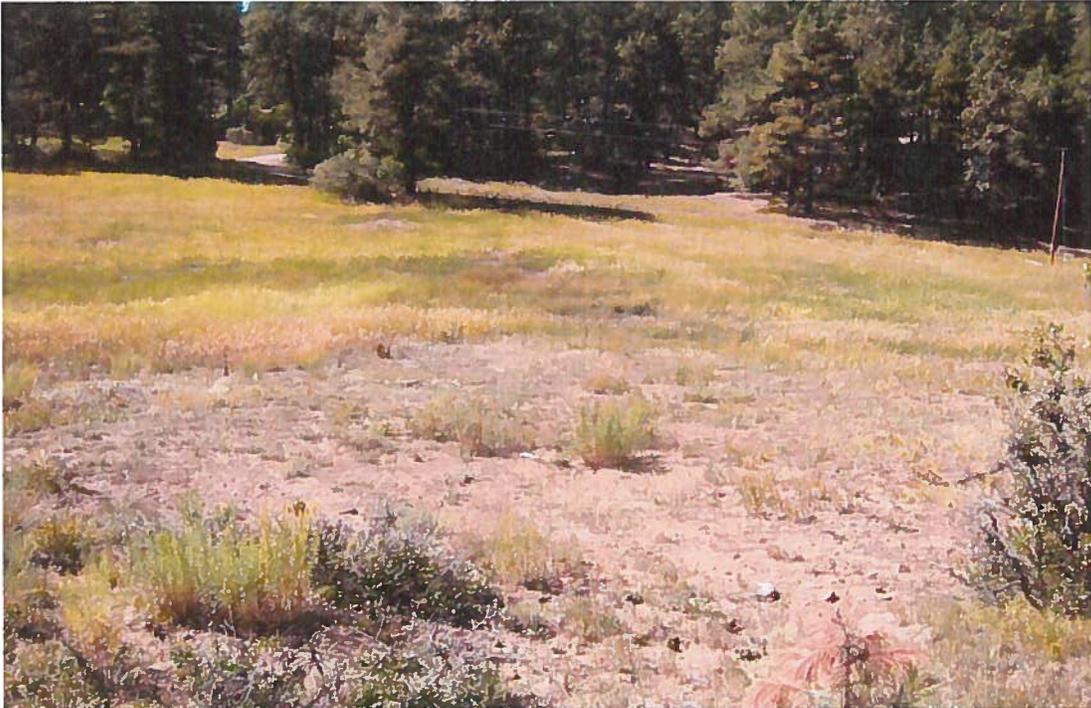
During the September 2005 site visit, the residence appeared unoccupied. LTE observed boards on several of the windows of the residence and plastic sheets over the furniture inside. The residence is most likely a second-home for the Ward family. The house is located on a hill overlooking the Texas Creek valley to the west and an unnamed drainage to the south. LTE observed areas of stressed and dead vegetation in the drainage to the south of the Ward residence (Photo #1). LTE also observed a

Areas of stressed and dead vegetation were observed in the valley to the south of the Ward residence. Methane was detected in these areas at concentrations ranging from 50,000 ppm (5%) to 260,000 ppm (26%). Methane was also detected in the four-inch PVC pipe at a concentration of 160,000 ppm (16%). Table 1 presents the methane measurements recorded during the site investigation. The methane measurements along with their respective locations are shown as Figure 1 and Figure 2.

Photo 1: Area of stressed vegetation, view west.

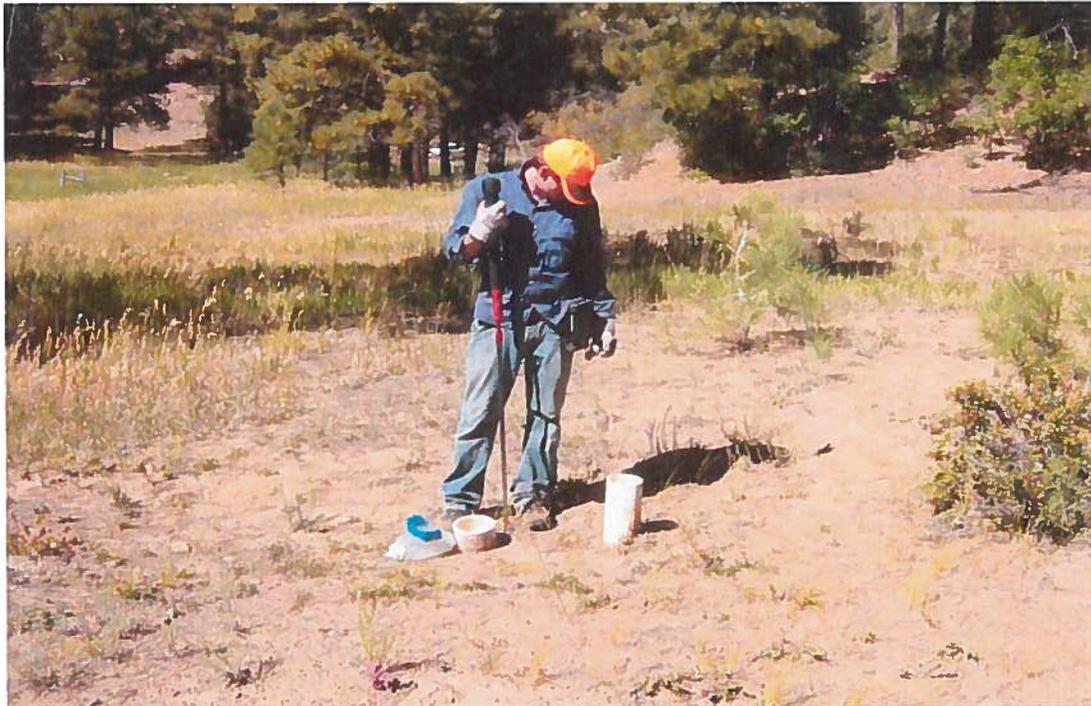
four-inch polyvinyl chloride (PVC) pipe in the ground on the eastern portion of the drainage to the south of the Ward residence (Photo 2). The purpose of the PVC pipe is unknown at this time.

Photo 2: Four-inch polyvinyl chloride pipe, view north.

LTE recommends that the PVC pipe on the Ward property be investigated to determine the use or prior use of the pipe. If it is found that the PVC pipe is not currently in use, LTE recommends that the pipe be plugged or removed in order to reduce the potential for the pipe to act as a conduit for seeping gas.
