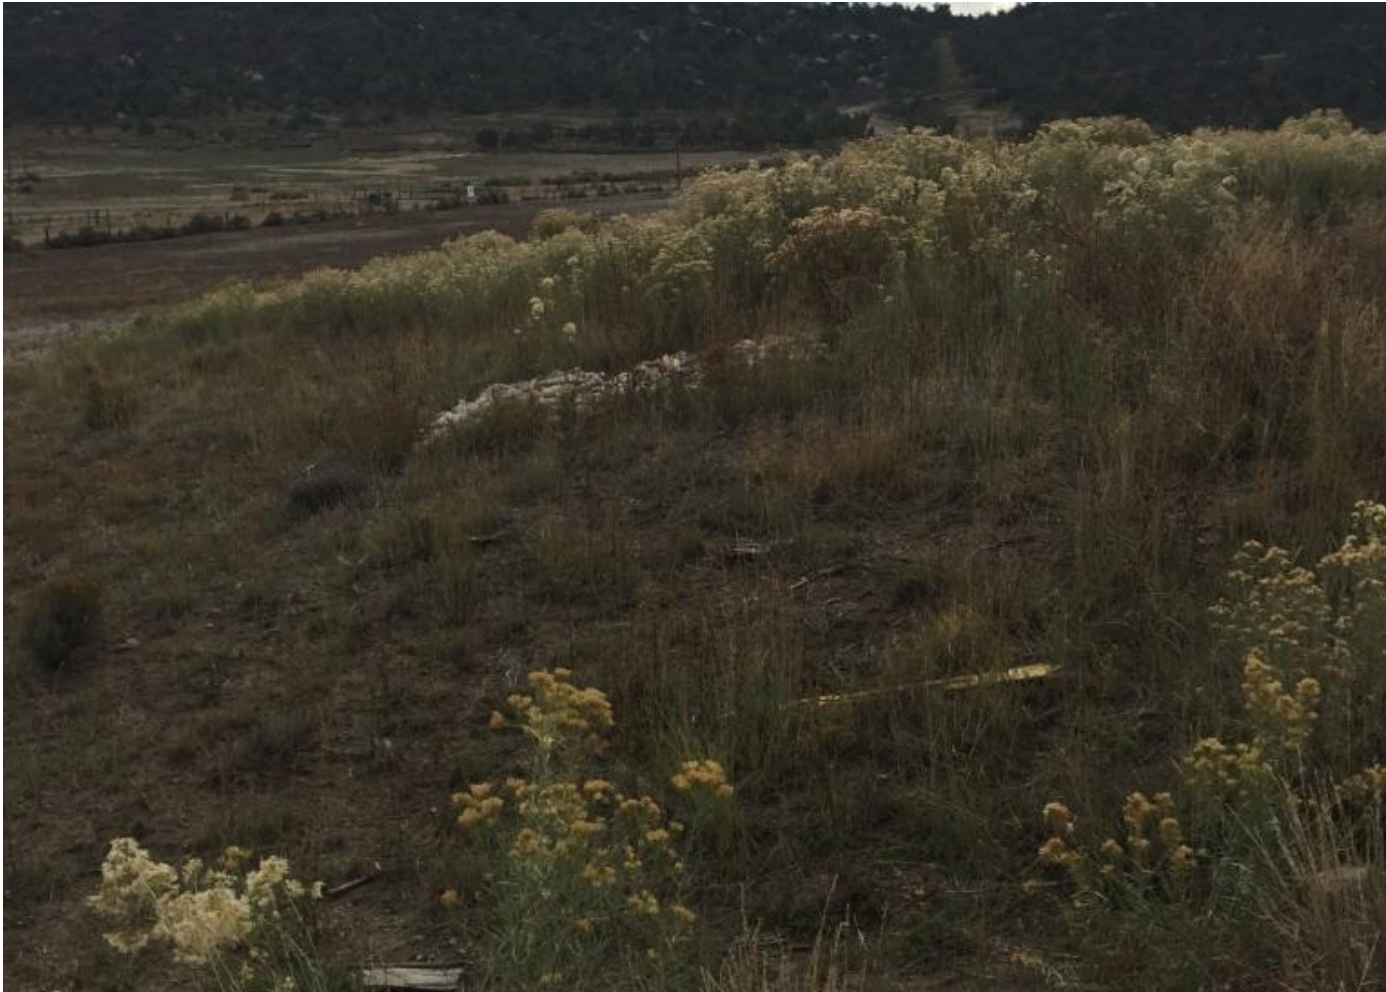
Photo 1. View of eastern portion of project area from well pad entrance (northeast) facing southward. Revegetation is largely comprised native species such as rubber rabbitbrush (*Chrysothamnus nauseosus*), western wheatgrass (*Pascopyrum smithii*), and fourwing saltbush (*Atriplex canescens*).

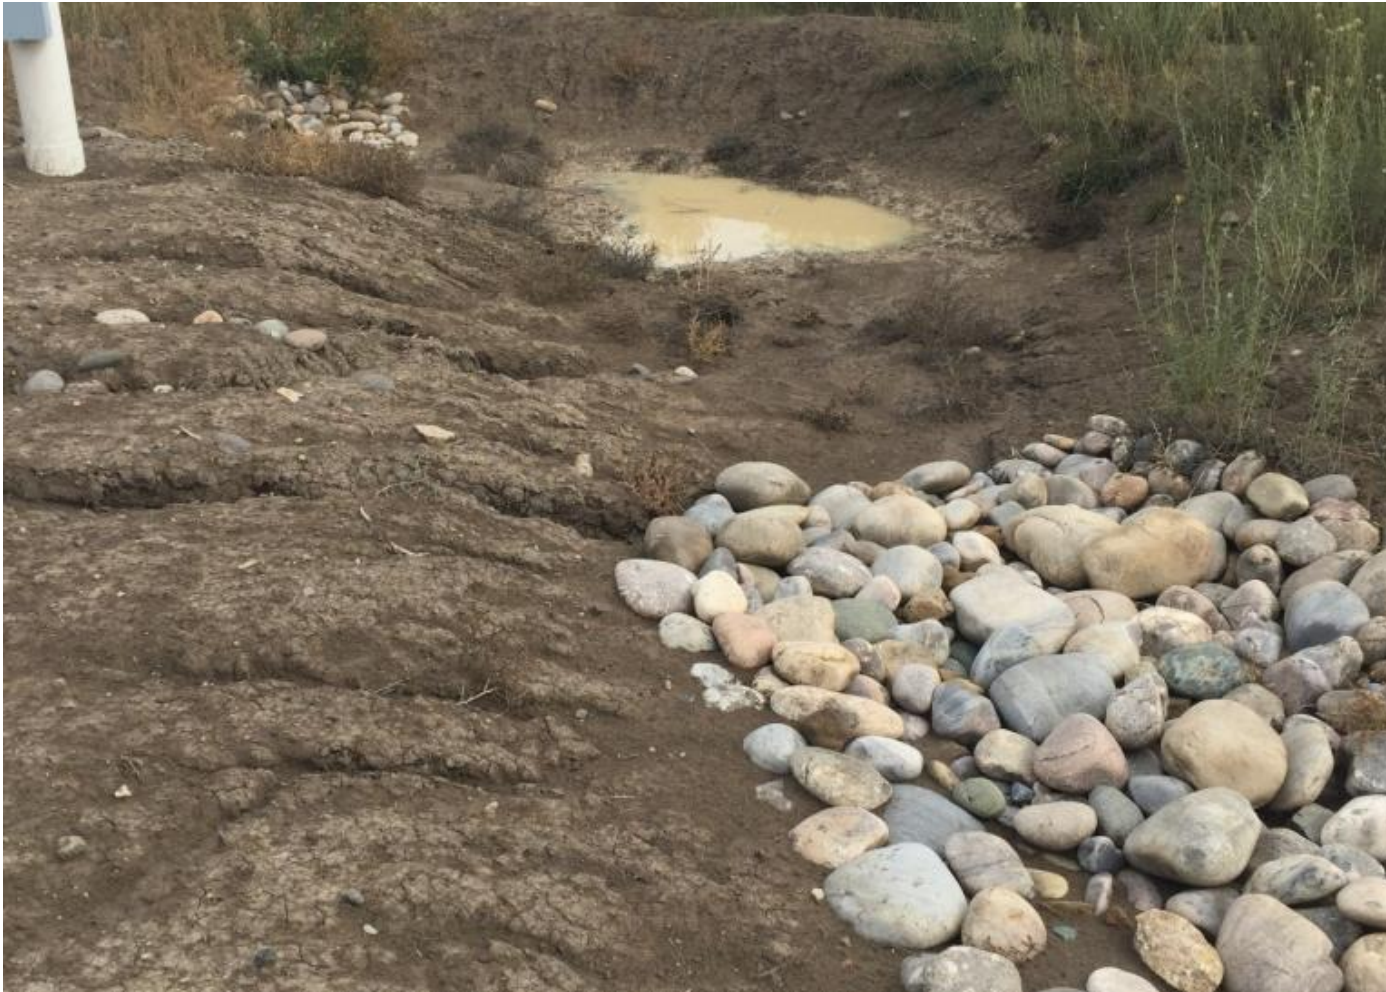
Photo 2. View of stormwater BMP (cobble lining and silt trap) within northeastern portion of the project area.

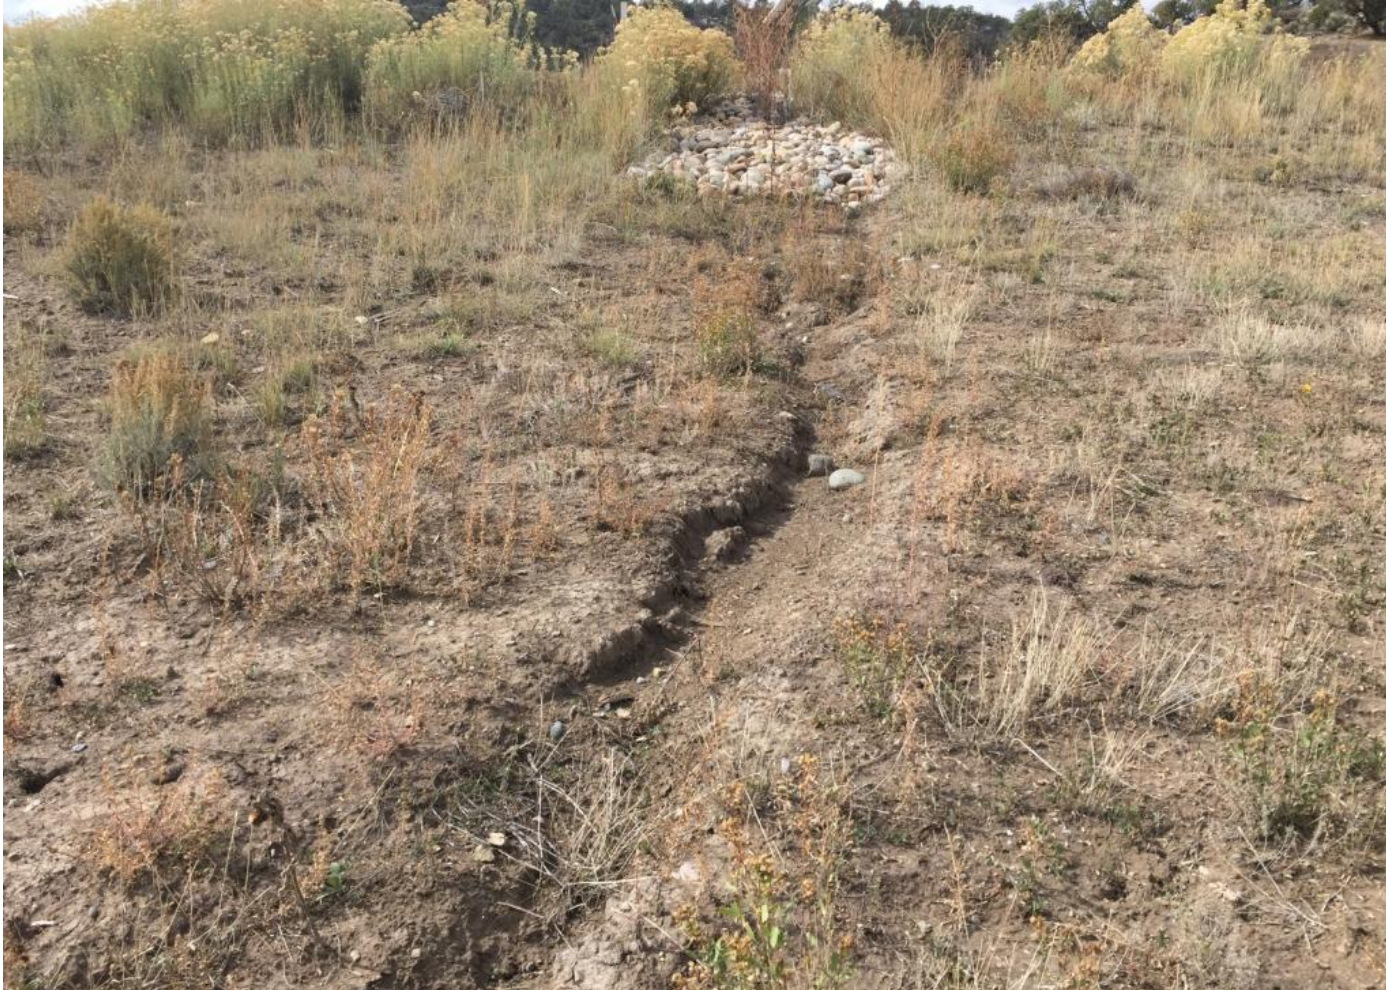
Photo 3. View of erosional channel (approximately 1.5 feet wide and 8 inches deep) forming downstream of stormwater BMP in northeastern portion of the project area.

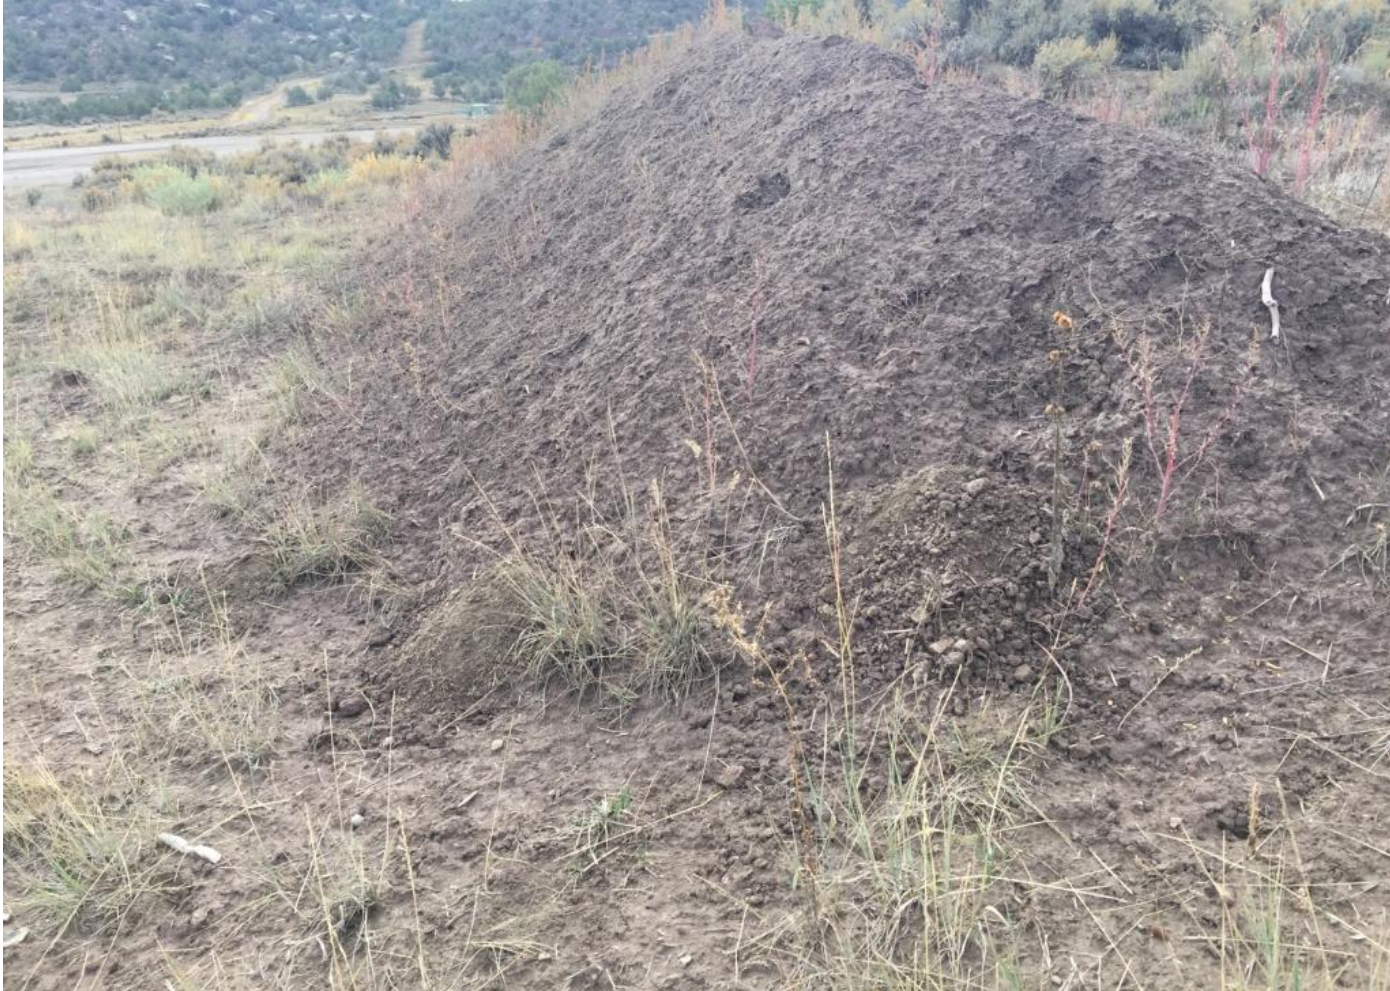
Photo 5. View of soil stockpile within the southwestern portion of the project area facing southward.
