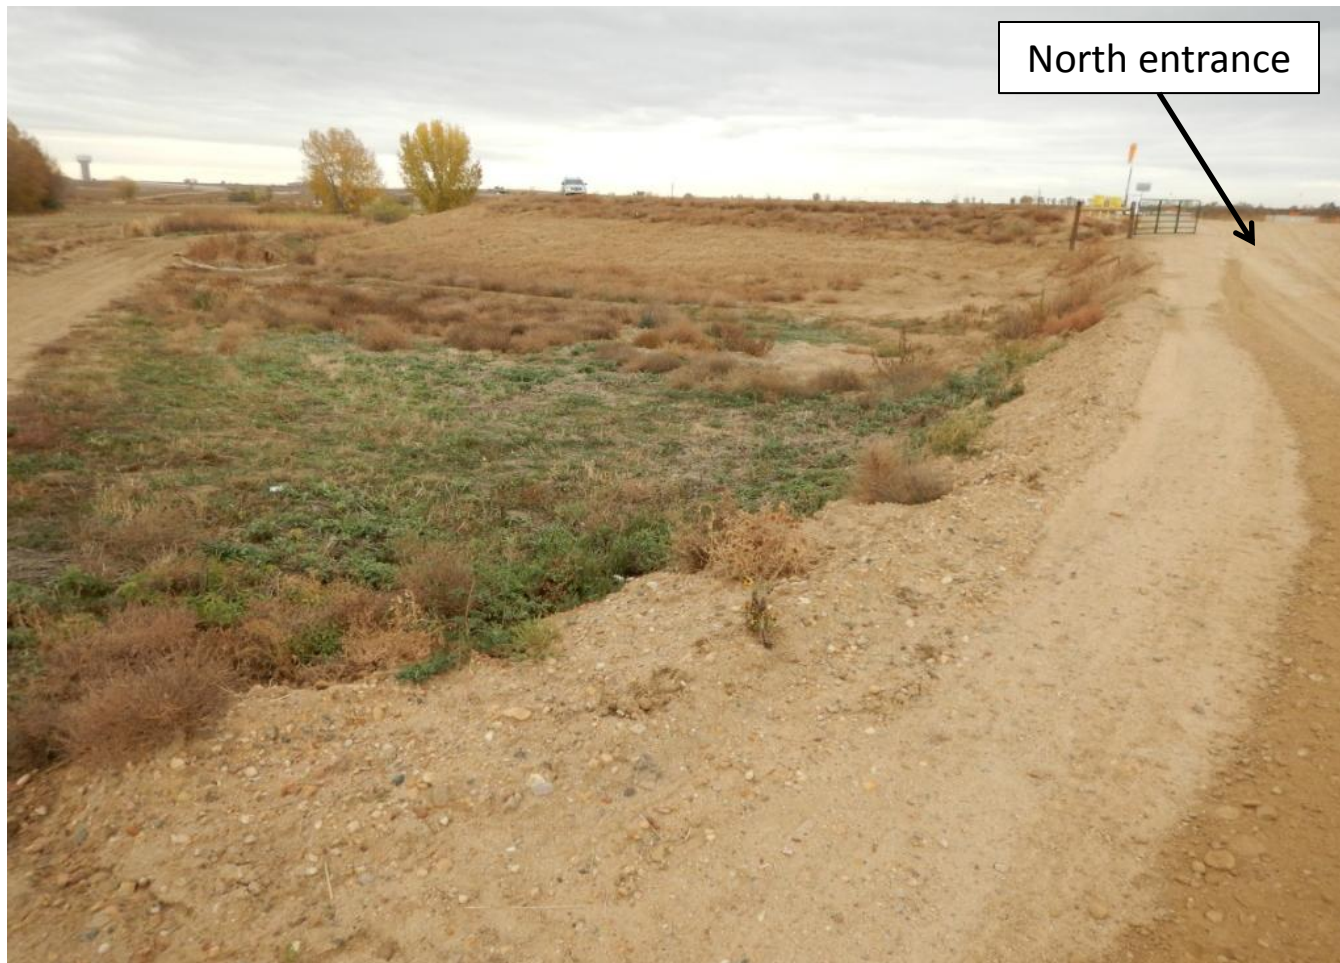
Photo 1. Photo taken from north entrance, facing Southeast. Note the prominent weeds (Kochia, Russian thistle, Field Bindweed, and Canada thistle) throughout this location. Kochia (*Kochia sp.*) and Russian thistle (*Salsola sp.*) are debris and will break off, encroach upon adjacent lands and needs to be removed from entire location.

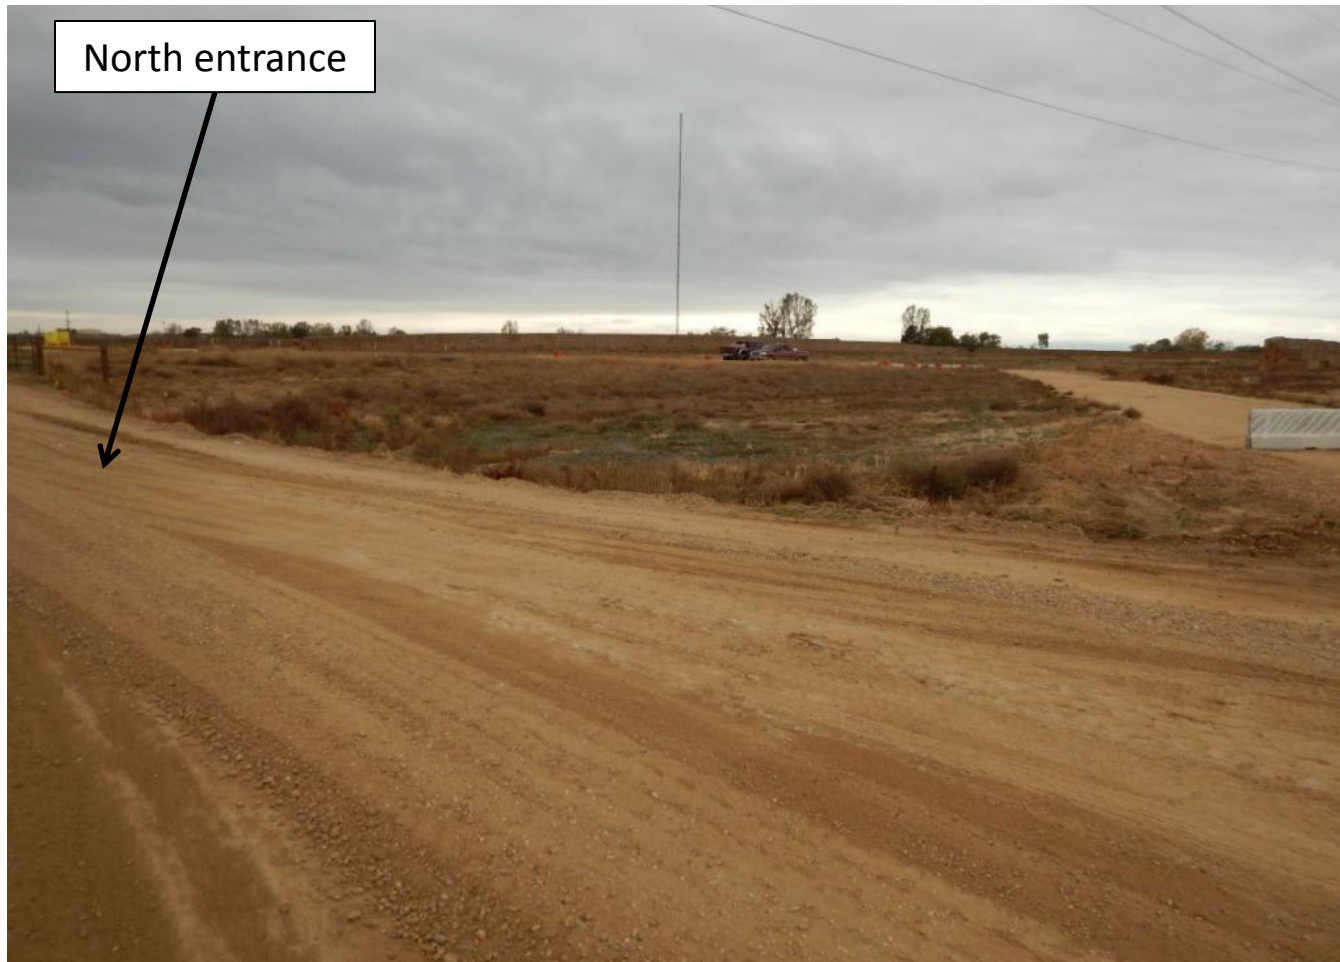
Photo 2. Photo taken from north entrance, facing South. Weed maintenance is needed.

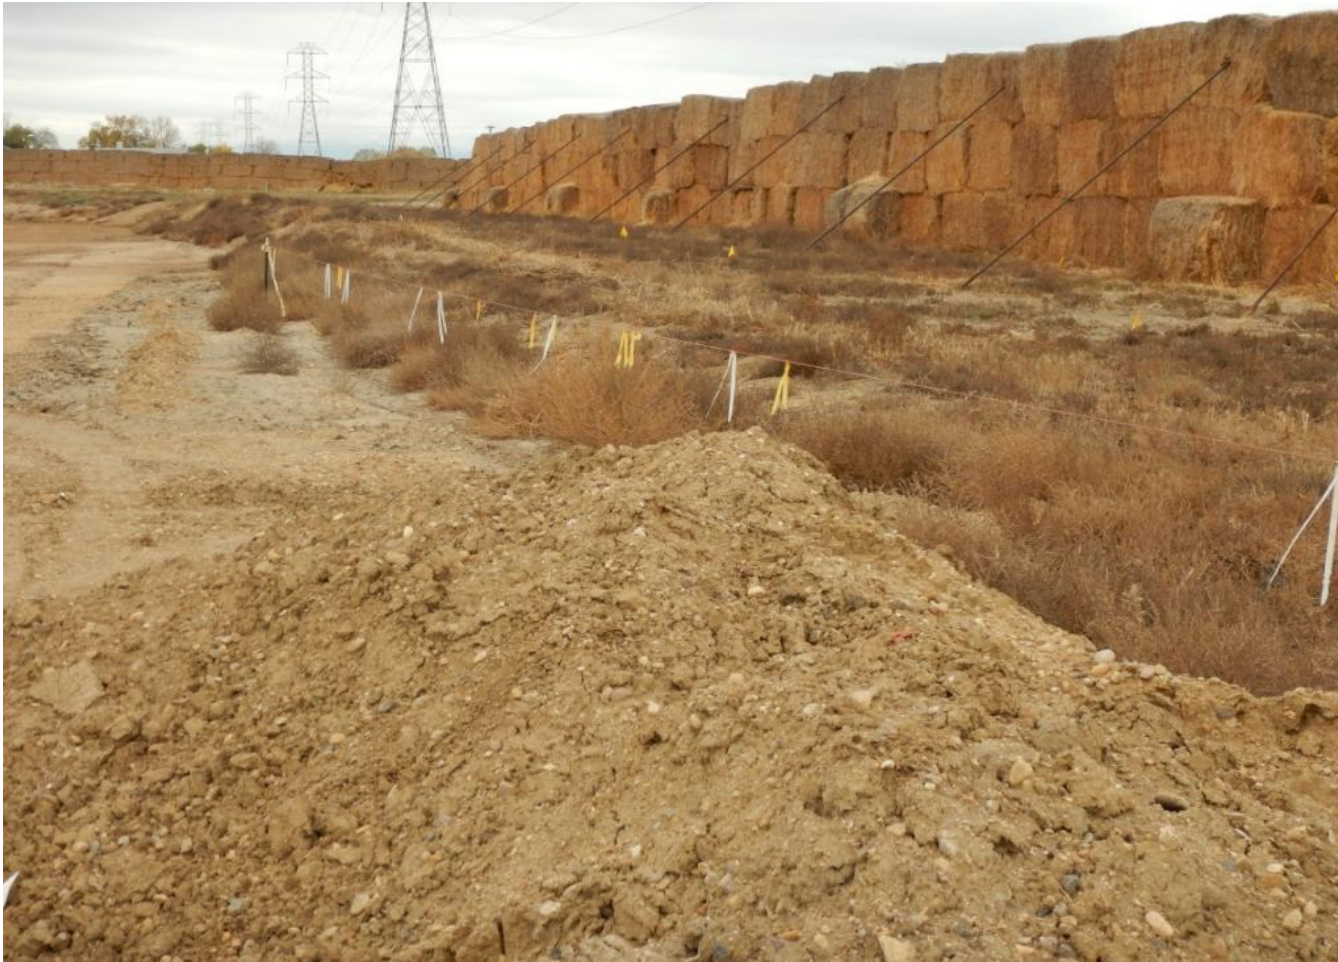
Photo 4. Photo taken from northern location, facing West. Note the prominent weed debris (Kochia and Russian thistle). Weed maintenance is needed.

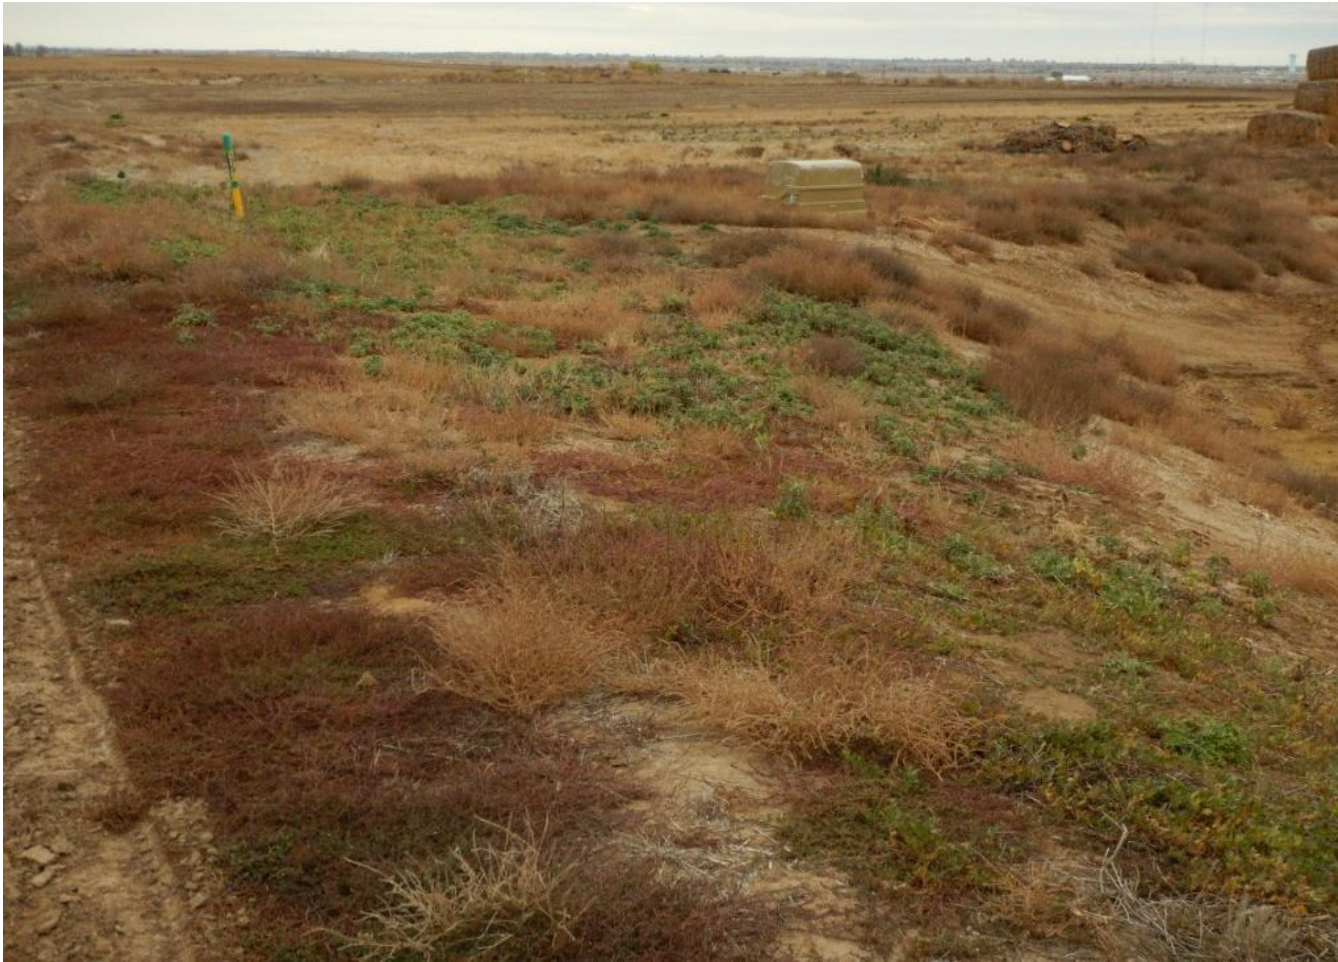
Photo 5. Photo taken from northwest location, facing Northeast. Note the prominent weeds (Kochia, Russian thistle, and Canada thistle). Weed maintenance is needed.

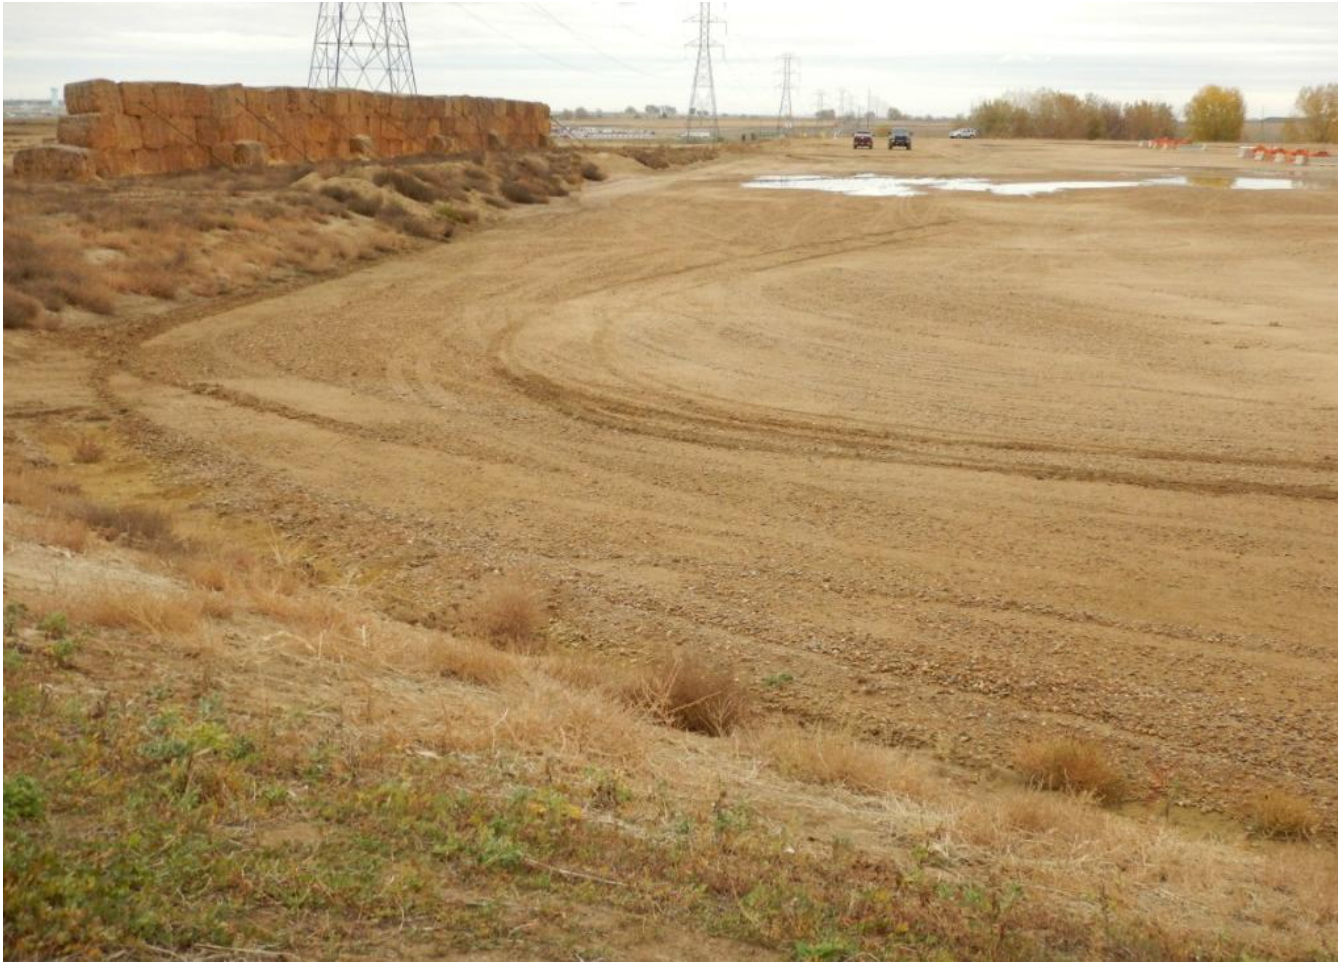
Photo 6. Photo taken from northwest location, facing East. Need to reclaim and minimize areas where production or facilities are no longer necessary.

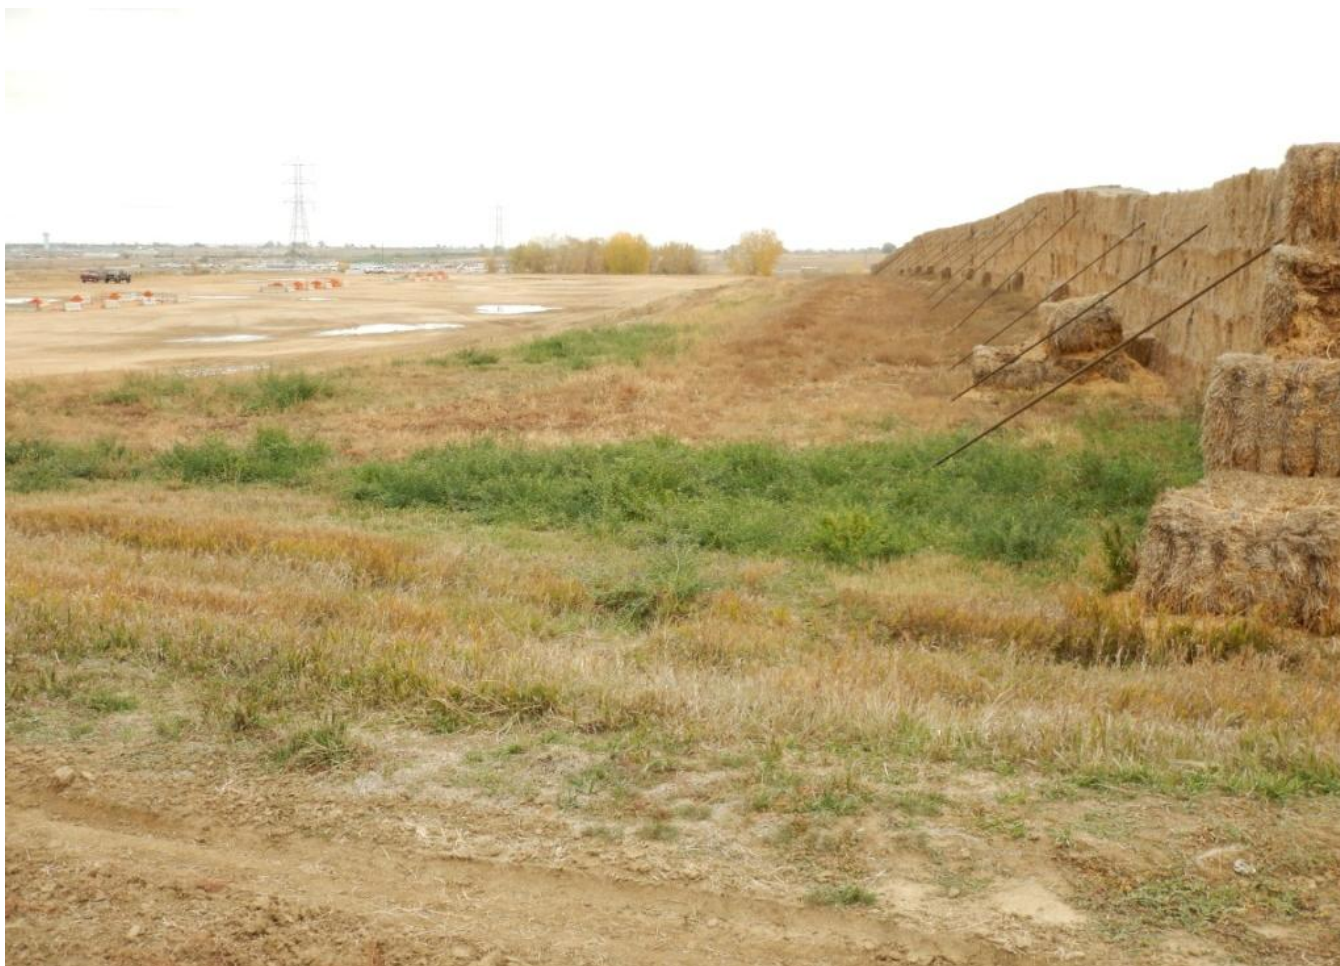
Photo 8. Photo taken from southwest location, facing East. Need to reclaim and minimize areas where production or facilities are no longer necessary.

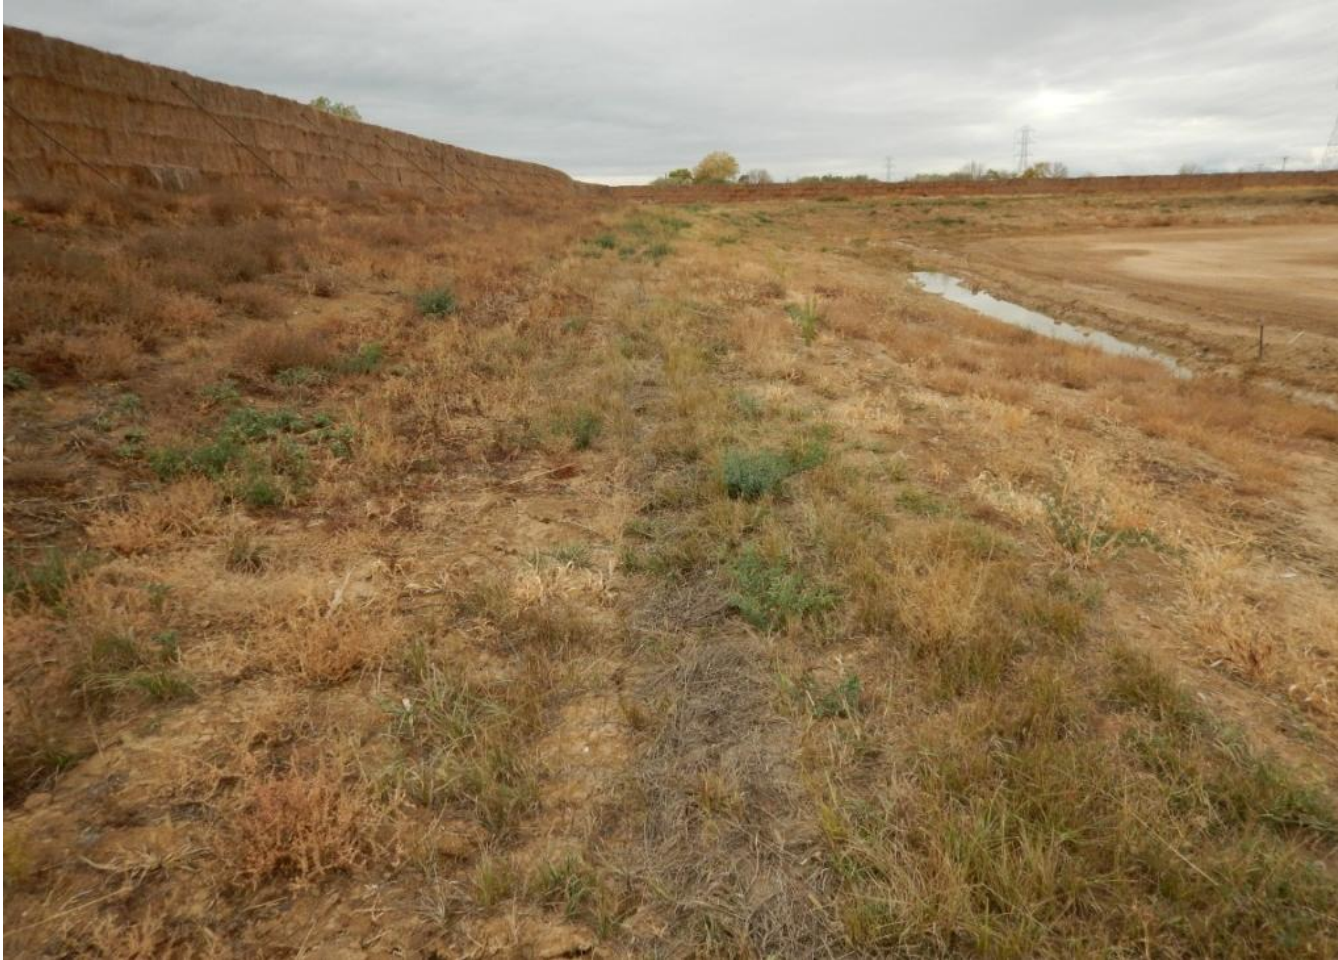
Photo 9. Photo taken from southern location, facing West. Need to reclaim and minimize areas where production or facilities are no longer necessary. Note the prominent weeds (Kochia, Russian thistle, and Canada thistle). Weed maintenance is needed.

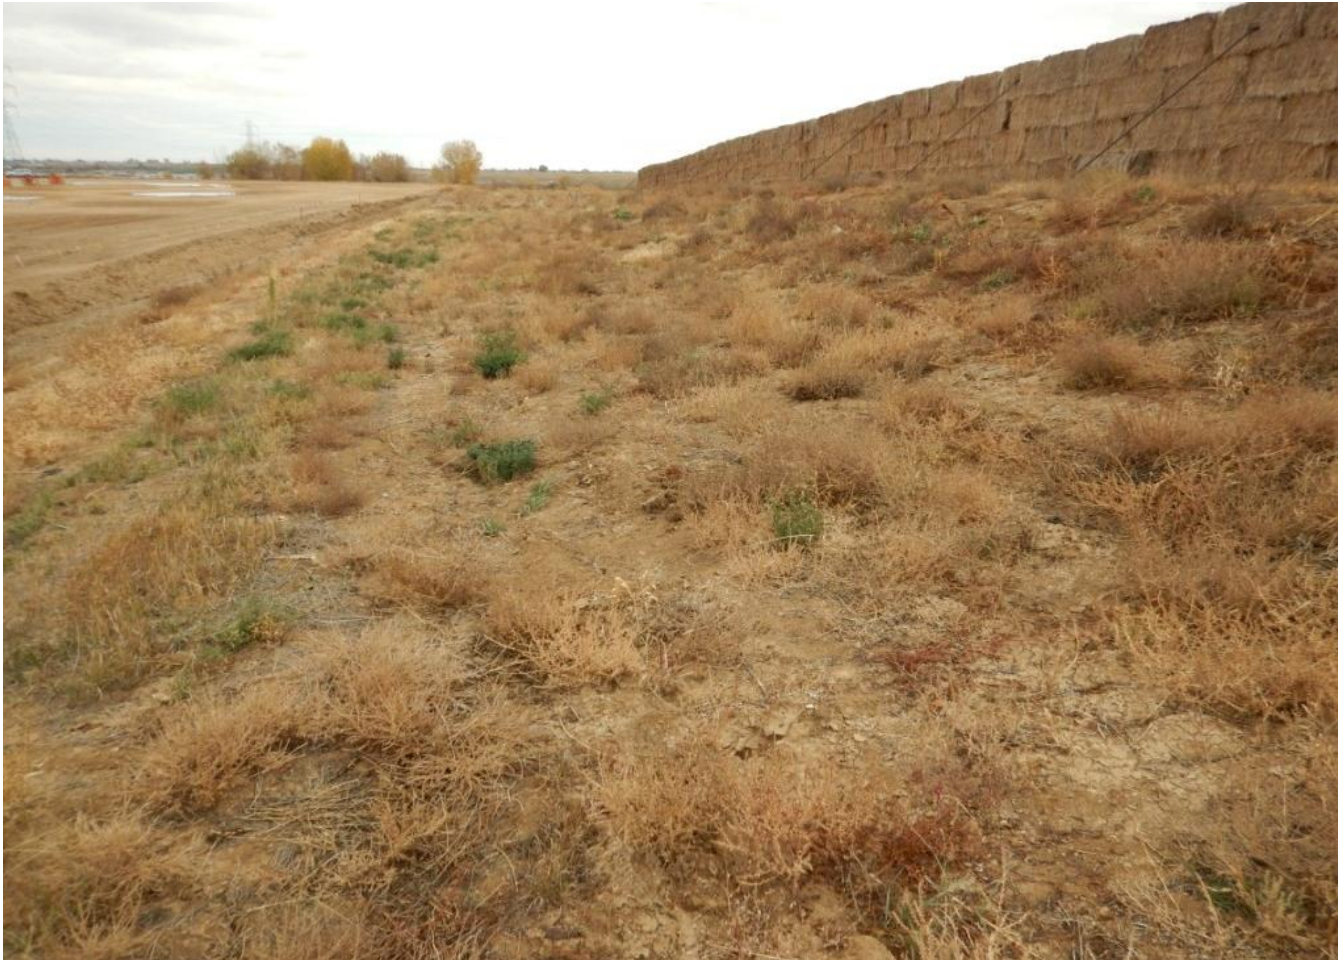
Photo 10. Photo taken from southern location, facing East. Need to reclaim and minimize areas where production or facilities are no longer necessary. Note the prominent weeds (Kochia, Russian thistle, and Canada thistle). Weed maintenance is needed.

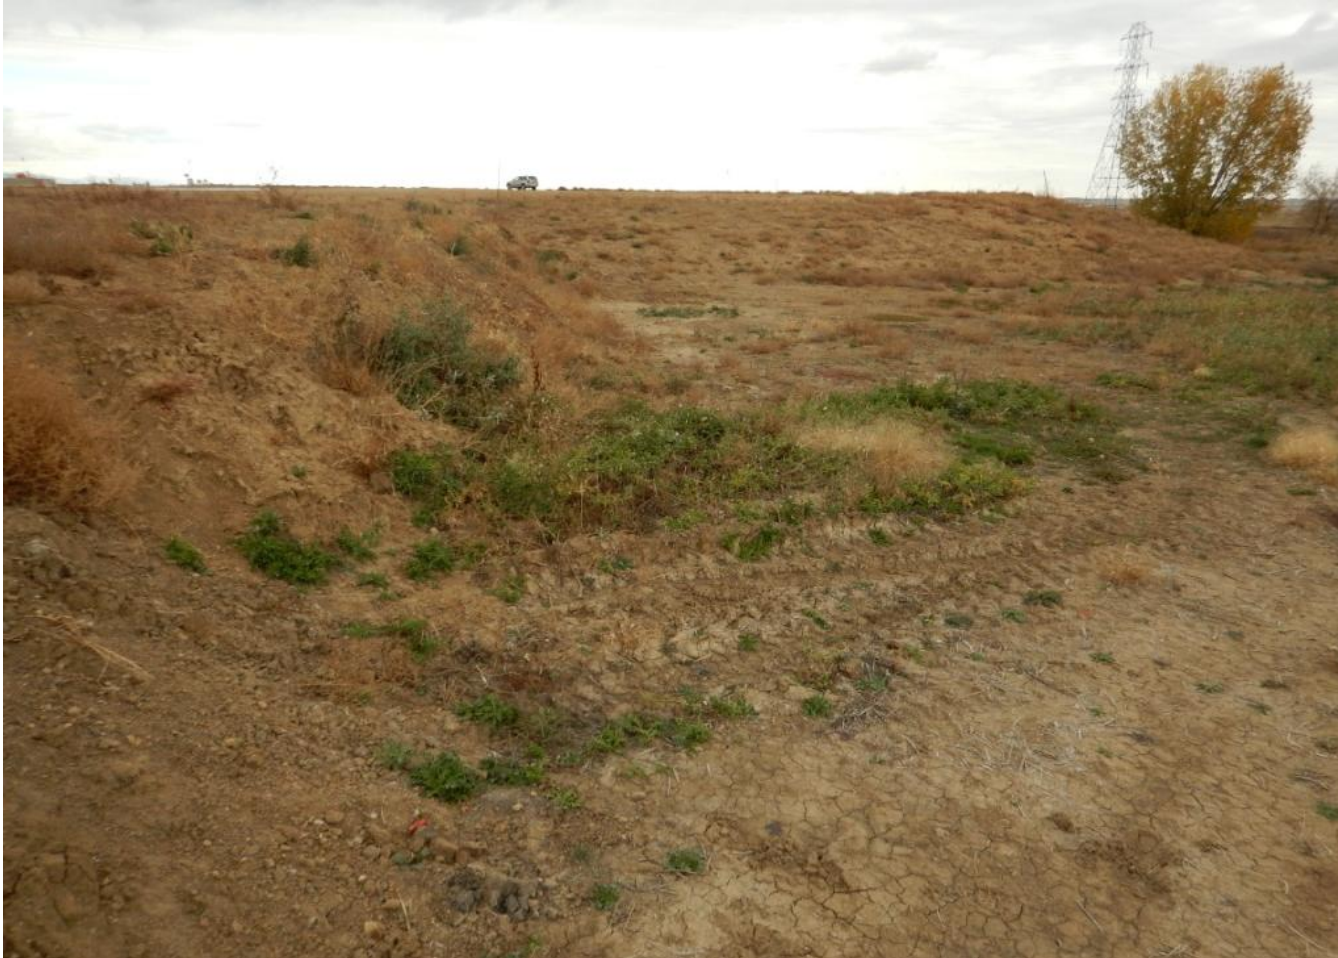
Photo 11. Photo taken from southeast location, facing Northeast. Need to reclaim and minimize areas where production or facilities are no longer necessary. Note the prominent weeds (Kochia, Russian thistle, and Canada thistle). Weed maintenance is needed.

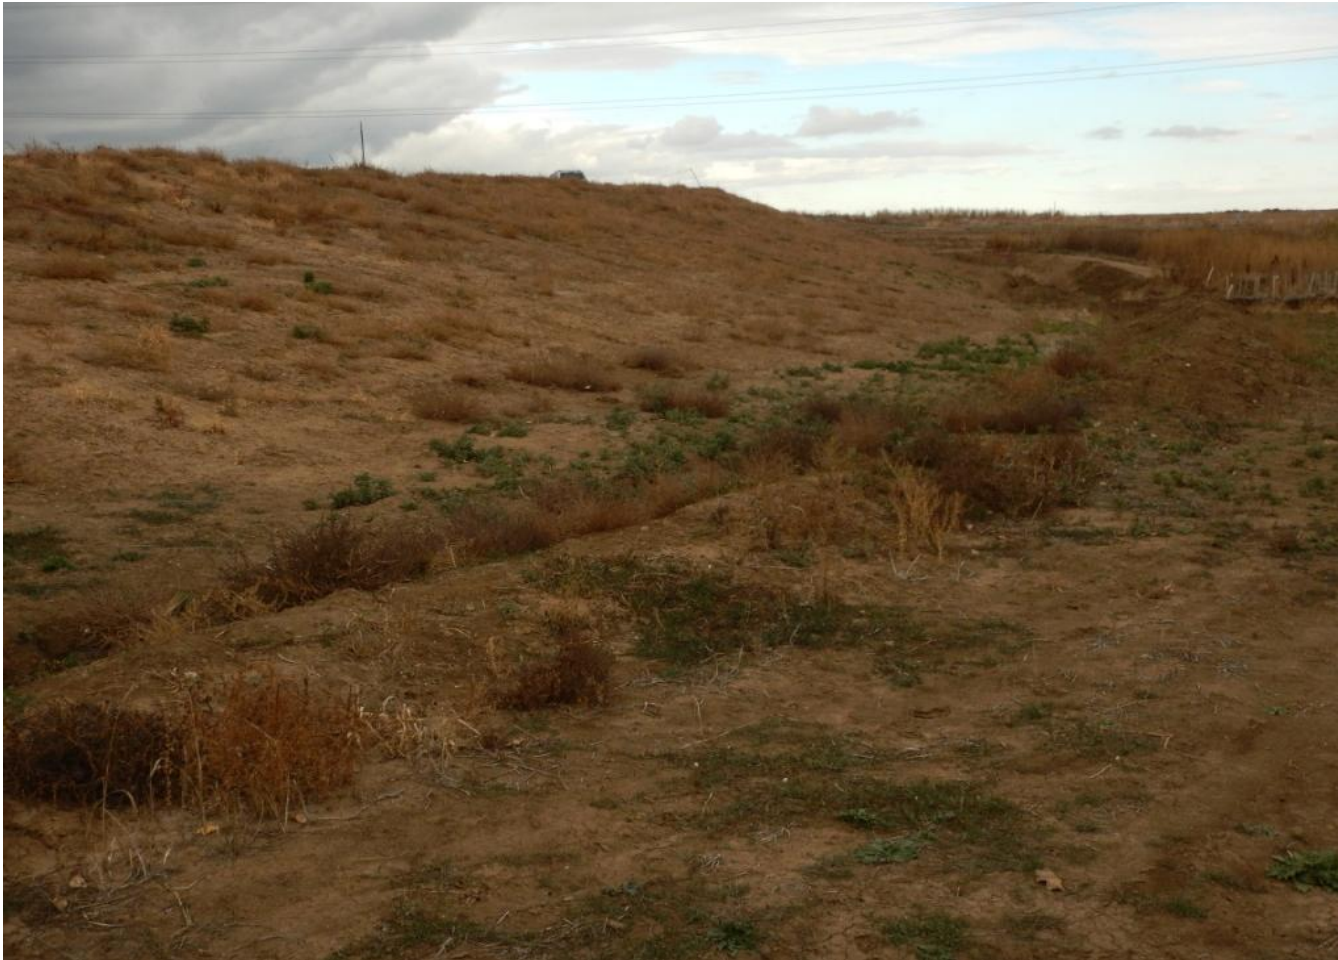
Photo 12. Photo taken from southeast location, facing North. Need to reclaim and minimize areas where production or facilities are no longer necessary. Note the prominent weeds (Kochia, Russian thistle, and Canada thistle). Weed maintenance is needed.

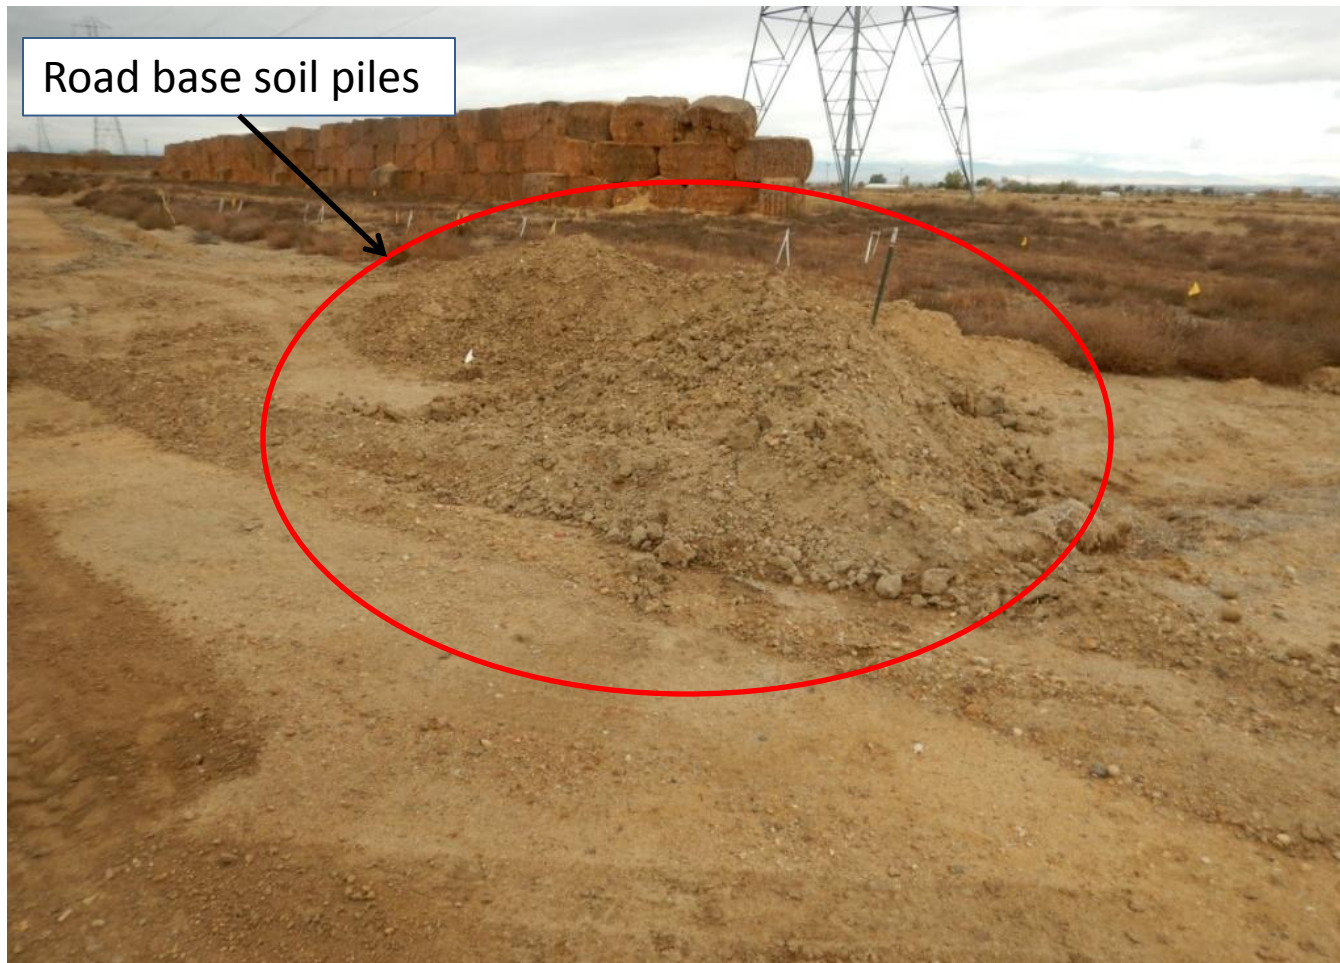
Photo 14. Photo taken from northern well pad location, facing Northwest. Need to remove road base soil pile.

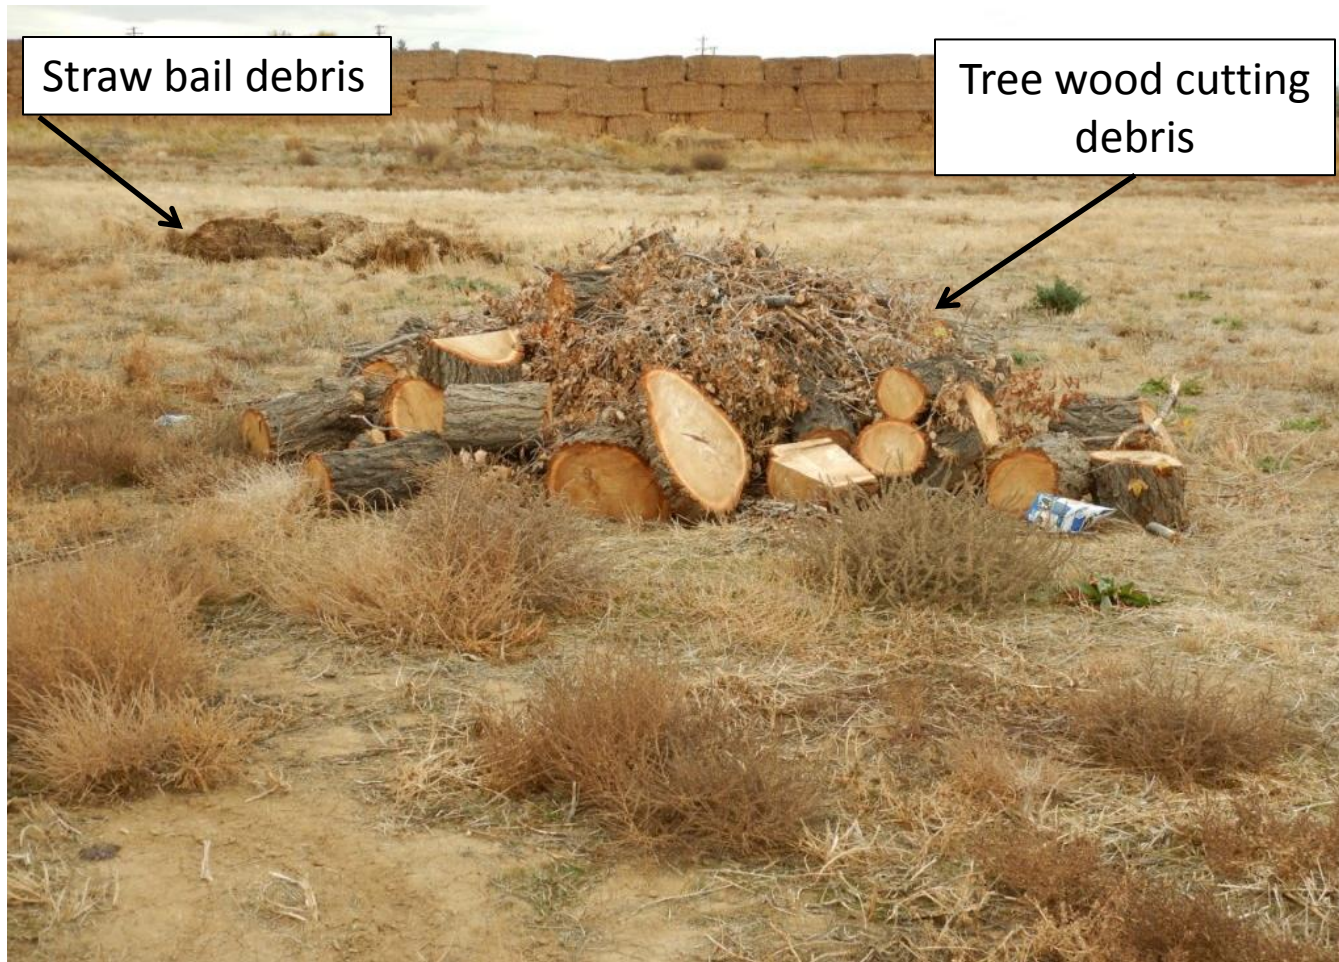
Photo 15. Photo taken from northwestern location, facing West. Need to remove debris.

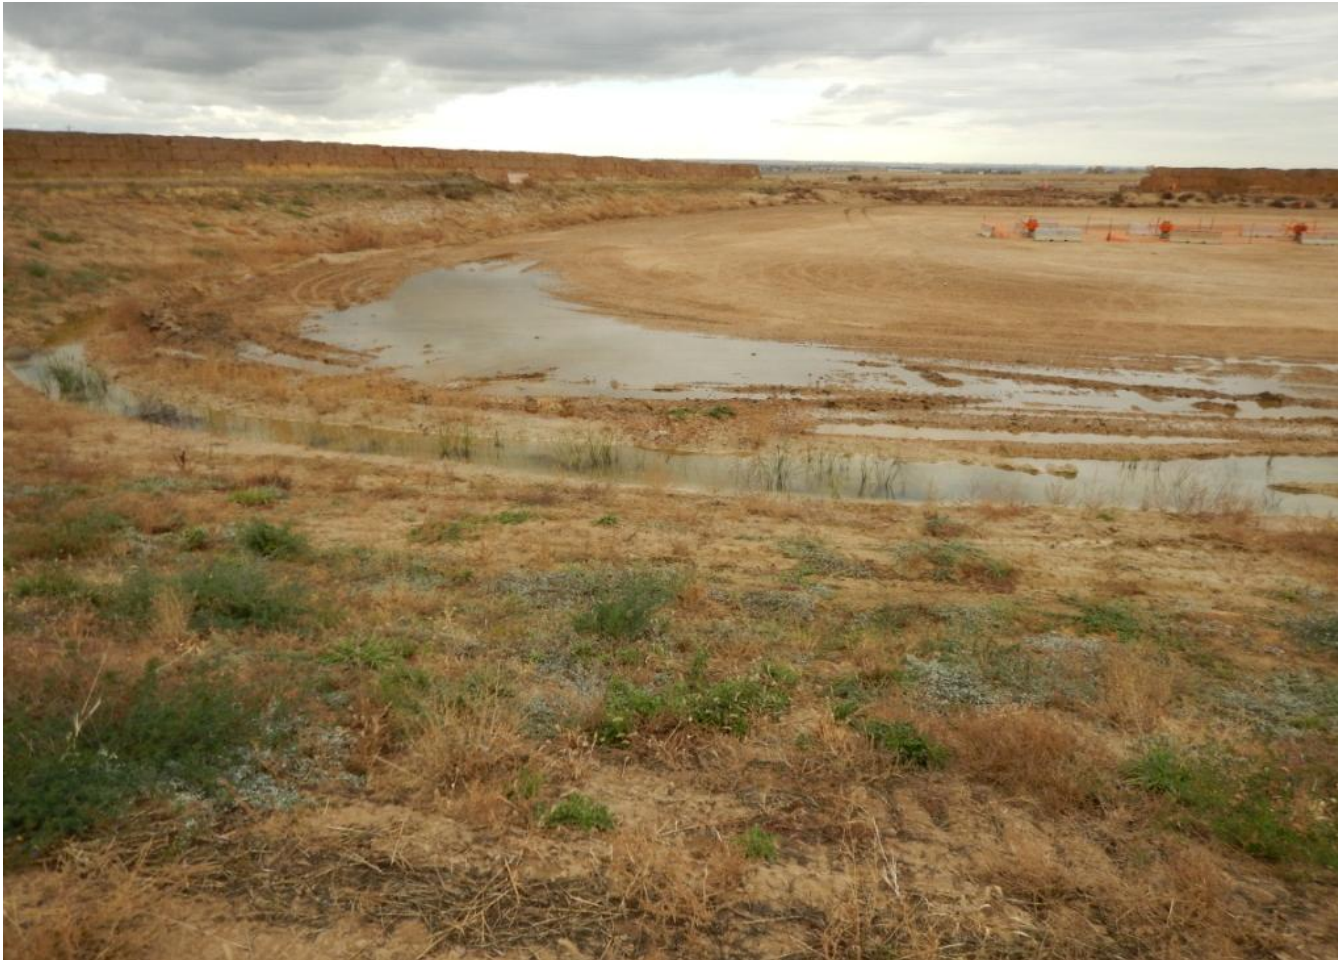
Photo 16. Photo taken from southern location, facing Northwest. Note pooling water in center of photo. Need to reclaim and minimize areas where production or facilities are no longer necessary.

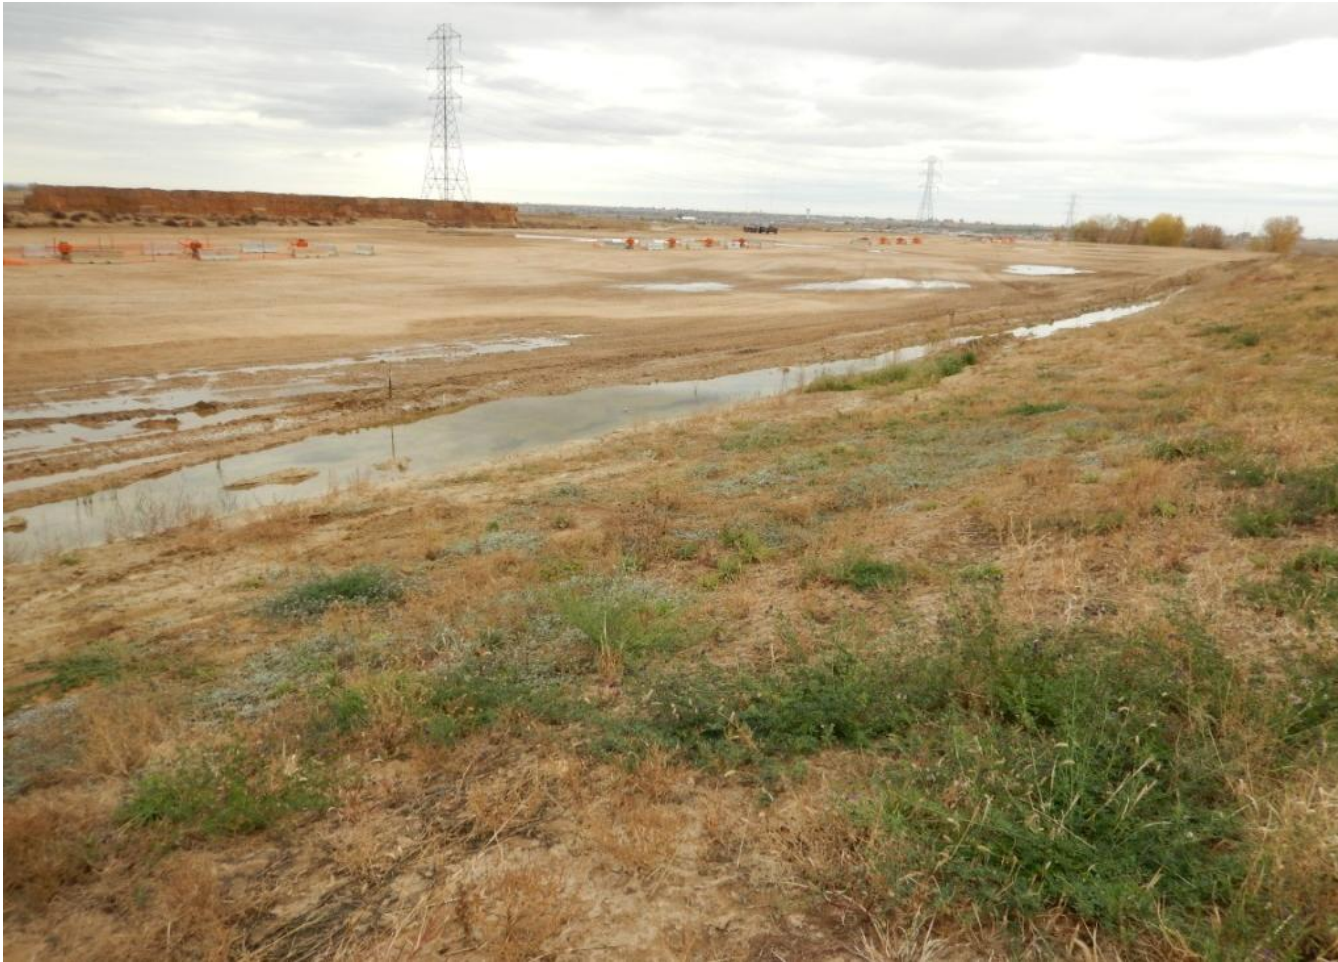
Photo 17. Photo taken from southern location, facing East. Note pooling water in center of photo. Need to reclaim and minimize areas where production or facilities are no longer necessary.

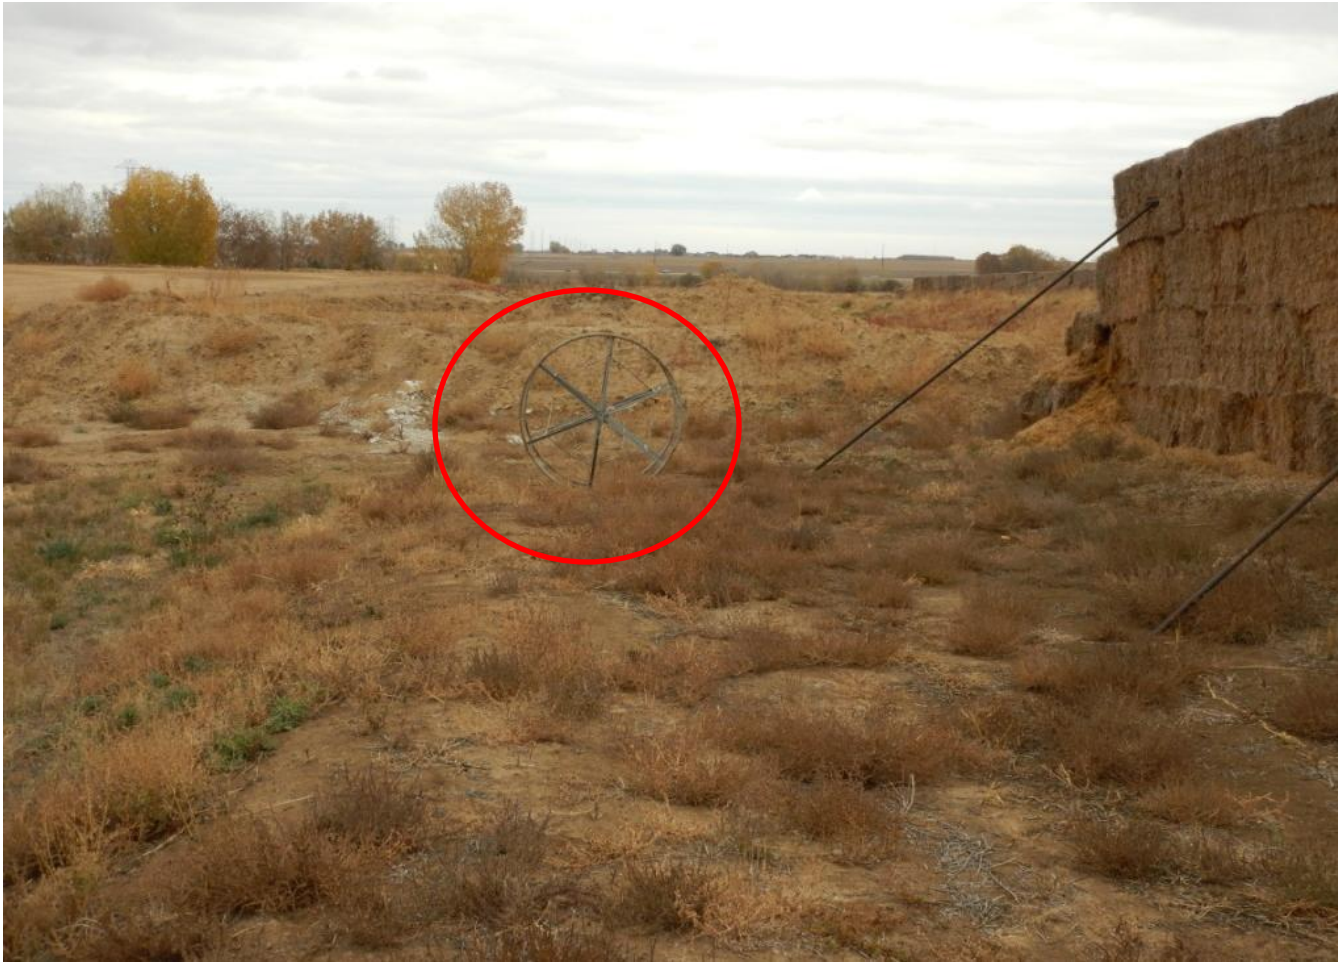
Photo 18. Photo taken from southeastern location, facing East. Unused or unneeded equipment needs to be removed. Weed maintenance is needed.

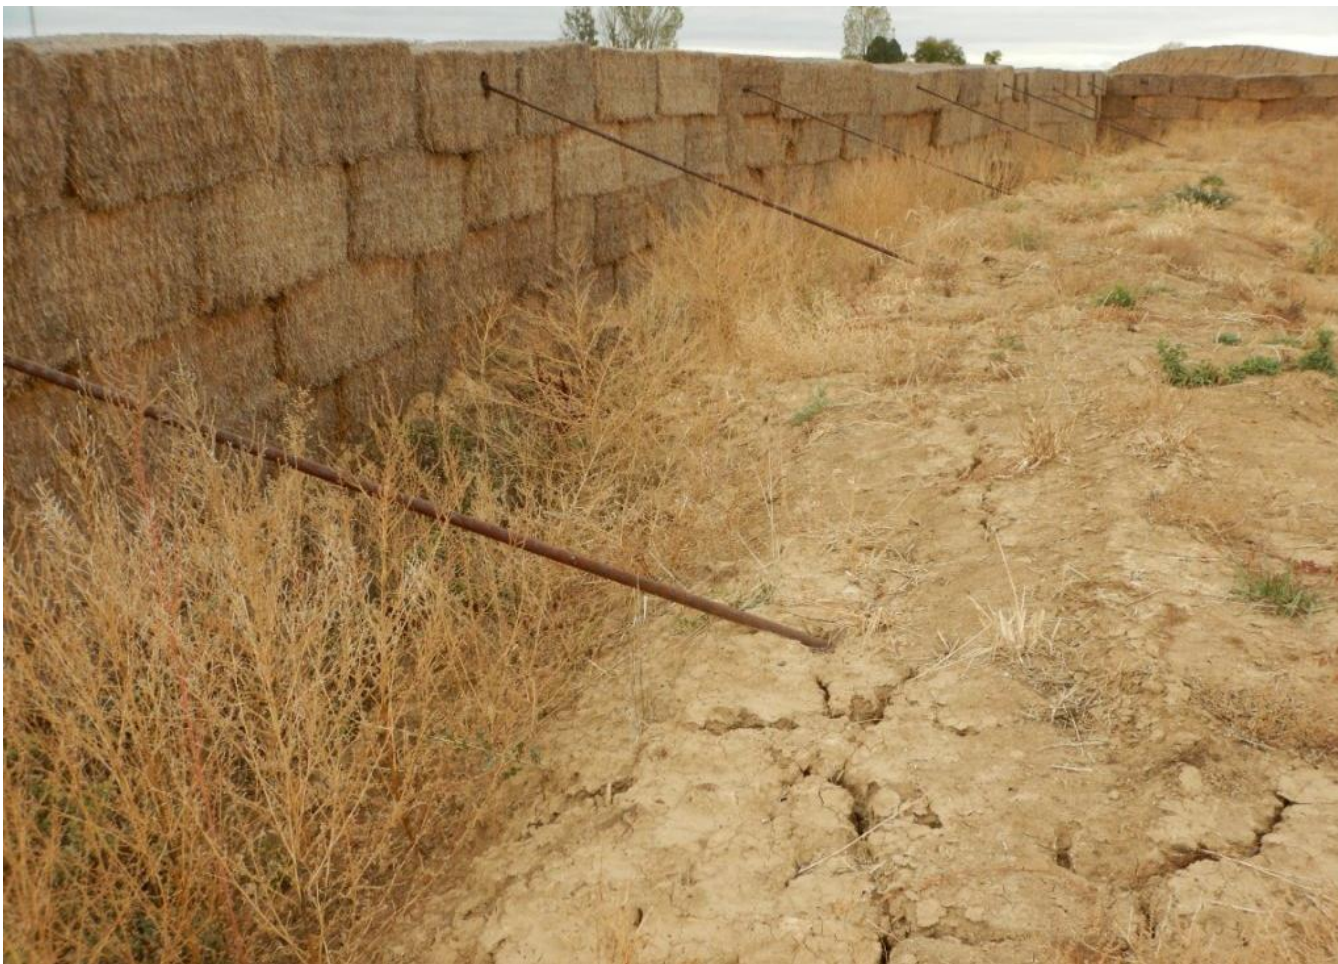
Photo 20. Photo taken from the southeast location. Need to stabilize location. Weed maintenance is needed.

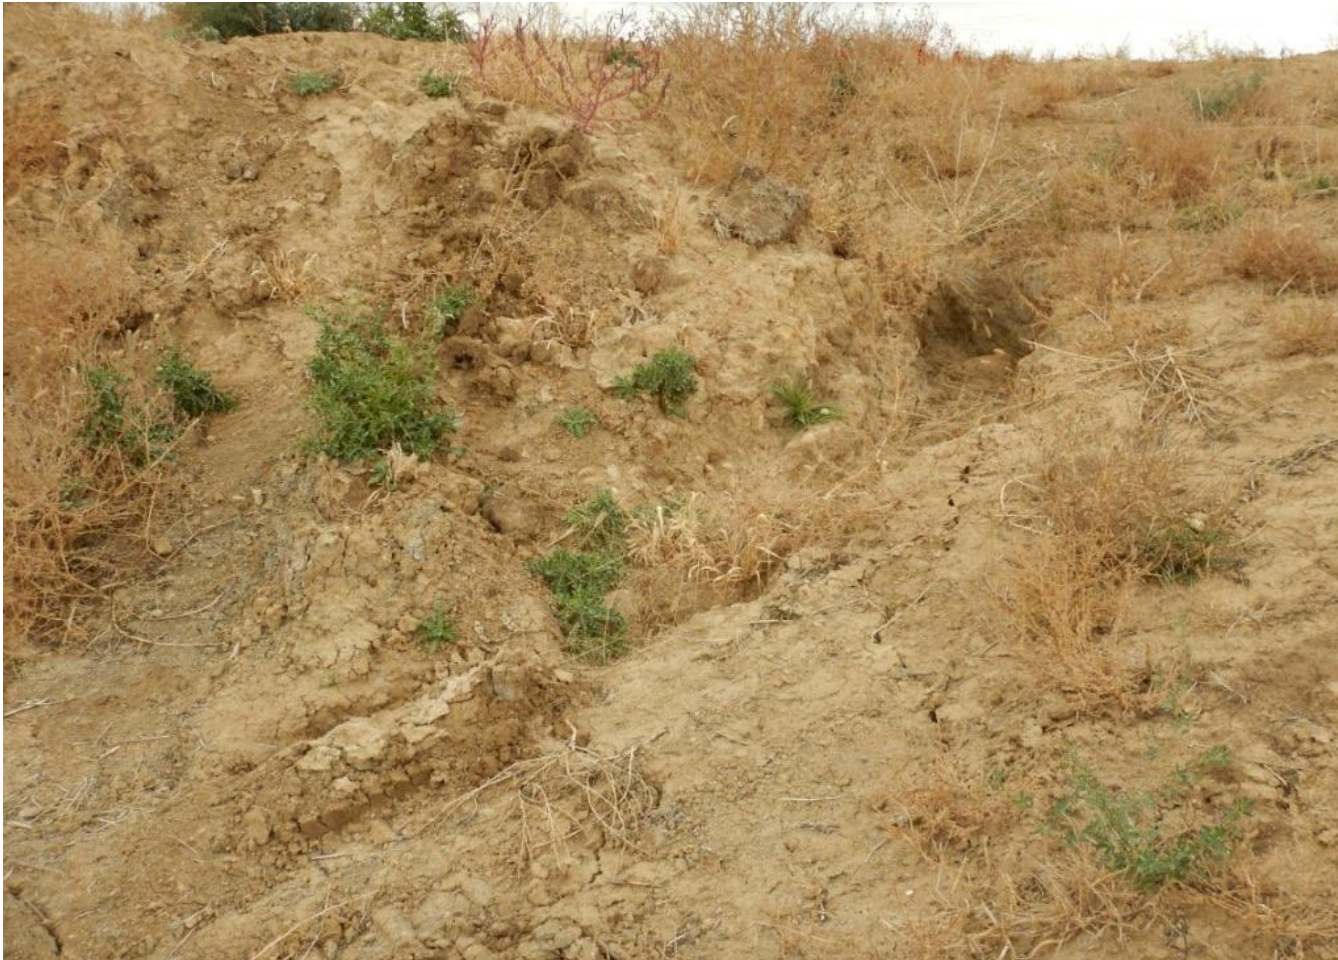
Photo 21. Photo taken from east location, facing West. Sediment movement and erosion needs to be controlled. Weed maintenance is needed.
