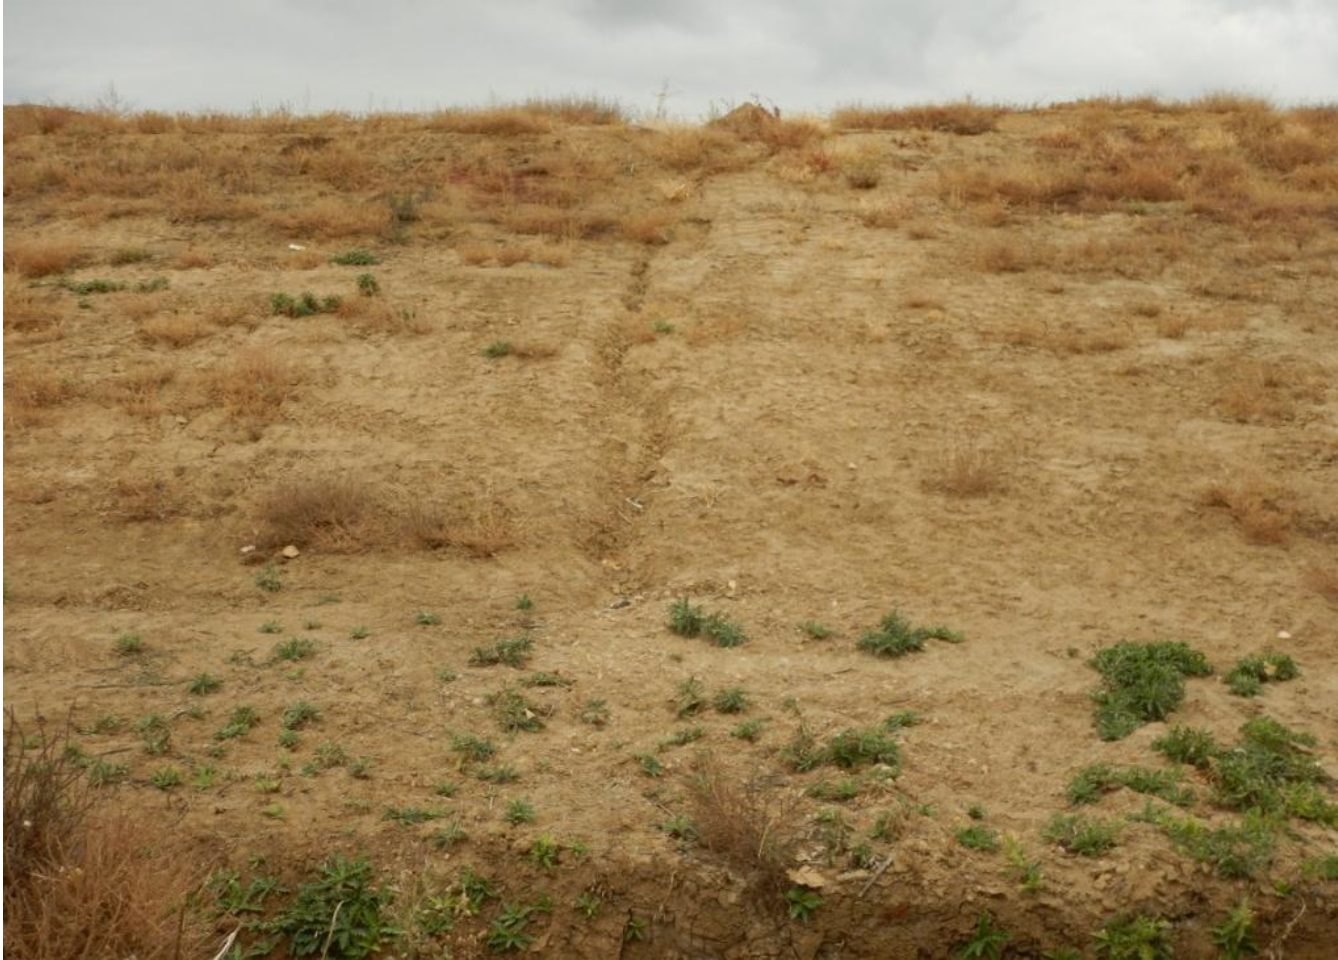
Photo 22. Photo taken from east location, facing West. Sediment movement and erosion needs to be controlled. Weed maintenance is needed.

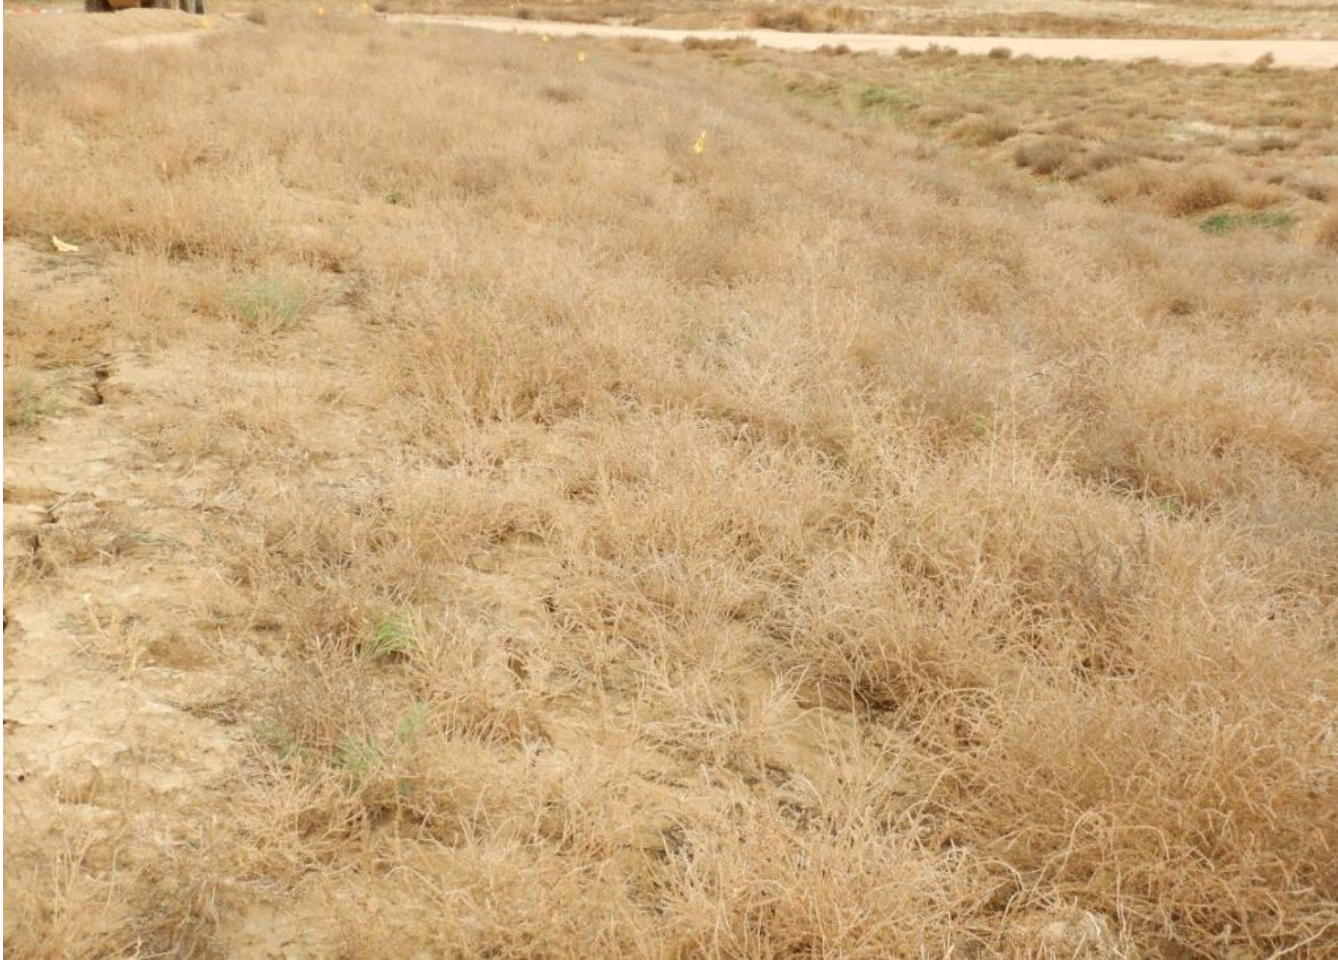
Photo 23. Photo taken from east entrance area, facing West. Kochia (*Kochia sp.*) is debris and will break off, encroach upon adjacent lands and needs to be removed from entire location.

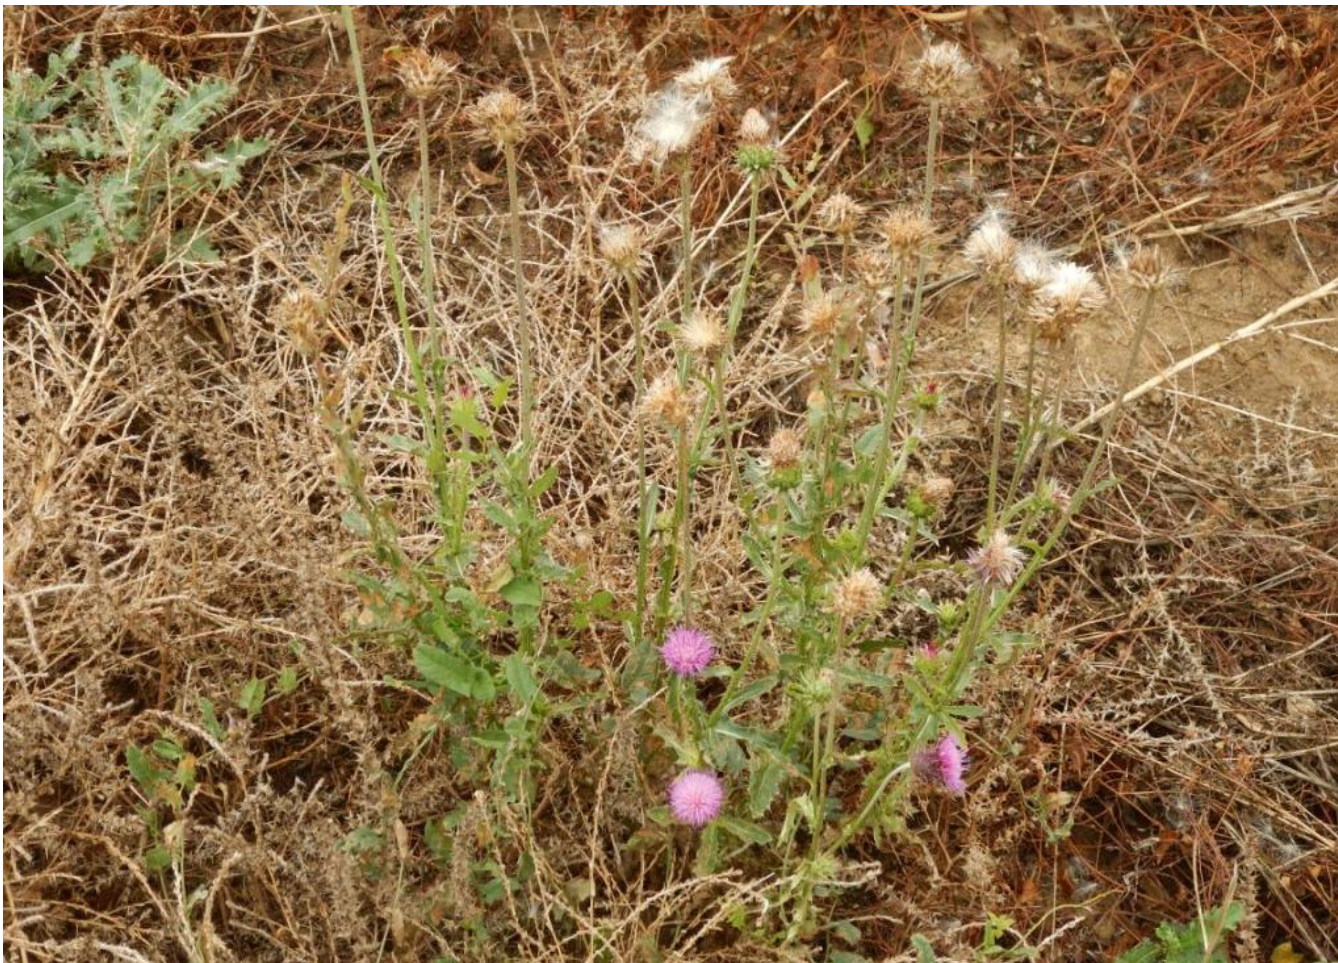
Photo 25. Musk thistle (*Carduus nutans*) observed throughout location. Weed maintenance is needed.

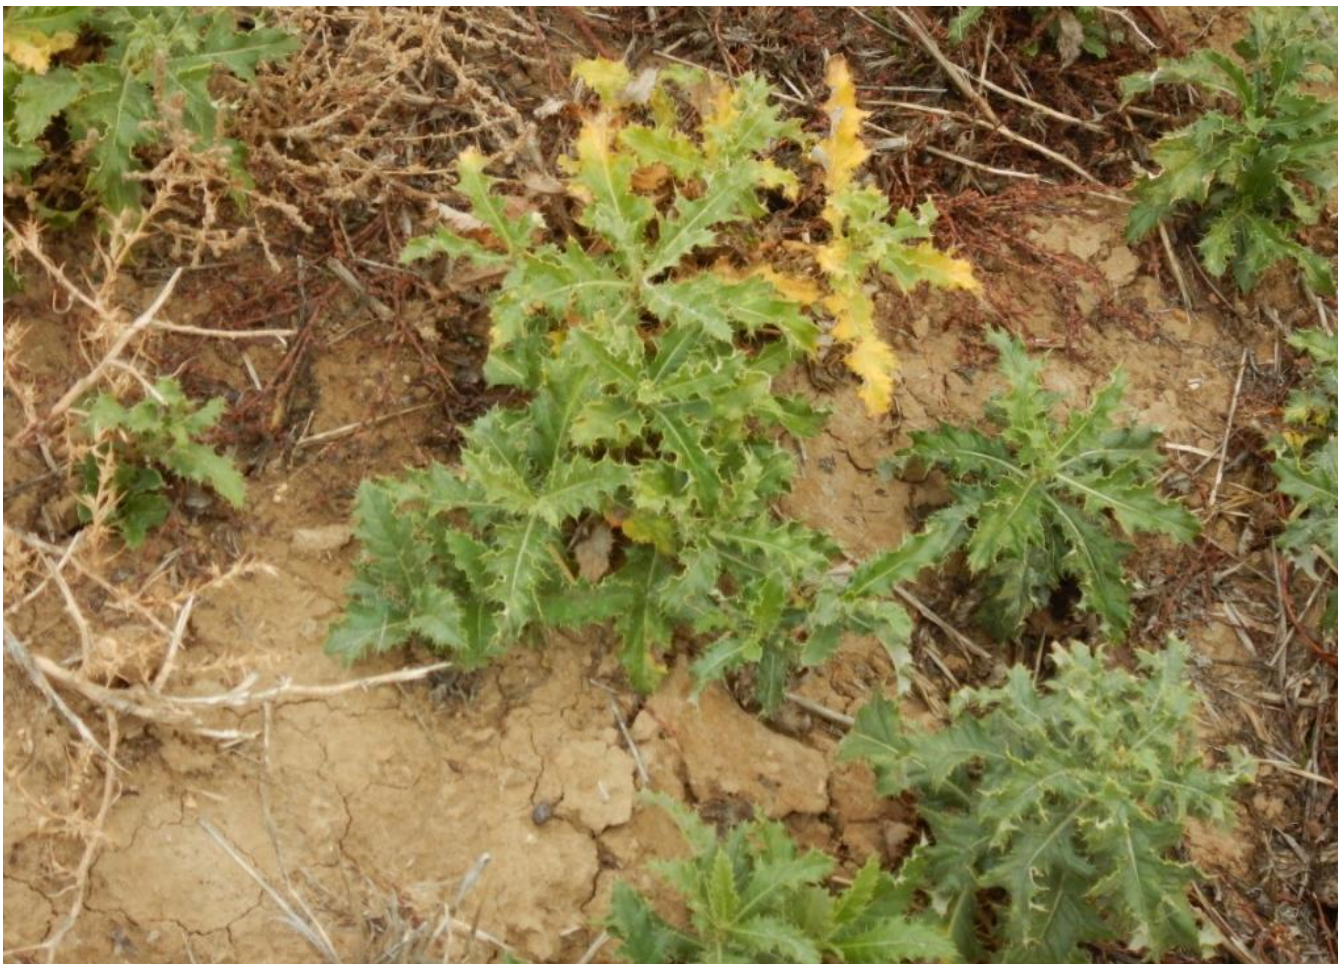
Photo 26. Canada thistle (*Cirsium arvense*) observed throughout location. Weed maintenance is needed.
