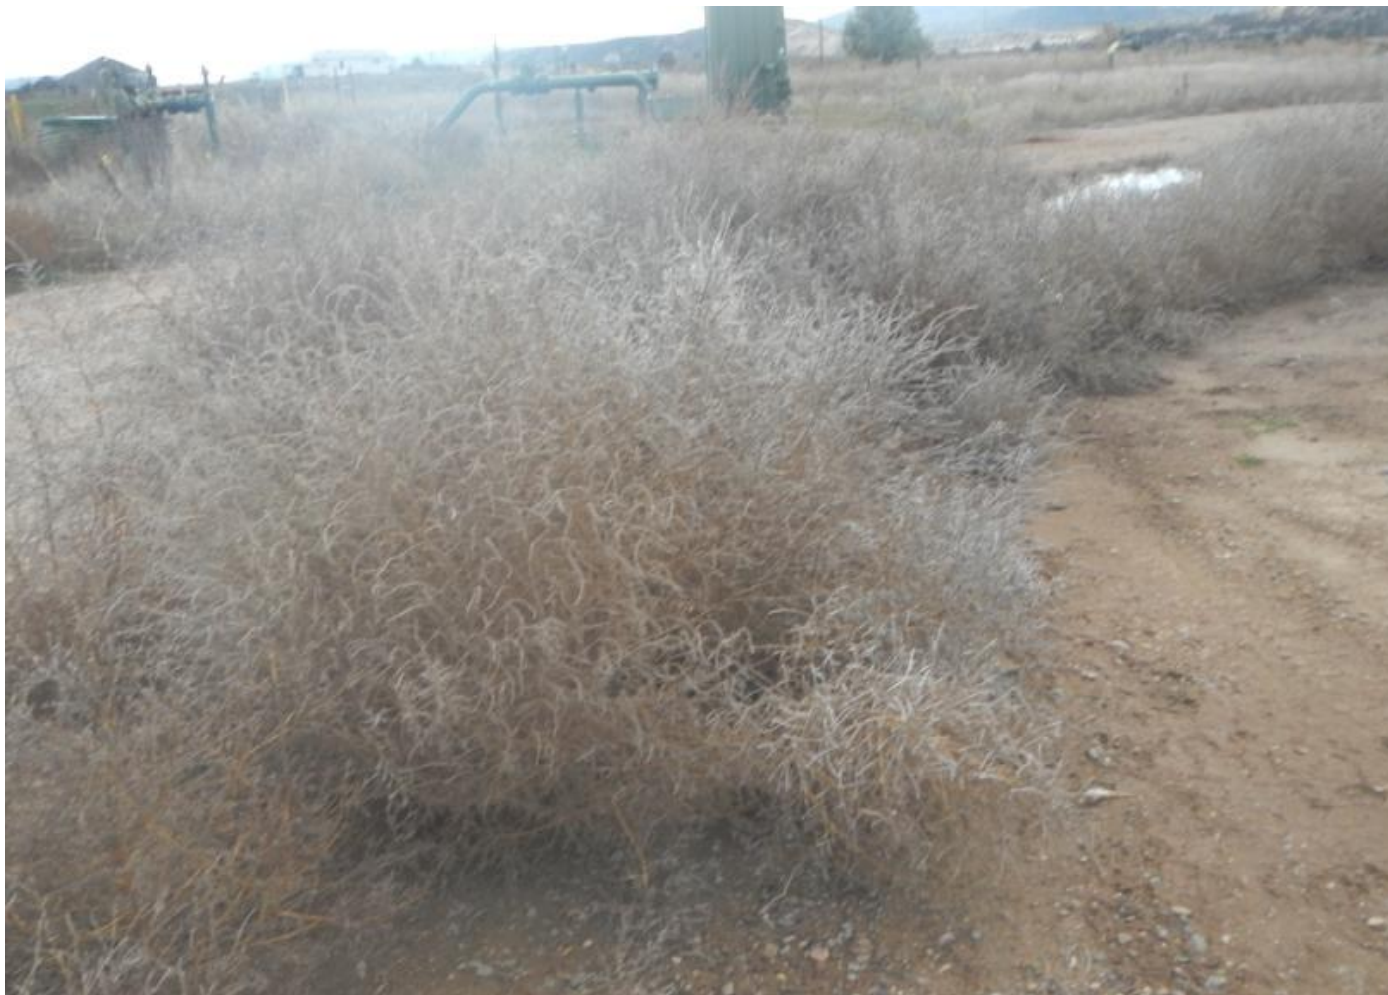
Photo 1. View of kochia (*Kochia scoparia*) debris (approximately 3 feet tall) on working surface of the well pad. Kochia debris needs to be removed and properly disposed of.

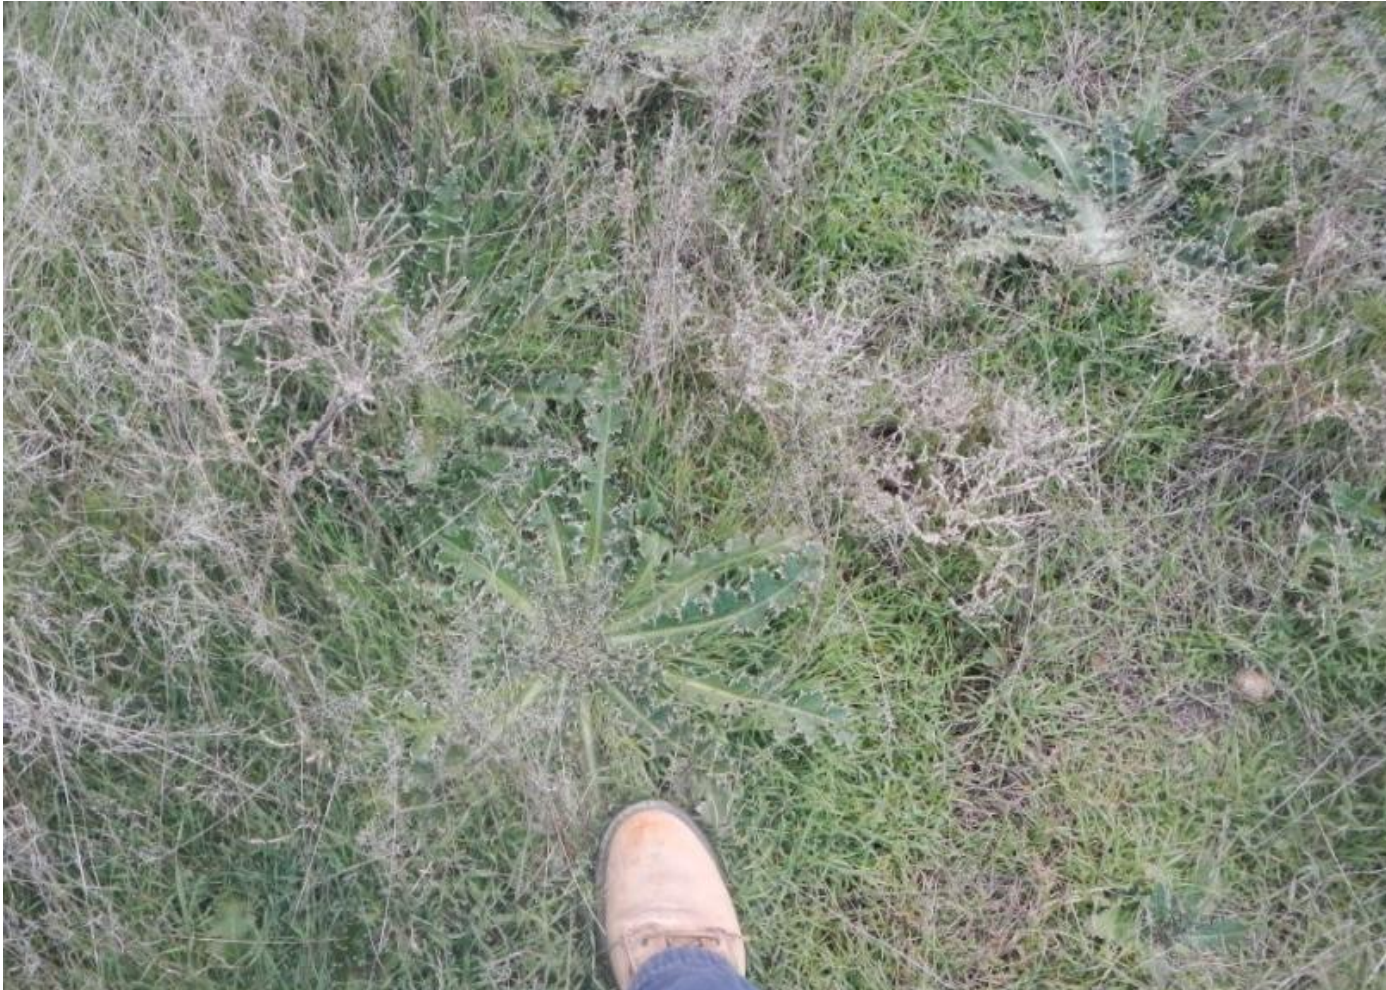
Photo 2. View of musk thistles (*Carduus nutans*) growing within the southern portion of the interim reclamation area among cheatgrass (*Bromus tectorum*).

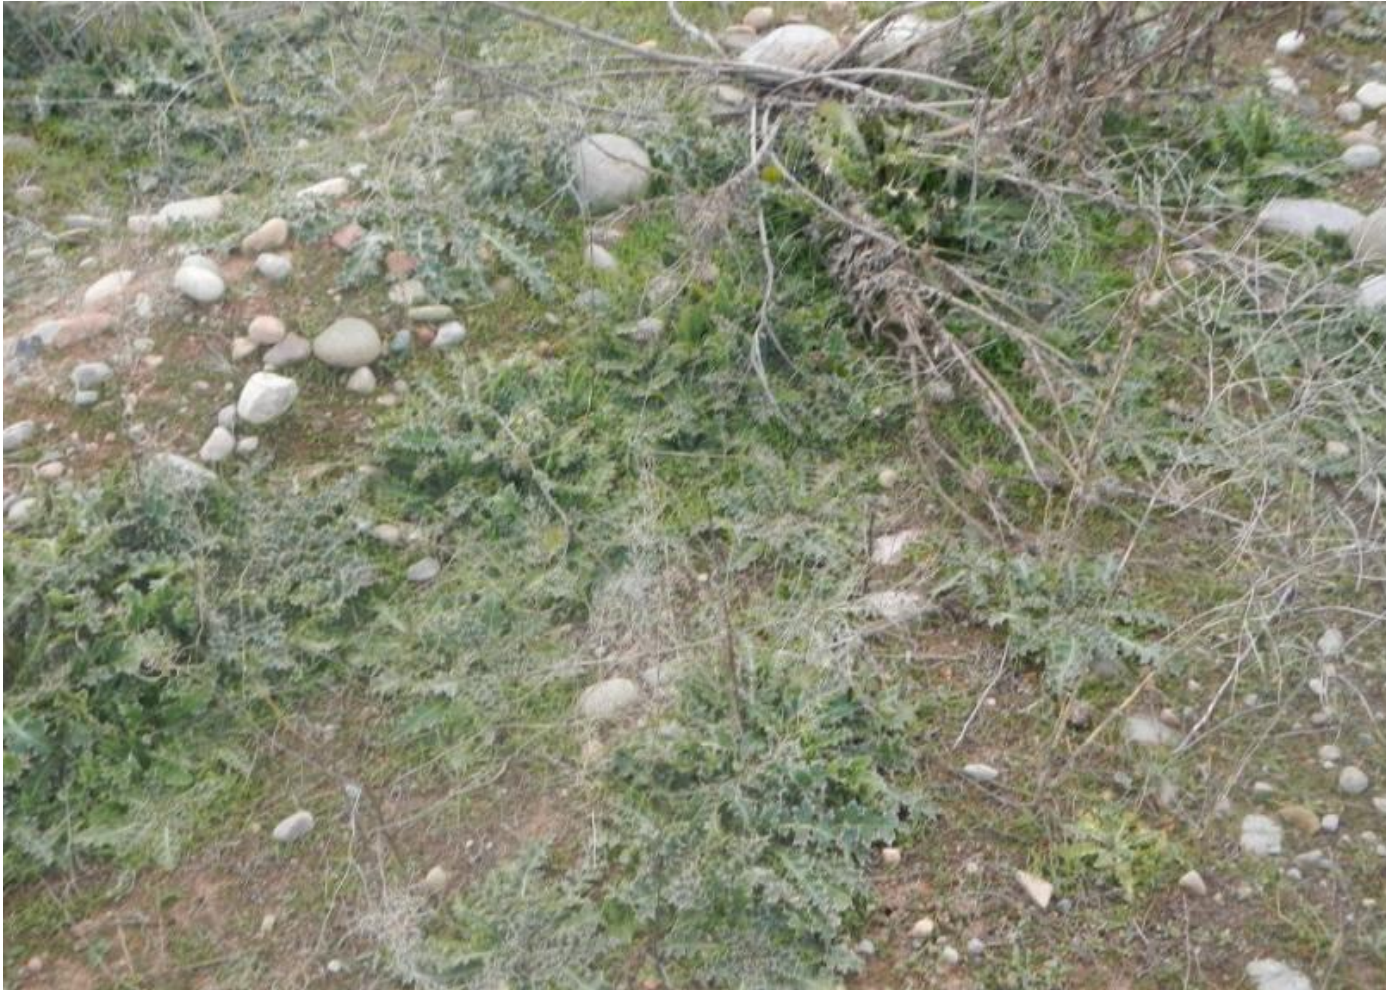
Photo 3. View of musk thistles within the northern portion of the interim reclamation area.

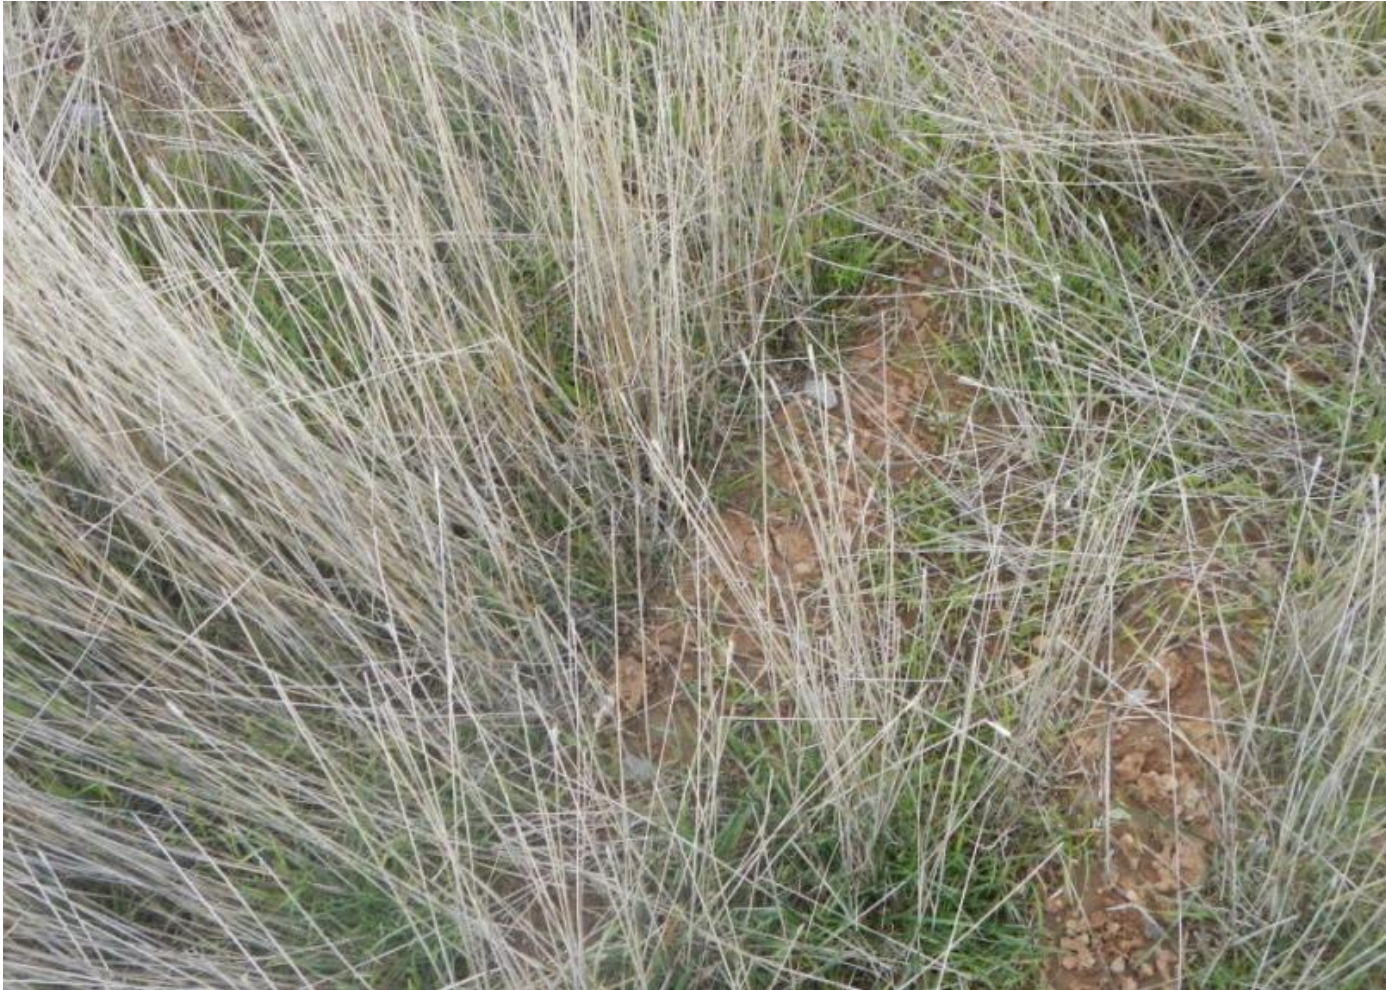
Photo 4. View of jointed goatgrass (*Aegilops cylindrica*) within the western portion of the interim reclamation area.

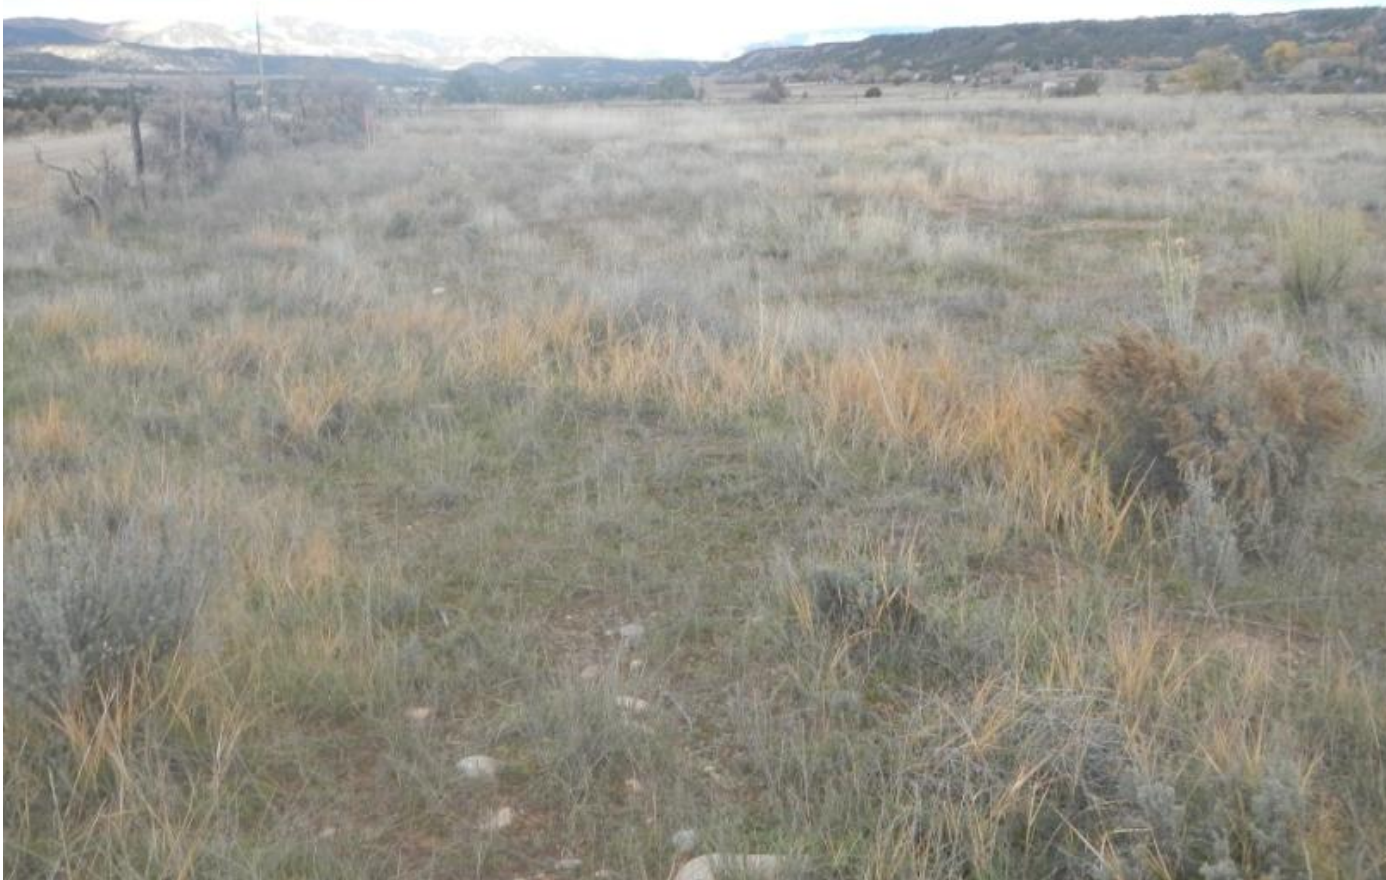
Photo 5. View of northwestern portion of the project area from mid-western edge facing northward. Grasses such as smooth brome (*Bromus inermis*), and western wheatgrass (*Pascopyron smithii*) as well as scattered big sagebrush (*Artemisia tridentata*) shrubs are growing here.
