Thomas L Spring LLC hand mowed, raked, and disposed of the weeds on November 10th at the Gregory well site and road. Weed control was performed to follow COGCC Conditions of Approval COA for the Gregory 1-21X Reclamation plan. Below are pictures that show the moving and removal work.

Seeding and soil stabilization was performed on the Gregory site on November 27th. The land was raked to break the soil crust and then was hand broadcast seeded. We had Habitat Management determine the areas that needed to be reseeded and have soil stabilization applied. Once the seeds were hand broadcast, we raked again to incorporate the seed into the soil and achieved good seed soil contact. Once seeding was performed, we applied wood straw mulch from Mountain Pine Manufacturing, Inc. out of Steamboat Springs. We applied the wood straw at a rate of over 60% coverage. Both the seeding and the wood straw application were performed to follow COGCC Conditions of Approval COA for the Gregory 1-21X Reclamation plan. Below are pictures for our seeding and soil stabilization work.

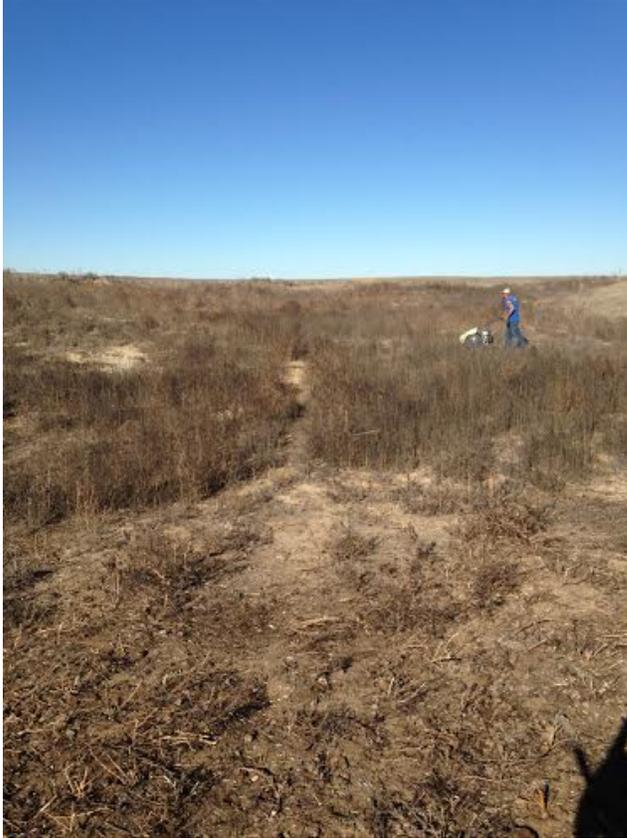
Hand moving the weeds. Picture is on well pad facing west.

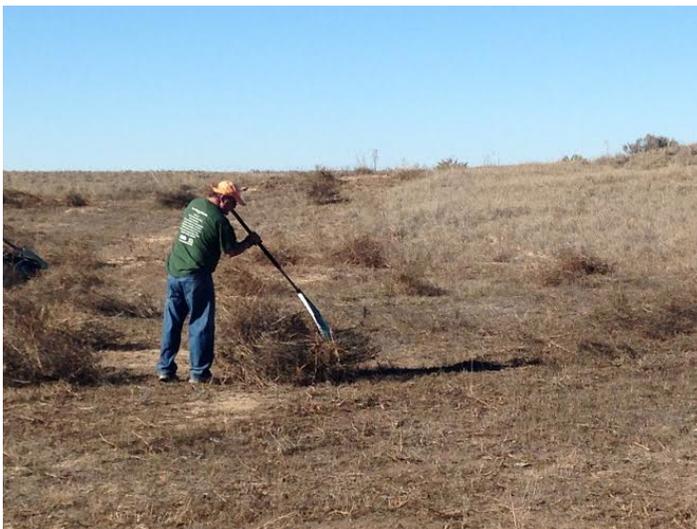
The weeds were then hand raked into piles and disposed of. Picture is facing west.

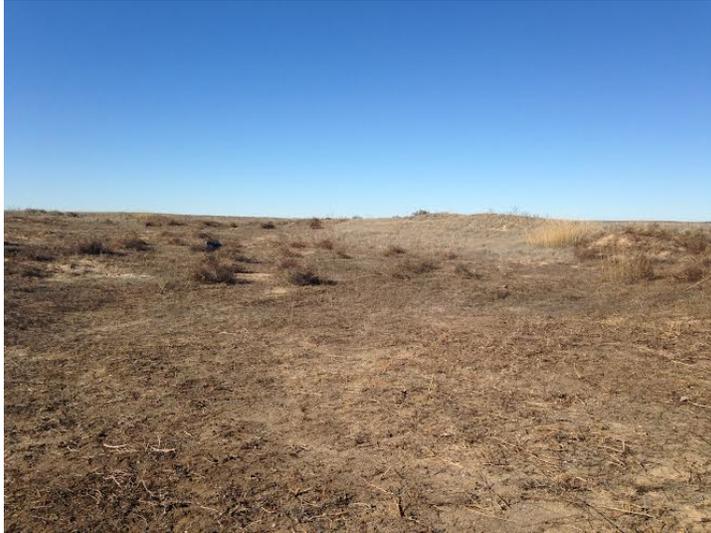
Picture is facing North on well pad and shows the cut weeds and raked piles.

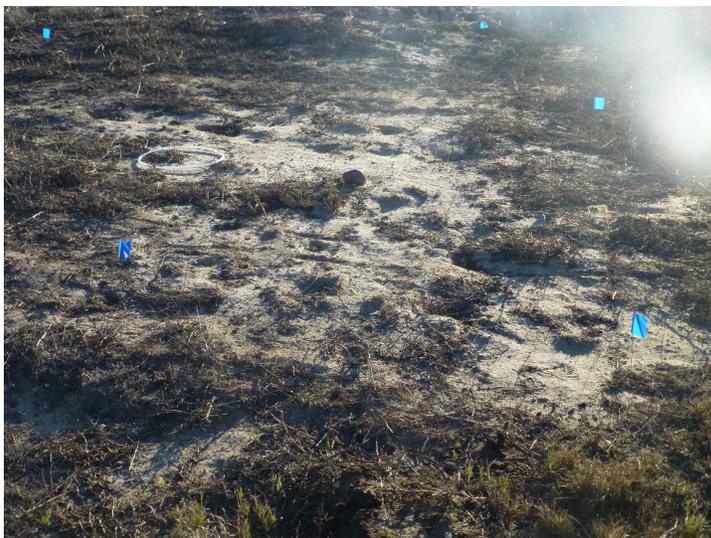
Picture shows the hoop and flags used to determine the areas that needed additional work. Habitat Management performed the surveying and determined the delineated areas for us.

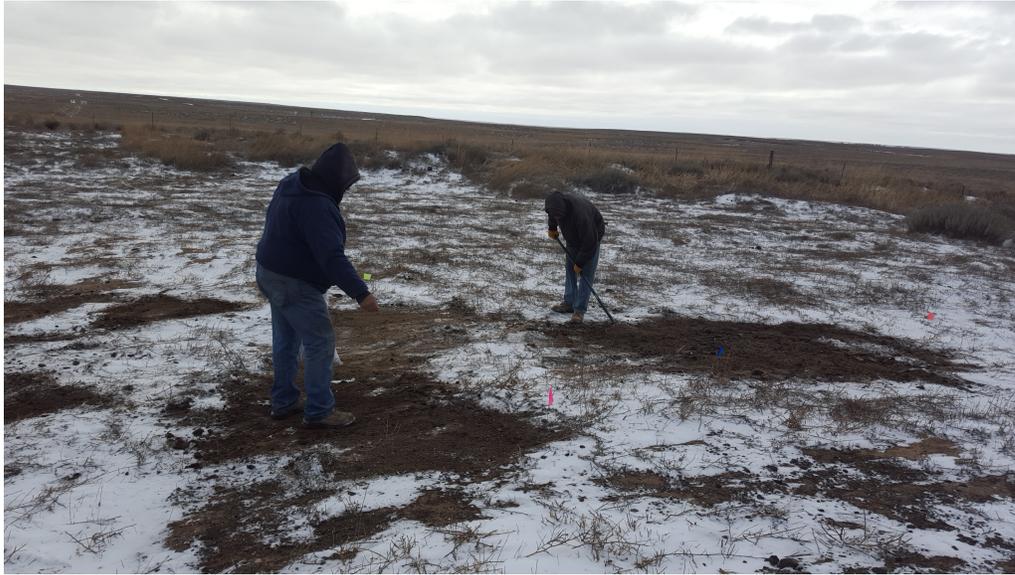
The soil is being raked and the seed hand broadcast.

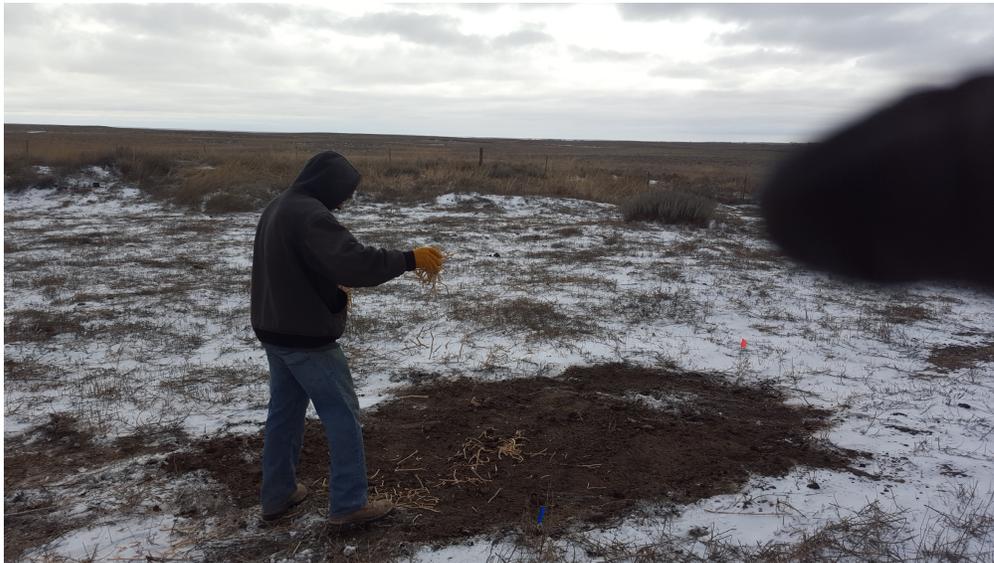
Wood straw is being applied at a coverage rate of at least 60% on top of the reseeded.

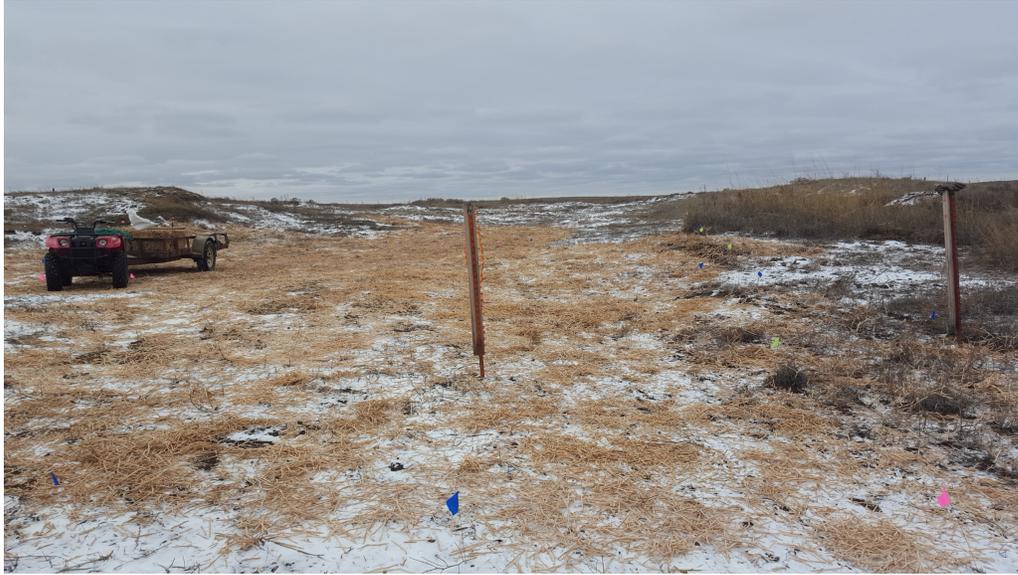
The wood straw coverage facing west on the well pad.
