Subject: Surficial Spill Report
COGCC Facility ID: ~~245790~~
COGCC Inspection Document Number: 679700051
Monahan Gas & Oil, Inc.
Fairmeadows #11-3 Facility
NESW, Sec.3, T5N, R65W
Greeley, Colorado
CGRS Project No. 1-12986-15780aa

FIGURE 1
SITE LOCATION MAP
 MONAHAN GAS & OIL, INC.
 FAIRMEADOWS 11-3
 NESW, SEC.3, T5N, R65W
 GREELEY, COLORADO

FIGURE 2A SITE CONDITIONS MAP

FIGURE 2B
SPILL PATHWAY & SAMPLE LOCATIONS

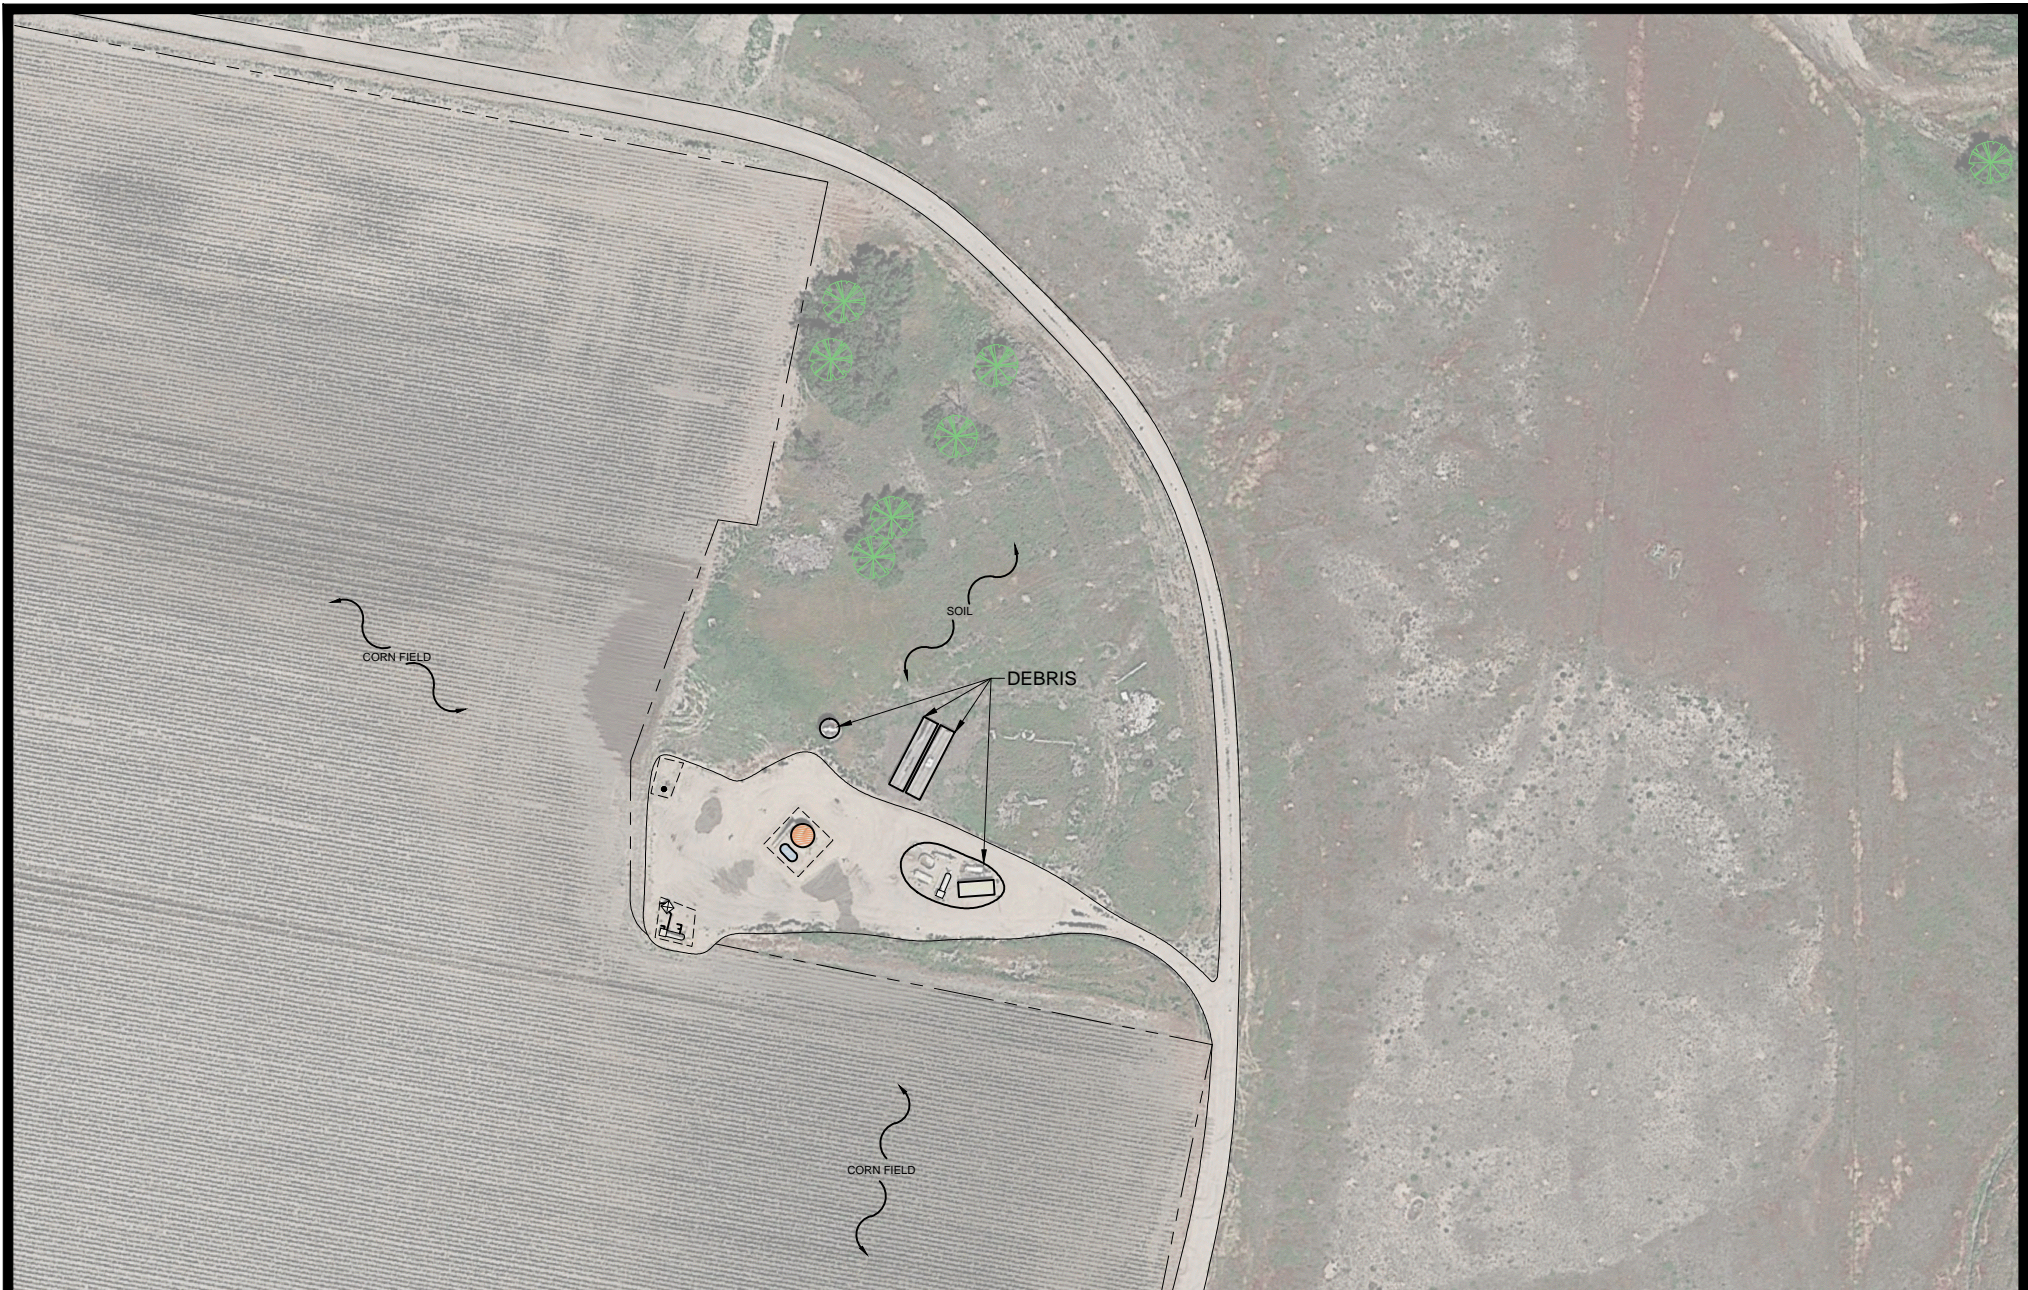
During the month of September, 2015 it was estimated that approximately 1.5 barrels (BBLs) of production fluid leaked from a damaged 2-inch valve on the production flow line as it enters the separator. The production stream from the Fairmeadows #11-3 wellhead is intermittent and the production fluid is scheduled to exit the wellhead for approximately nine minutes during each 24-hour period. Based on the duration of time that fluid is in transit and number of days that the valve was potentially leaking it is estimated that a total of 1.5 BBLs leaked from the pipe via a pressurized mist on three separate occasions and carried by prevailing wind southeast, south, and west across the adjacent cornfield. A minor amount of production fluid also spilled to the ground surface adjacent to the separator. Upon discovery, the well was immediately shut in and the damaged valve was replaced by Monahan Gas & Oil, Inc. A site location map is included as Figure 1, a site conditions map is included as Figure 2A and a Spill Pathway and Sample location Map is included as Figure 2B.

The leak was discovered by the landowner who manages the field adjacent to the Fairmeadows #11-3 Facility. The landowner called the Colorado Oil and Gas Conservation Commission (COGCC) who notified Monahan Gas & Oil, Inc. There was no visible standing fluid on site or in the surrounding farmland. The ground appeared to be slightly stained from the fluids and some crops showed signs of stress where the fluid was carried by wind and deposited on the tops of the stalks in three primary areas.

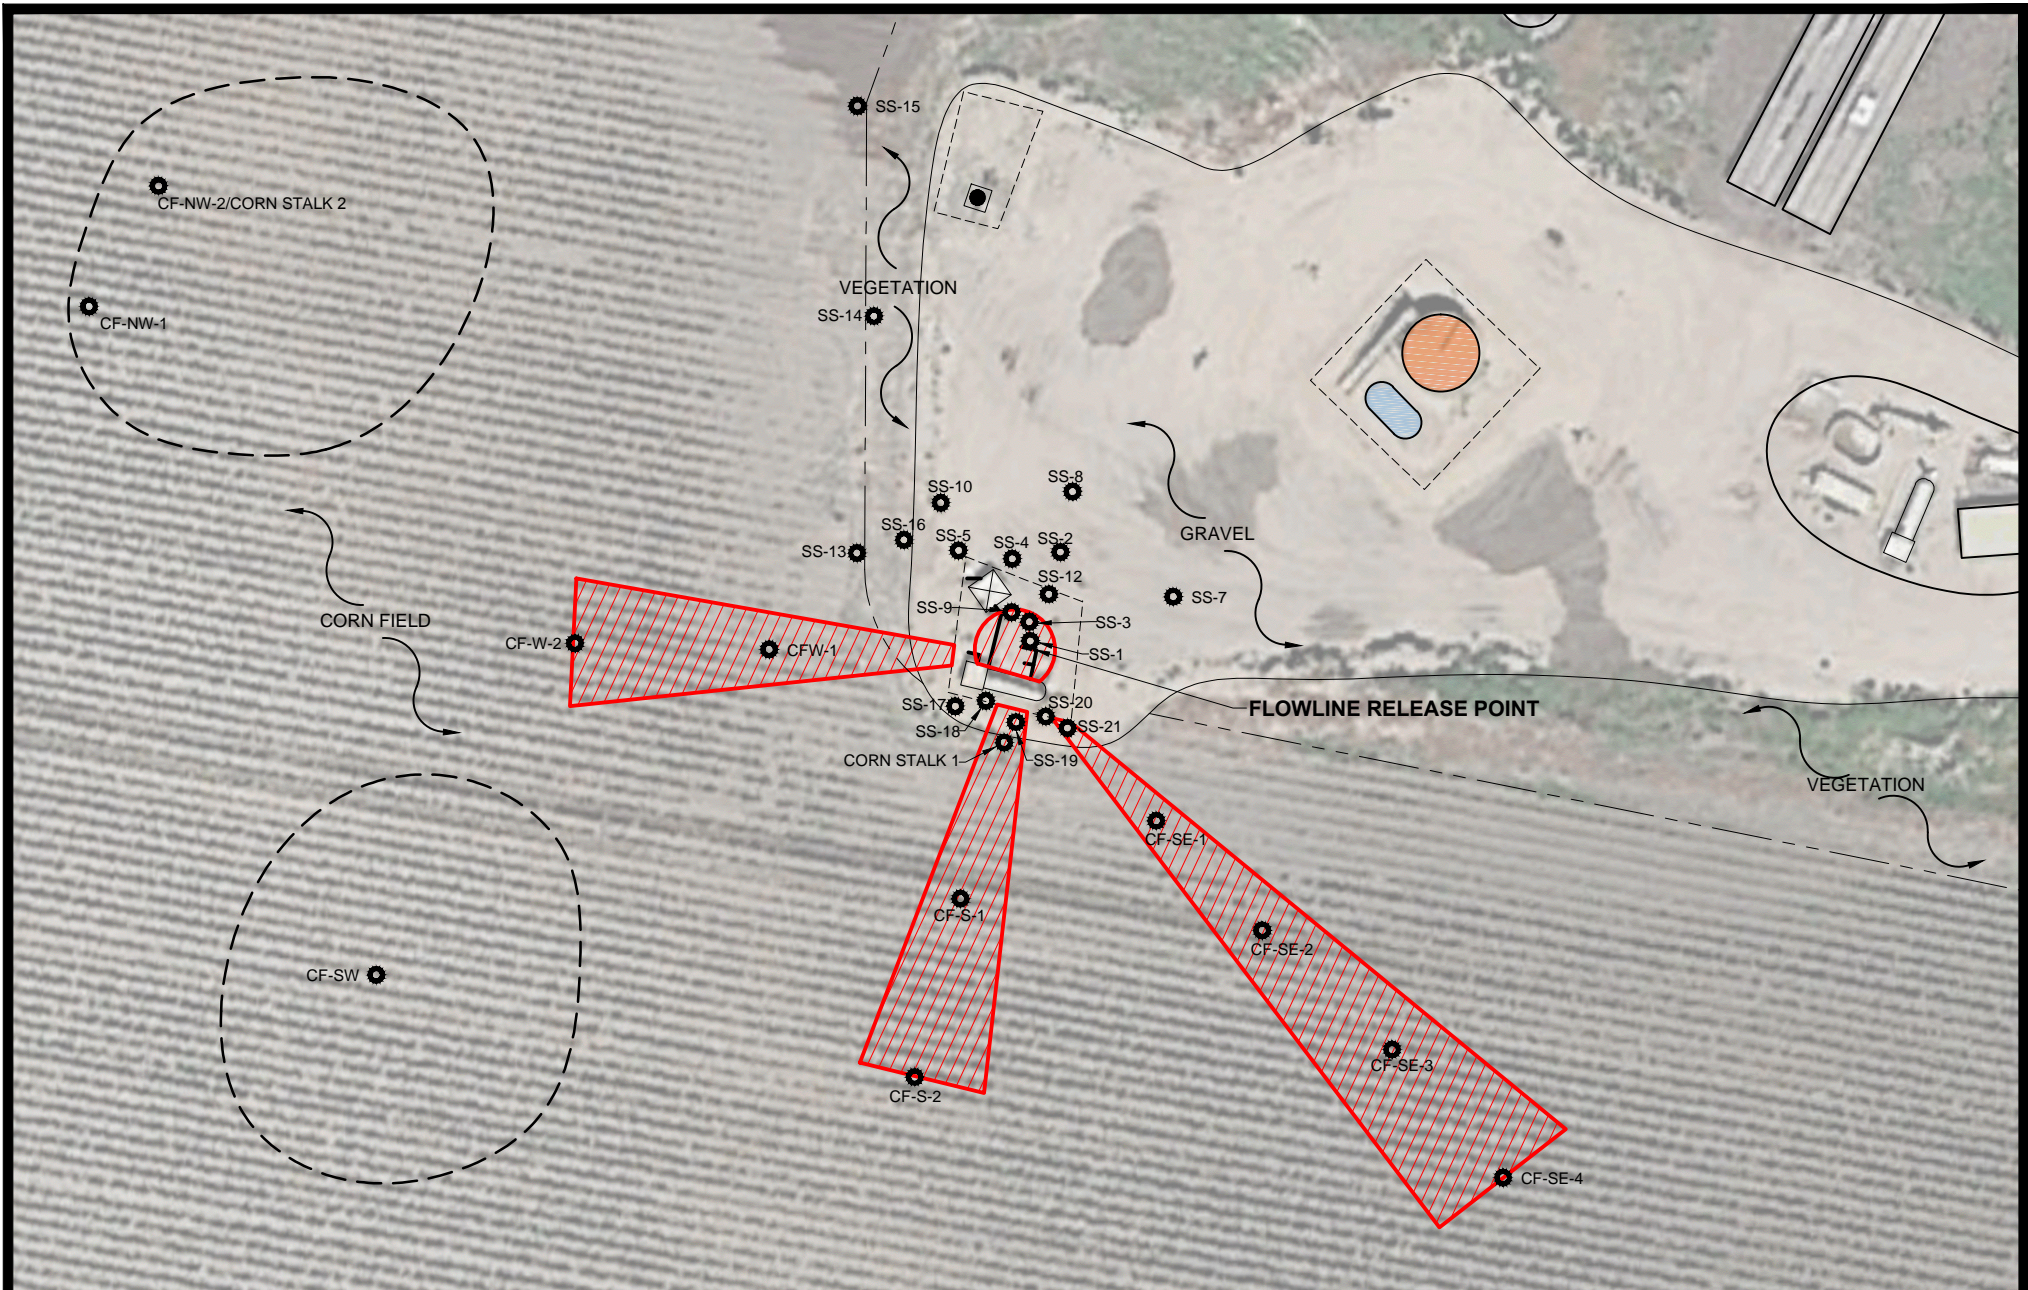
During the surficial soil assessment, thirty-one soil locations were screened along the perceived paths of the released production fluids and around the point of release. Two soil samples (SS-1 at the surface and SS-9 at the surface) were submitted to eAnalytics Laboratory, Inc. in Loveland, Colorado in order to determine potential hydrocarbon concentrations in the source area soil. Additionally, two corn stalk samples were collected (Corn Stalk 1 & Corn Stalk 2) and analyzed for total petroleum hydrocarbons – diesel range organics (TPH-DRO) in order to document potential impacts to the corn crop. Surface soil samples SS-1 and SS-9 were submitted for analysis of benzene, toluene, ethylbenzene and total xylenes (BTEX), total petroleum hydrocarbons – gasoline range organics (TPH-GRO), TPH-DRO, pH, sodium adsorption ratio (SAR), and electrical conductivity (EC). A summary of soil screening and soil analytical data is included as Table 1.

A review of soil analytical data from soil sample SS-1 at the surface revealed concentrations of benzene and TPH-DRO in excess of COGCC maximum allowable concentrations. All other analytes from soil sample SS-1 were below COGCC maximum allowable concentrations (MACs). A review of the soil quality analytical data for SS-9 at the surface shows that concentrations of BTEX, TPH-GRO, pH, EC & SAR were below laboratory method detection limits; however, SS-9 showed elevated TPH-DRO levels that exceeded MACs.

Laboratory data from vegetation sample Corn Stalk 1 indicates TPH-DRO levels above MACs. Vegetation sample Corn Stalk 2 revealed no detectable TPH-DRO levels. The corn in sample location Corn Stalk 2 appeared to be stressed from environmental factors not associated with the spill as no production fluids appeared to have traveled to the location from the spill release point. The area near Corn Stalk 2 appears to be in a natural topographic depression and thus may have been susceptible to overwatering. Laboratory analytical data and Chain-of-custody documentation are included as Attachment A.

The levels of pH, EC, SAR, and relatively low levels of volatile organics with the exception of SS-1 at the surface and SS-9 at the surface indicate a surficial soil zone with minor impacts from the production fluid spill that occurred during early September, 2015. Based on the soil screening and analytical data CGRS recommends that Monahan Gas & Oil, Inc. excavate the ground surface in the source area per any COGCC recommendations. As required by COGCC, follow up sampling event may be required to obtain additional confirmation soil samples pending remedial activities by Monahan Gas & Oil, Inc.
