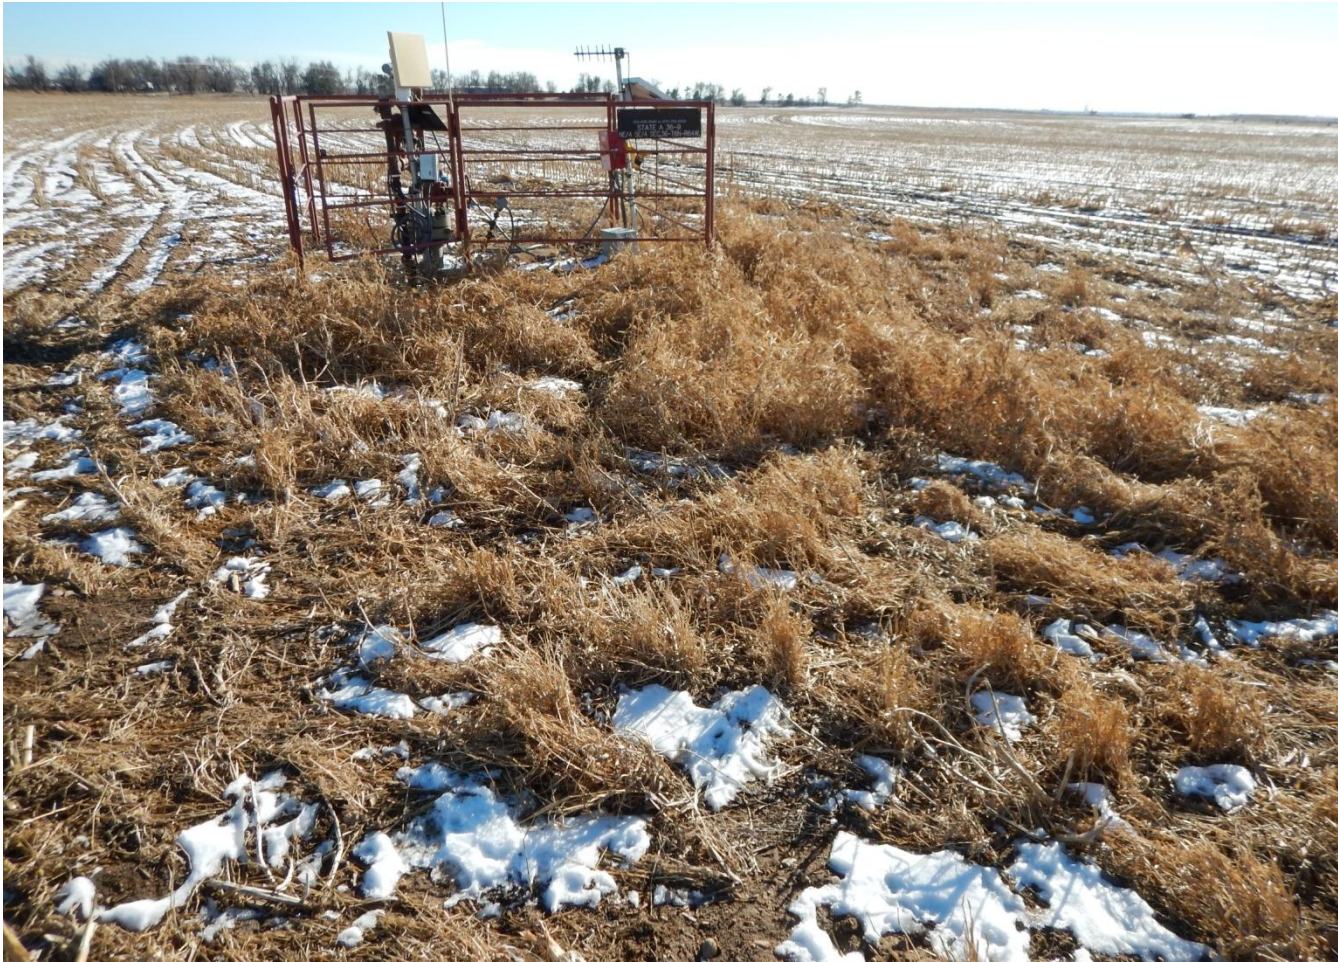
Photo 2. Photo taken from northern location, facing South. Weeds need to be removed from around the well per Rule 603.f. Interim reclamation success can not be evaluated until the next growing season.

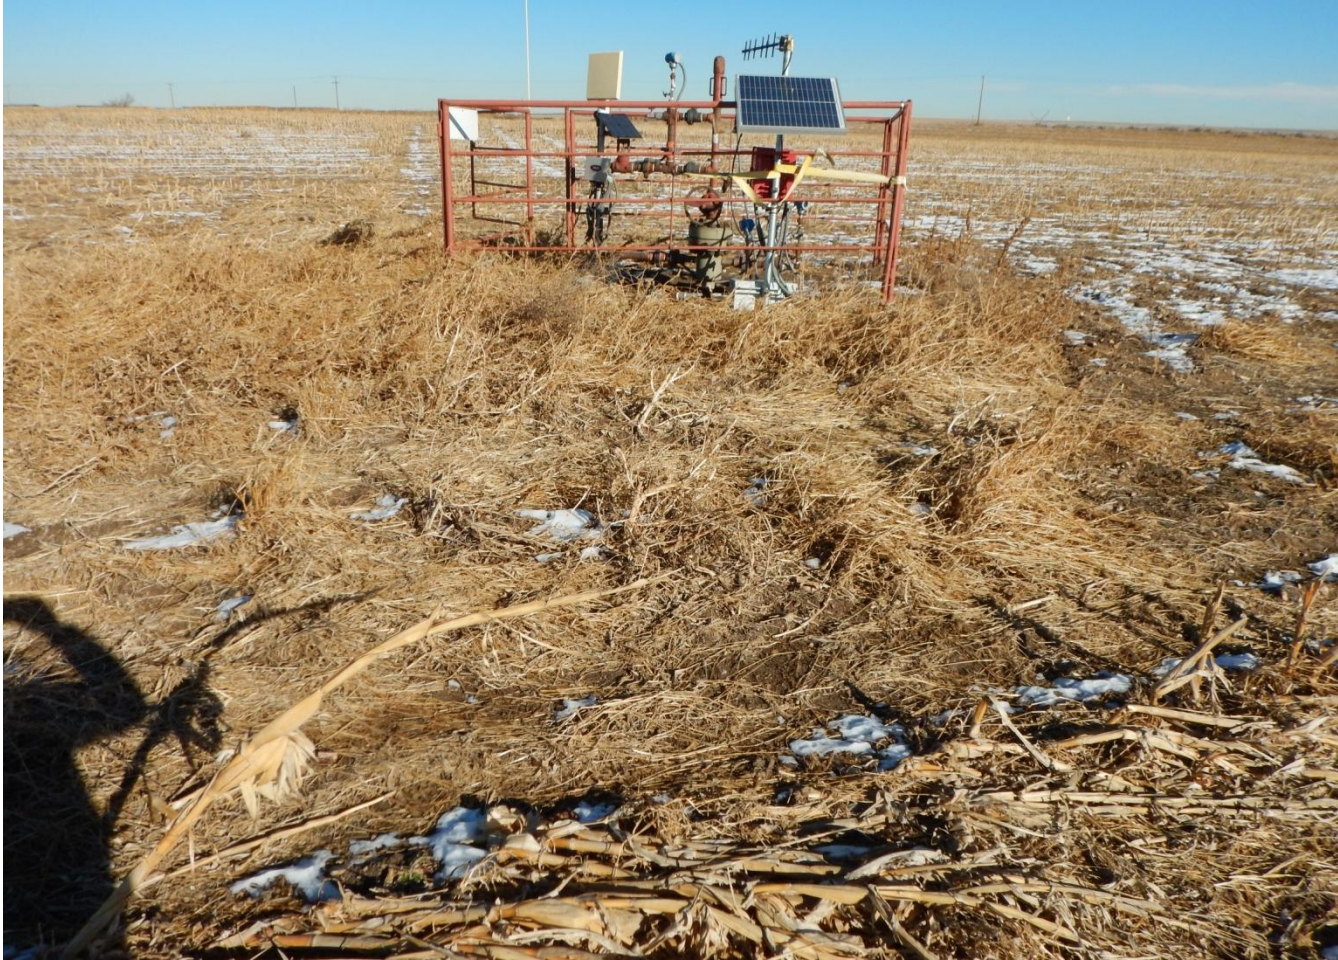
Photo 3. Photo taken from western location, facing East. Weeds need to be removed from around the well per Rule 603.f. Interim reclamation success can not be evaluated until the next growing season.

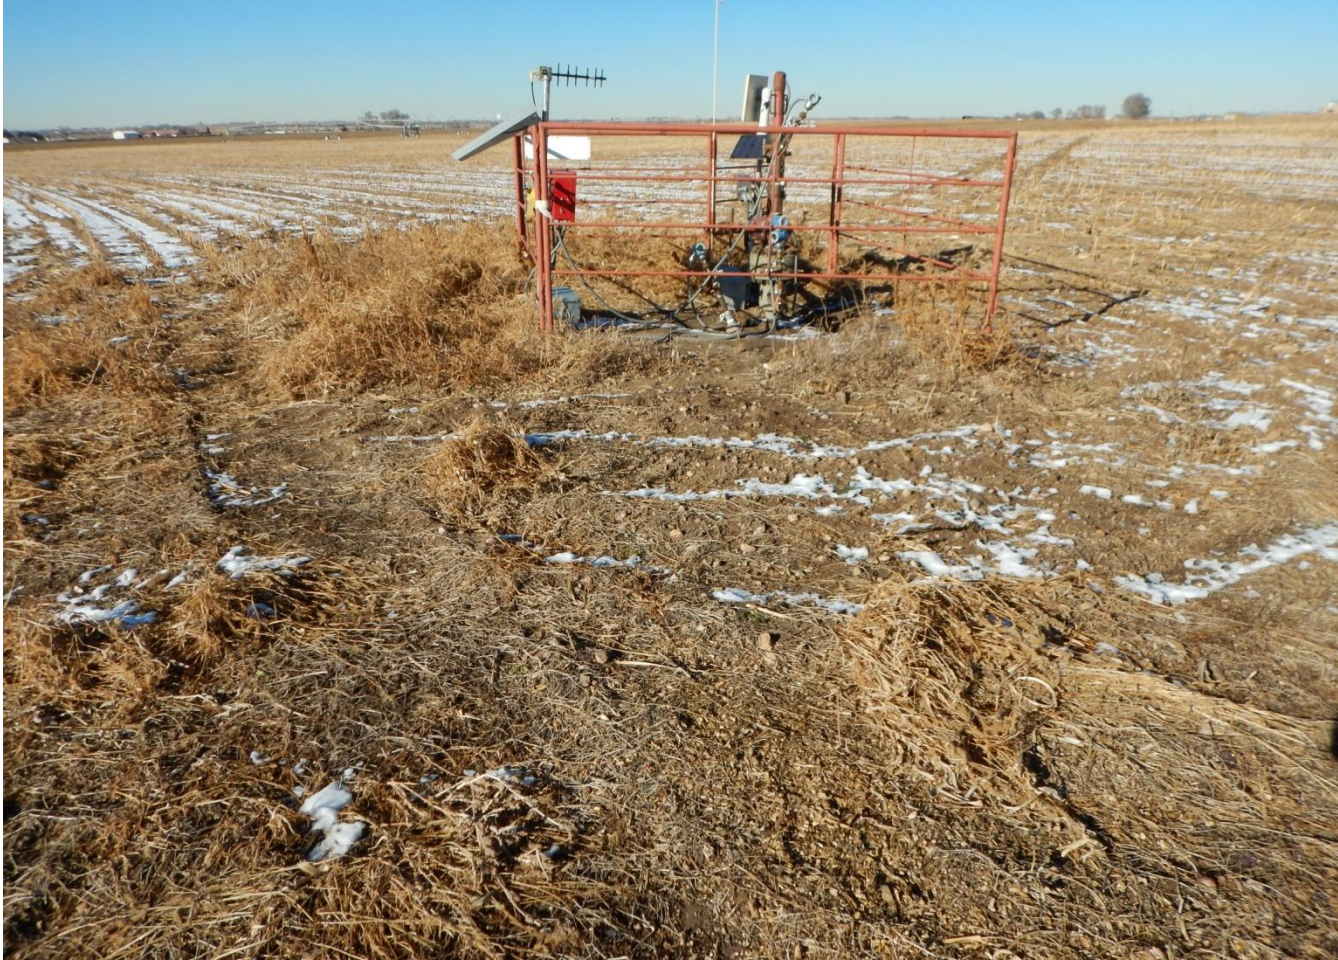
Photo 4. Photo taken from southern location, facing North. Weeds need to be removed from around the well per Rule 603.f. Interim reclamation success can not be evaluated until the next growing season.

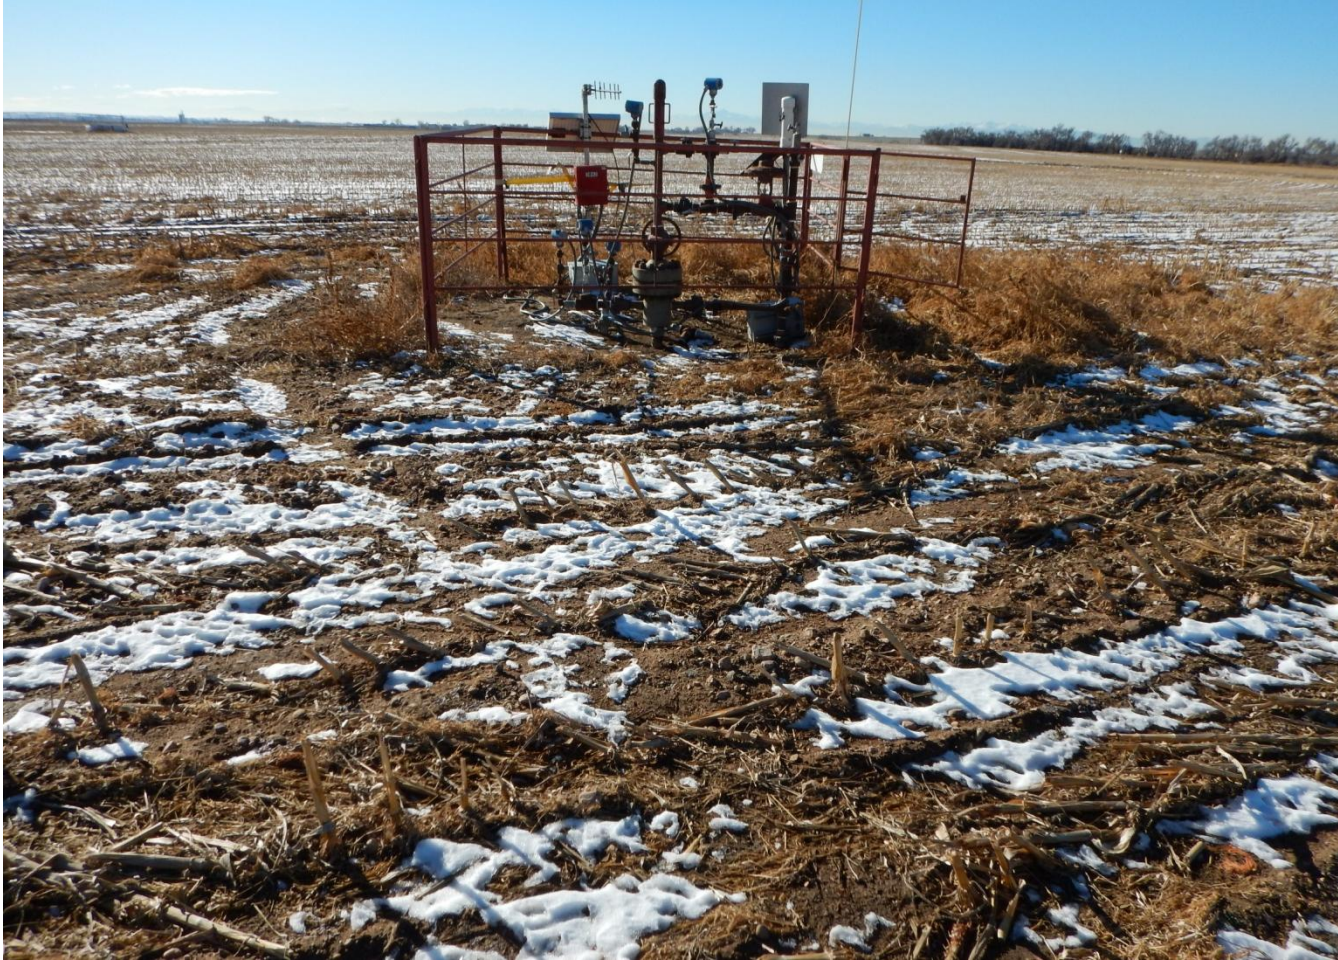
Photo 5. Photo taken from eastern location, facing West. Weeds need to be removed from around the well per Rule 603.f. Interim reclamation success can not be evaluated until the next growing season.
