Mahalo ##2, COGCC Field Inspection on 12/3/2015—Field Photos

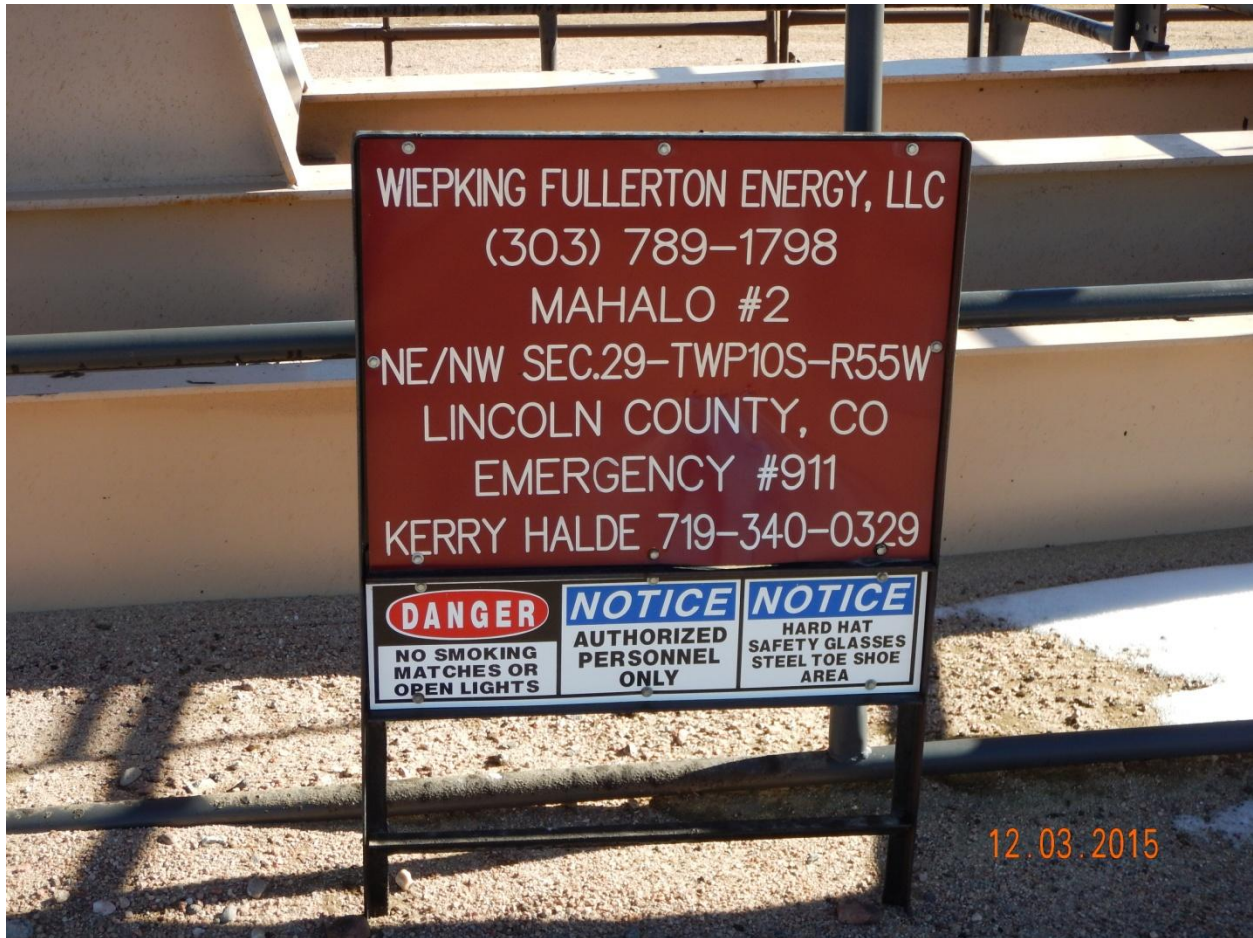
Figure 1 - Well sign. COGCC attempted to contact operator via both phone numbers provided on sign, which went to recorded messages. COGCC could not leave message for operator because there was no option to leave a message for the number ending in 1798 and the voice mailbox was full for the number ending in 0329.

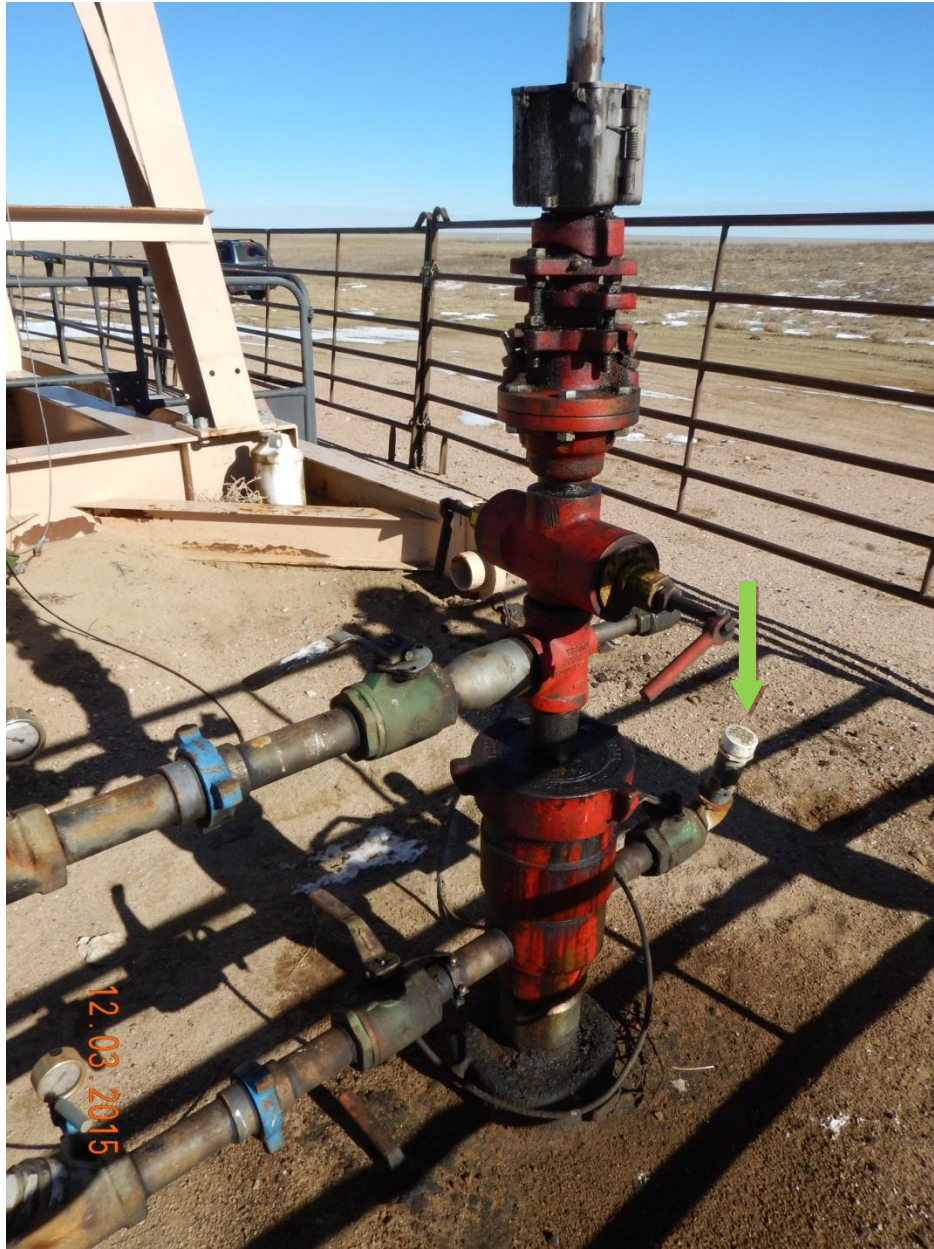
Figure 2 – Photo of actively venting wellhead with localized stained soil. Vent nipple location indicated by green arrow.

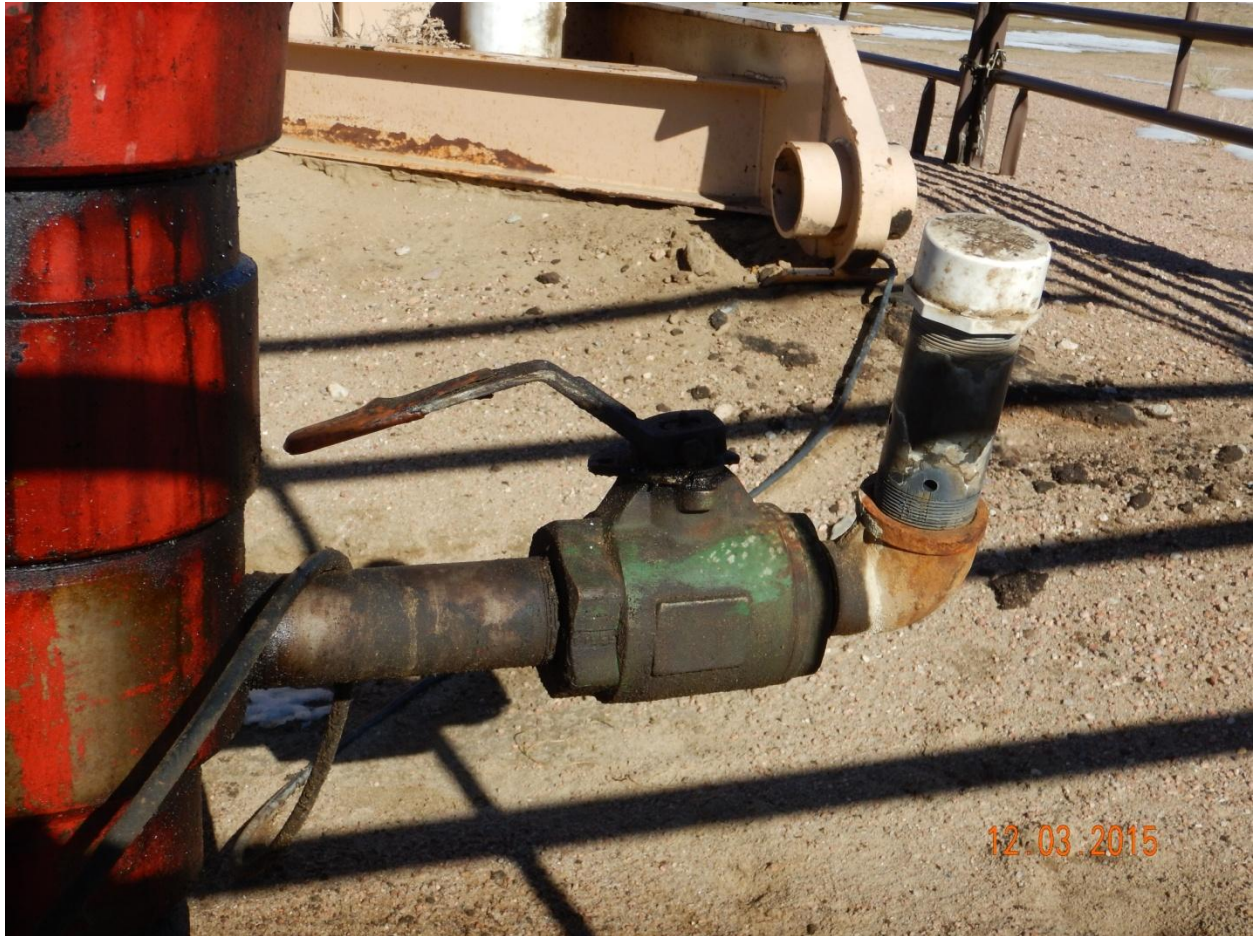
Figure 3 – Close up of vent nipple. COGCC Inspector's personal four-gas meter alarm was tripped for H<sub>2</sub>S and LEL.

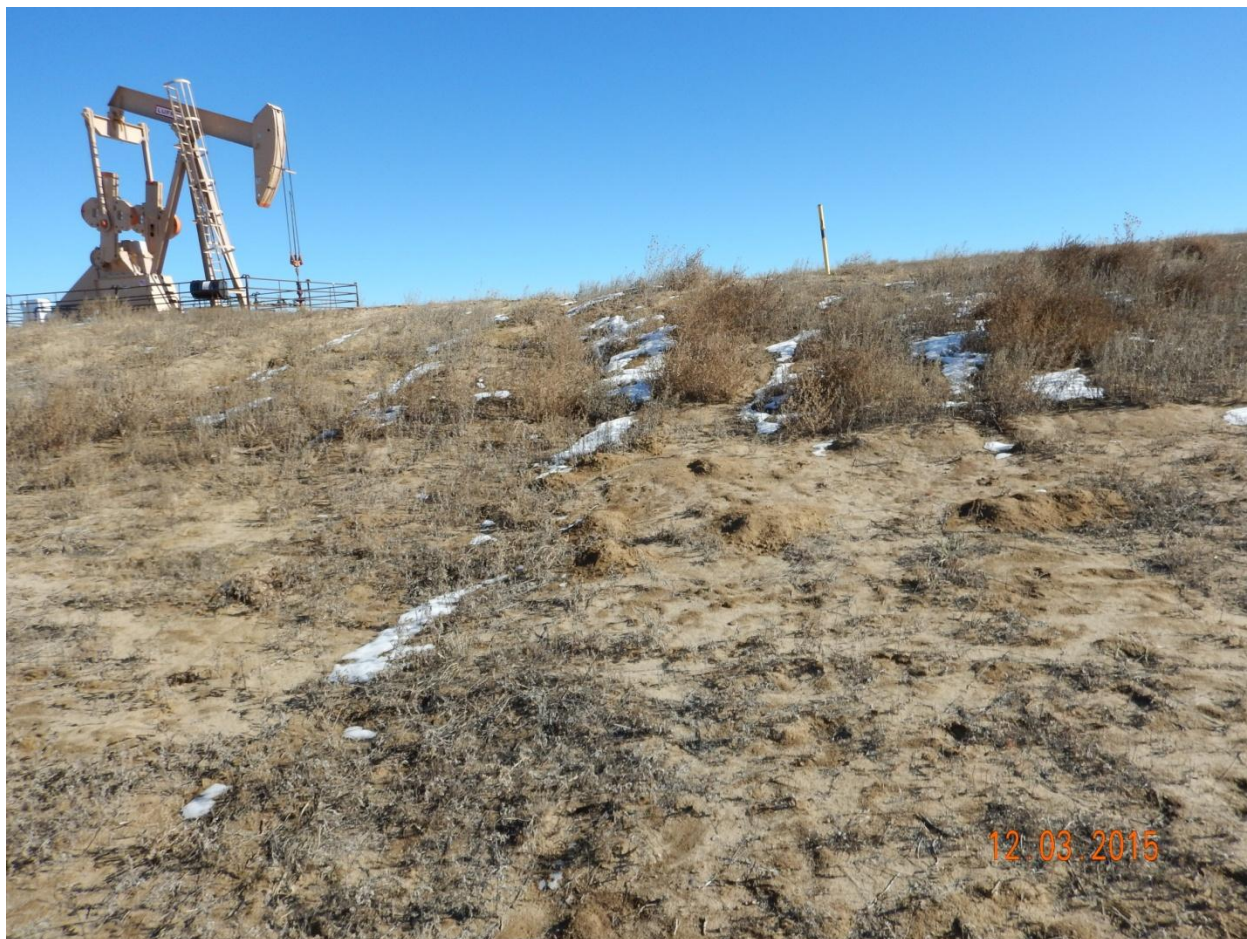
Figure 4 - View of drilling fluid leading west of well pad (looking east).

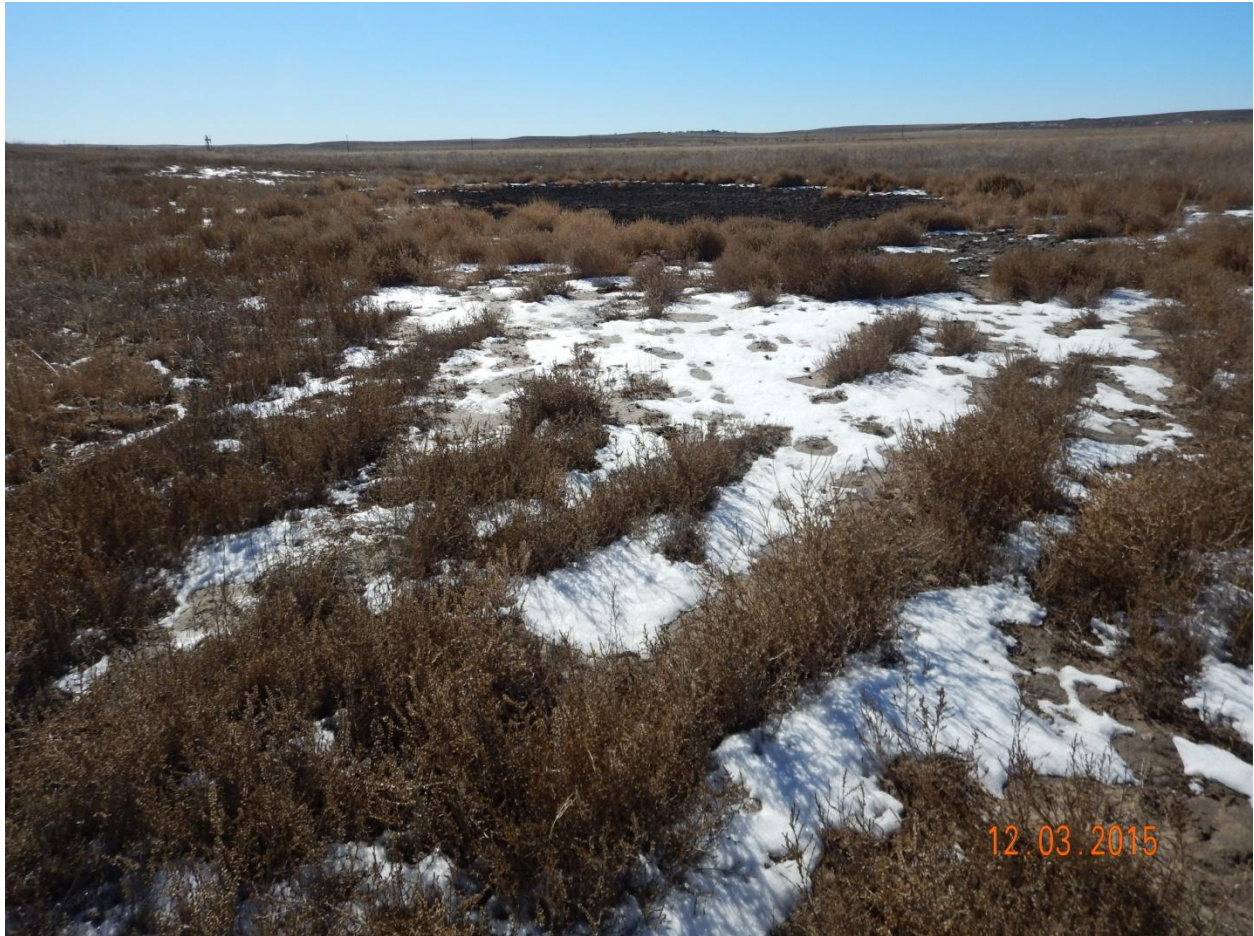
Figure 5 – View of bare soil and drilling fluid from northwest of pad (looking southeast).

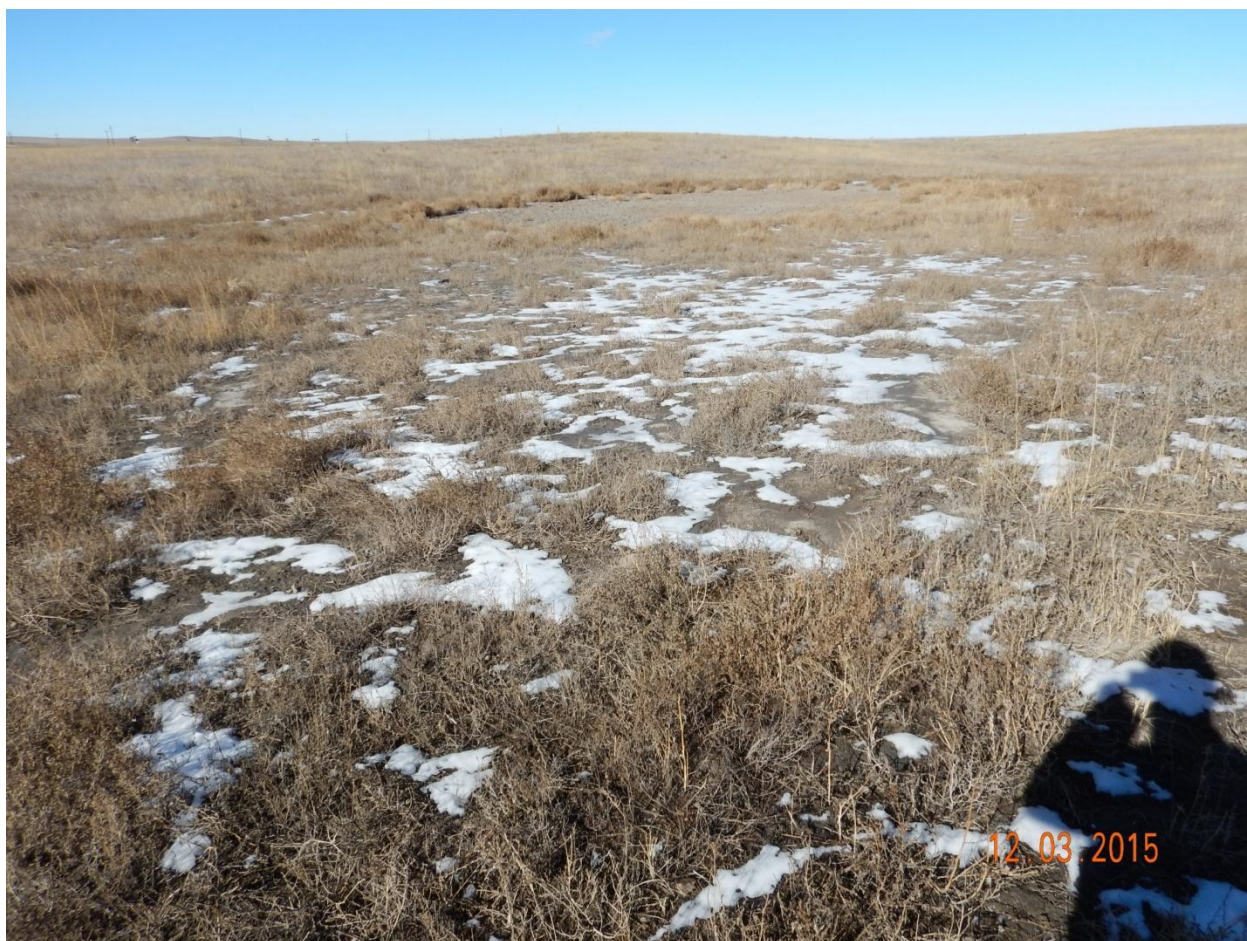
Figure 6 - View of bare soil, drilling fluid, and stressed vegetation southwest of pad, looking north-northwest.
