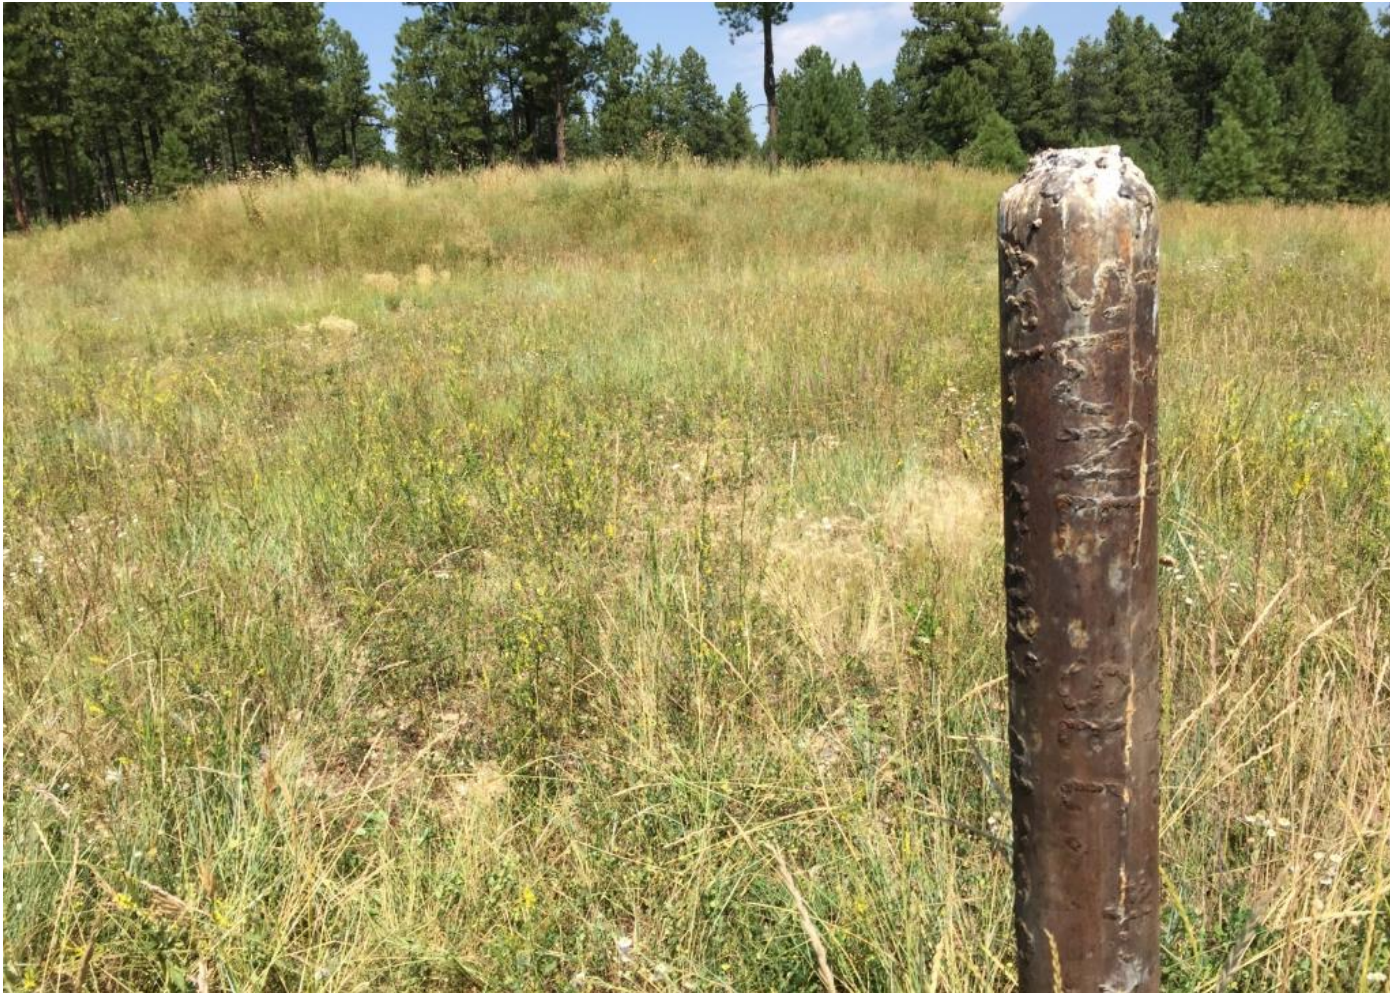
Photo 1. View from dry hole marker for 083-06388 on well pad facing northward. Stockpile of unknown material, approximately 8 feet tall and 70 feet long is present in the background.

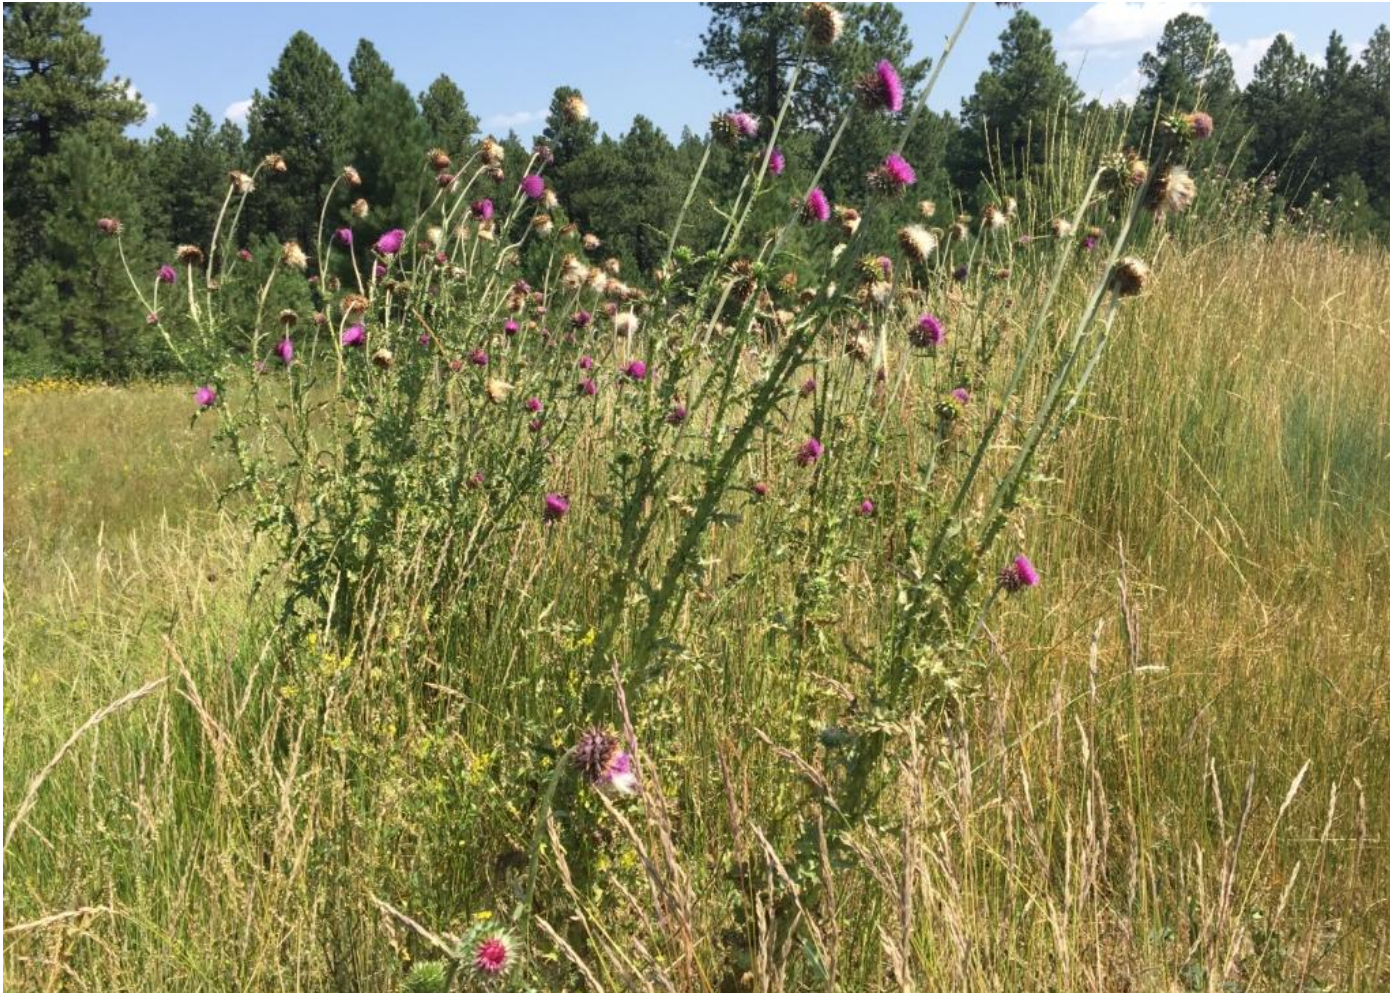
Photo 2. View of musk thistle (*Carduus nutans*) on well pad. Musk thistle needs to be controlled.

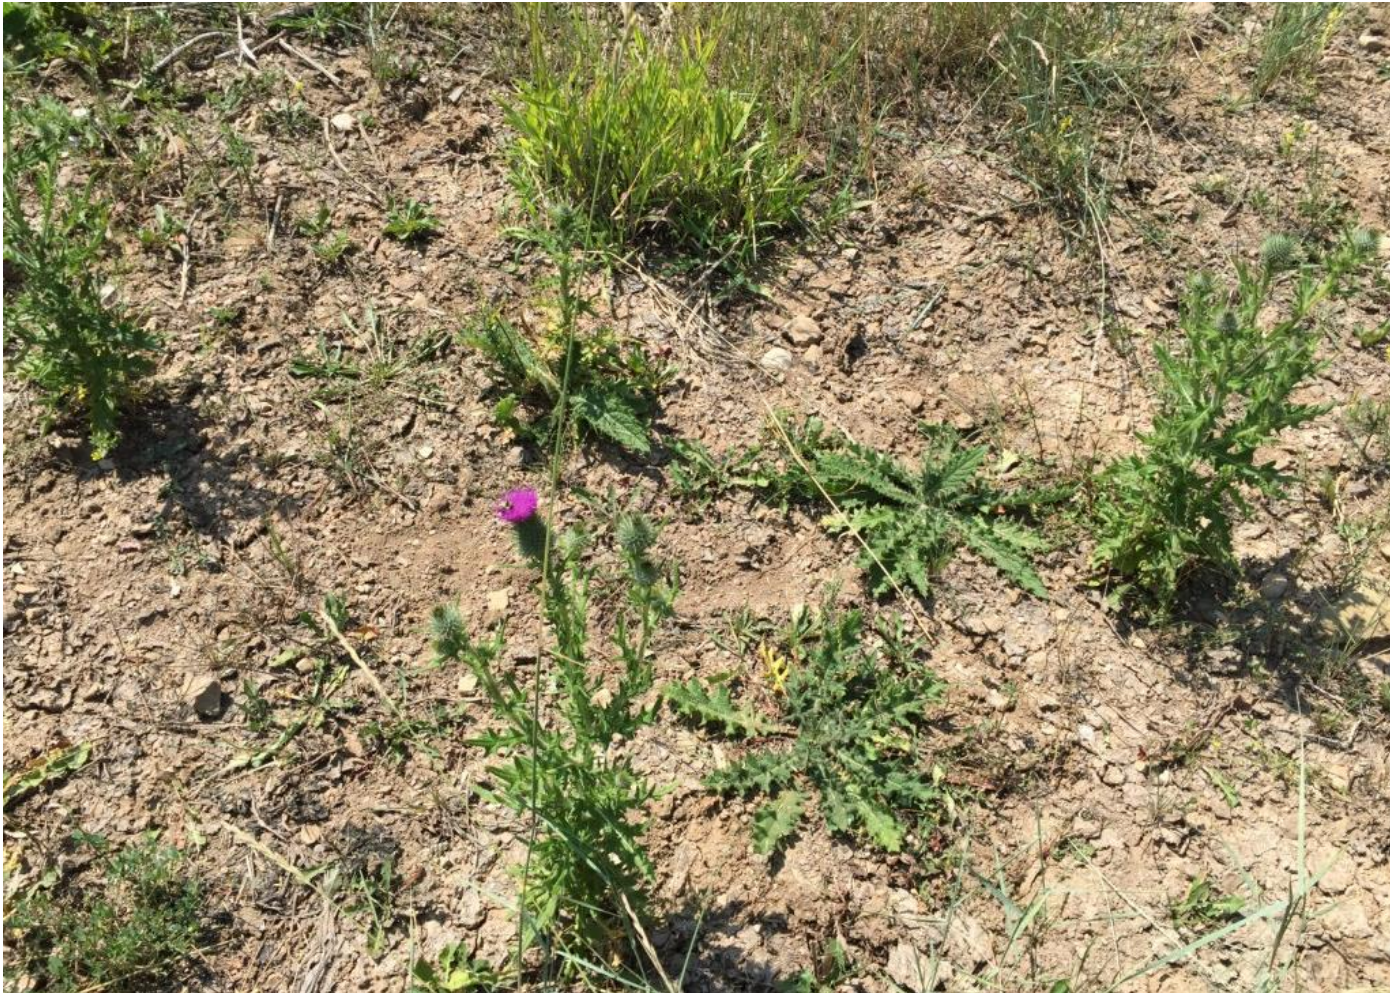
Photo 3. View of bull thistle (*Cirsium vulgare*) plants growing on the well pad. Bull thistle needs to be controlled.

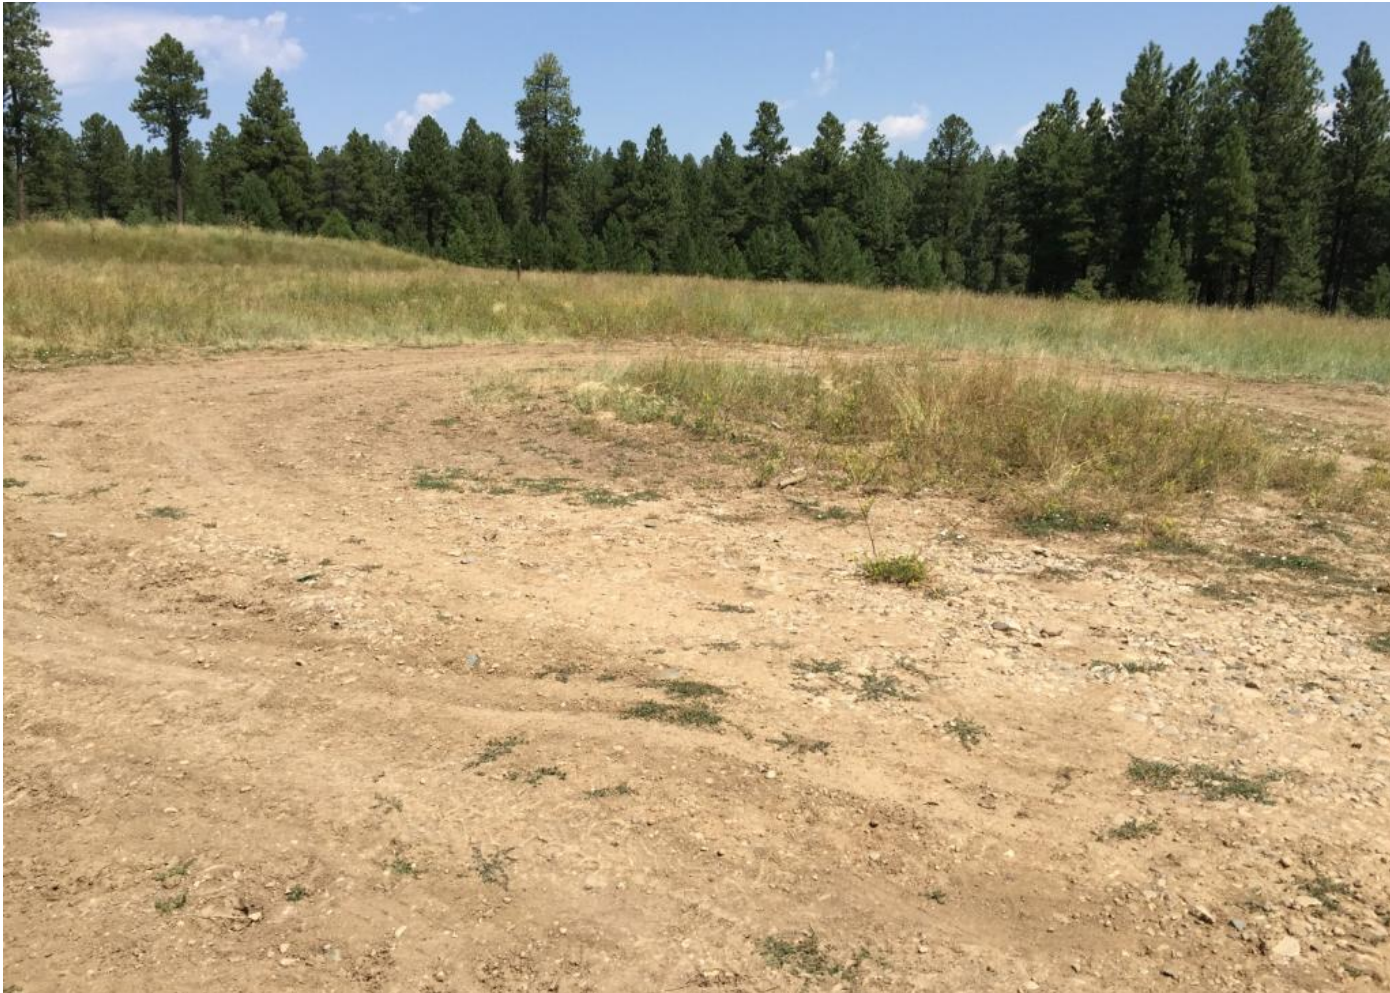
Photo 4. View of vehicle turnaround area on well pad surface. This area needs to be de-compacted to 18 inches and revegetated.

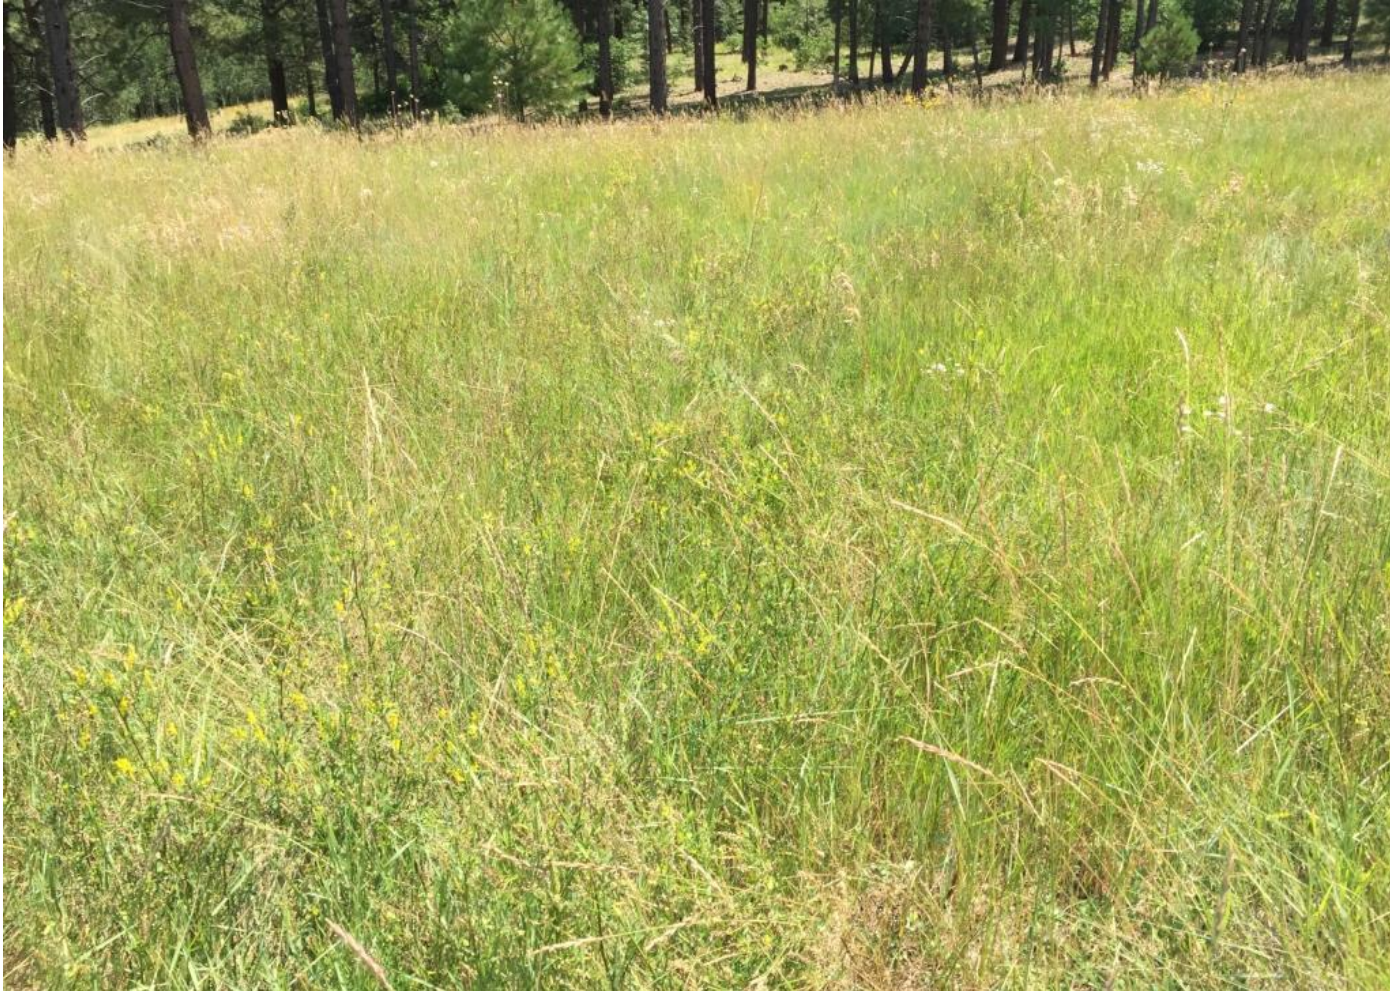
Photo 5. View of revegetation within the eastern portion of the project area. Dense grasses and forbs such as smooth brome (*Bromus inermis*), western wheatgrass (*Pascopyrum smithii*), and yellow sweetclover (*Melilotus officinalis*) are growing here.
