Interim Reclamation Inspection

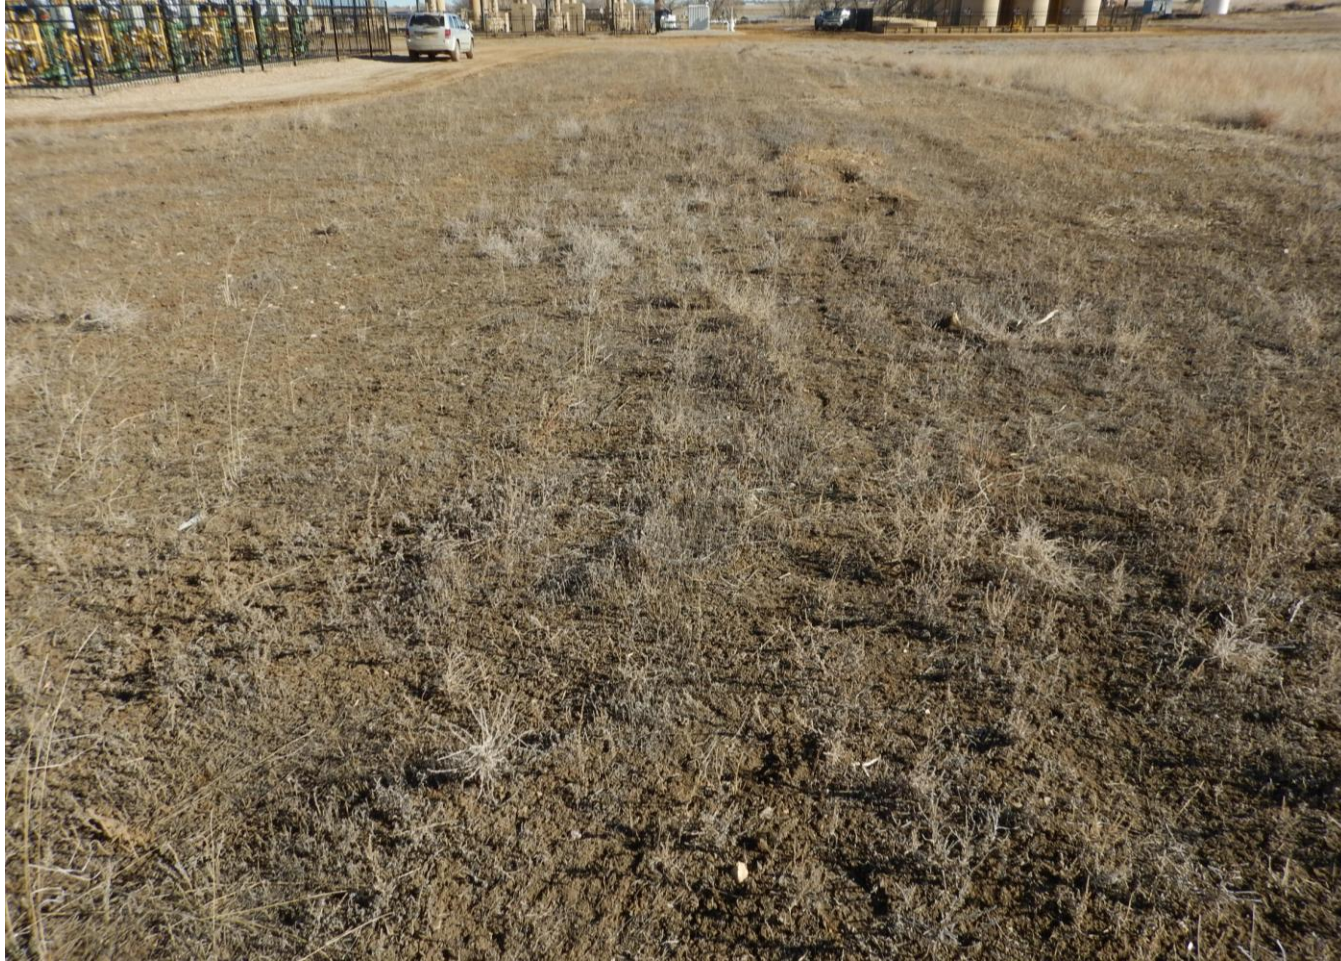
Photo 1. Photo taken from southwestern location, facing East. Kochia sp. and Russian thistle dominant vegetative growth inhabiting perennial vegetative establishment. Mechanical means (e.g. mowing) to control undesirable species (Kochia sp. and Russian thistle) is being performed.

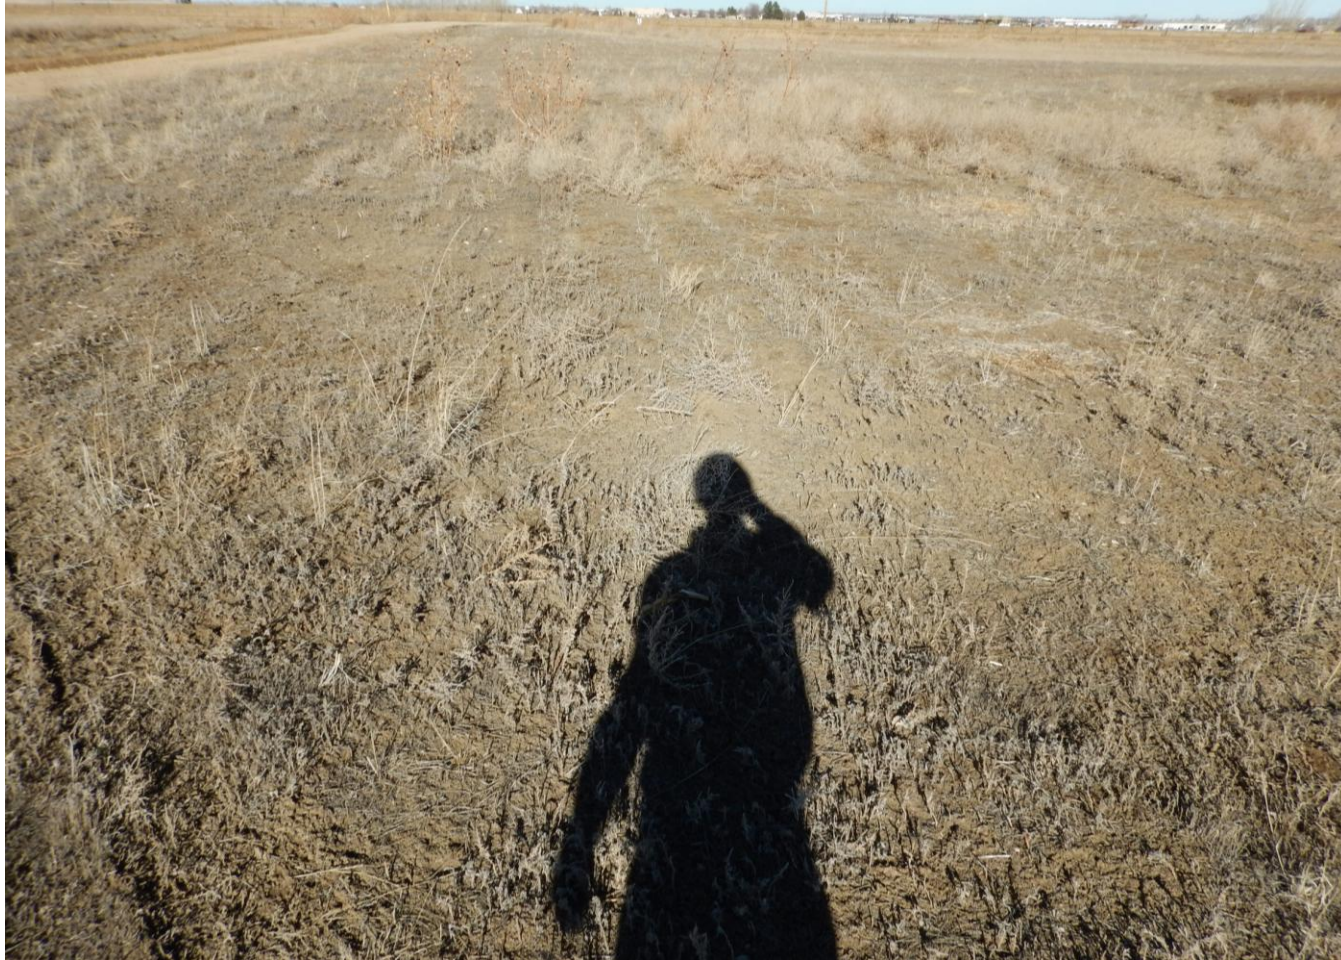
Photo 2. Photo taken from western location, facing North. Kochia sp. and Russian thistle dominant vegetative growth inhabiting perennial vegetative establishment. Mechanical means (e.g. mowing) to control undesirable species (Kochia sp. and Russian thistle) is being performed.

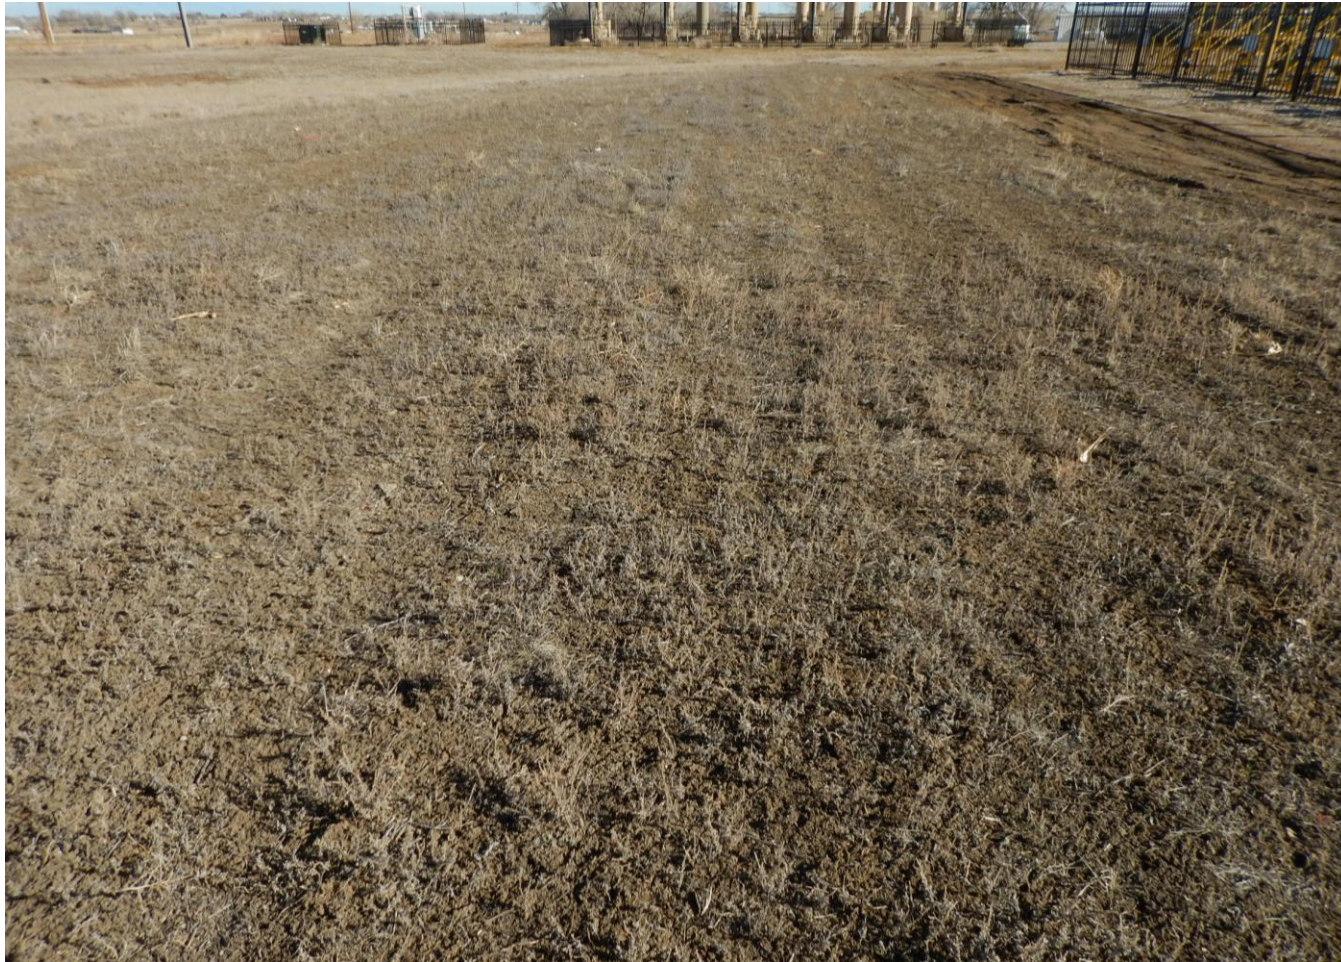
Photo 3. Photo taken from northern location, facing East. Kochia sp. and Russian thistle dominant vegetative growth inhabiting perennial vegetative establishment. Mechanical means (e.g. mowing) to control undesirable species (Kochia sp. and Russian thistle) is being performed.

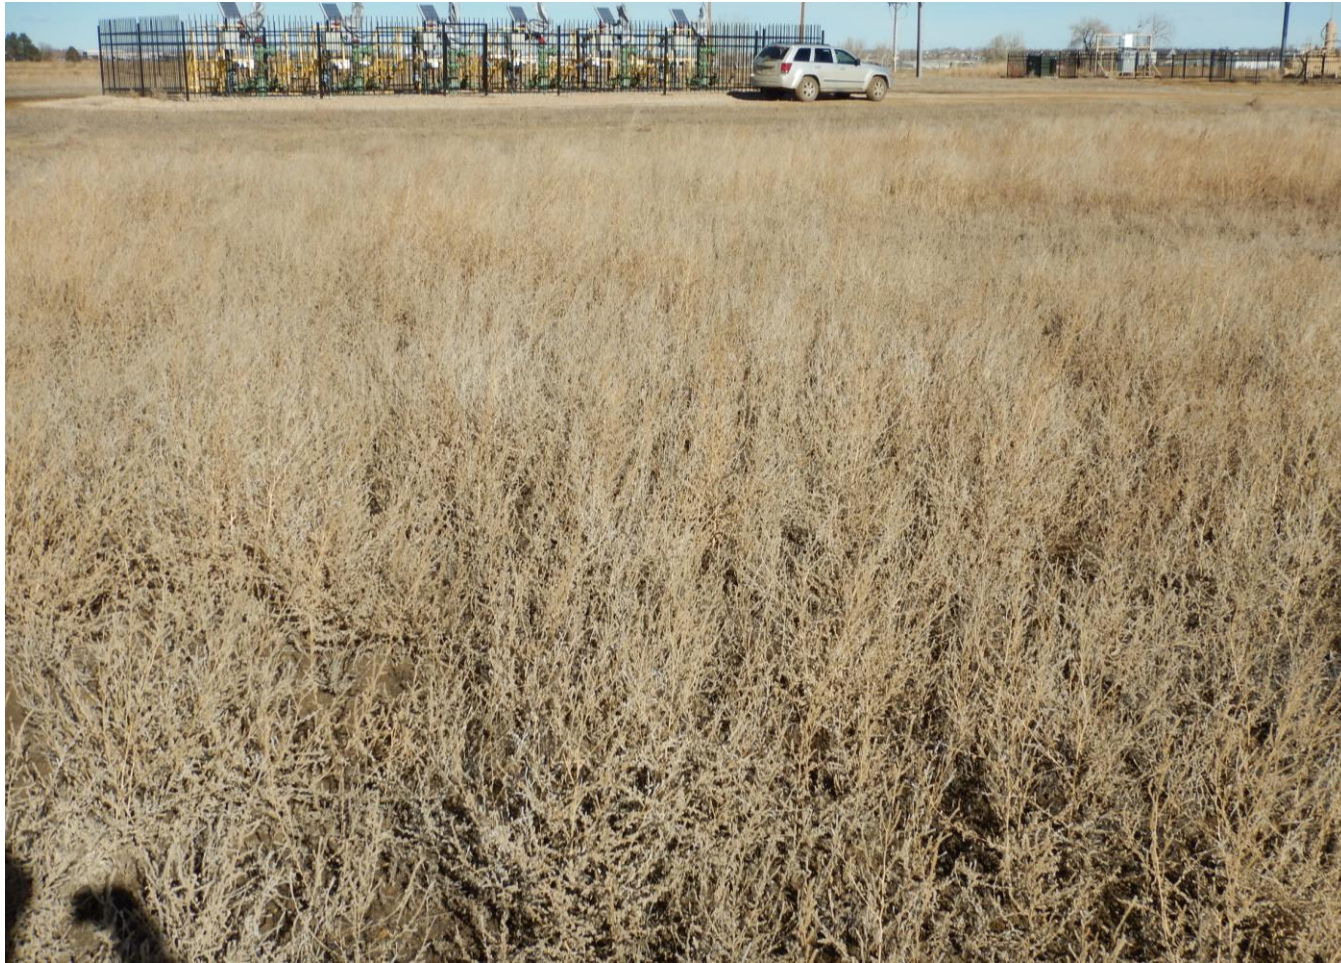
Photo 4. Photo taken from southern location, facing North. Kochia sp. and Russian thistle dominant vegetative growth inhabiting perennial vegetative establishment. This area should be managed (e.g. mow) to reduce undesirable seed sources onto the interim reclamation area.

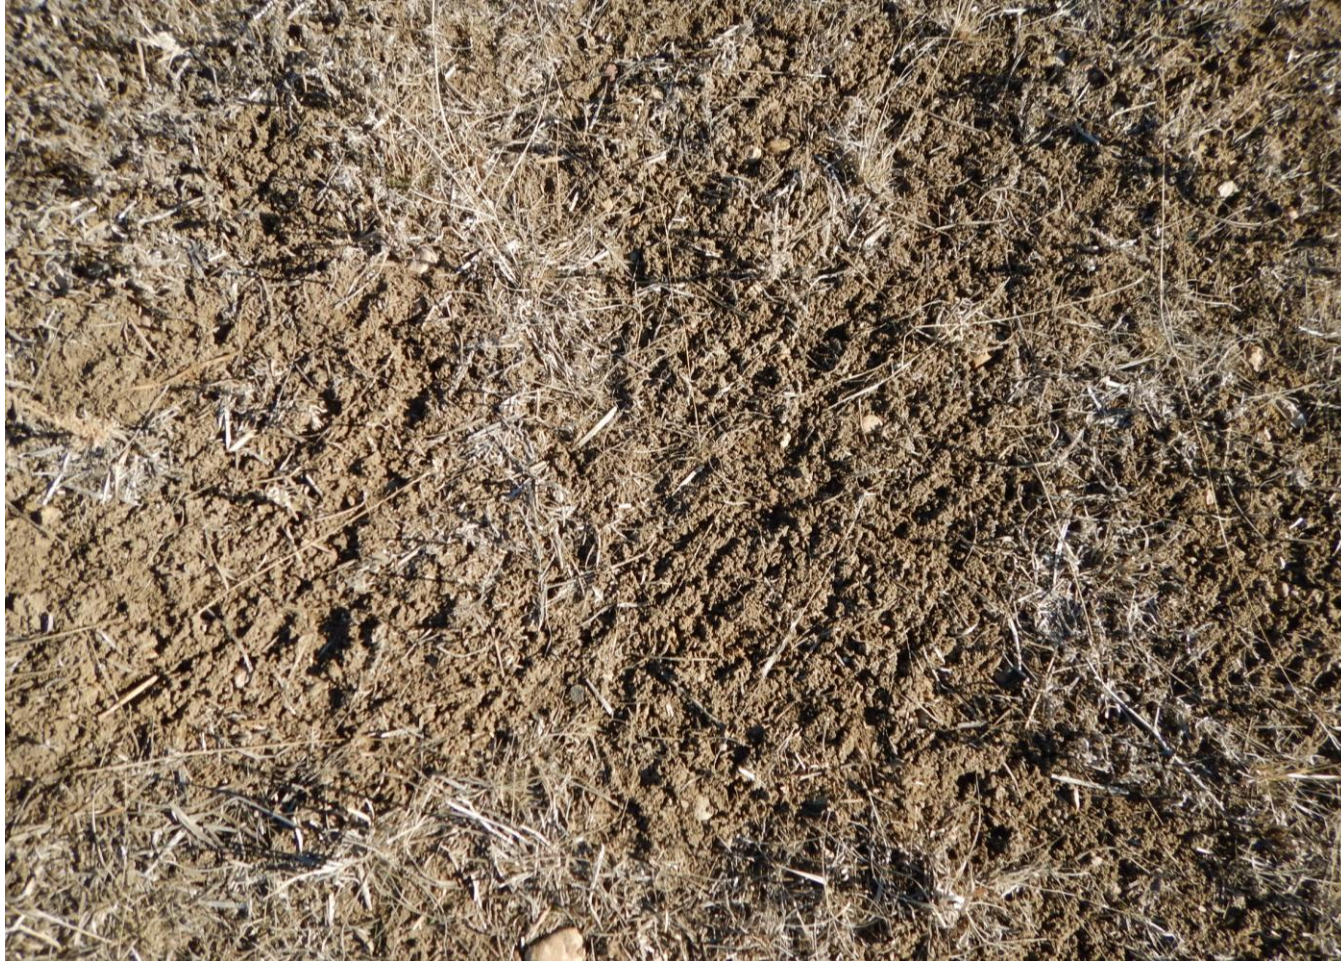
Photo 5. Photo taken from general interim reclamation area indicating lack of perennial vegetative growth.
