SITE INVESTIGATION AND REMEDIATION WORKPLAN

January 5, 2016

**RE: Excavation and Site Delineation Report and Proposed Remediation Strategy
Stroh 35-2 Tank Battery (436964)
Weld County, Colorado
Spill/Release Point #443097**

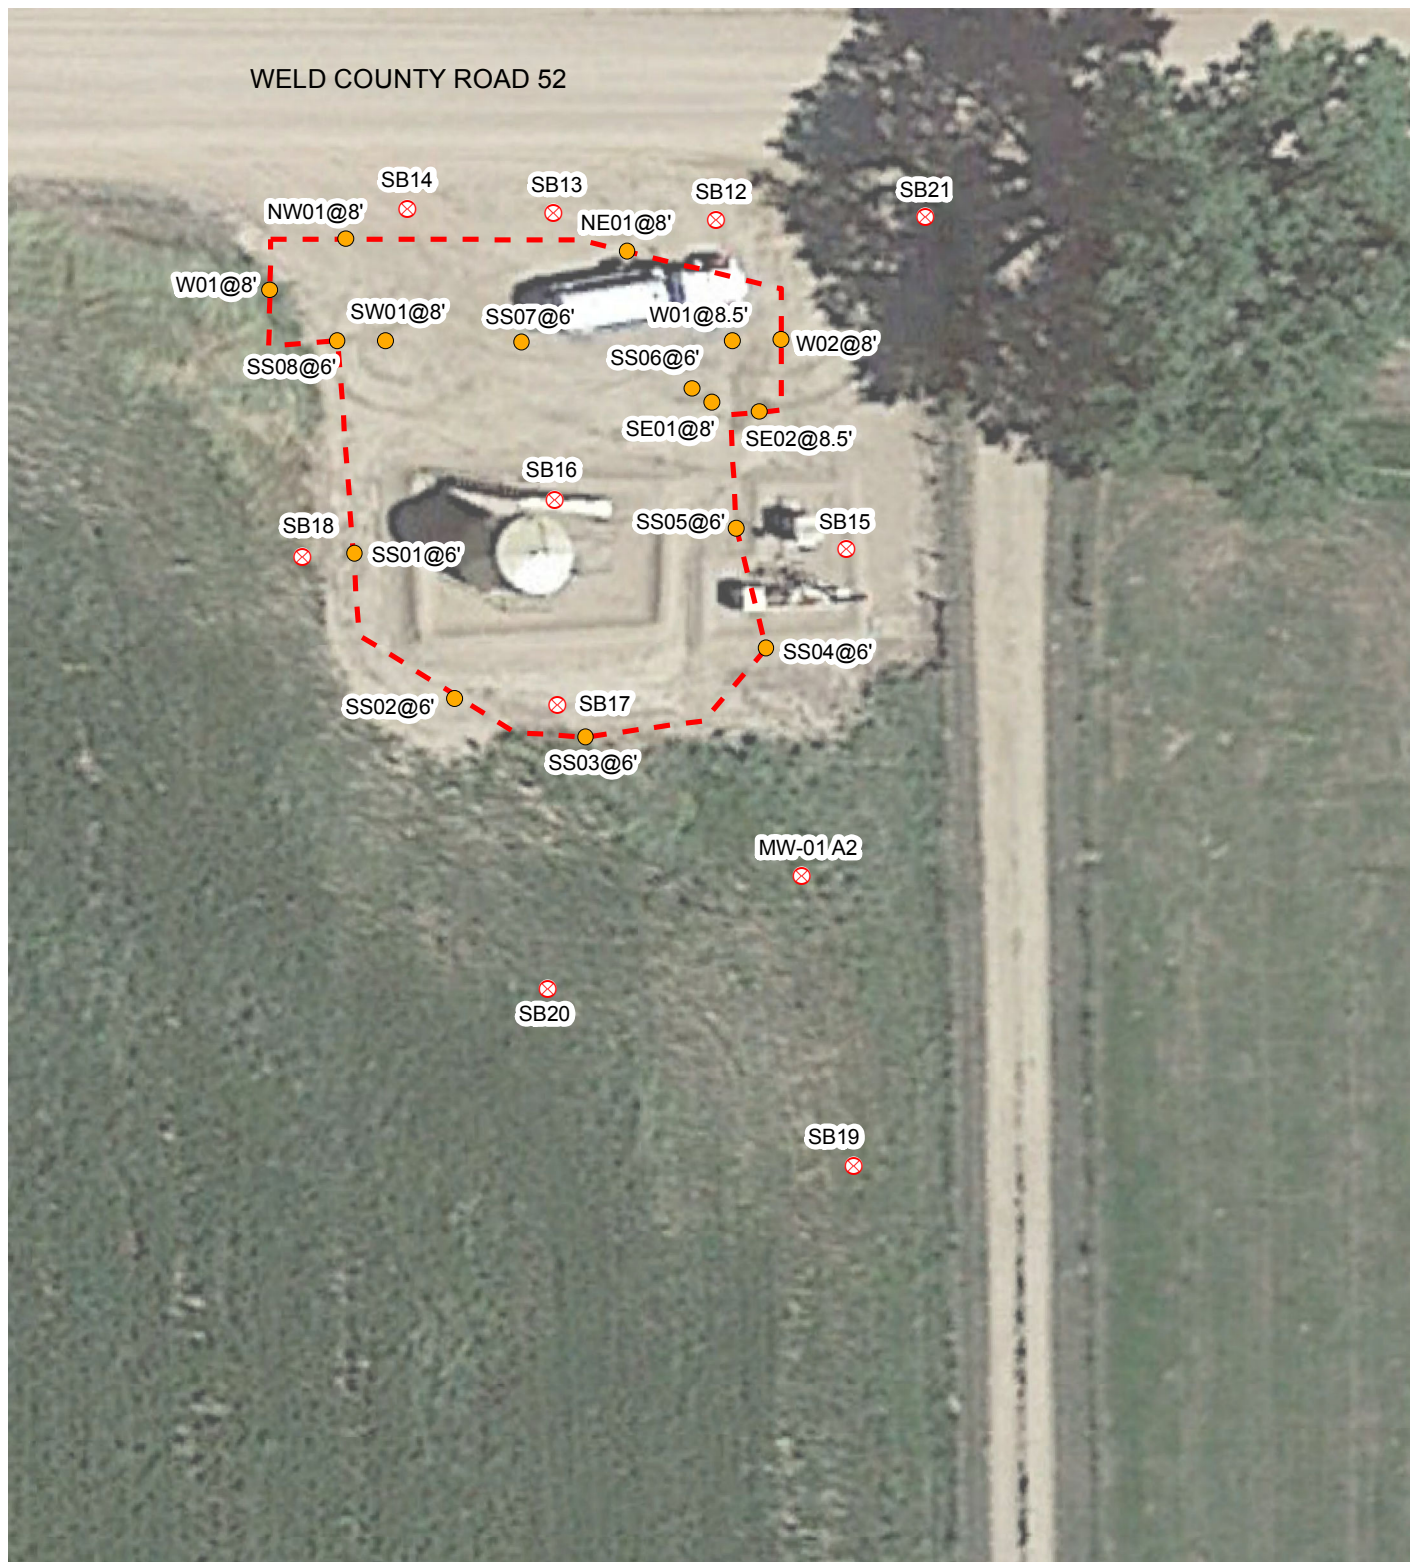
FIGURE 2
SITE MAP
STROH 35-2
WELD COUNTY, COLORADO
SYNERGY RESOURCES CORPORATION

The source removal excavation was located within the vicinity of the above ground production tank, the partially buried produced water vault, and the separator. These structures were moved to accommodate the excavation. The total extent of the excavation was approximately 70 feet east-west by 80 feet north-south to a total depth of 8 to 10 feet below ground surface (bgs). The limits of the excavation are provided in Figure 2. Excavated soil consisted primarily of clayey sand from ground surface to total depth with increasing clay content with depth. Groundwater was encountered at approximately 6 feet bgs. A total of approximately 2,100 cubic yards of soil were removed from the Site and transported under waste manifest protocol to Waste Management North Weld Landfill in Ault, Colorado, for final disposal.

Between September 4, 2015 and November 30, 2015, under the direction of Synergy, LTE personnel collected 15 discrete confirmation soil samples from the source removal excavation sidewalls. The soil samples were collected from zones with the highest PID readings or where there was evidence of hydrocarbon impacts including soil staining or hydrocarbon odors. The location of the confirmation soil samples are provided on Figure 2. All soil samples were collected, placed on ice, then submitted with a completed chain of custody form to eAnalytics Laboratory (eAnalytics) of Loveland, Colorado, for laboratory analysis of benzene, toluene, ethylbenzene, and total xylenes (BTEX) and total petroleum hydrocarbons (TPH) as gasoline range organics (GRO) by United States Environmental Protection Agency (EPA) Method 8260B, and TPH as diesel range organics (DRO) by EPA Method 8015.

LTE, under the direction of Synergy, continued source removal excavation of the areas where the confirmation soil samples exceeded the COGCC Table 910-1 standards for TPH and collected additional confirmation soil samples upon completion of the additional source removal from these areas. This process was continued until representative confirmation soil samples were below applicable standards.

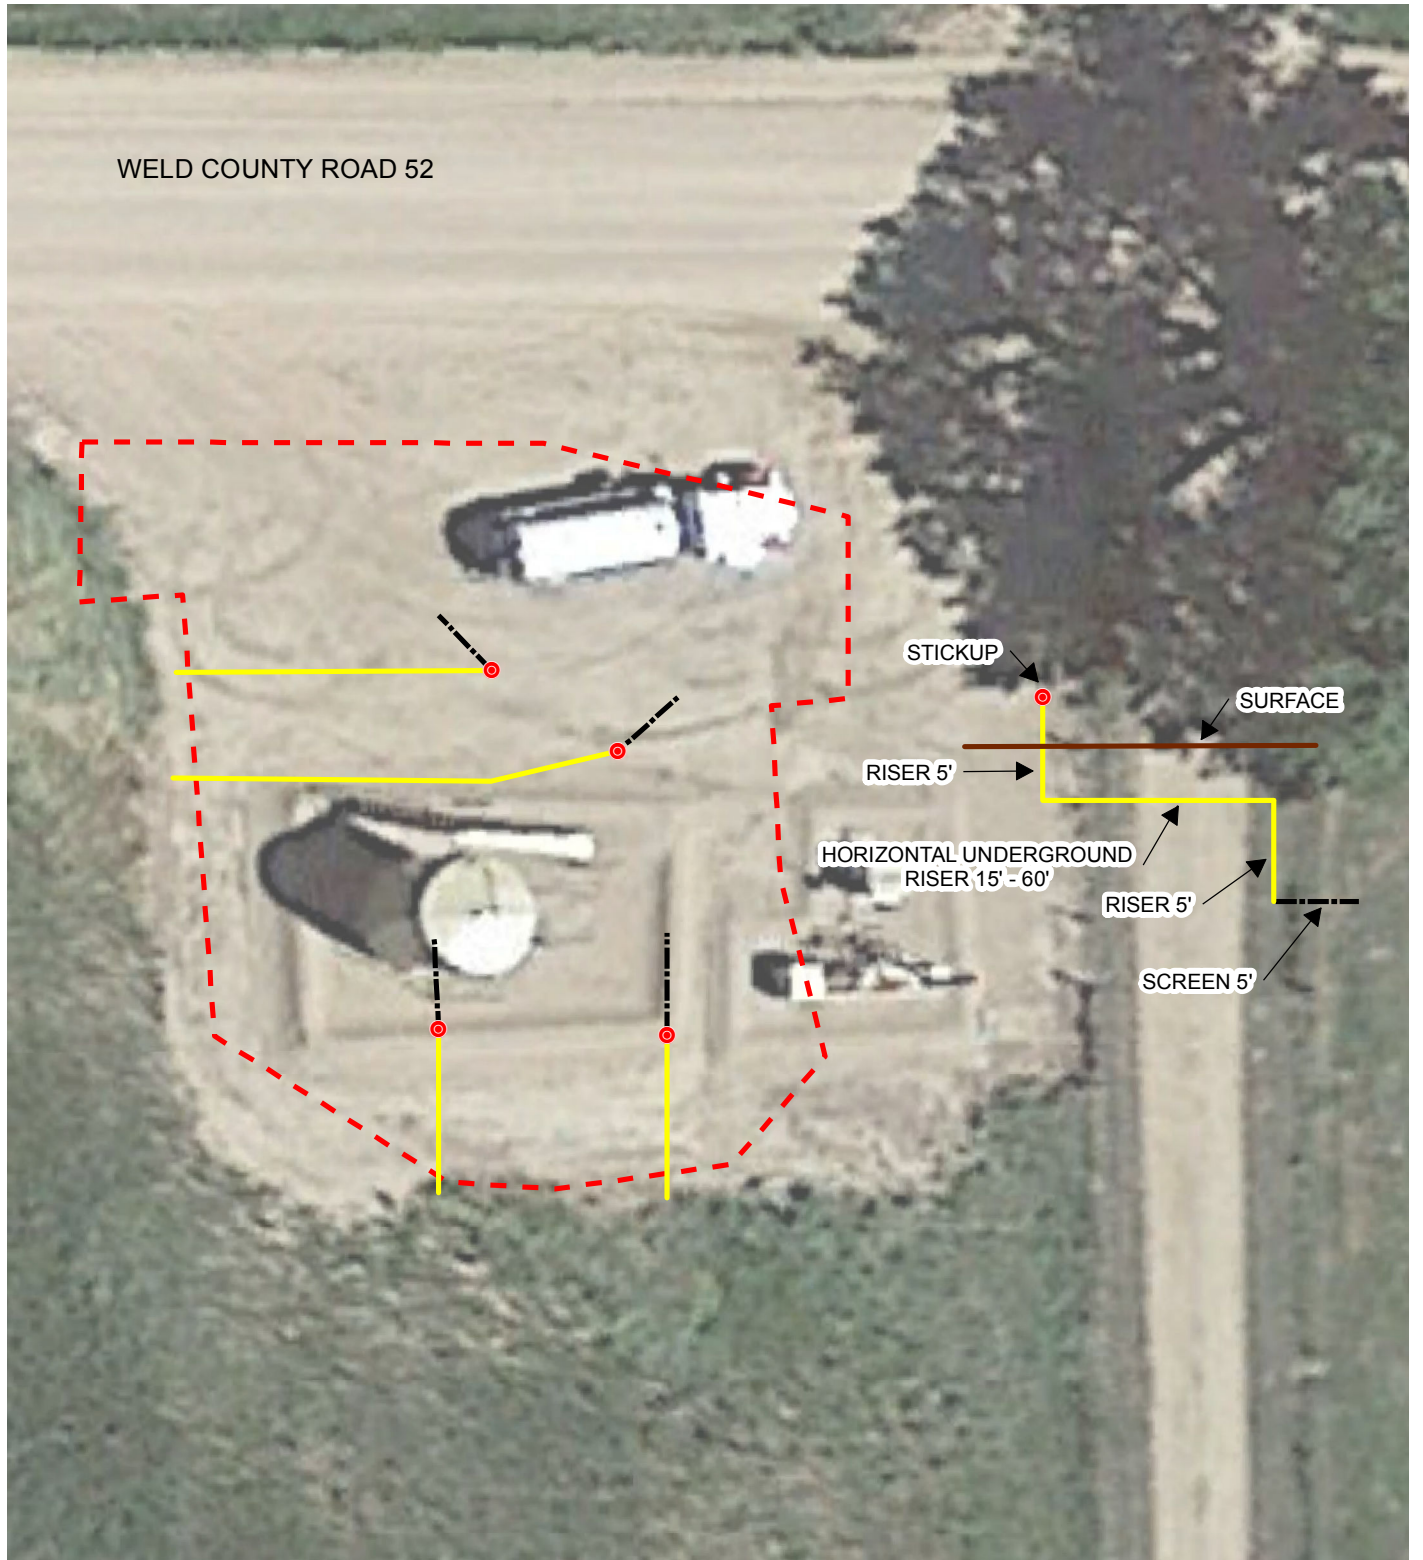
FIGURE 5
INFILTRATION GALLERY
STROH 35-2
WELD COUNTY, COLORADO

LTE, under the direction of Synergy, oversaw the installation of an infiltration gallery in the open excavation prior to backfilling. The infiltration gallery was installed to allow for future treatment of the source area without requiring excessive surface disturbance and subcontractor efforts. The infiltration gallery is comprised of 2-inch diameter, schedule 40, polyvinyl chloride (PVC) pipes with 0.01-inch milled slots (screened zone). The screened zone was installed, laterally, along the bottom of the excavation approximately 2 feet below the top of the groundwater. Pea gravel comprised of ¼-inch minus gravel with less than 10% fines was used for bedding and backfill. Riser pipes connect the screened zone to the surface. The excavation was backfilled with pea gravel from the base of the excavation to approximately 5 feet bgs. Native soil material was placed on top of the pea gravel to ground surface. Figure 5 illustrates the approximate location of the infiltration gallery and construction specifications.

Trap & Treat[®] BOS 200[®] (BOS 200) is a groundwater amendment used for *in-situ* hydrocarbon remediation. It is comprised of activated carbon combined with petroleum-degrading microorganisms and electron acceptors such as nitrogen and phosphorous. The purpose of adding the BOS 200 product to groundwater is to promote biologically dedicated benzene oxidation reactions in the impacted groundwater. In order to remediate the dissolved phase impact, LTE proposes to perform batch injections of the BOS 200 slurry into the infiltration galleries. LTE, on behalf of Synergy, will continue to perform quarterly groundwater monitoring at the Site until 4 quarters of groundwater samples are below applicable COGCC standards.

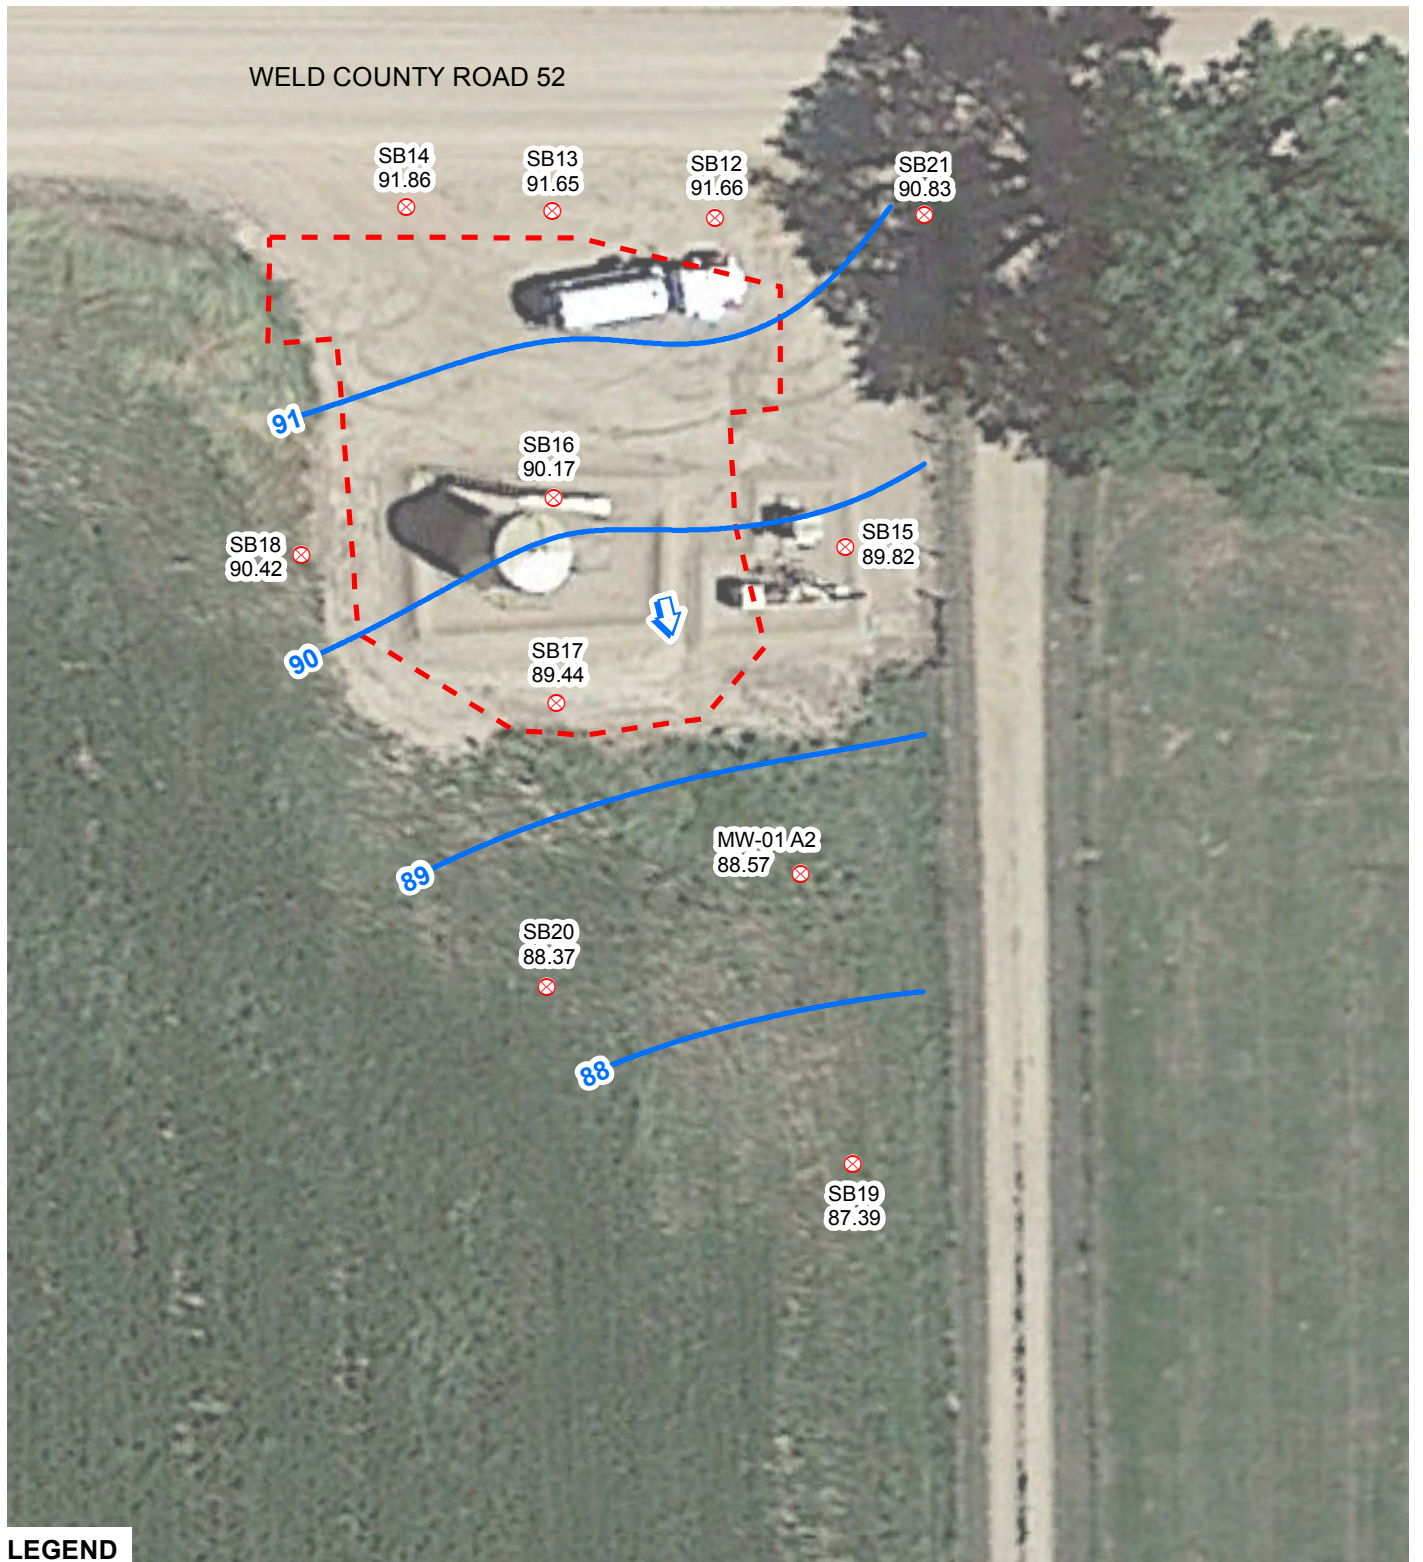
FIGURE 6
RELATIVE GROUNDWATER ELEVATION MAP
STROH 35-2
WELD COUNTY, COLORADO

Prior to well development, depth to groundwater was measured and recorded to calculate groundwater elevations. During the October 2015 monitoring event, depth to groundwater ranged from 5.60 feet bgs in monitoring well SB20 to 8.25 feet bgs in monitoring well SB21. Groundwater was calculated to flow southeast with an average hydraulic gradient of 0.027 feet per foot. Relative groundwater elevations are presented in Figure 6 and summarized in Table 2.

RELATIVE GROUNDWATER ELEVATION CONTOUR
CONTOUR INTERVAL = 1 FOOT
GRADIENT = 0.027 FEET/FOOT
-

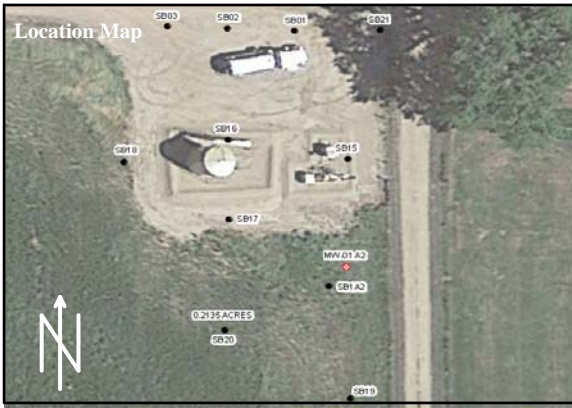
BORING LOG/MONITORING WELL COMPLETION DIAGRAM

LOGGED BY: Dan Hosler
SAMPLE MTHD: Continuous
DRILL MTHD: Direct Push
DRILLED BY: Elite Drilling
DETECTOR: UltraRae 3000
FILTER PACK: 10-20 silica sand
ANNULUS SEAL: Bentonite chips
SURFACE SEAL: Concrete

PID (ppm)	Staining	Moisture Content	Sample ID	Recovery (ft/ft)	Depth (ft)	USCS	USCS Graphic	Lithology Description	Well Construction
		Dry			0	CL		CL: CLAY - 0.0' - 4.0' - silty, brown, dry to moist, no odor, no staining, silt content increases with depth, moist at 2' bgs	
0.00							4.0' - 8.0' - No recovery		
0.00		Wet	SB12 @ 8.0'		5	ML		ML: SILT - 8.0' - 15.0' - sandy, brown, little clay, wet, no odor, no staining, clay content increases with depth	
0.00					10				
0.00					15

The soil borings were logged by an LTE geologist, and the soil was characterized by visual inspection of the collected soil samples. The total depth of each soil boring was between 14 and 15 feet bgs. The soil borings were continuously logged from ground surface to the total depth. The estimated depth to groundwater observed in the soil borings ranged from approximately 5 to 8 feet bgs.

The soil identified at the Site was predominantly silty clay and clayey sand from ground surface to between approximately 8 to 14 feet bgs, and silt to total depth. Elevated PID readings (greater than 10 parts per million) were observed in soil borings SB01, SB03, SB04, and SB05. Petroleum hydrocarbon staining was observed in soil borings SB15, SB16, SB17, and SB19. The soil boring and groundwater monitoring well completion logs are provided as Attachment 3.

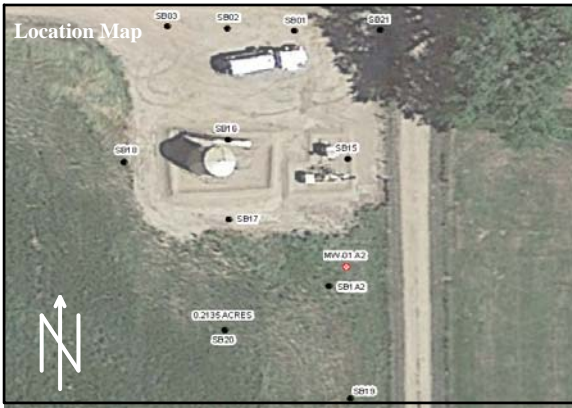
BORING LOG/MONITORING WELL COMPLETION DIAGRAM

HOLE DIAMETER.: 2.25"
WELL DIAMETER: 1.0"
CASING TYPE: PVC
SCREEN TYPE: PVC

PID (ppm)	Staining	Moisture Content	Sample ID	Recovery (ft/ft)	Depth (ft)	USCS	USCS Graphic	Lithology Description	Well Construction
		Dry			0	Road Base		Road Base: 0.0' - 1.0' - road base	
0.00						CL		CL: CLAY - 1.0' - 7.0' - silty, brown, dry to moist, no odor, no staining, clay content increases with depth, moist at 2' bgs	
0.00					5				
0.00		Wet	SB13 @ 7.0'			ML		ML: SILT - 7.0' - 15.0' - sandy, brown, some clay, wet, no odor, no staining, clay content varies with depth	
0.00					10				
0.00					15

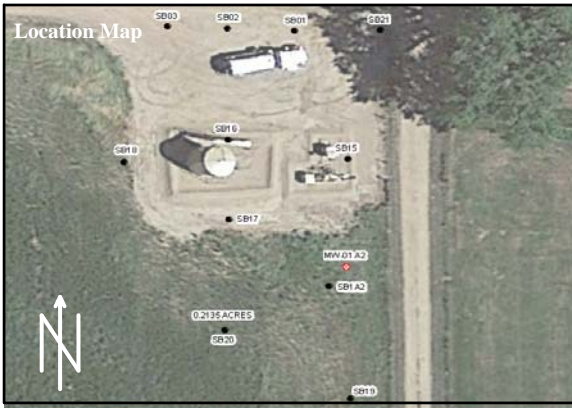
BORING LOG/MONITORING WELL COMPLETION DIAGRAM

LOGGED BY: Dan Hosler
SAMPLE MTHD: Continuous
DRILL MTHD: Direct Push
DRILLED BY: Elite Drilling
DETECTOR: UltraRae 3000
FILTER PACK: 10-20 silica sand
ANNULUS SEAL: Bentonite chips
SURFACE SEAL: Concrete

PID (ppm)	Staining	Moisture Content	Sample ID	Recovery (ft/ft)	Depth (ft)	USCS	USCS Graphic	Lithology Description	Well Construction
		Dry			0	CL		CL: CLAY - 0.0' - 5.0' - silty, brown, dry to moist, no odor, no staining, clay content increases with depth, moist at 2' bgs	
		Wet	SB14 @ 5.0'		5	ML		ML: SILT - 5.0' - 14.5' - sandy, brown, little clay, wet, no odor, no staining, clay content varies with depth	
		Wet			15	CL		CL: CLAY - 14.5' - 15.0' - silty, brown, wet, no odor, no staining

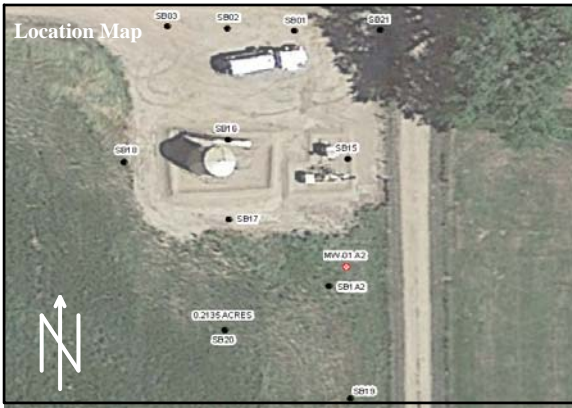
BORING LOG/MONITORING WELL COMPLETION DIAGRAM

HOLE DIAMETER.: 2.25"
WELL DIAMETER: 1.0"
CASING TYPE: PVC
SCREEN TYPE: PVC

PID (ppm)	Staining	Moisture Content	Sample ID	Recovery (ft/ft)	Depth (ft)	USCS	USCS Graphic	Lithology Description	Well Construction
0.00		Dry			0	SC		SC: SAND - 0.0' - 12.0' - fine grained, clayey, brown, dry to moist, no odor, no staining, Wet at 5' bgs, decrease in clay content with depth	
4.60		Wet	SB15 @ 5.0'		5				
0.00					10	ML		ML: SILT - 12.0' - 14.0' - sandy, olive gray, little clay, wet, no odor, hydrocarbon staining

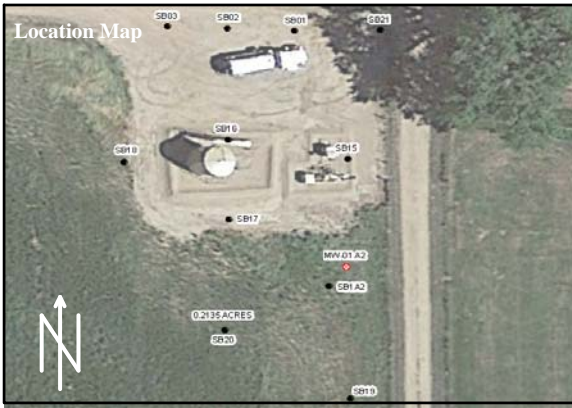
BORING LOG/MONITORING WELL COMPLETION DIAGRAM

HOLE DIAMETER.: 2.25"
WELL DIAMETER: 1.0"
CASING TYPE: PVC
SCREEN TYPE: PVC

PID (ppm)	Staining	Moisture Content	Sample ID	Recovery (ft/ft)	Depth (ft)	USCS	USCS Graphic	Lithology Description	Well Construction
		Dry			0	SC		SC: SAND - 0.0' - 11.0' - fine grained, clayey, brown, dry to moist, no odor, no staining, wet at 5' bgs, decrease in clay content with depth, little recovery 2" fine to coarse grained sand lense at 5' bgs	
		Wet	SB18 @ 5.0'		5				
					10	ML		ML: SILT - 11.0' - 14.0' - sandy, olive gray, little clay, wet, no odor, no staining

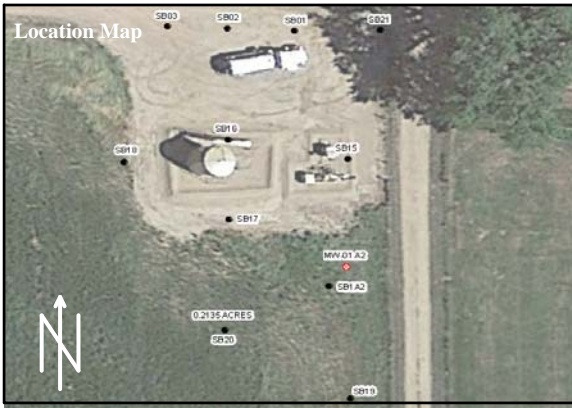
BORING LOG/MONITORING WELL COMPLETION DIAGRAM

HOLE DIAMETER.: 2.25"
WELL DIAMETER: 1.0"
CASING TYPE: PVC
SCREEN TYPE: PVC

PID (ppm)	Staining	Moisture Content	Sample ID	Recovery (ft/ft)	Depth (ft)	USCS	USCS Graphic	Lithology Description	Well Construction
0.00		Dry			0	SC		SC: SAND - 0.0' - 11.0' - fine grained, clayey, brown, dry to moist, no odor, no staining, wet at 5' bgs, decrease in clay content with depth	
0.00		Wet	SB19 @ 5.0'		5				
29.10					10				
984.40						ML		ML: SILT - 11.0' - 13.0' - sandy, brown, little clay, wet, no odor, no staining, slight stain and odor at 11'-12' bgs	
0.00		Wet				SC		SC: SAND - 13.0' - 14.0' - fine grained, clayey, brown, wet, no odor, no staining

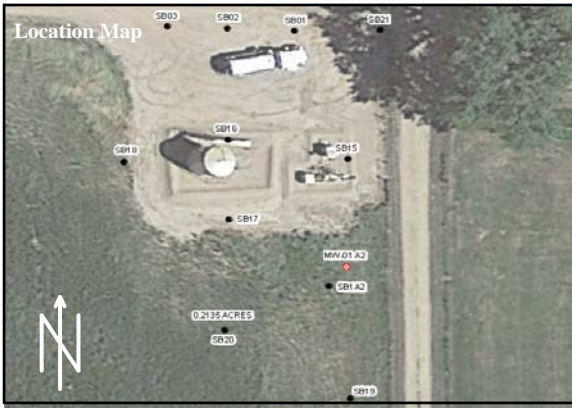
BORING LOG/MONITORING WELL COMPLETION DIAGRAM

LOGGED BY: Dan Hosler
SAMPLE MTHD: Continuous
DRILL MTHD: Direct Push
DRILLED BY: Elite Drilling
DETECTOR: UltraRae 3000
FILTER PACK: 10-20 silica sand
ANNULUS SEAL: Bentonite chips
SURFACE SEAL: NA

PID (ppm)	Staining	Moisture Content	Sample ID	Recovery (ft/ft)	Depth (ft)	USCS	USCS Graphic	Lithology Description	Well Construction
		Dry			0	SC		SC: SAND - 0.0' - 11.0' - fine grained, clayey, brown, dry to moist, no odor, no staining, wet at 5' bgs, decrease in clay content with depth	
17.00									
119.10		Wet	SB20 @ 5.0'		5				
0.00									
0.00									
0.00					10				
13.40						ML		ML: SILT - 11.0' - 13.0' - sandy, olive gray, little clay, wet, no odor, no staining	
894.00		Wet							
78.6						SC		SC: SAND - 13.0' - 14.0' - fine grained, clayey, brown, wet, no odor, no staining

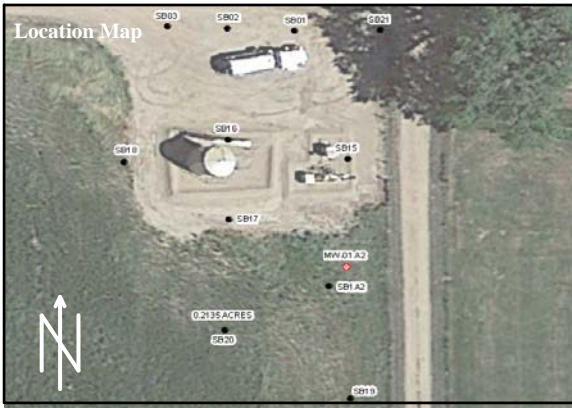
BORING LOG/MONITORING WELL COMPLETION DIAGRAM

PID (ppm)	Staining	Moisture Content	Sample ID	Recovery (ft/ft)	Depth (ft)	USCS	USCS Graphic	Lithology Description	Well Construction
		Dry			0	SC		SC: SAND - 0.0' - 13.0' - fine grained, clayey, brown, dry to moist, no odor, no staining, wet at 5' bgs, decrease in clay content with depth	
		Wet	SB21 @ 5.0'		5				
					10	ML		ML: SILT - 13.0' - 14.0' - sandy, brown, little clay, wet, no odor, no staining
