Interim Reclamation Inspection

Operator: Whiting Oil and Gas

Location ID: 430313

NWSW Section 27 T10N R58W

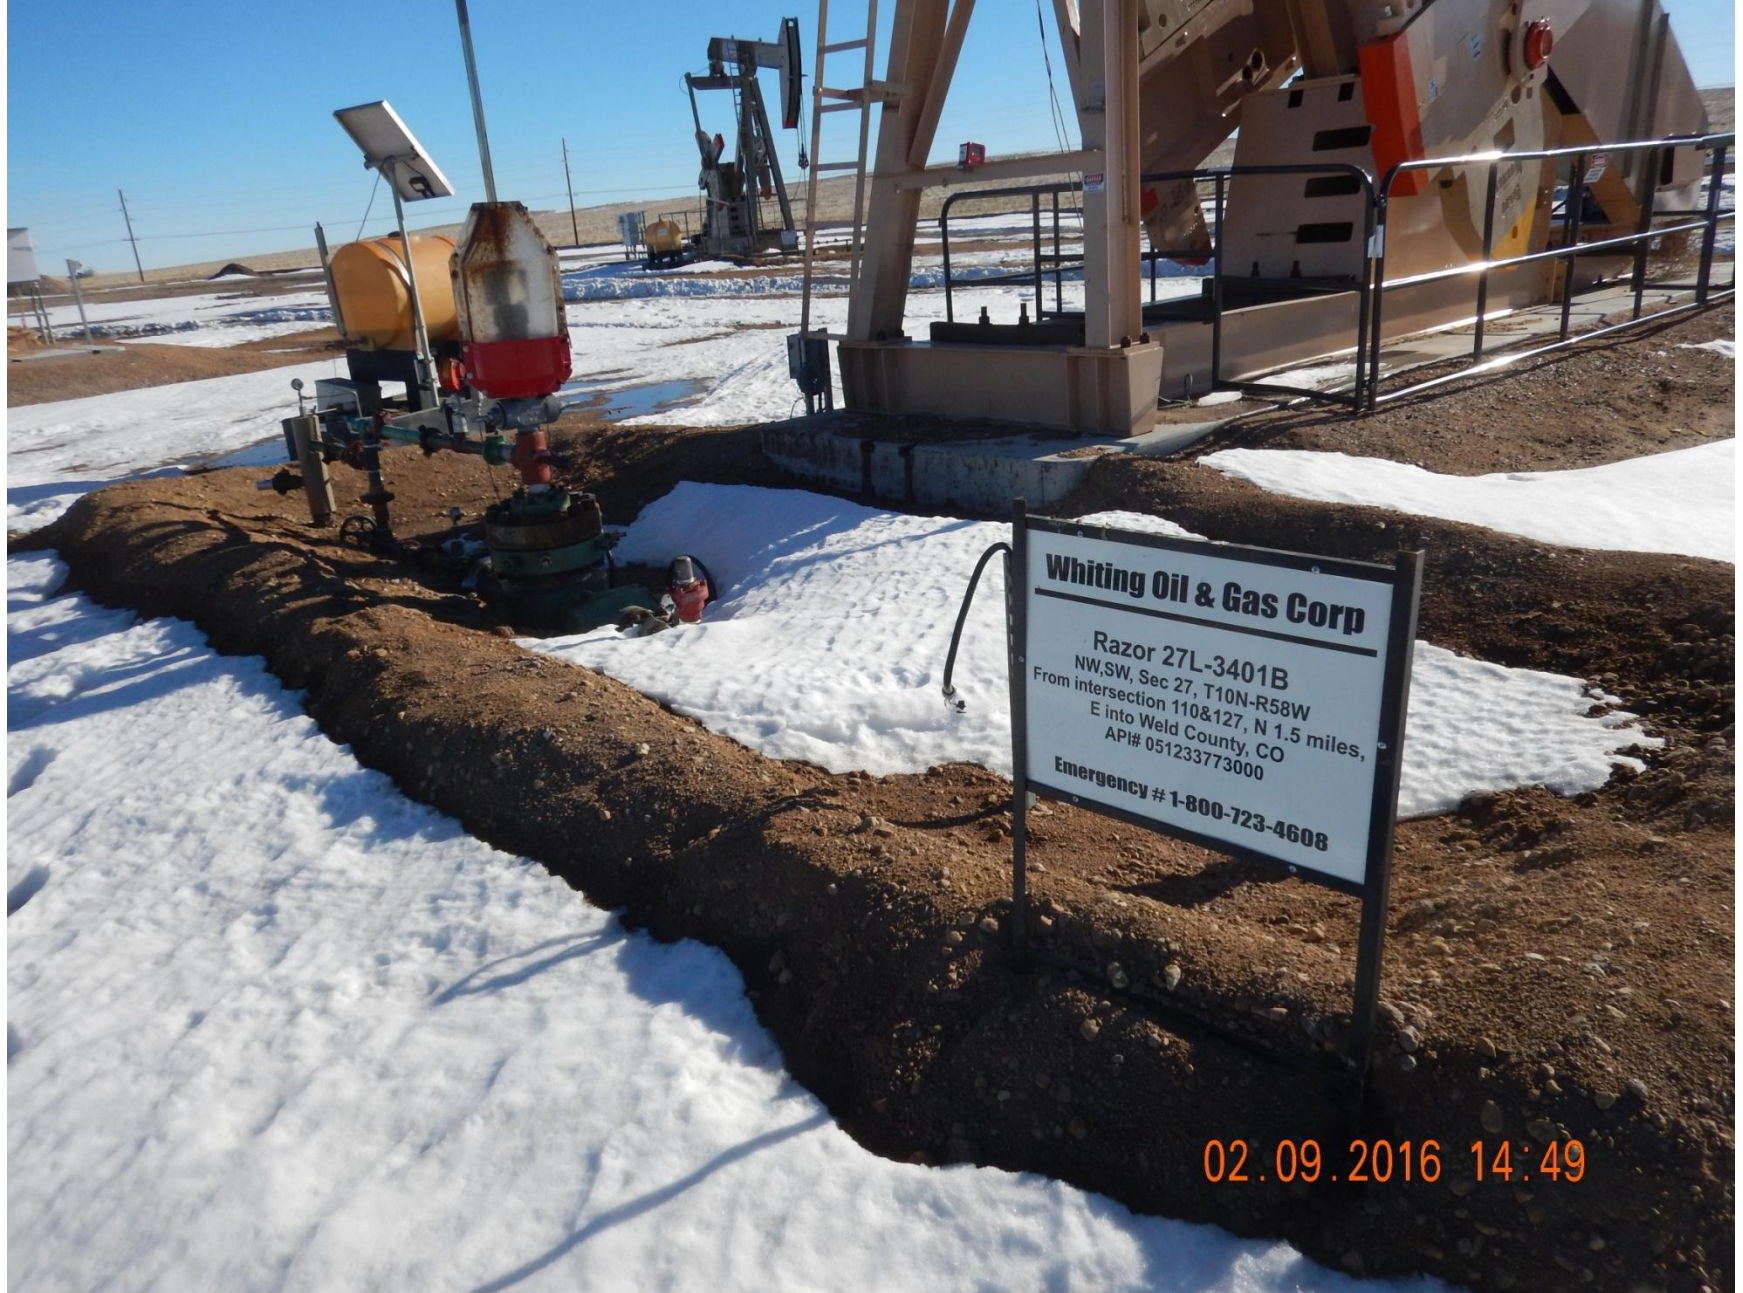
Figure 1: Photo of well #123-37730.

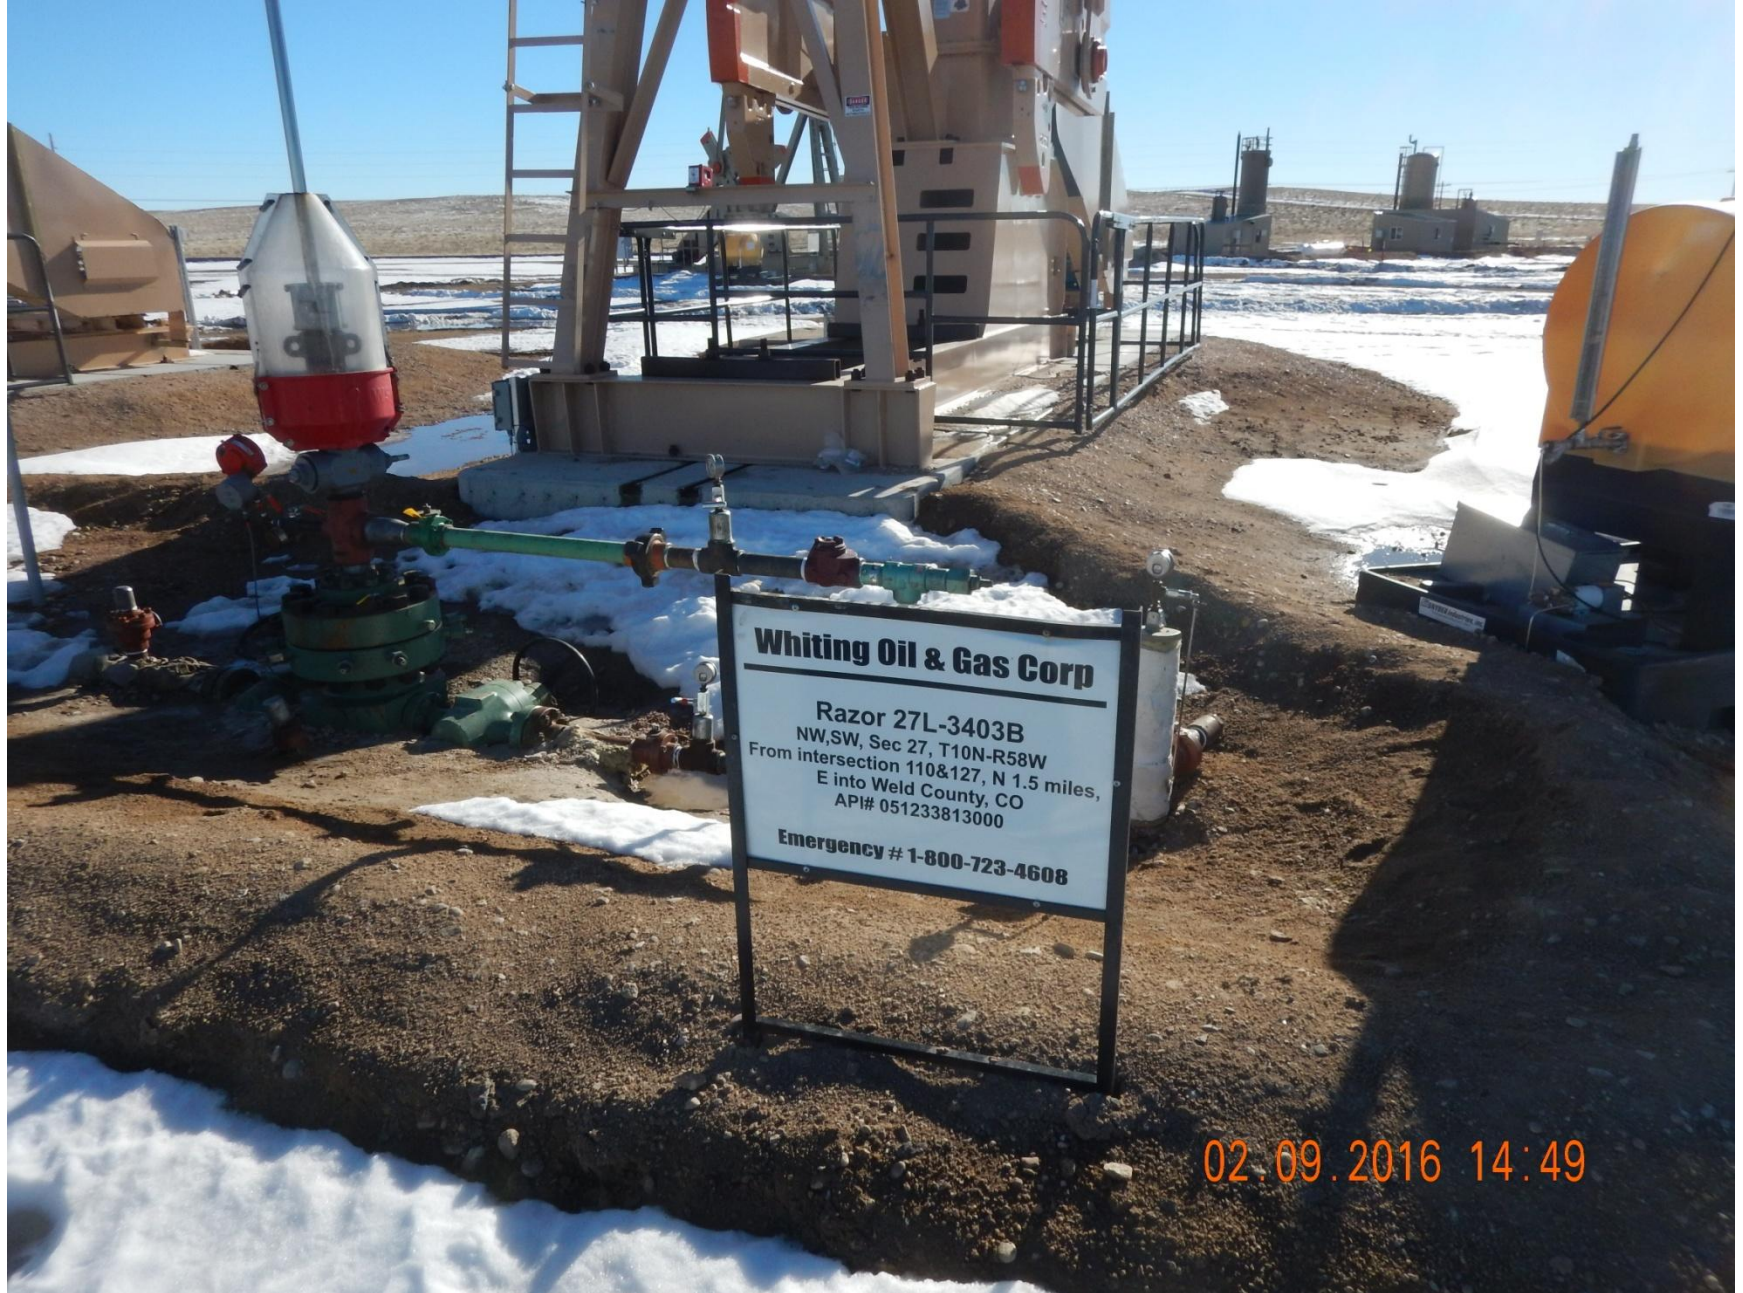
Figure 2: Photo of well #123-38130

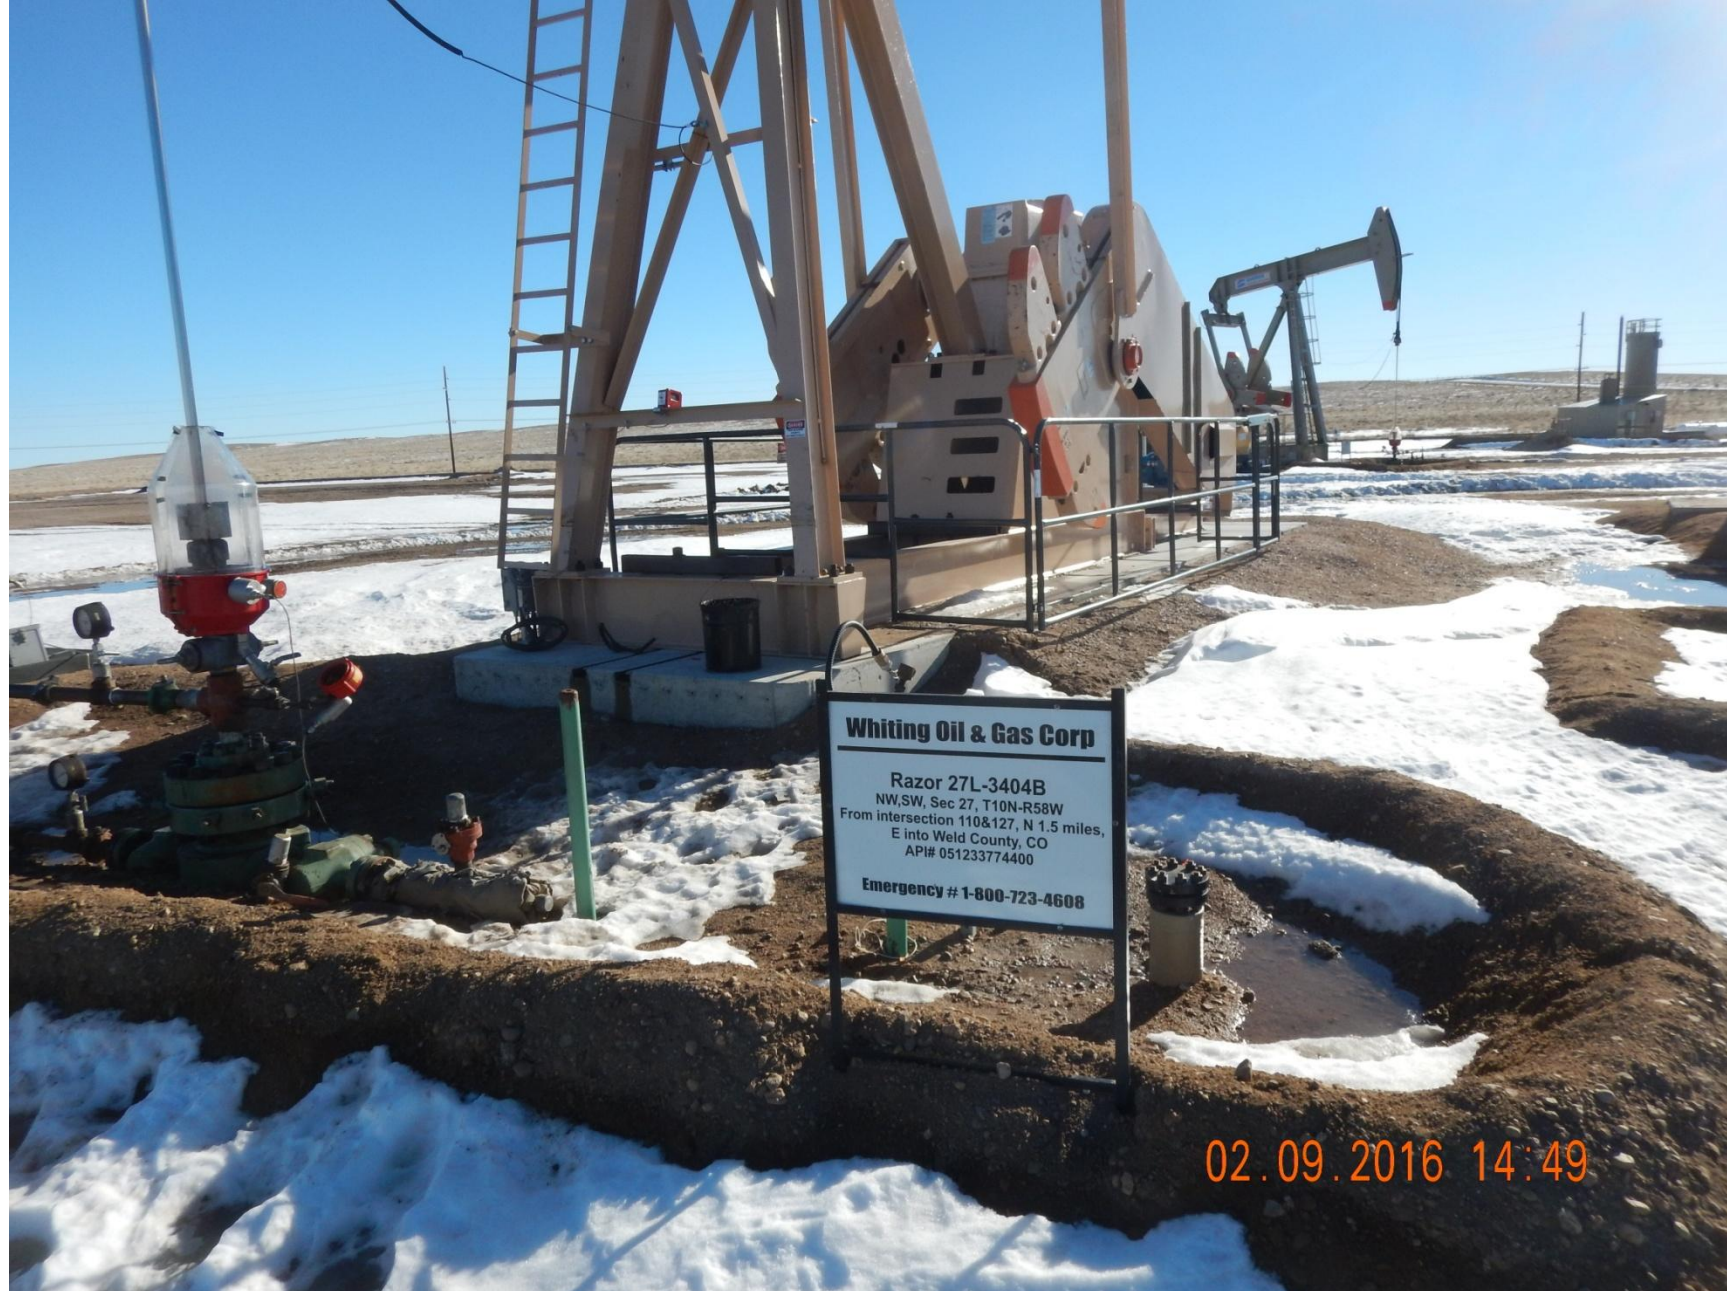
Figure 3: Photo of well #123-37744.

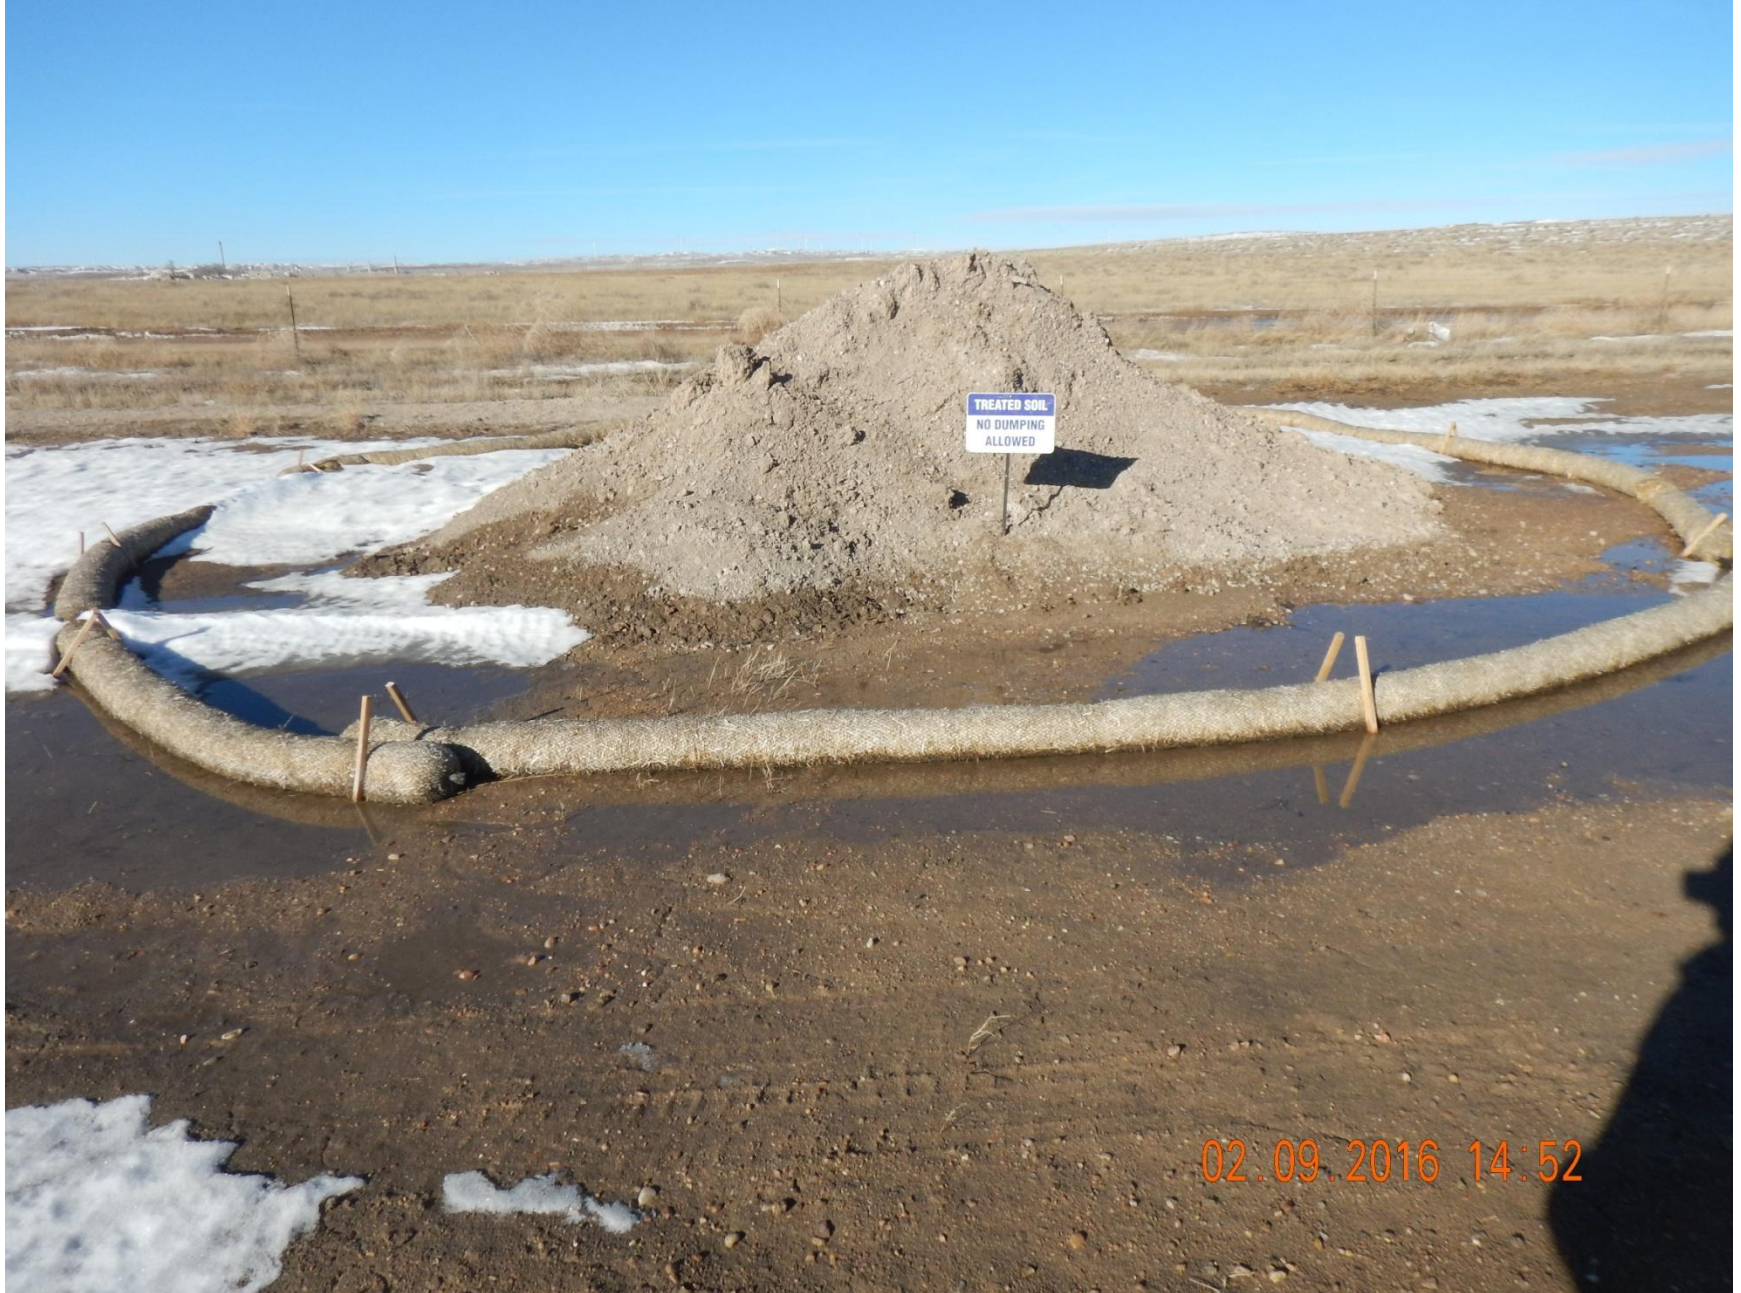
Figure 5: Photo taken from the northern end of location, facing north. Photo of treated soils.

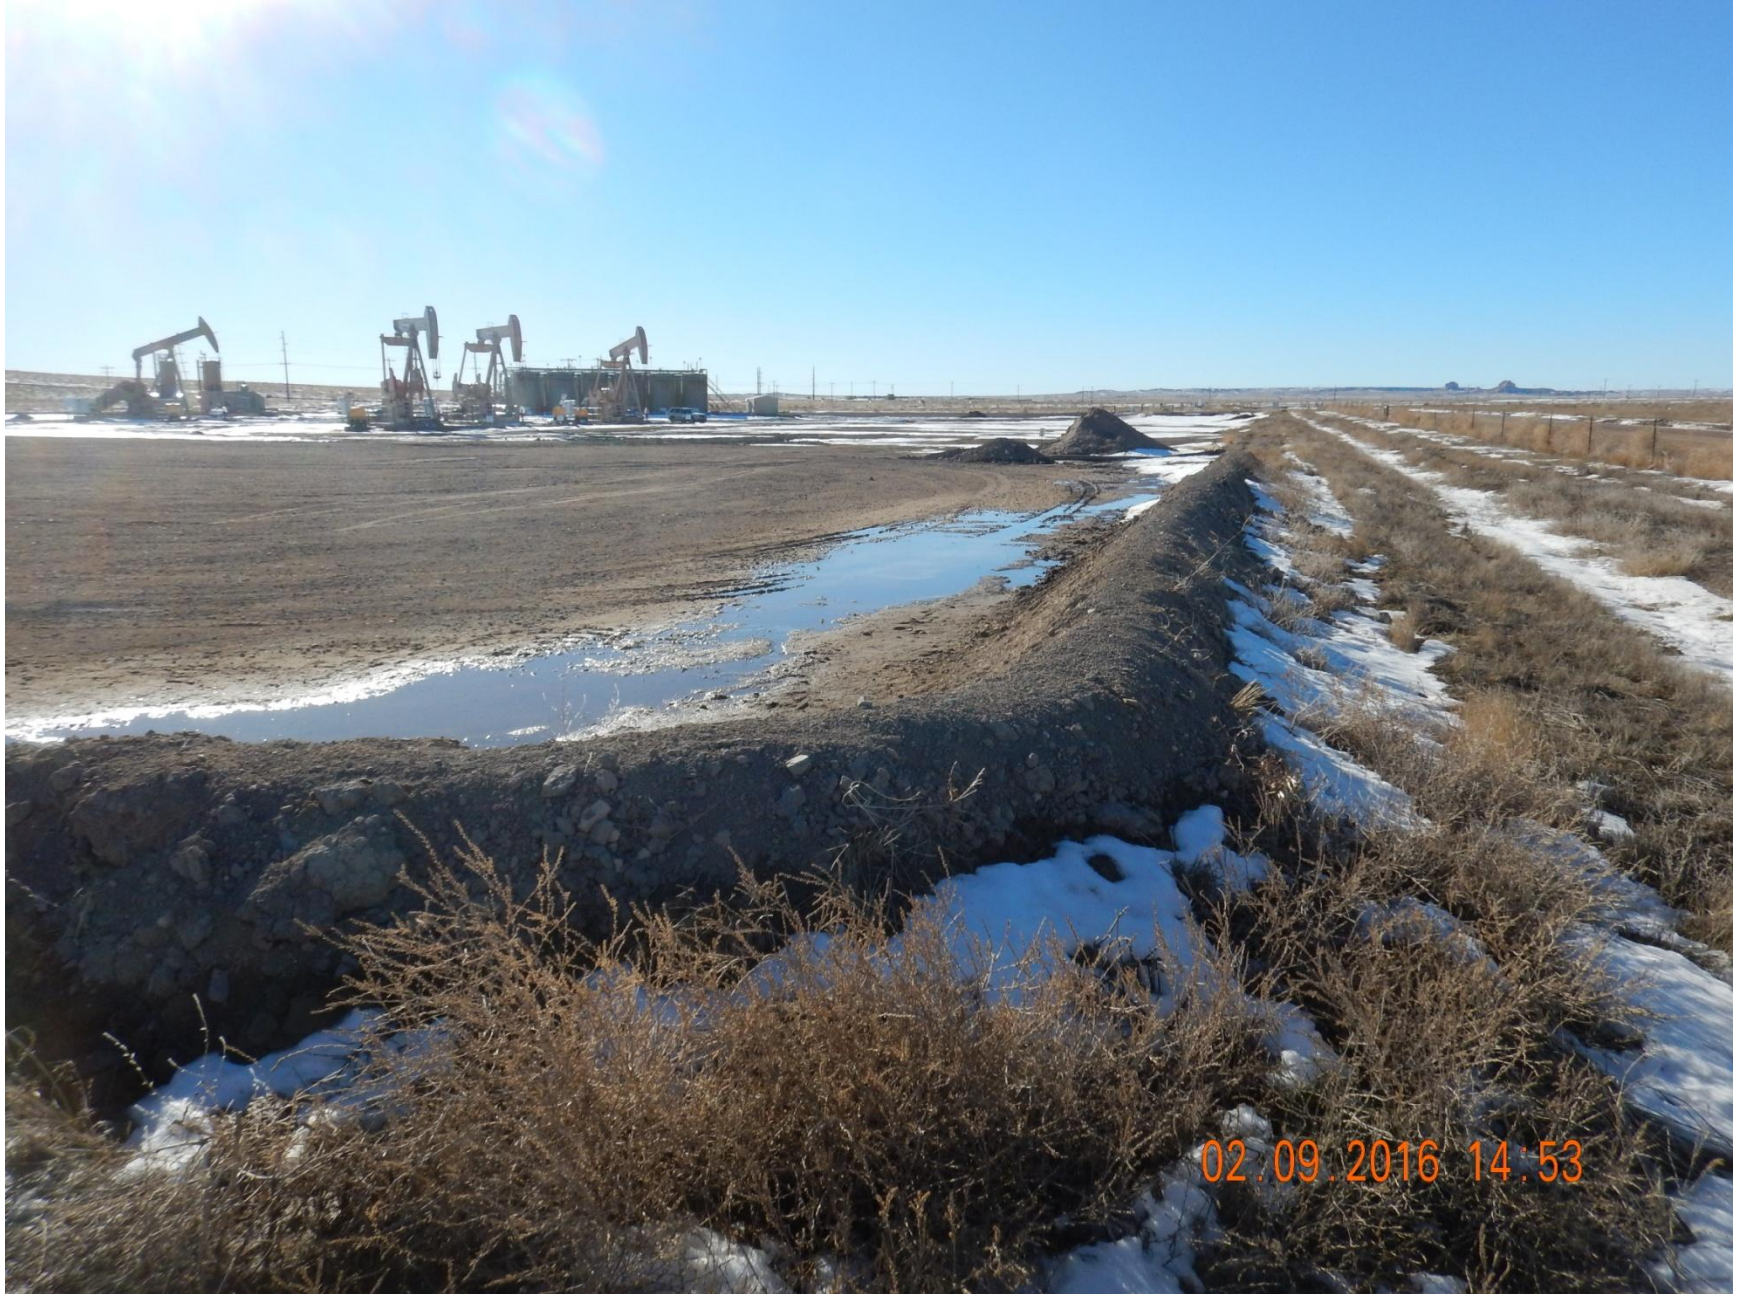
Figure 6: Photo taken from the northeast corner of location, facing west. Photo shows stormwater berm along northern end of location, and portion of the project and interim area.

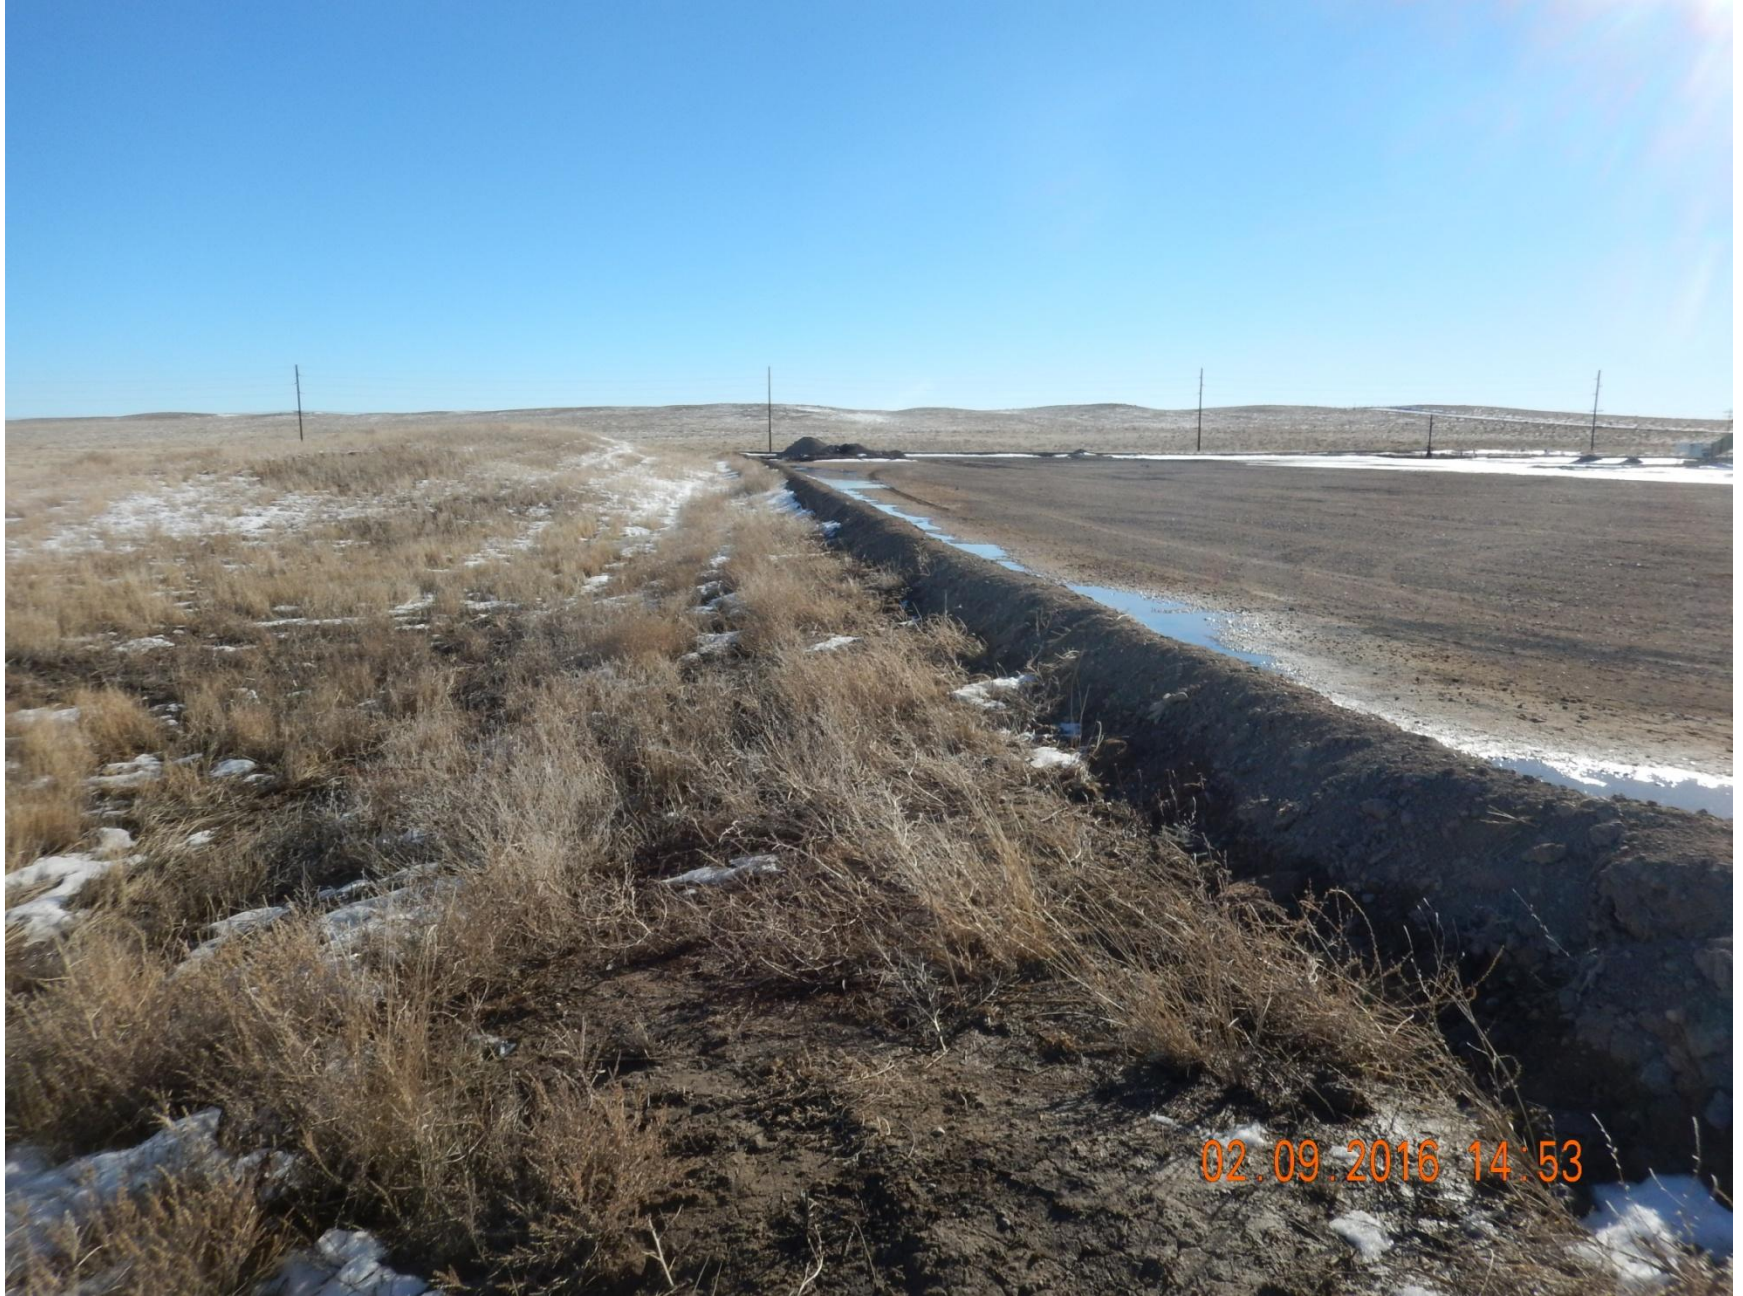
Figure 7: Photo taken from the northeast portion of location, facing south. Photo shows stormwater berm along eastern end of location, and portion of the project and interim area.

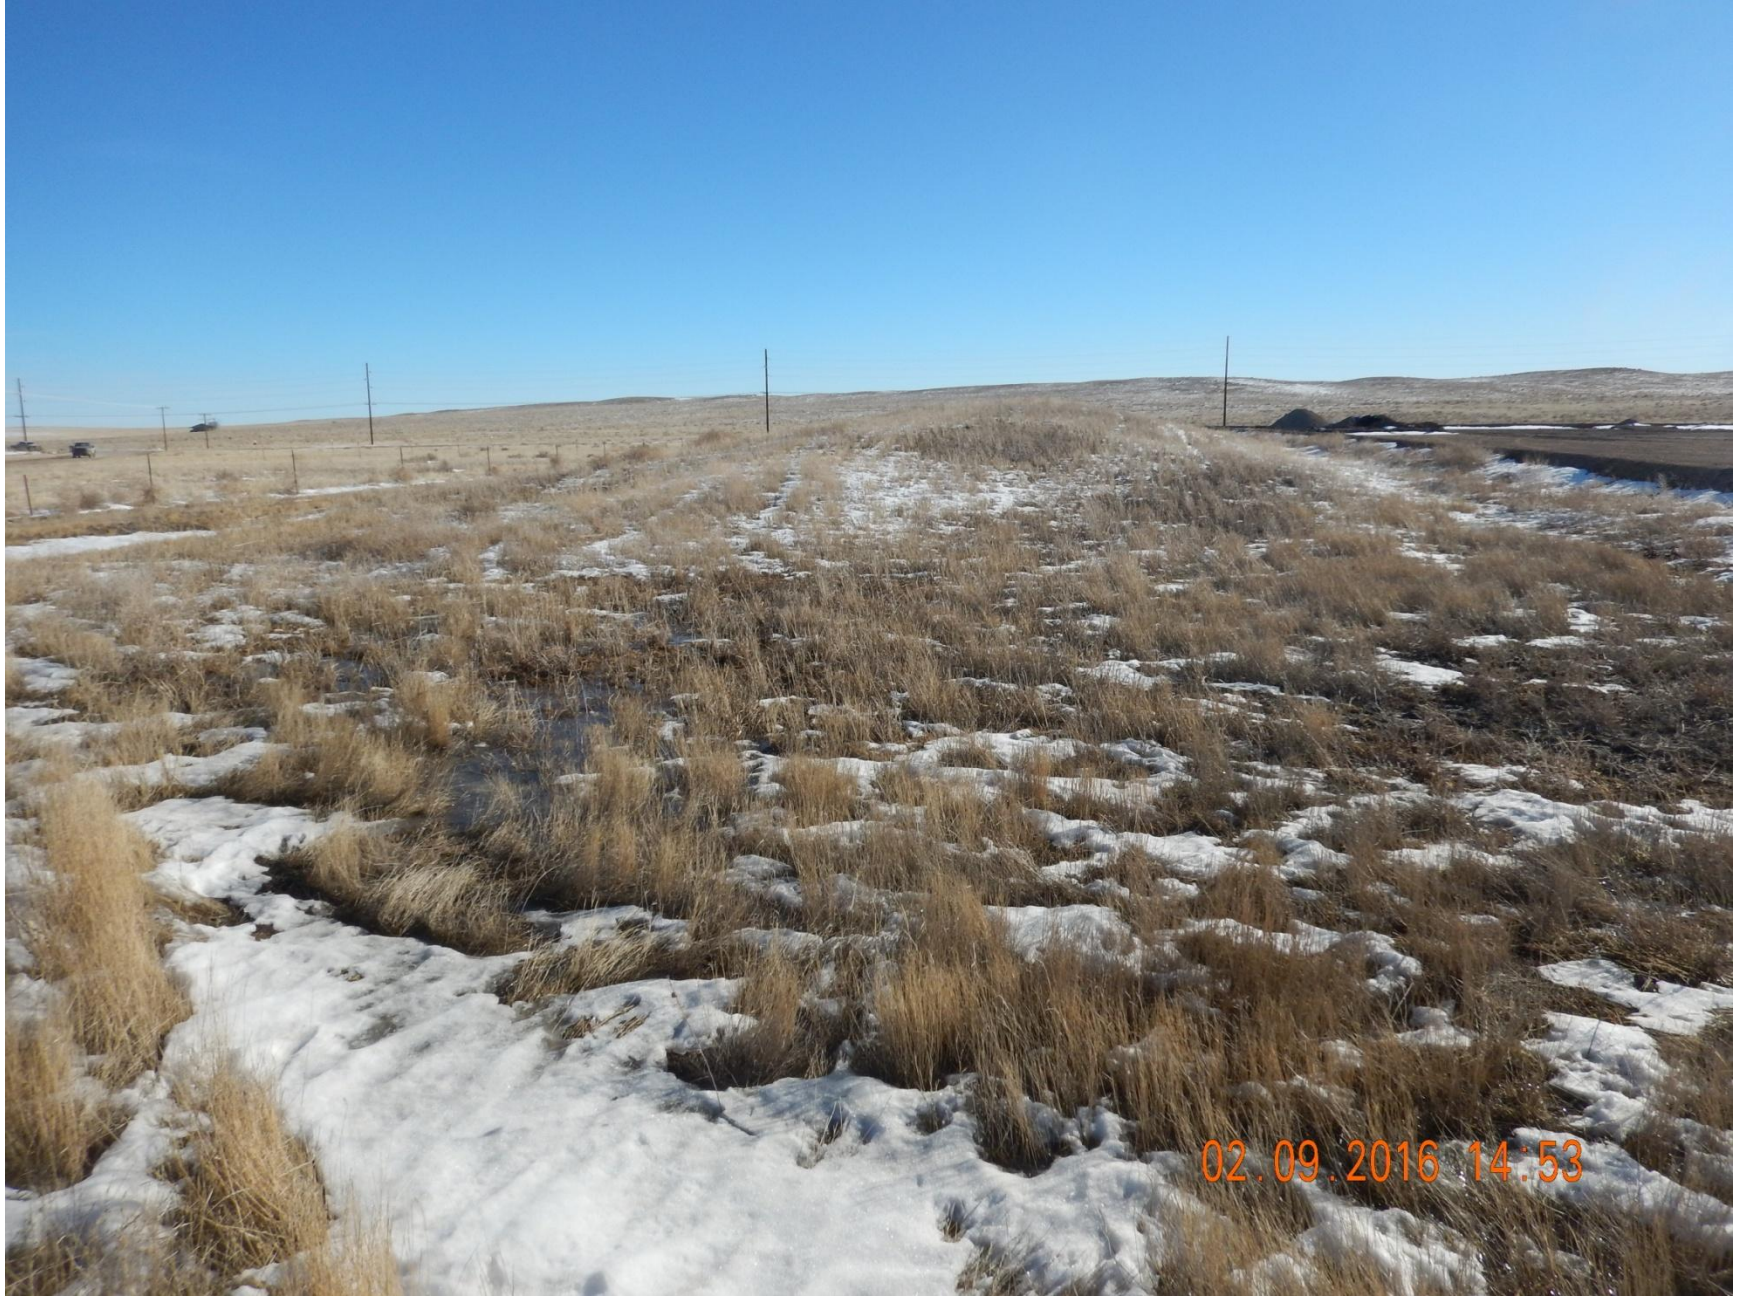
Figure 8: Photo taken from the northeast end of location, facing south. Photo of vegetation on the eastern portion of the interim area.

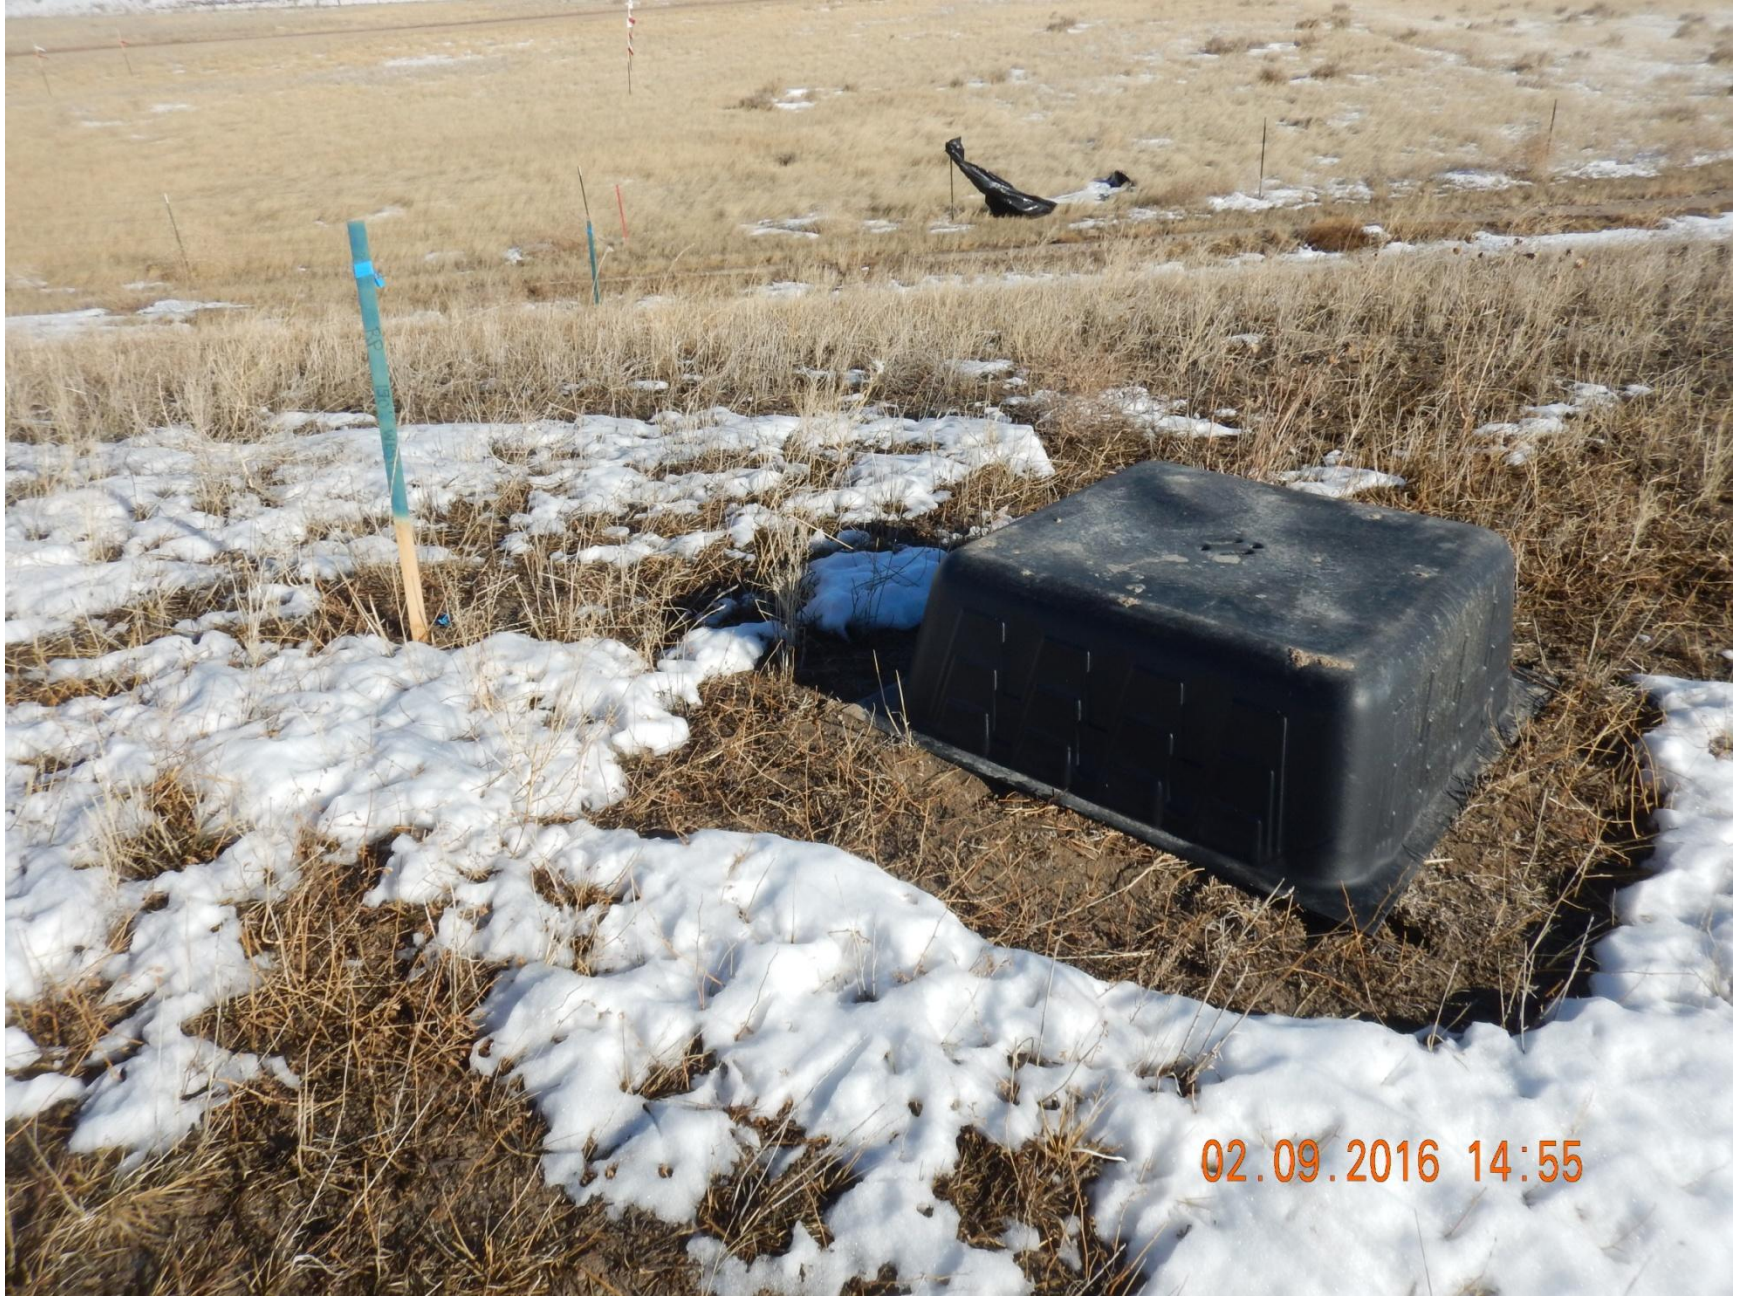
Figure 9: Photo taken from topsoil stockpile on the east end of location, facing east. Photo of trash debris in interim area, and fence. Trash appears to be a large tub, and a plastic tarp.

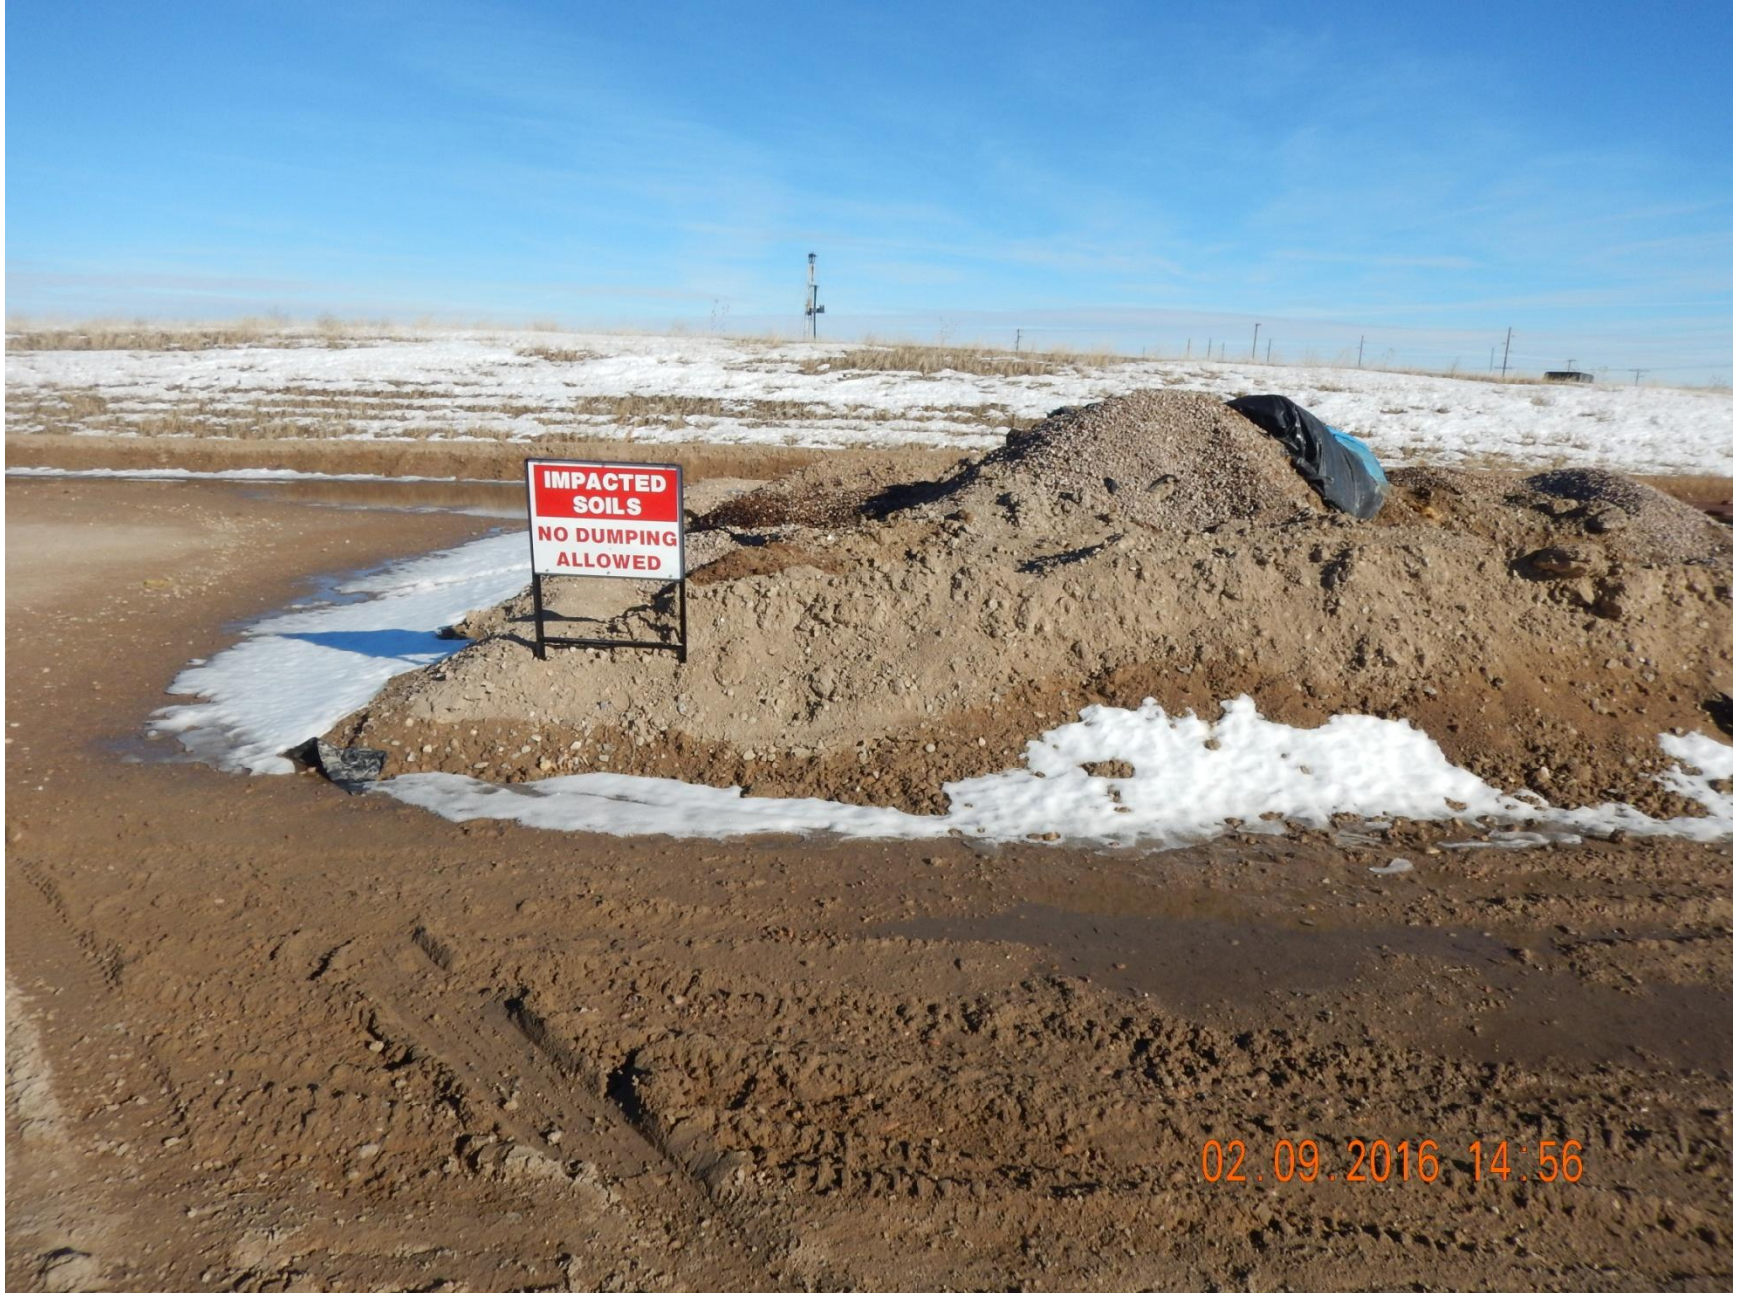
Figure 10: Photo taken from the east end of the project location. Photo of impacted soils.

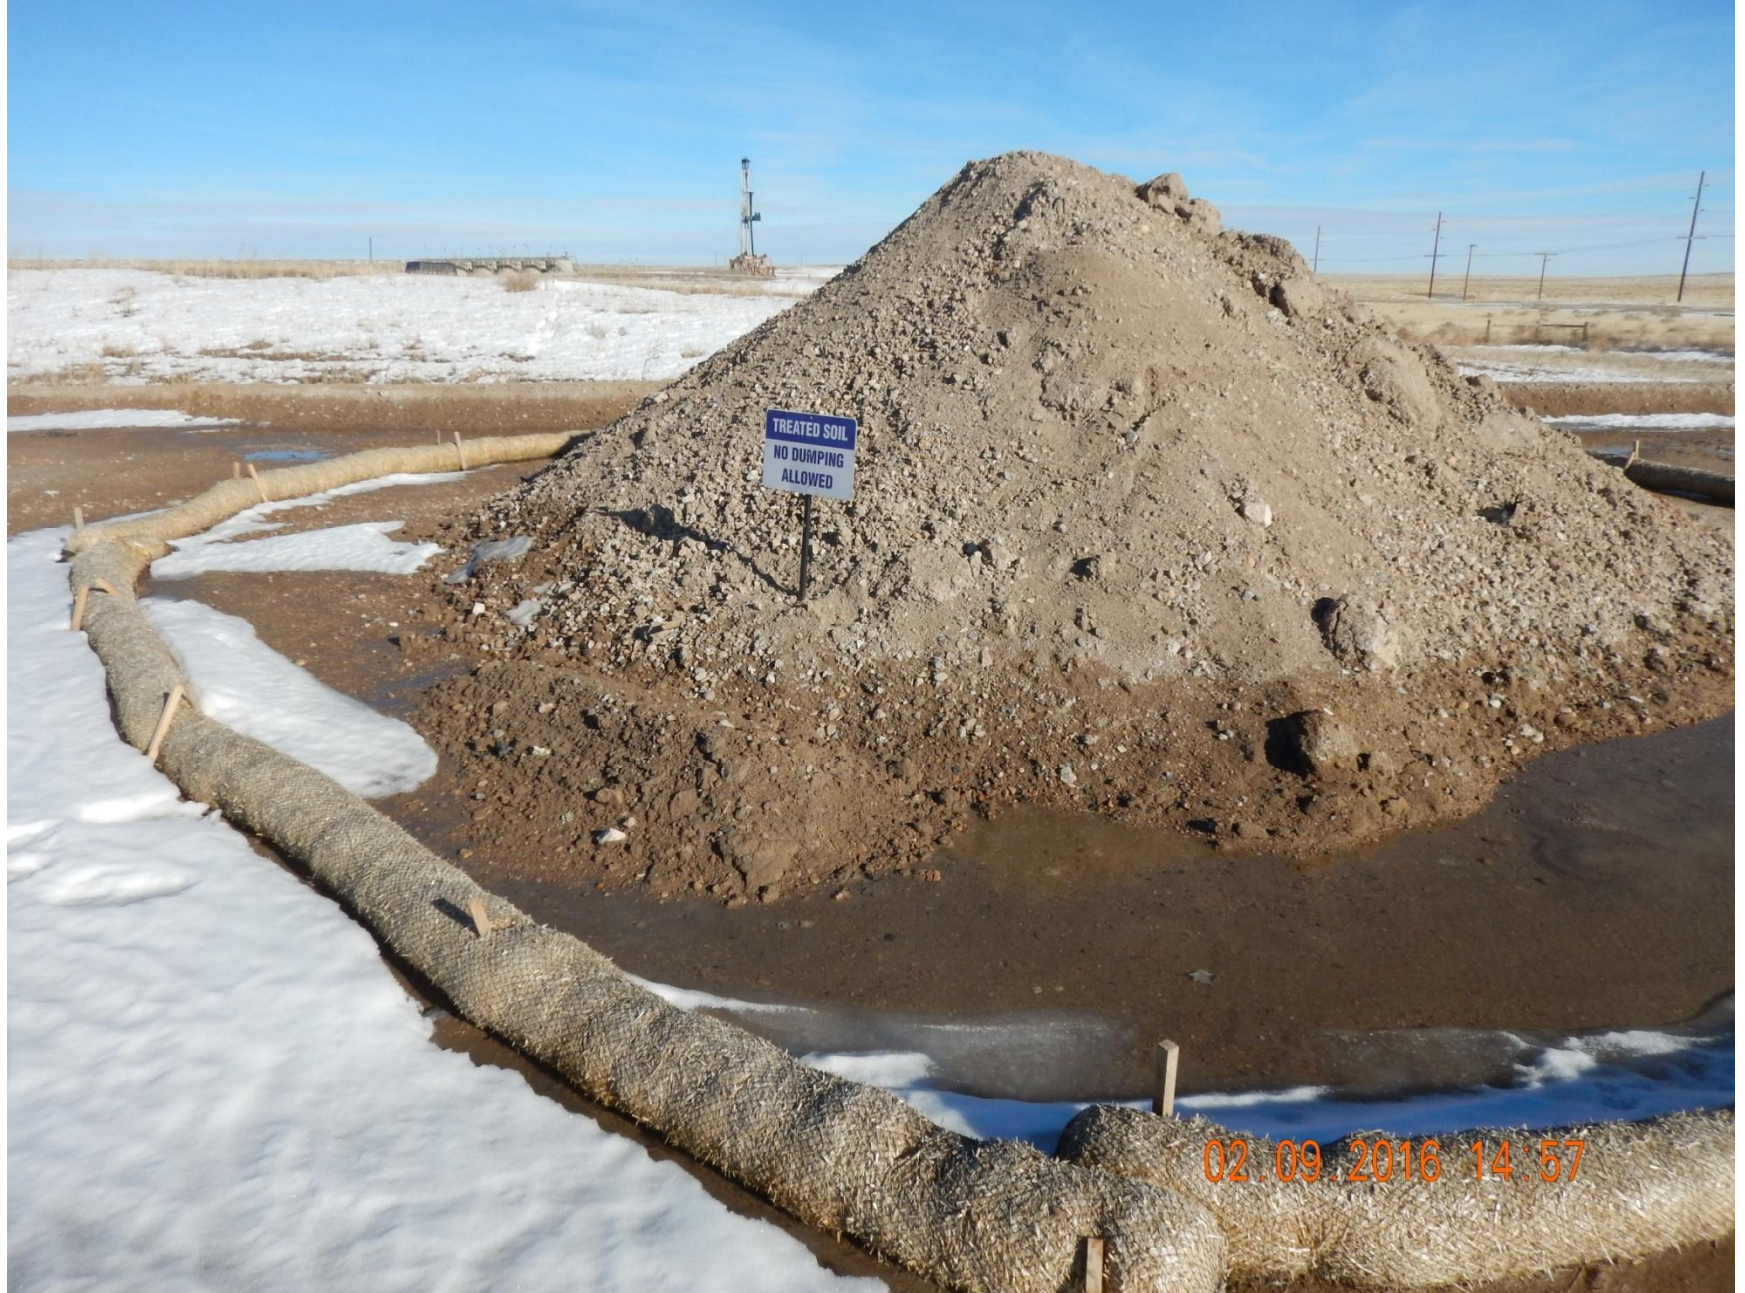
Figure 11: Photo taken from the east end of project area, photo of treated soils.
