Interim Reclamation Inspection

Operator: Whiting Oil and Gas

Location ID: 430313

NWSW Section 27 T10N R58W

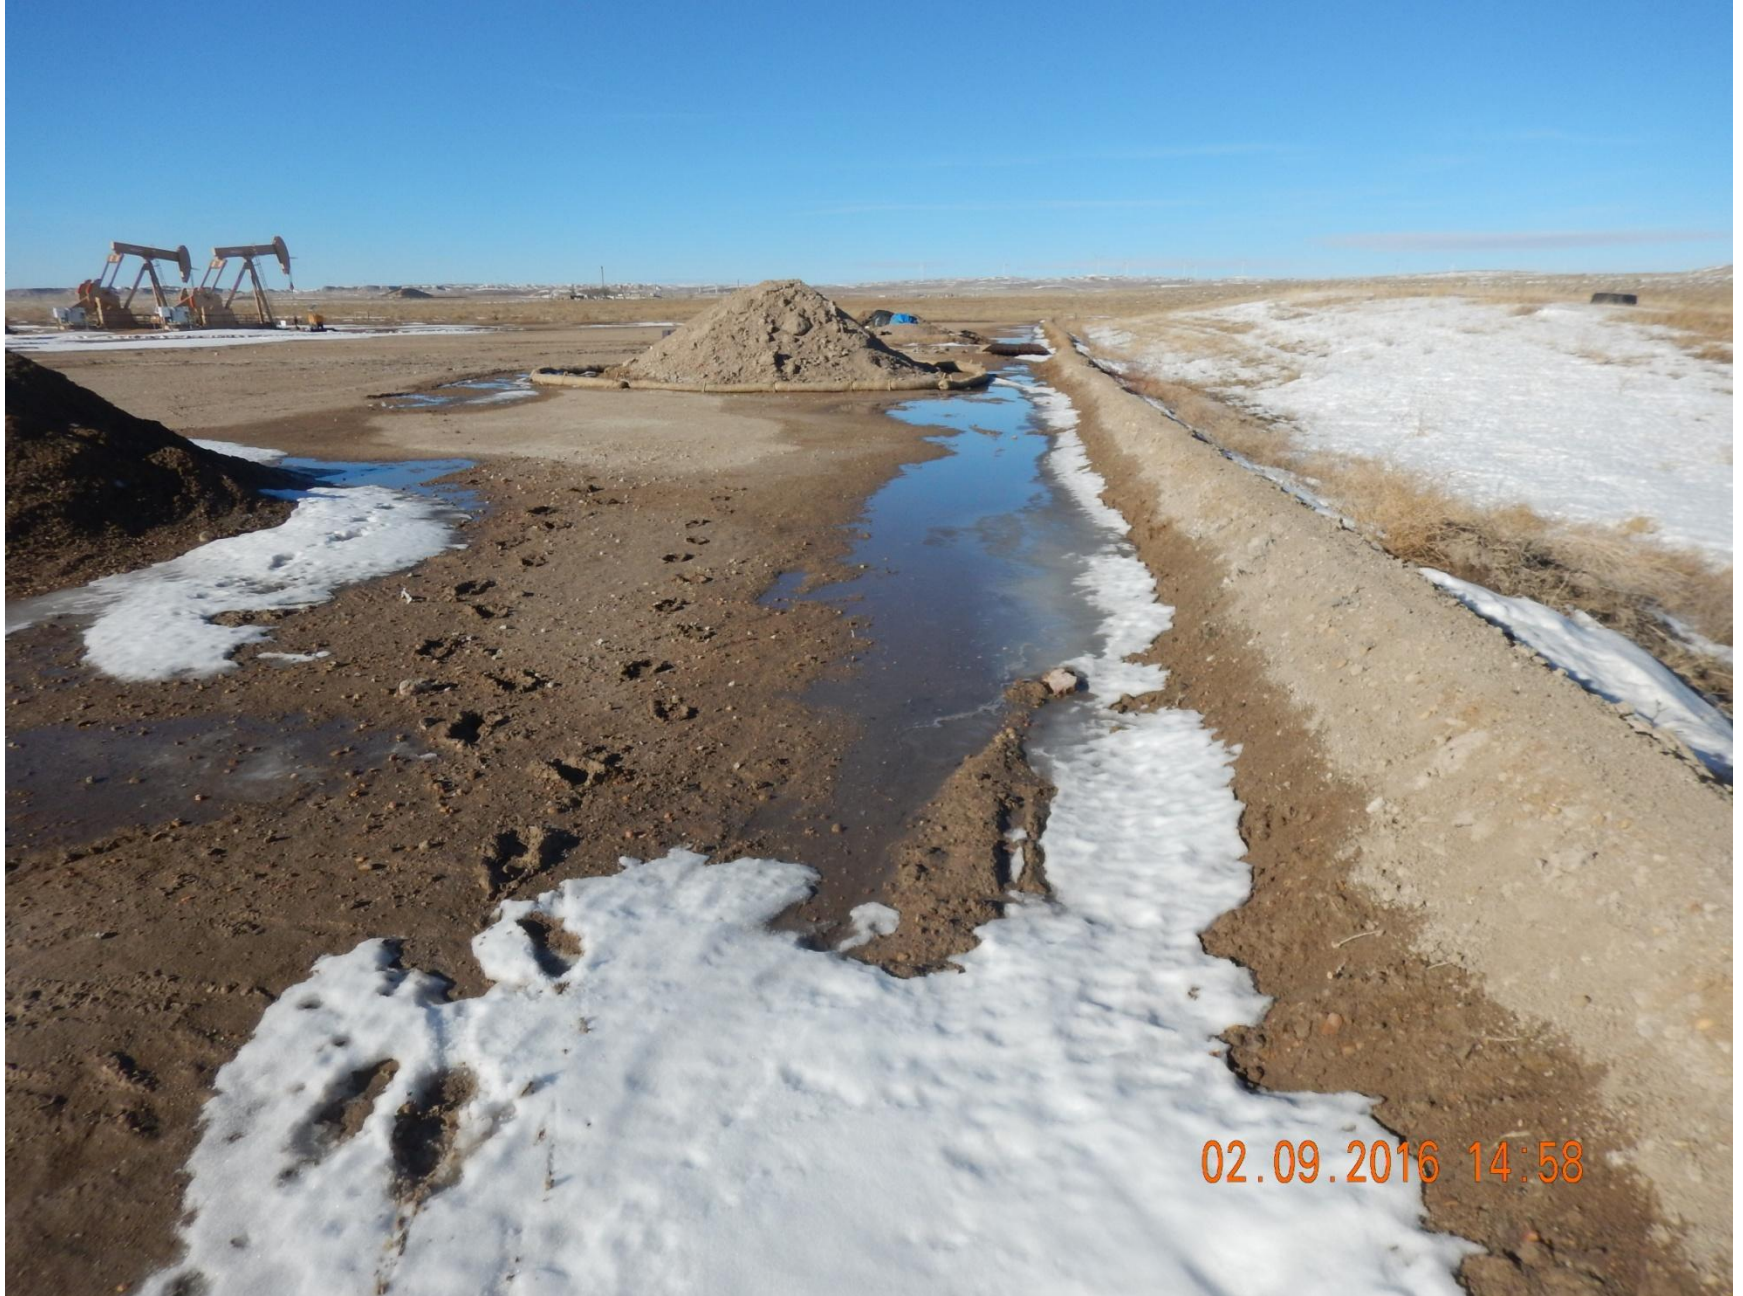
Figure 12: Photo taken from the southeast portion of the project area, facing south. Photo shows stormwater berm along eastern end of location, and portion of the project and interim area

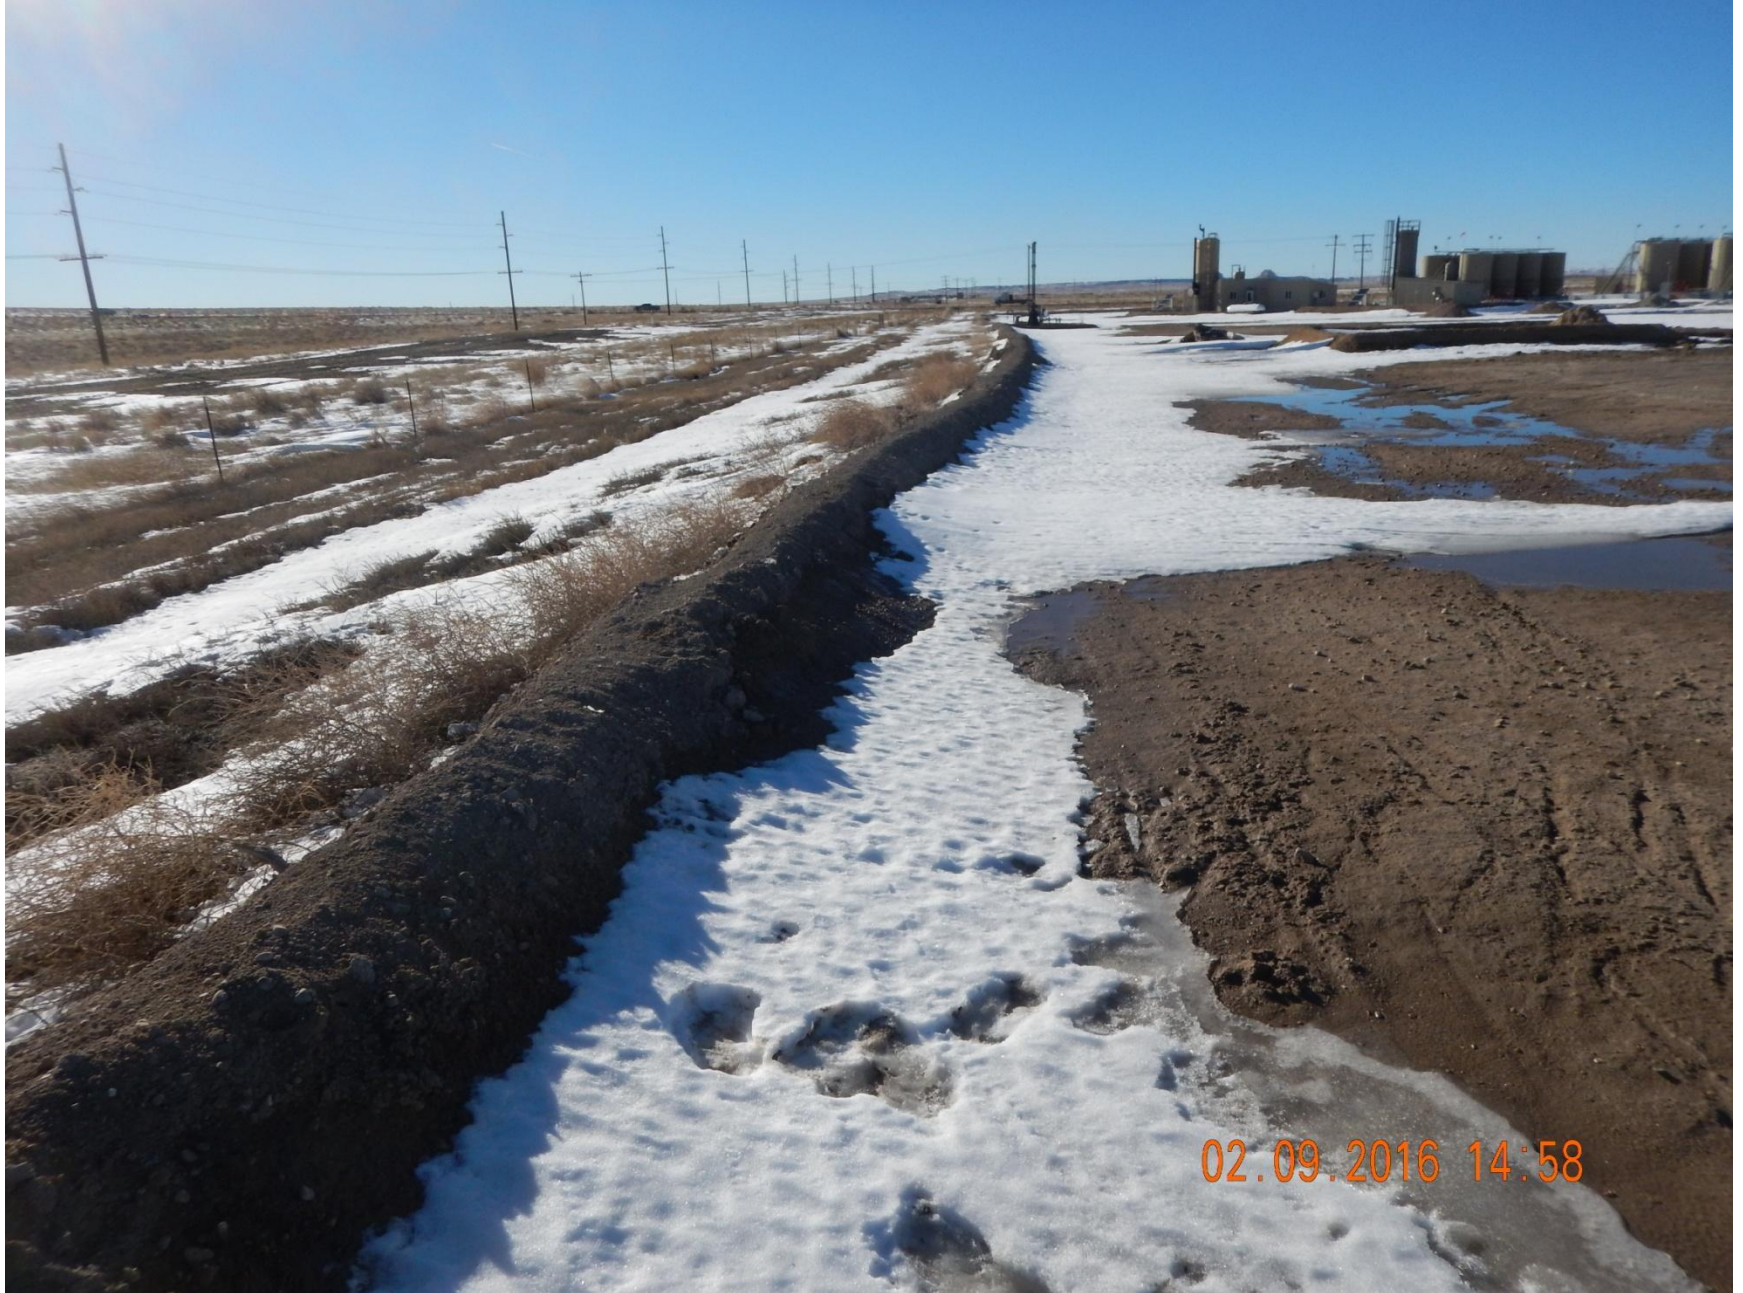
Figure 13: Photo taken from the southeast portion of the project location, facing west. Photo shows stormwater berm along the southern end of location, and portion of the project and interim area

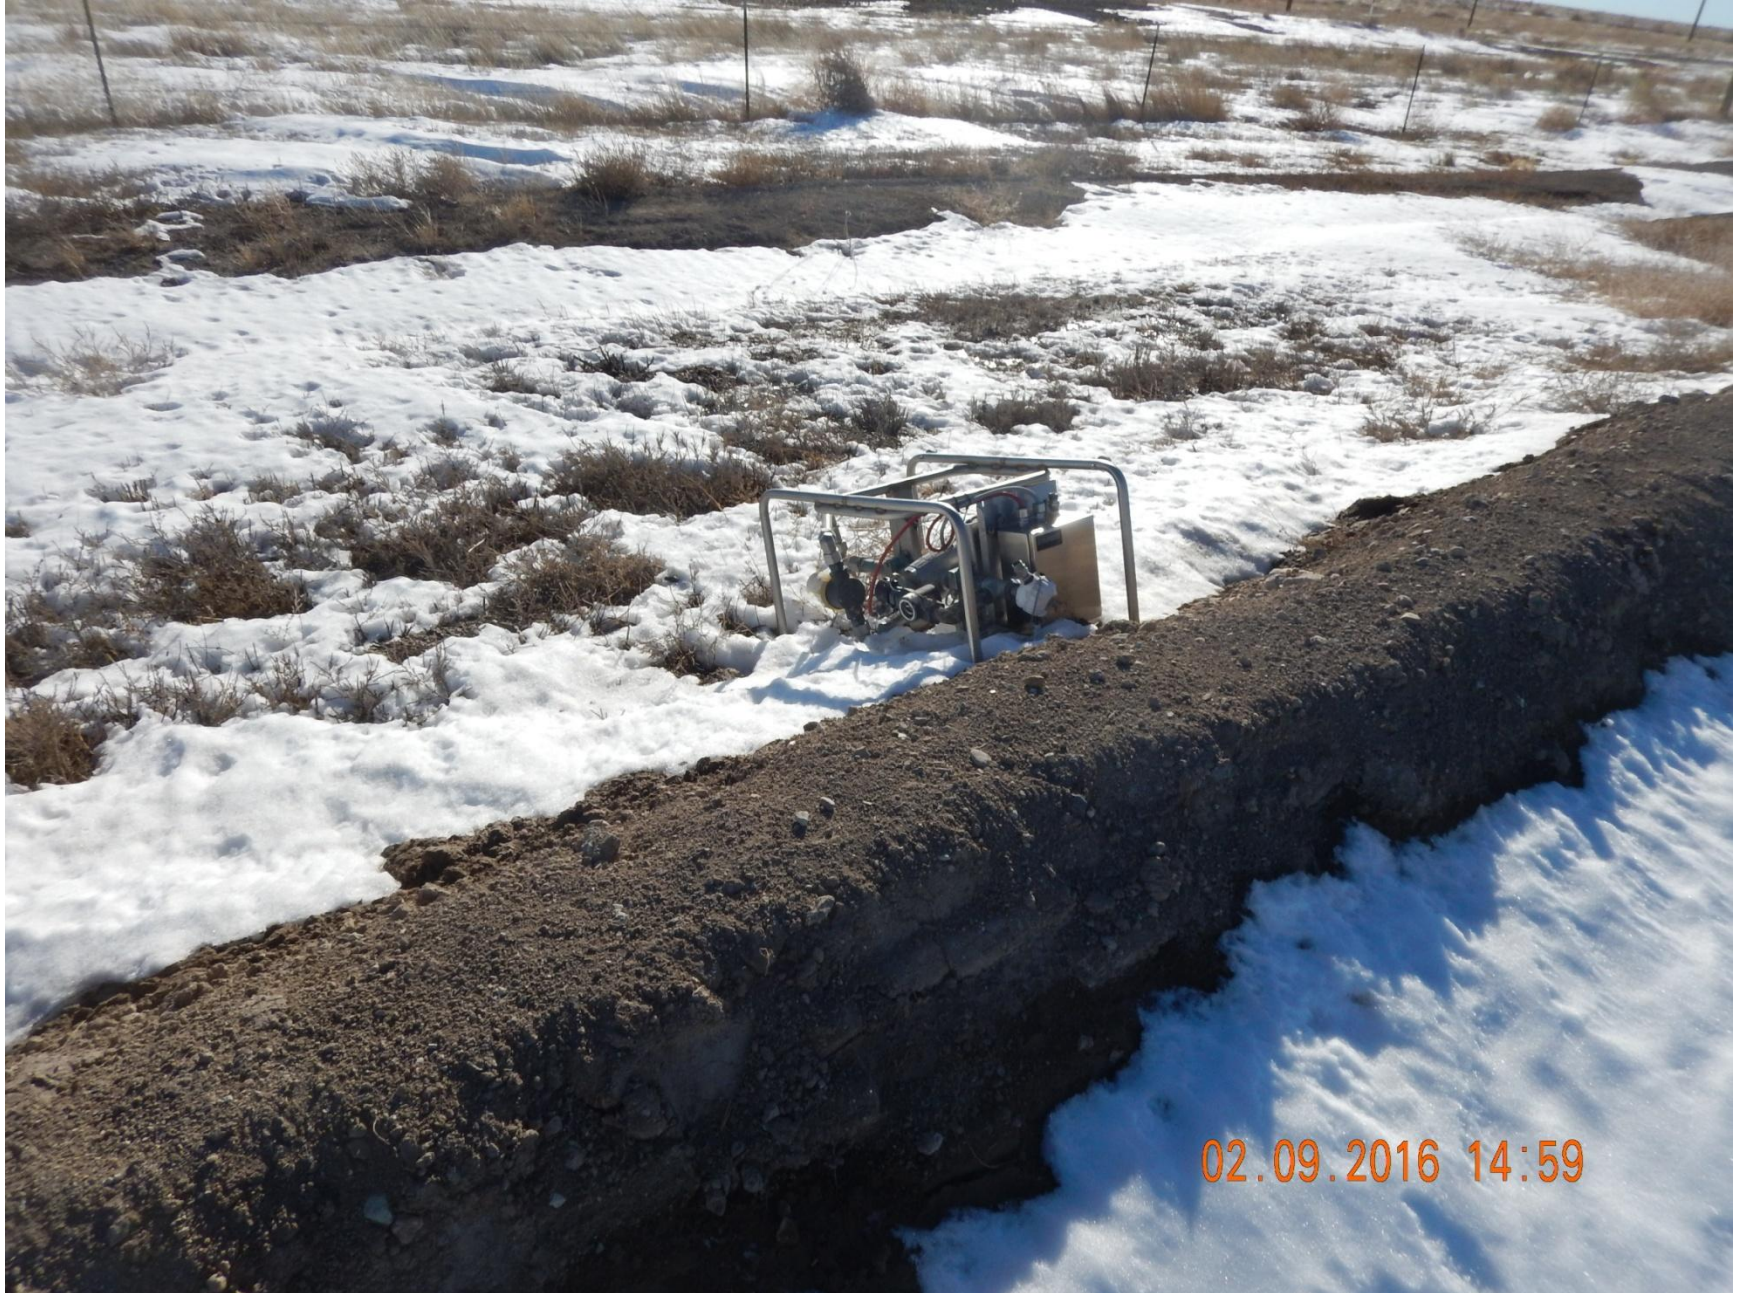
Figure 14: Photo taken from southern end of the location. Photo of equipment stored on the interim area.

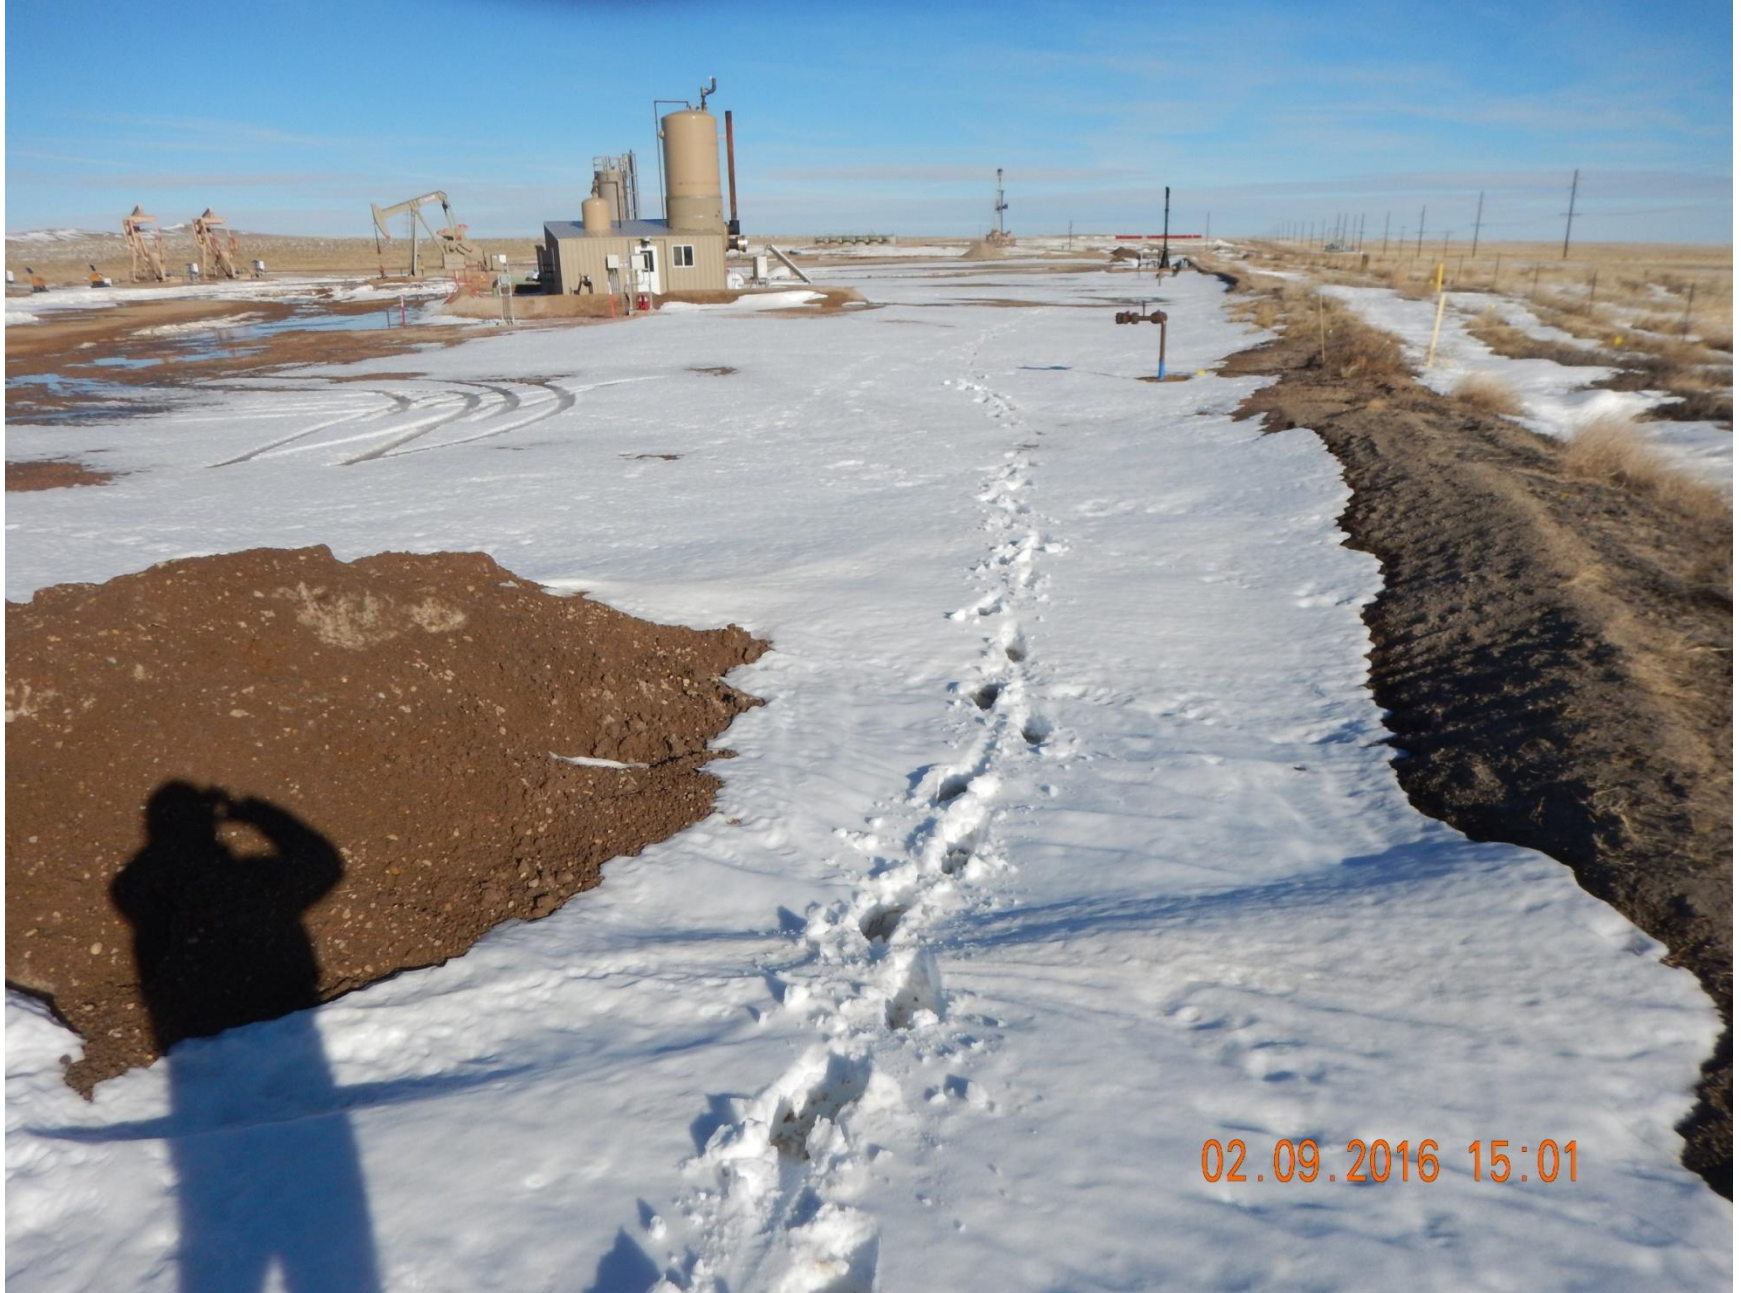
Figure 15: Photo taken from the southwest portion of the project area, facing east. Photo shows stormwater berm along the southern end of location, and portion of the project and interim area

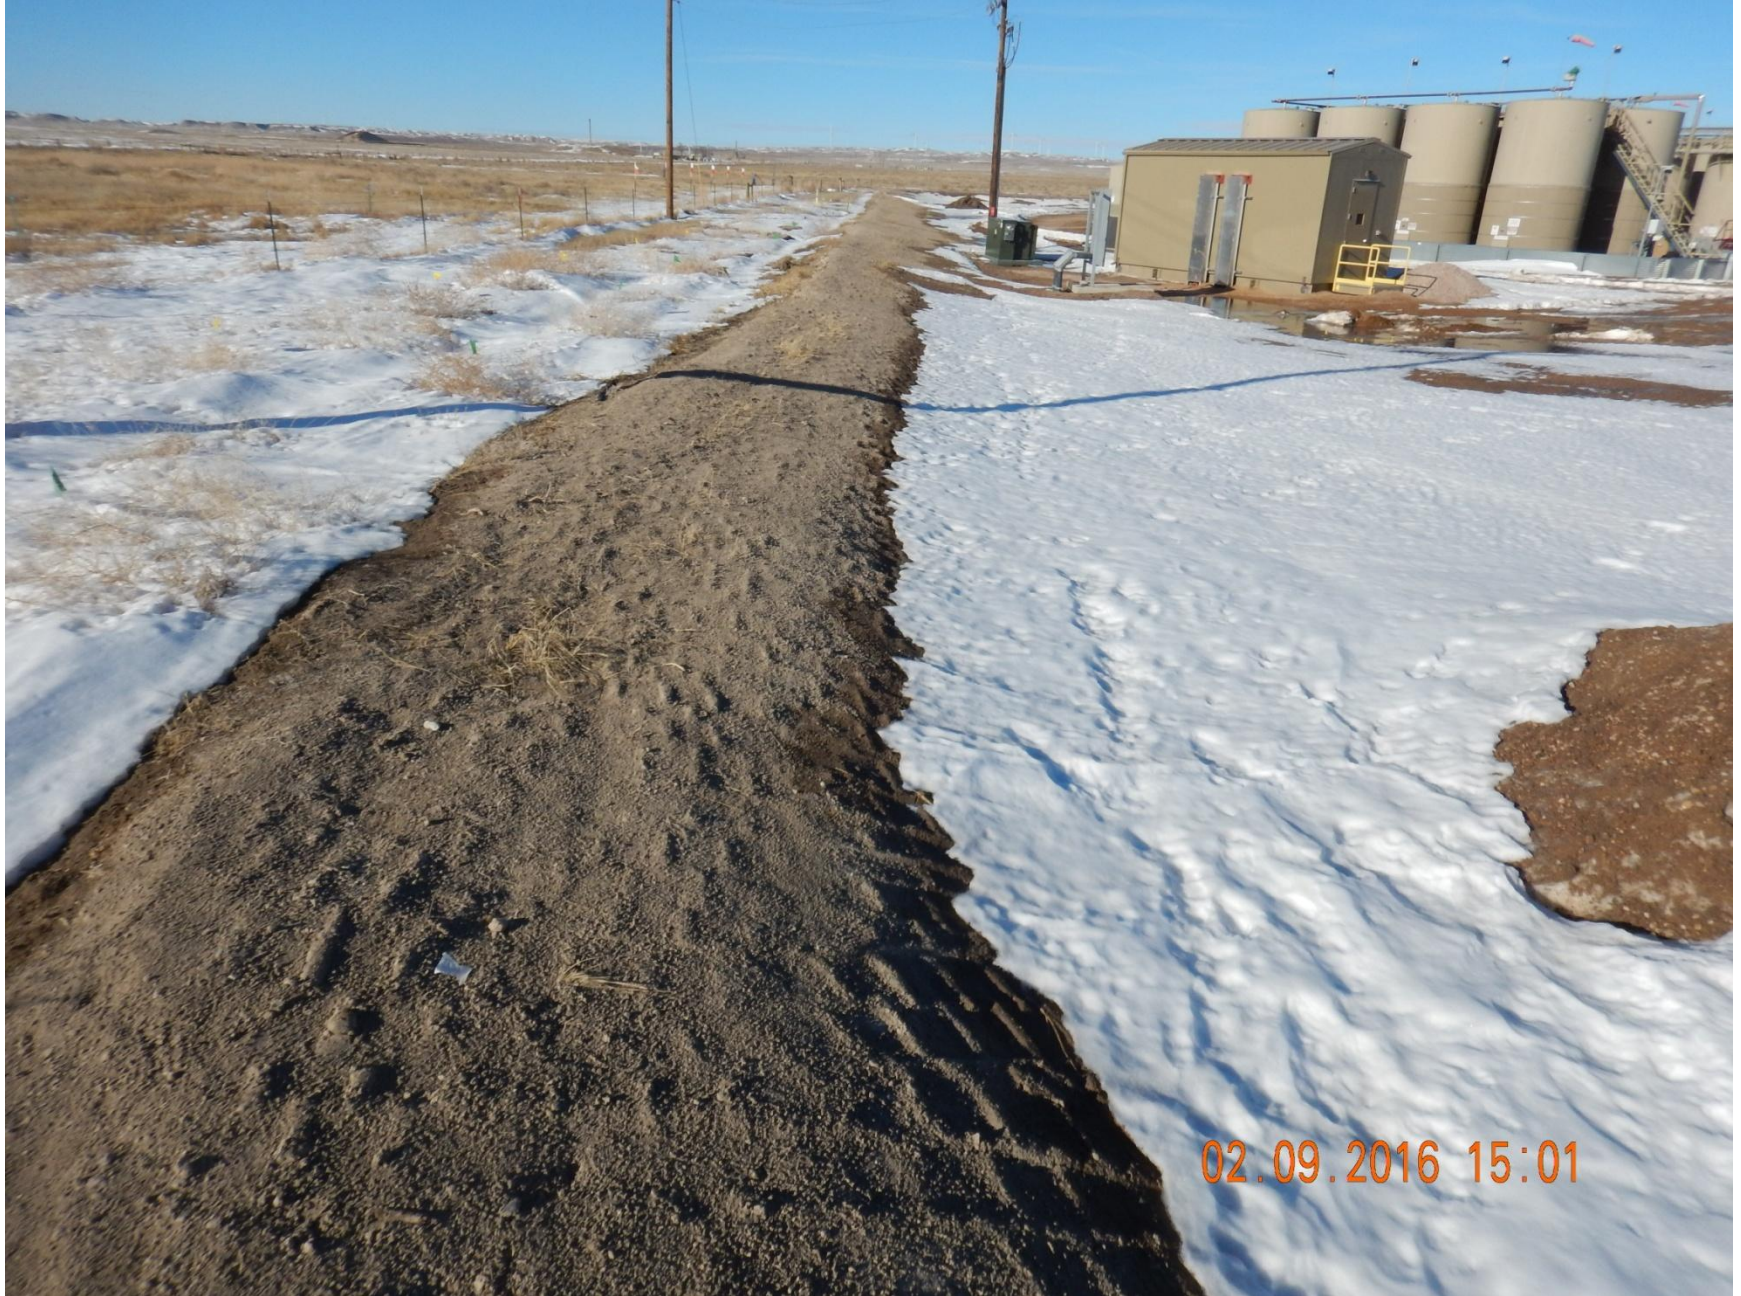
Figure 16: Photo taken from the southwest portion of the project area, facing north. Photo shows stormwater berm along the western end of location, and portion of the project and interim area

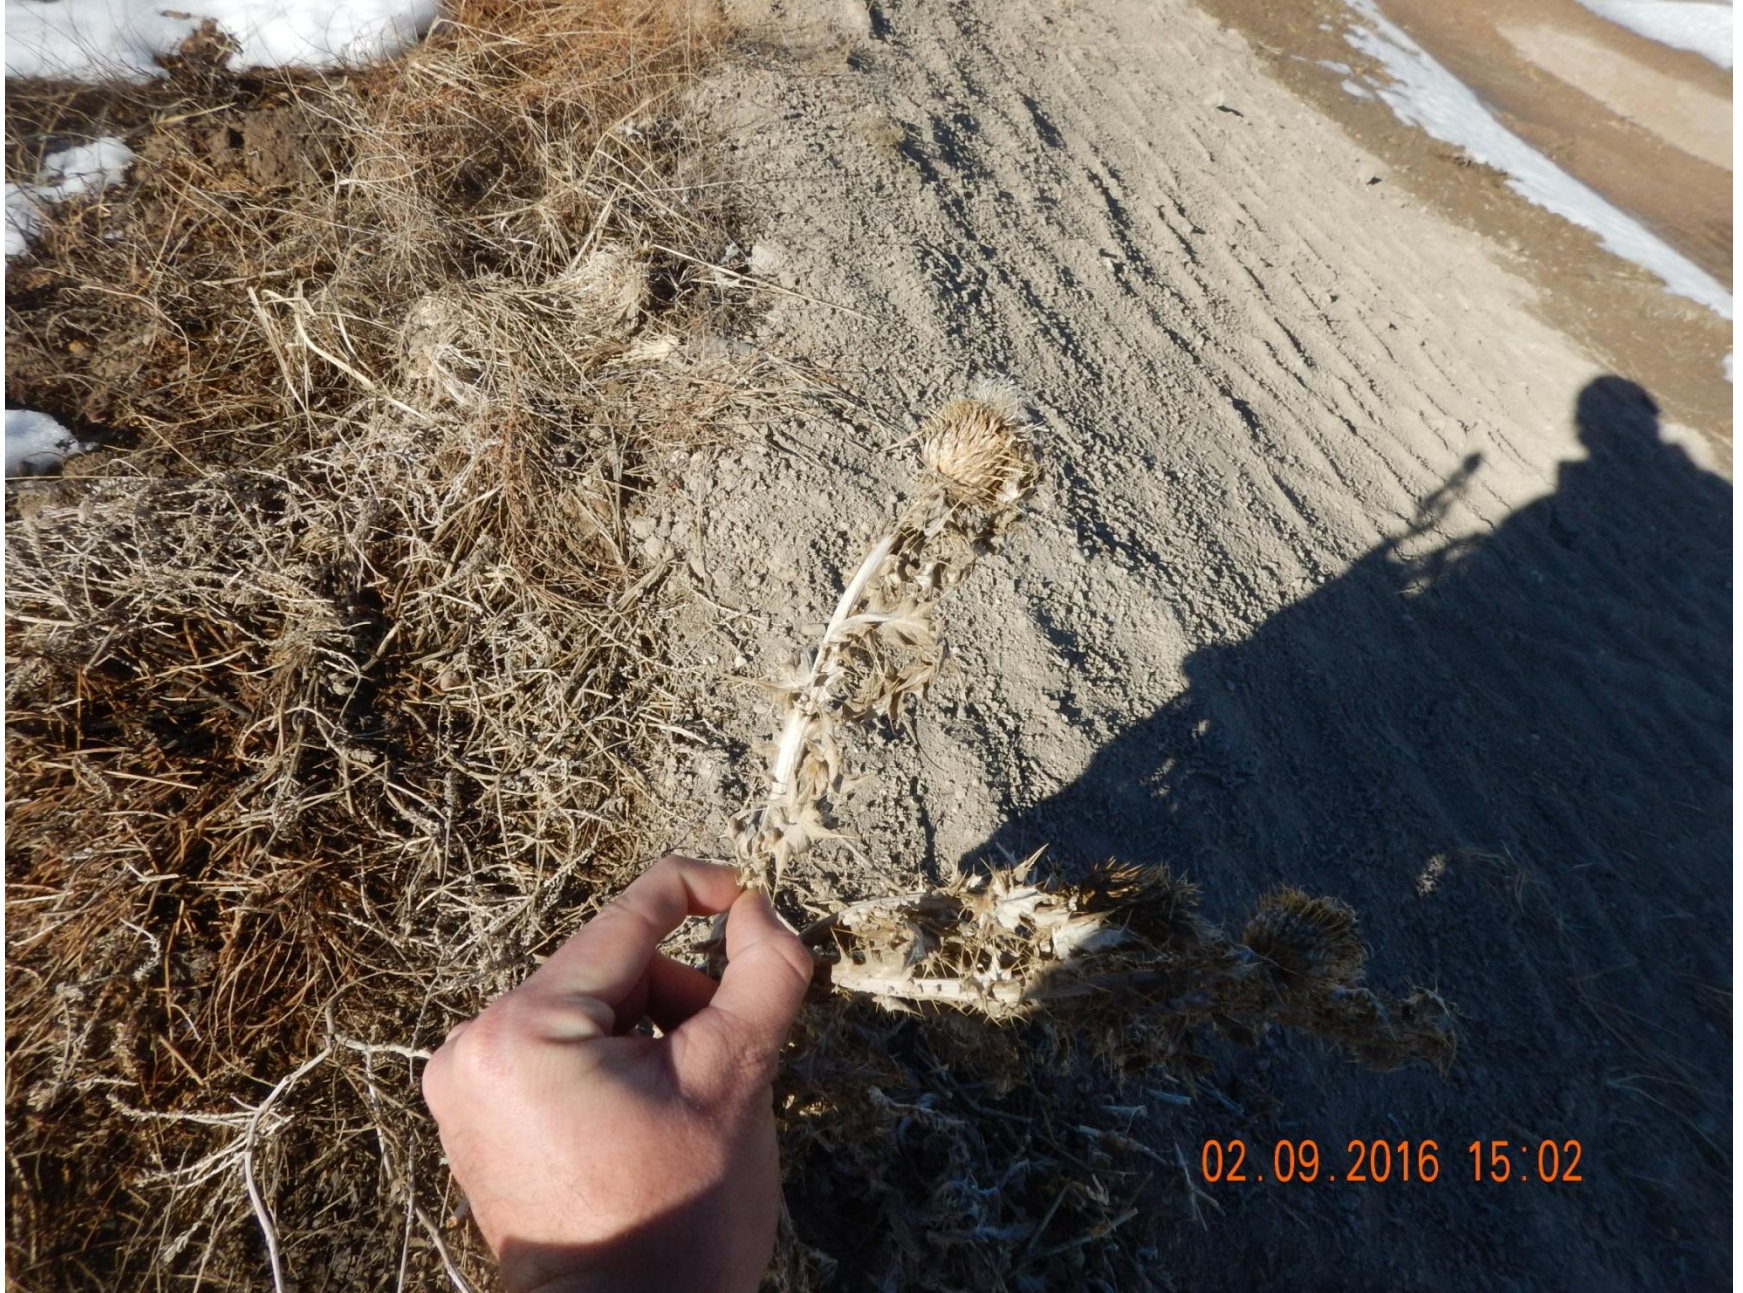
Figure 17: Photo taken from the berm on the west end of the location, facing east. Photo of musk thistle (*Carduus nutans*).

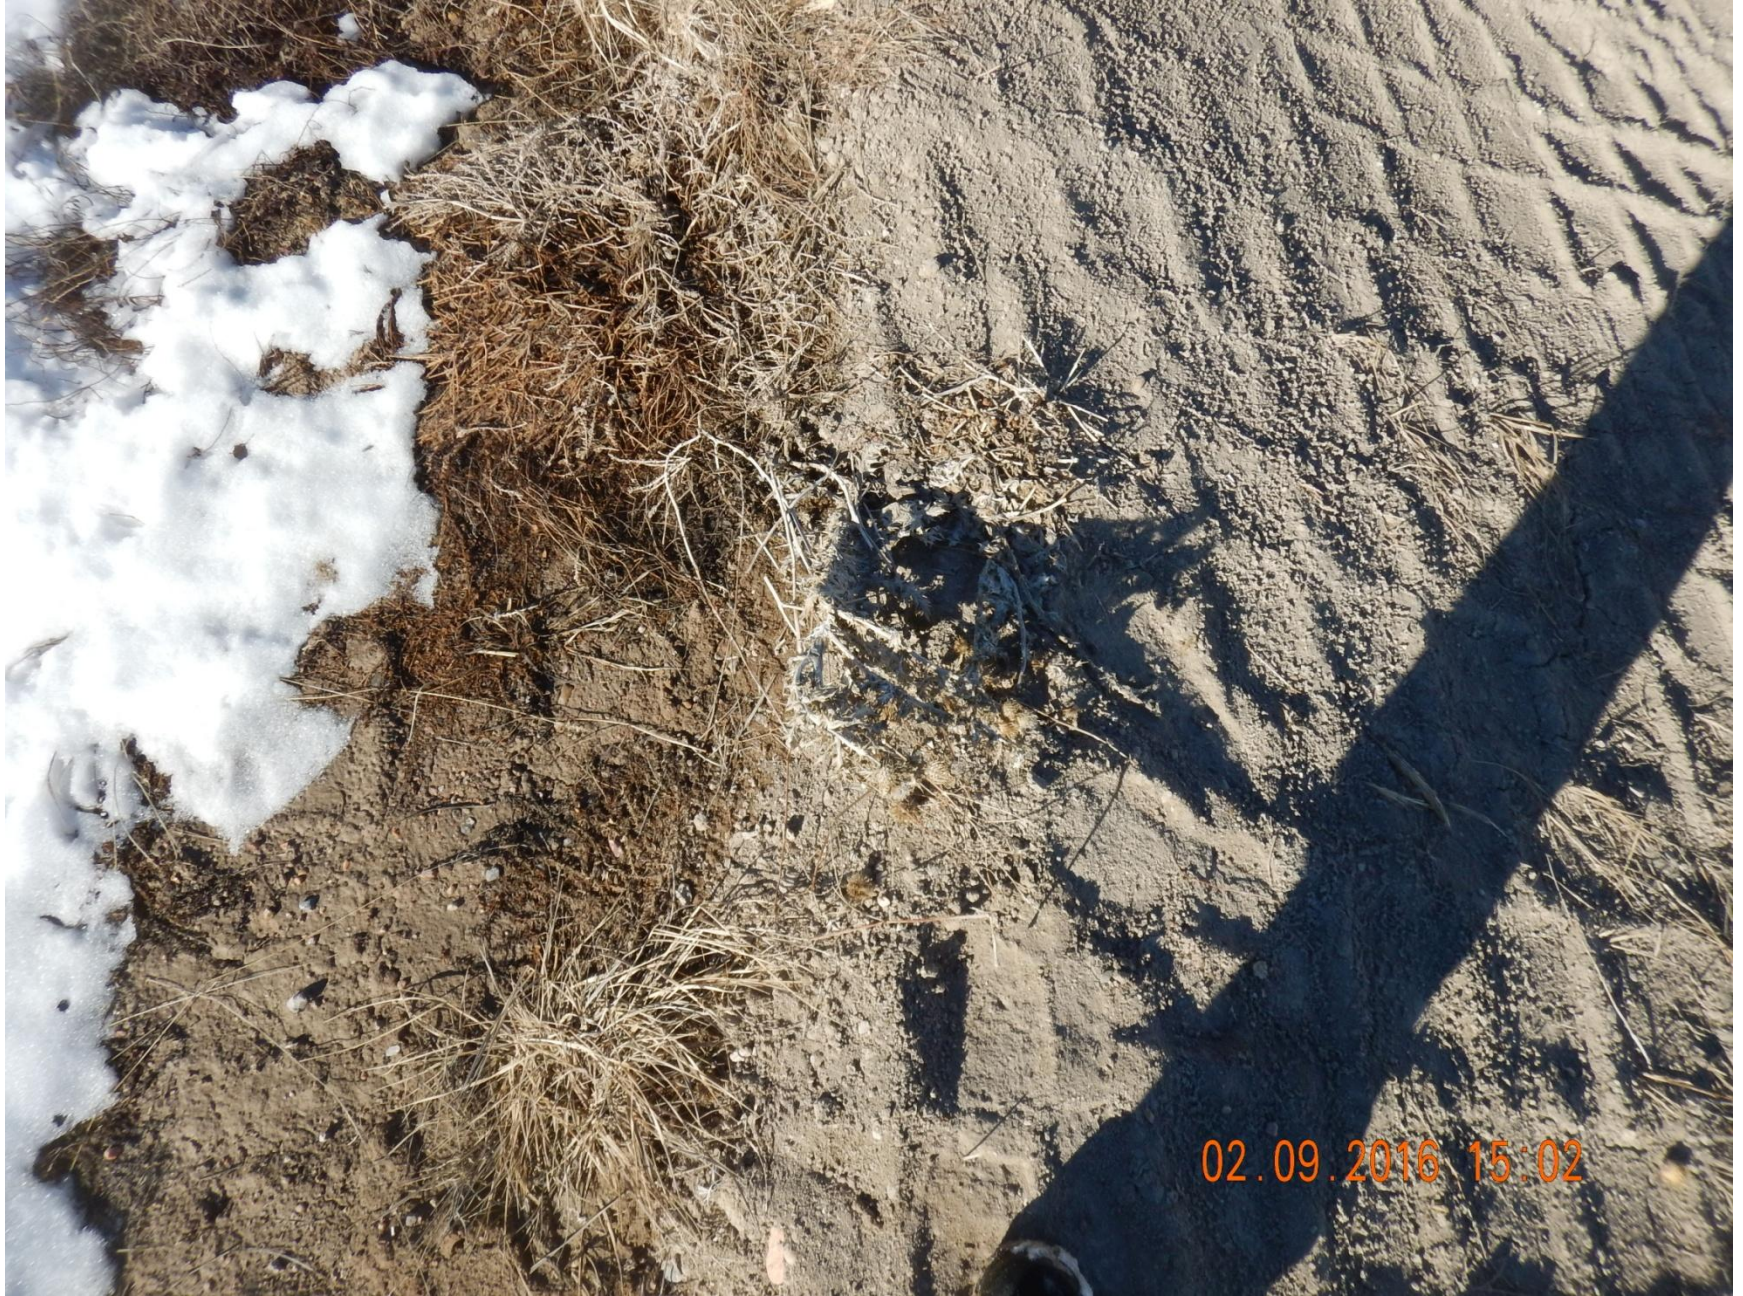
Figure 18: Photo taken from the berm on the west end of the location, facing east. Photo of musk thistle (*Carduus nutans*).
