Western Water & Land, Inc.

RE: Status Report: Drill Pads KP 22-17, KP 24-17& KP 34-18 COGCC Rule 317B Post DCPS Operations Water Quality Sampling, September/October 2015

**Figure 1: September/October 2015 DCPS Operations
Rule 317B Sampling Evaluation
S 17 & 18, T6S, R91W, 6 PM**

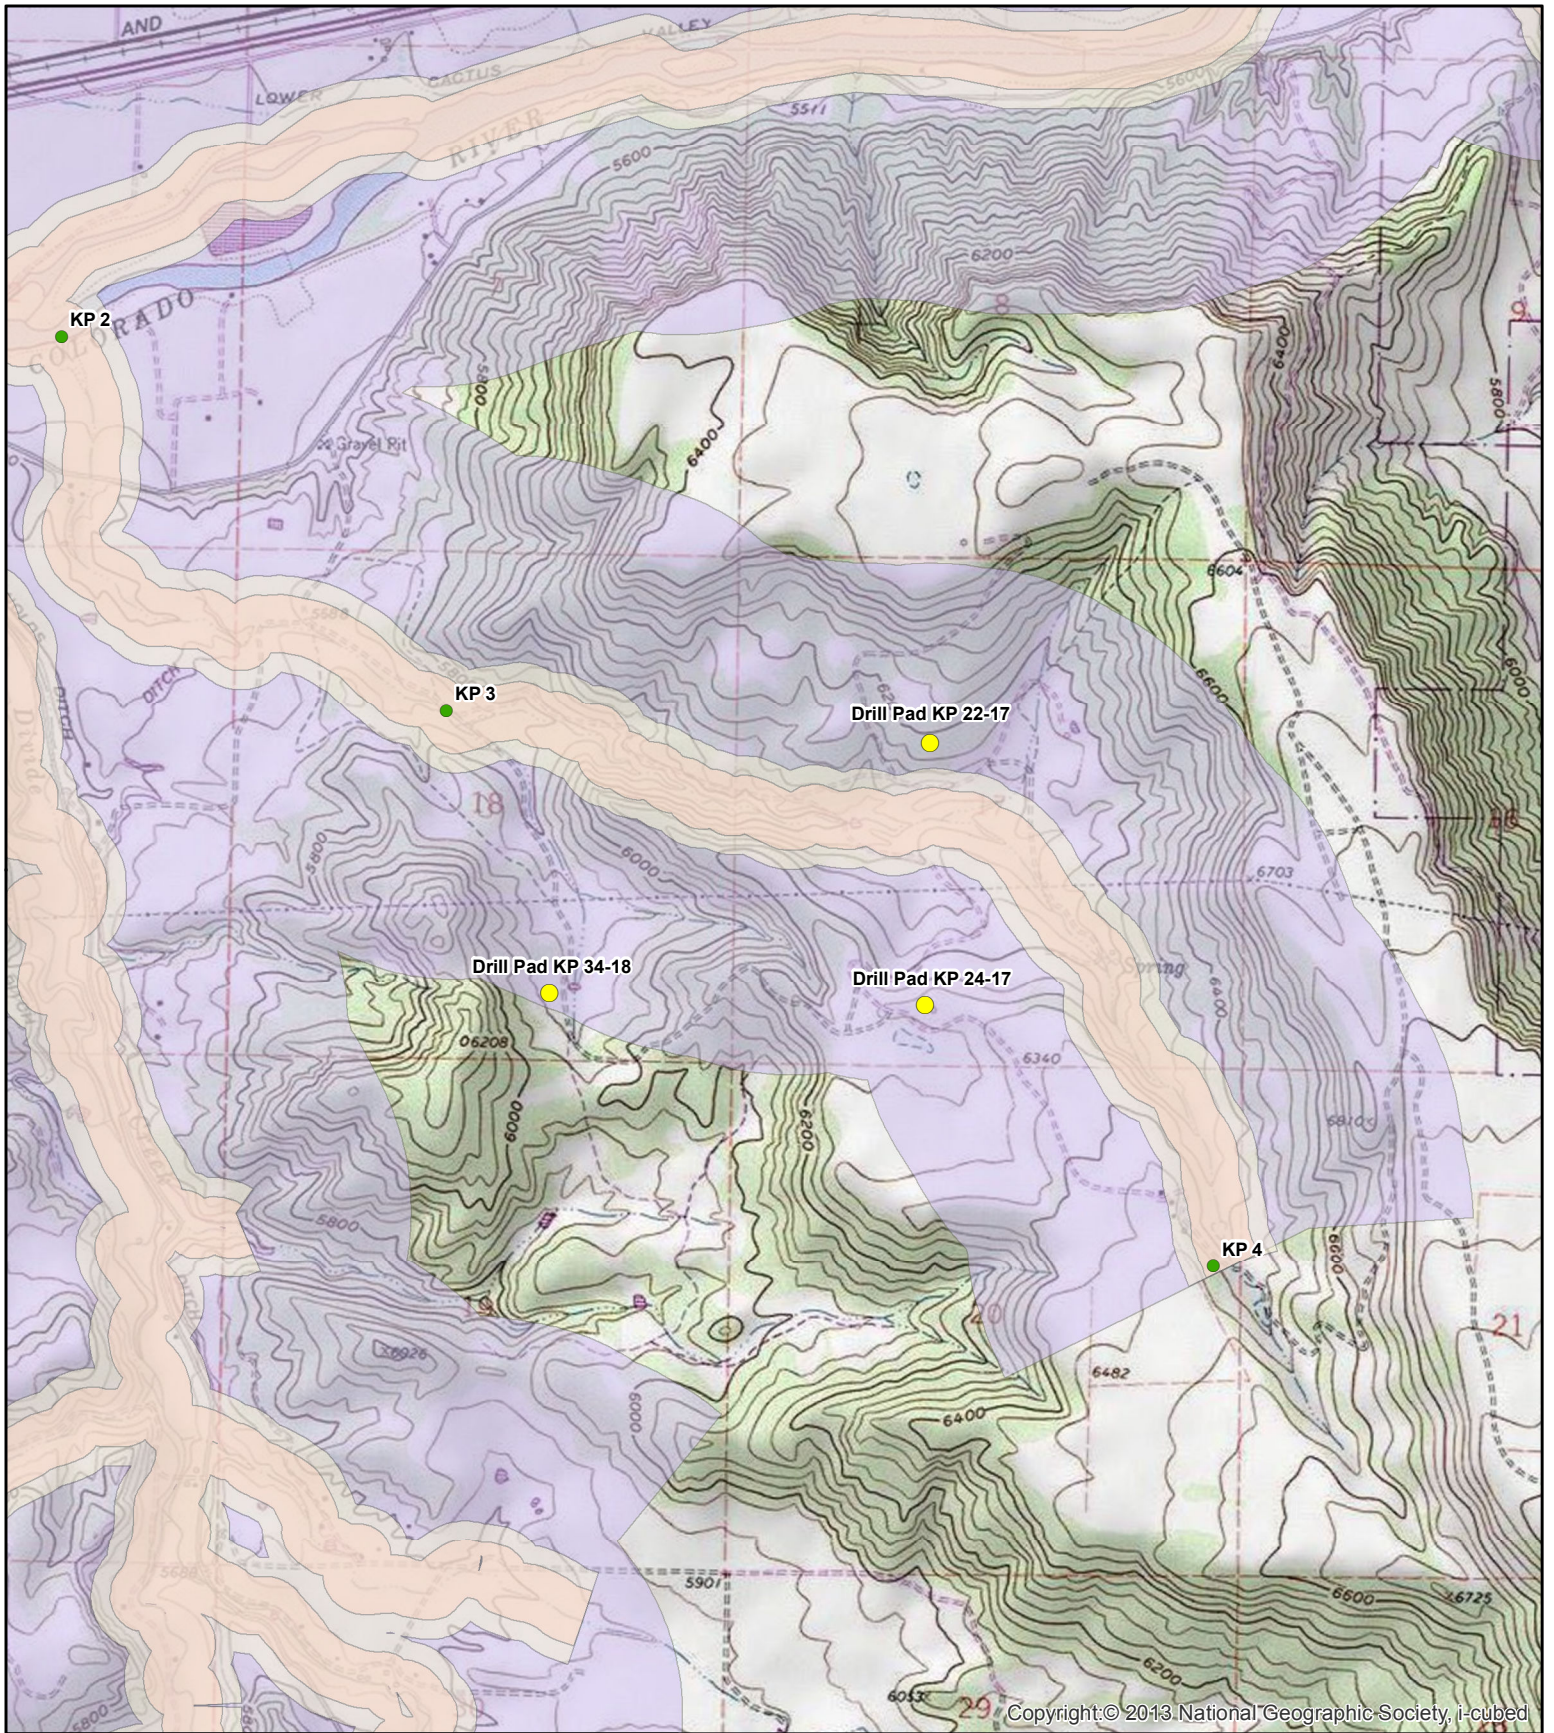
Previously established sampling locations for the SSWSA were provided to WWL by WPX. The sampling locations were established by HRL Compliance Solutions, Inc. (HCSI). Sampling locations downgradient of the referenced WPX DCPS Operations locations are shown in Figure 1. Sampling location KP 3 (COGCC Facility ID 752549) is the nearest downgradient sampling location to the referenced WPX DCPS Operations locations and was therefore identified as the preferred sampling location.

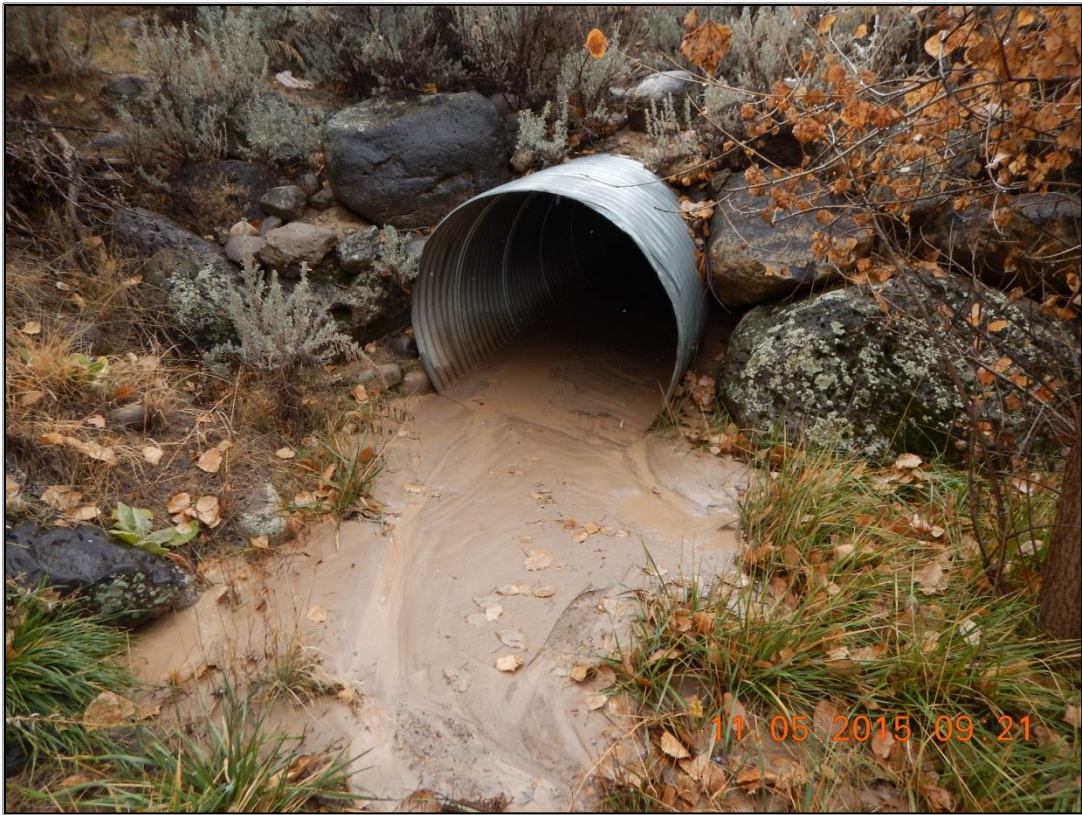
Sampling location KP 3 was visited by WWL personnel on November 5, 2015. This sampling location resides in an ephemeral drainage immediately downgradient of a culvert under the access road. Small amounts of standing water were present in the drainage and a slow trickle of water was flowing through the culvert but was an insufficient amount for the collection of a water quality sample. The next downgradient sampling location, KP 2 (COGCC Facility ID 752548), was not visited because WPX does not have property owner consent to access this location. Photographs from the field activities are

Photo 1. Sampling location KP 3. (November 5, 2015)

included in Attachment A. As a result of these events, no samples were collected during the September/October 2015 DCPS Operations sampling event.

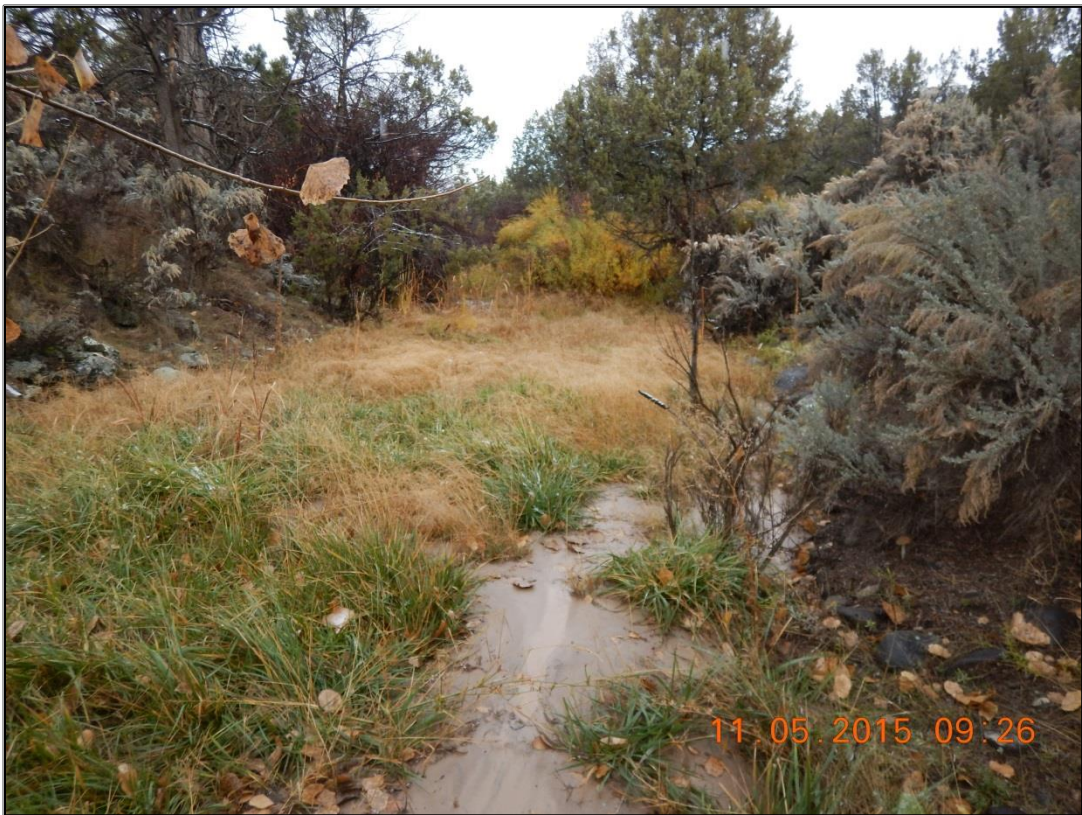
Photo 2. Drainage downstream of sampling location KP 3. (November 5, 2015)
