Photos from the Chivington pit closure project

Project: 8333
Document #: 2211853
Date: 03/09/2016

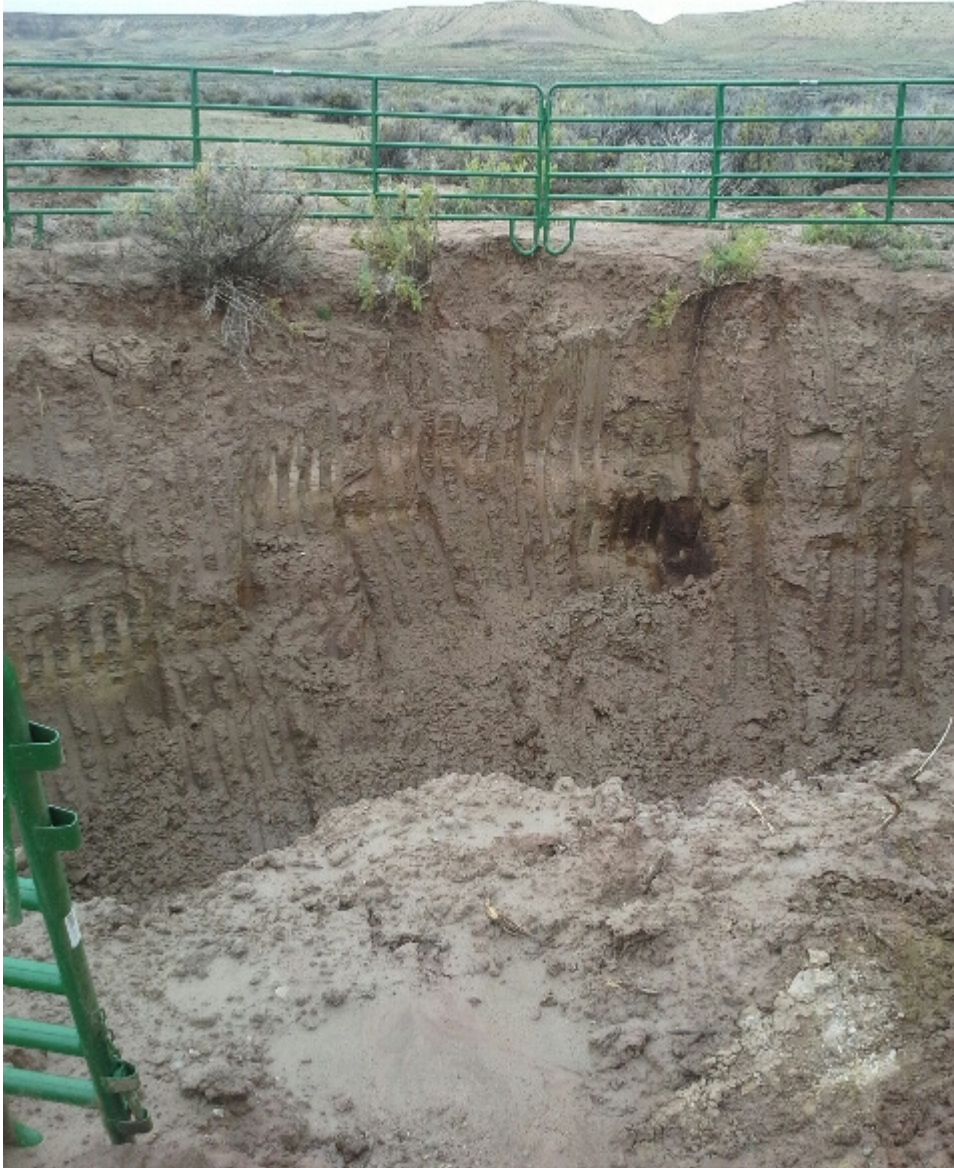
September 2014

This is after a major storm event and everything is very saturated. Note the oil seeping out of side-wall of excavation. This picture is facing North West. It is difficult to gain perspective from the pictures, and the coloration of the other contamination is not very visible due to the saturation.

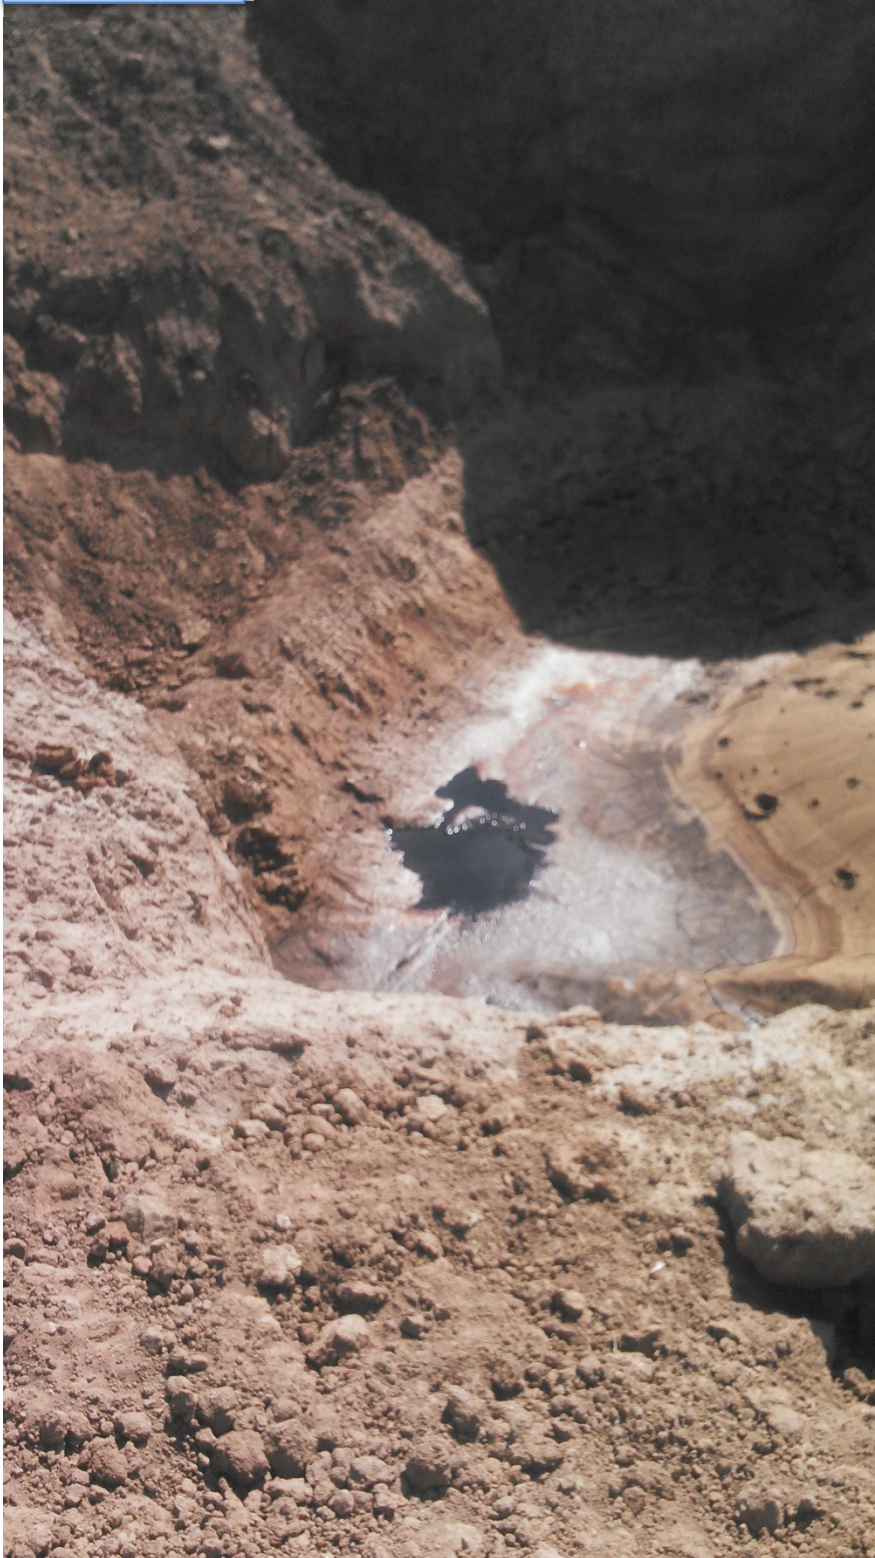
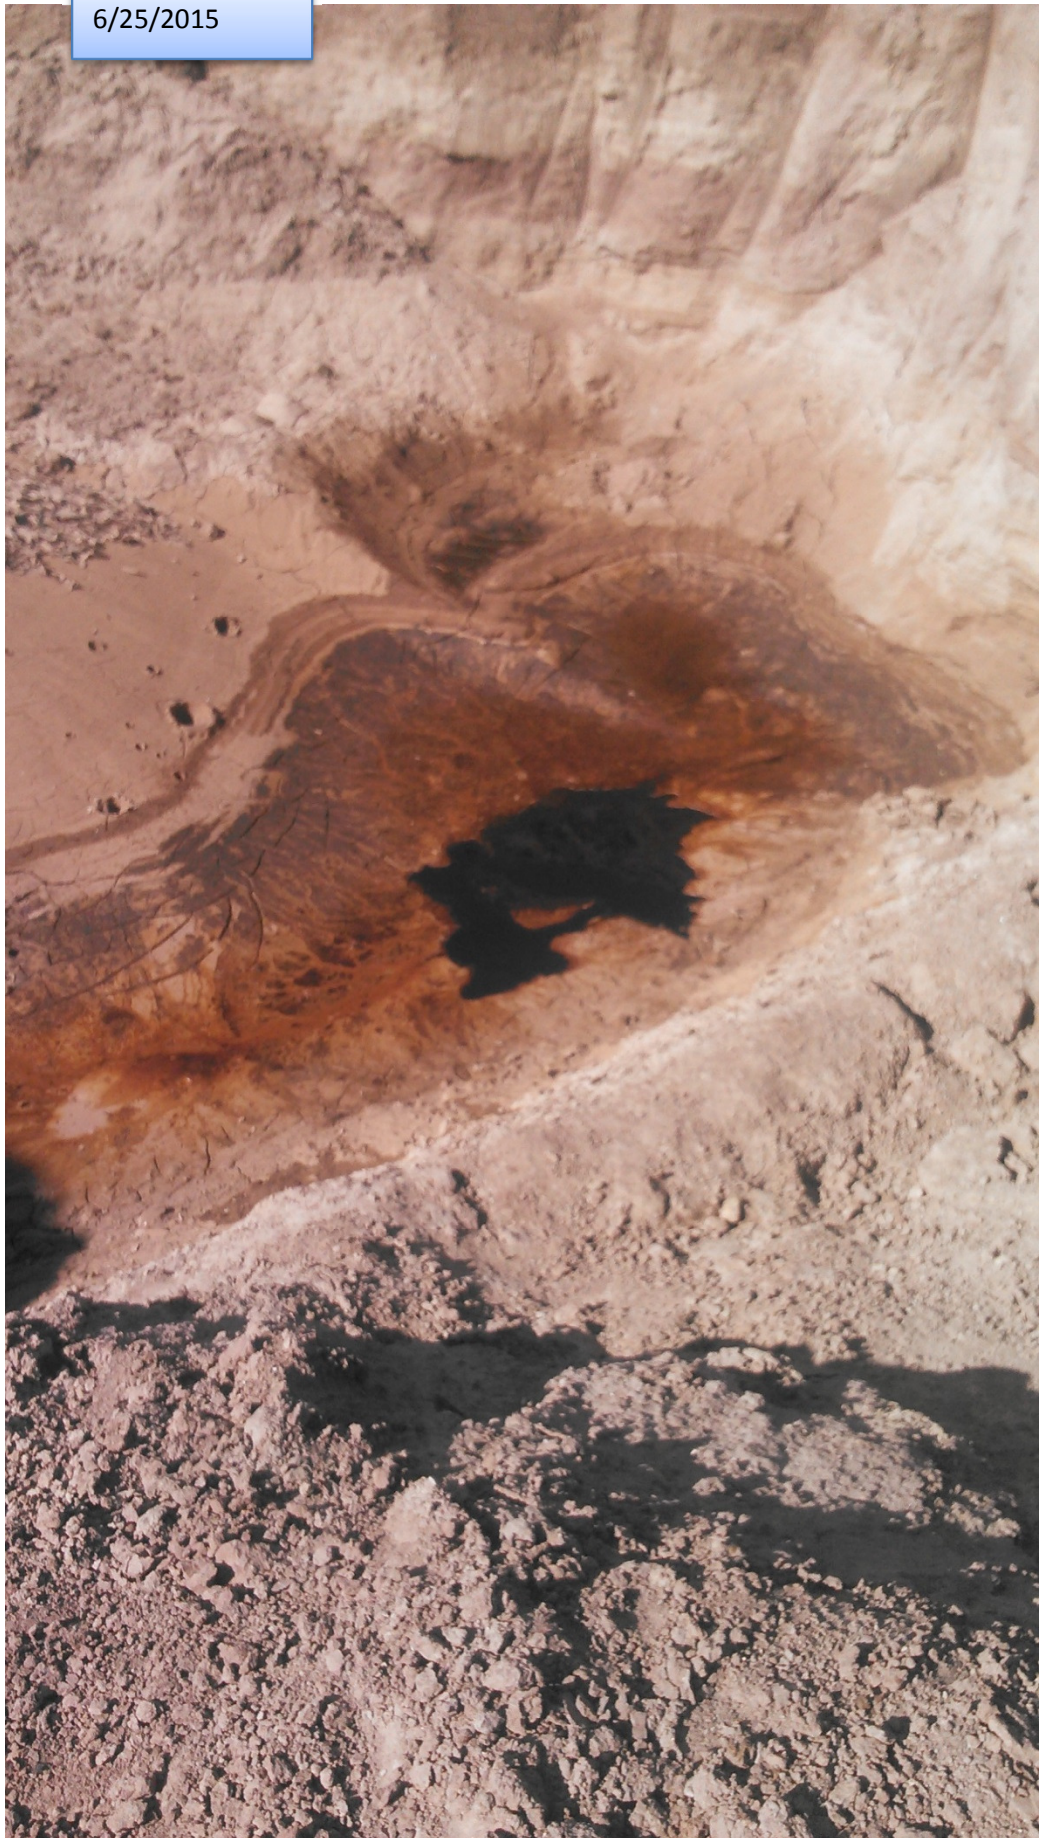
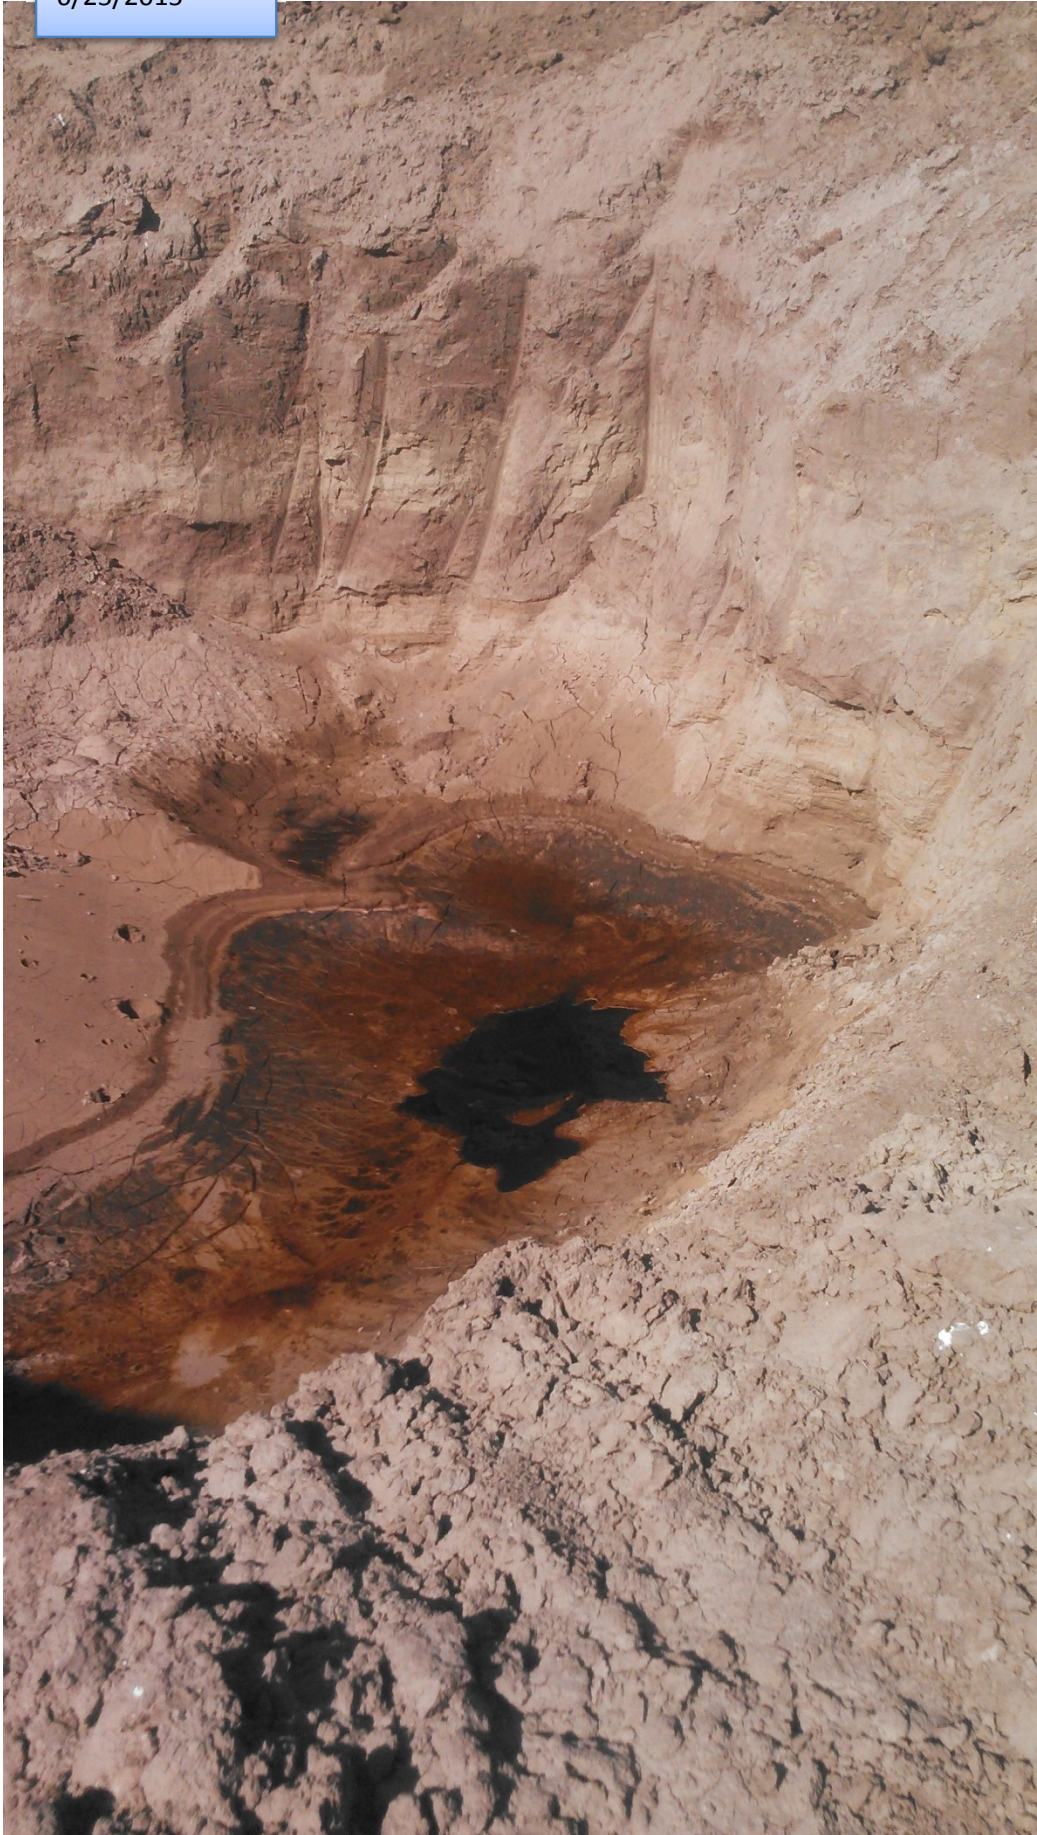
The following 3 pictures were taken after the major rain storms from June 2015. Storm-water had run into the pit. After a few days in the sun, the oil from in the ground floated to the surface. The storm-water and standing oil was sucked up with a vac truck and hauled to Great Divide Water disposal. This event did seem to greatly benefit the cleanup. The photos were taken looking down after most all of the storm-water/oil was sucked out

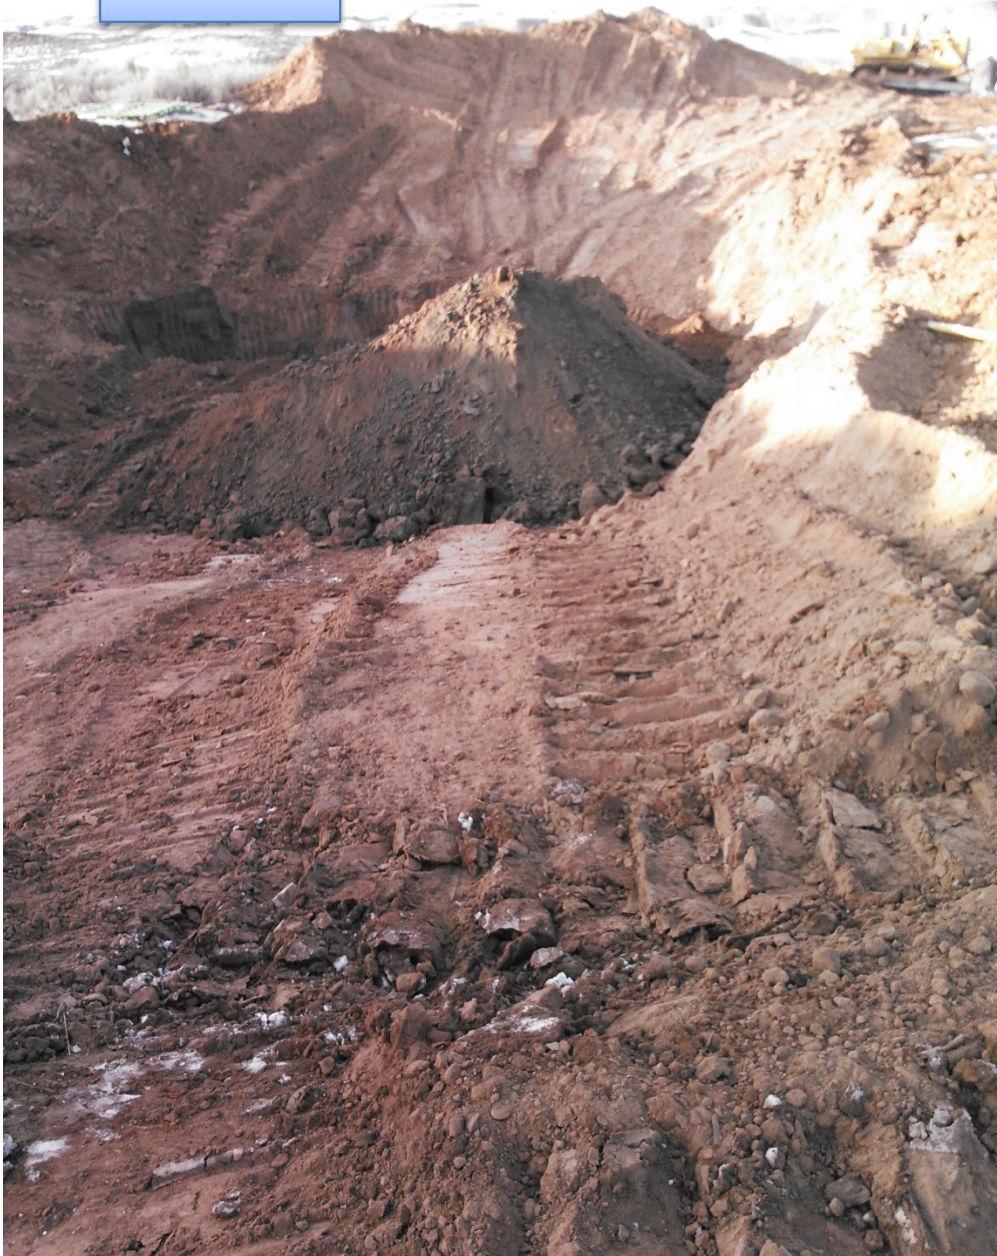
3/2/2015

3/2/2015. The soil pile in the center is contaminated, excavated from the pit bottom, working towards the south. Sample readings average around 12,000-20,000 ppm in this pile. It is difficult to see the coloration in the photos. The next photo will show the coloration. This picture is facing directly north.

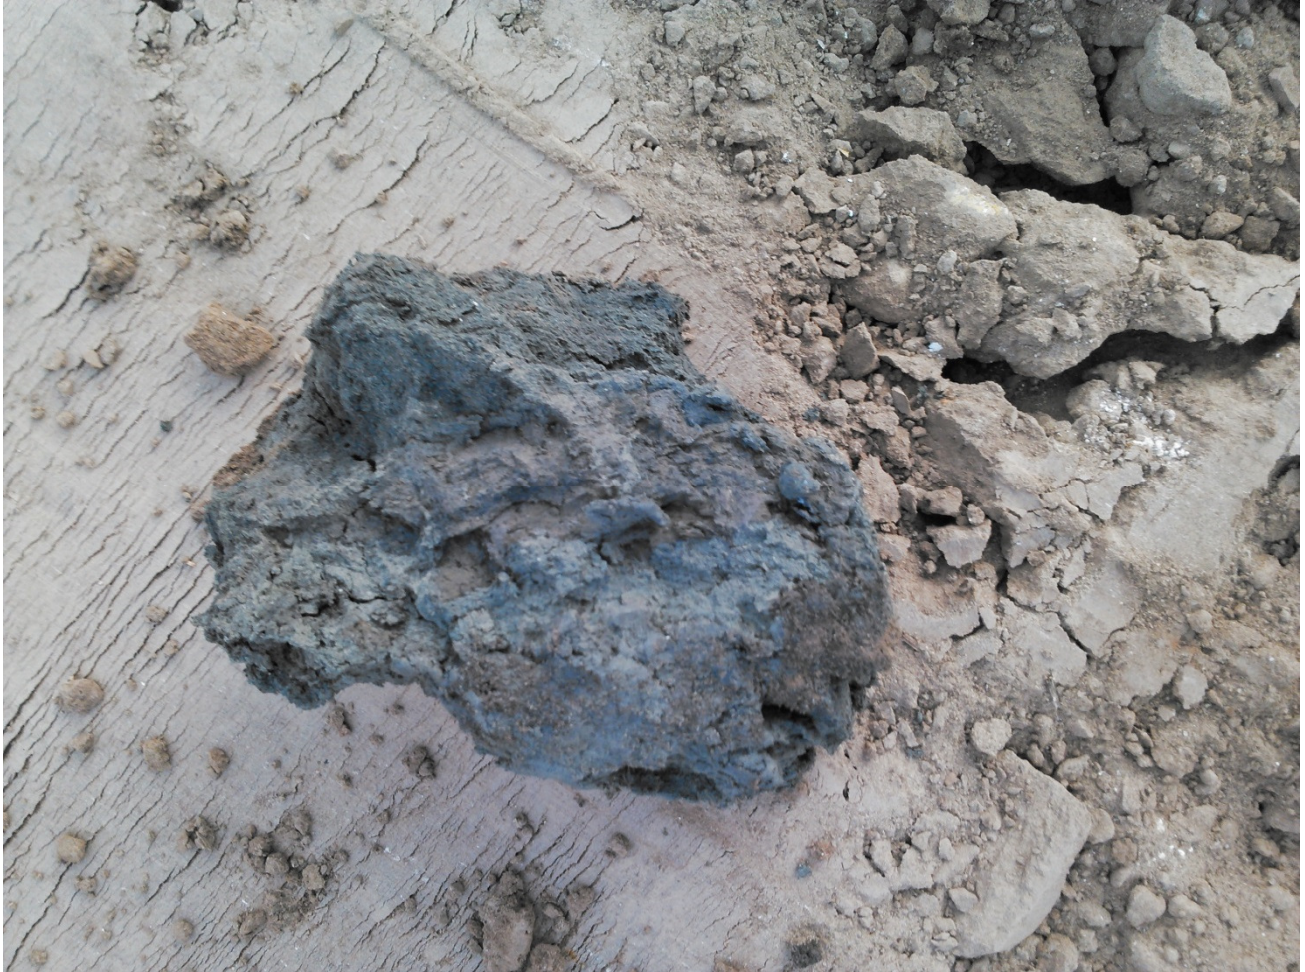
3/02/2015

This picture shows the coloration typical of the contaminated soil. It is a clod taken from the pile in the previous picture in contrast to clean soil. This sample was in the 12,000ppm range. After a period of a few days in the sun, the bad soils would get much lighter in color but still smell strong of oil/ condensate and have the same VOC readings.

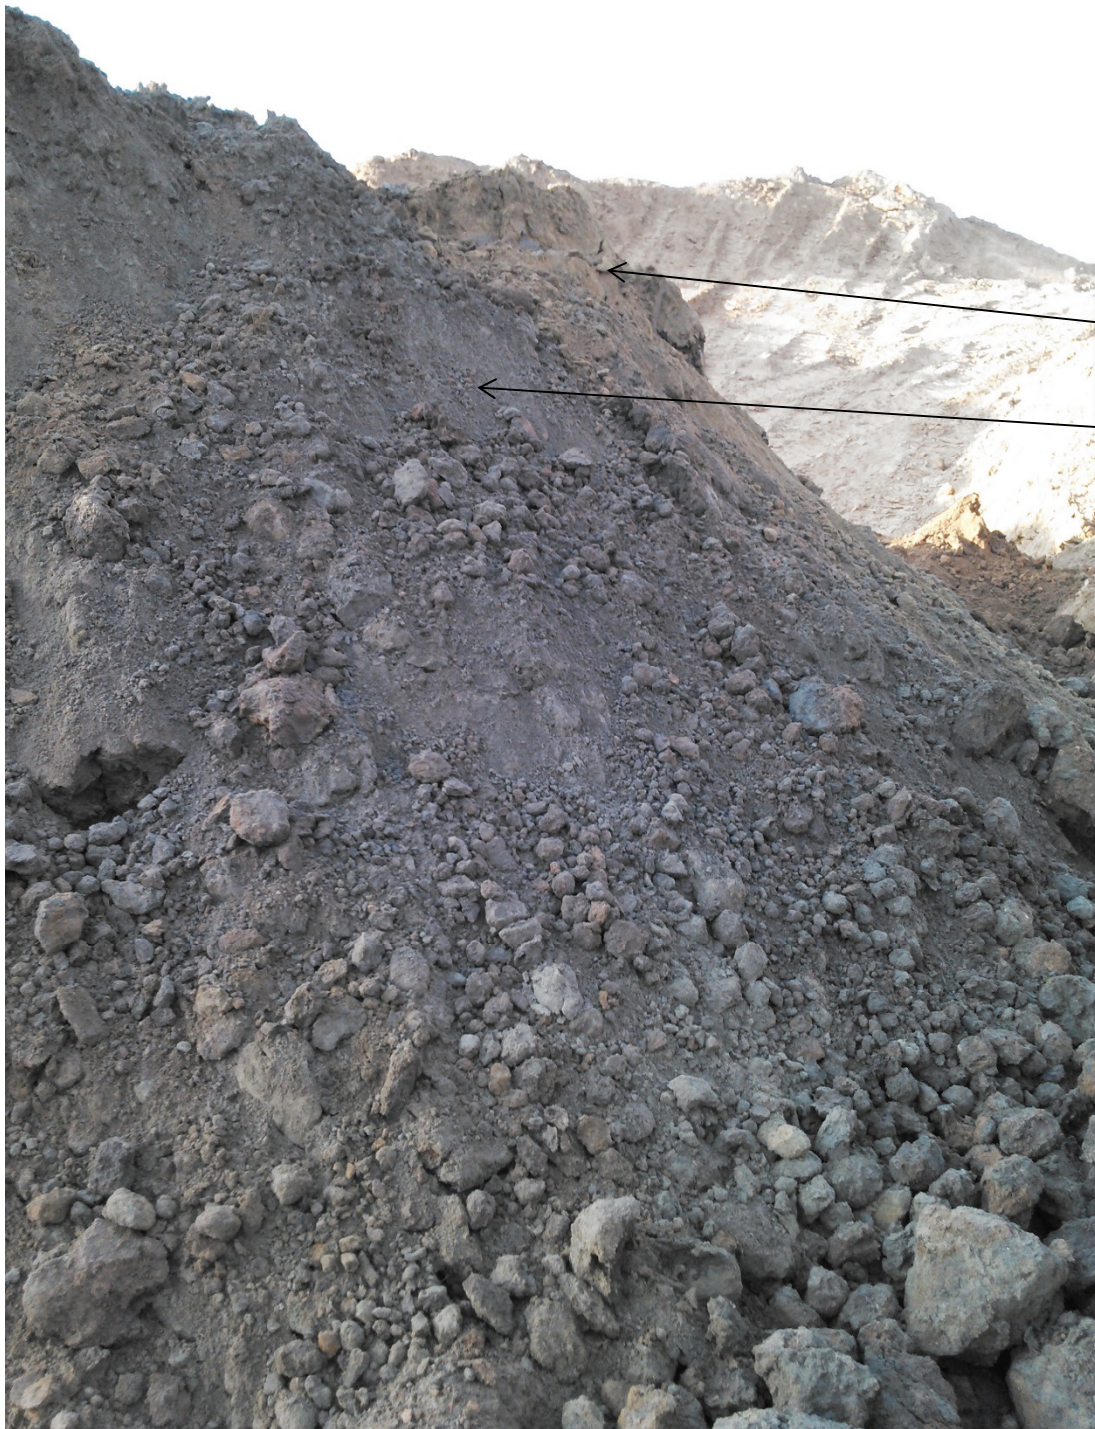
5/22/2015

You can note the color contrast between here and here

Contaminated soils from the southwest side. This was about where it cleaned up to the south. Again, it is difficult to see the color contrast in the picture. Also, this pile had been sitting exposed several days and had lost color. Readings of this pile were 900-8000ppm

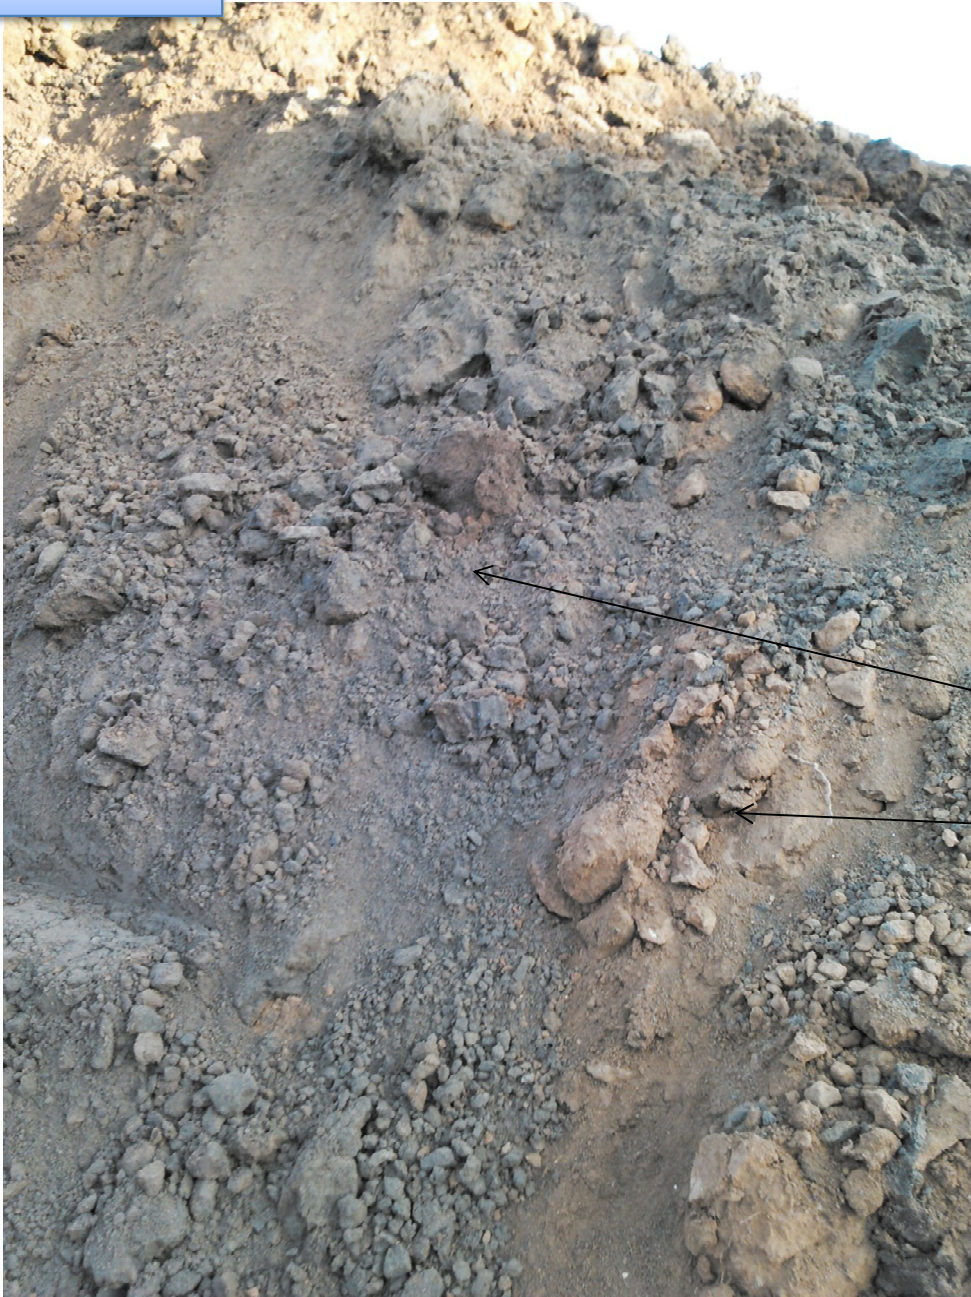
7/25/2015

You can note the color contrast between here and here

This is another contaminated soil pile excavated from the south side. This finished the south side of pit excavation. Work on the northwest side remains.

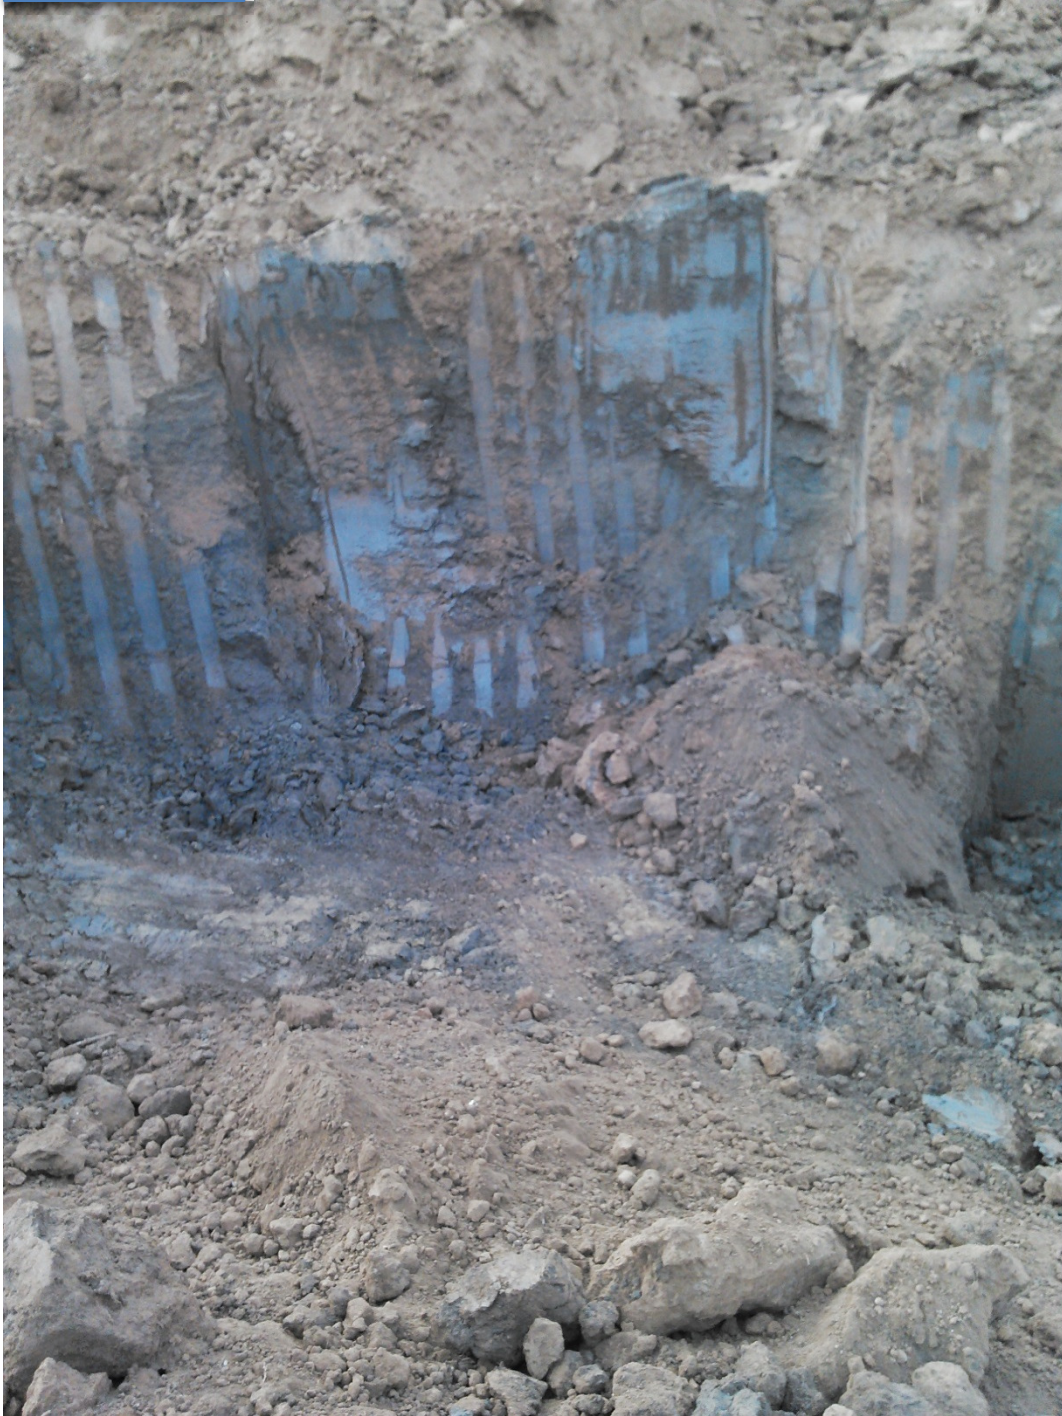
7/25/2015

This is an example of the contamination as it is excavated. This is from the pit bottom north side. You can see the dark stained soil versus lighter color soils.

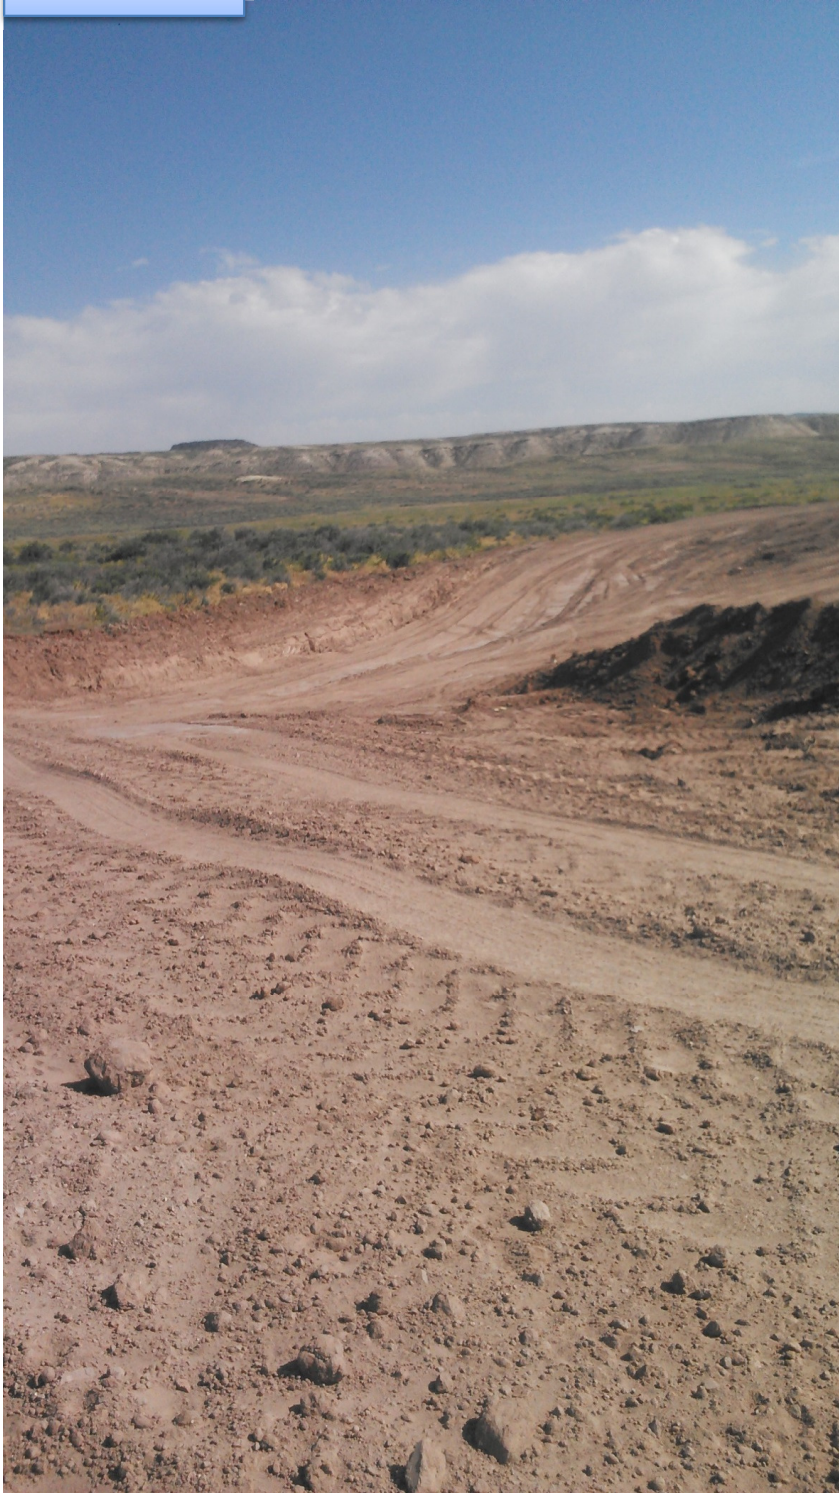
3/2/2015

This picture is from the west side looking northeast. Beginning of benching down on northwest to strip and stockpile clean soils and get safe access to north west side of pit.

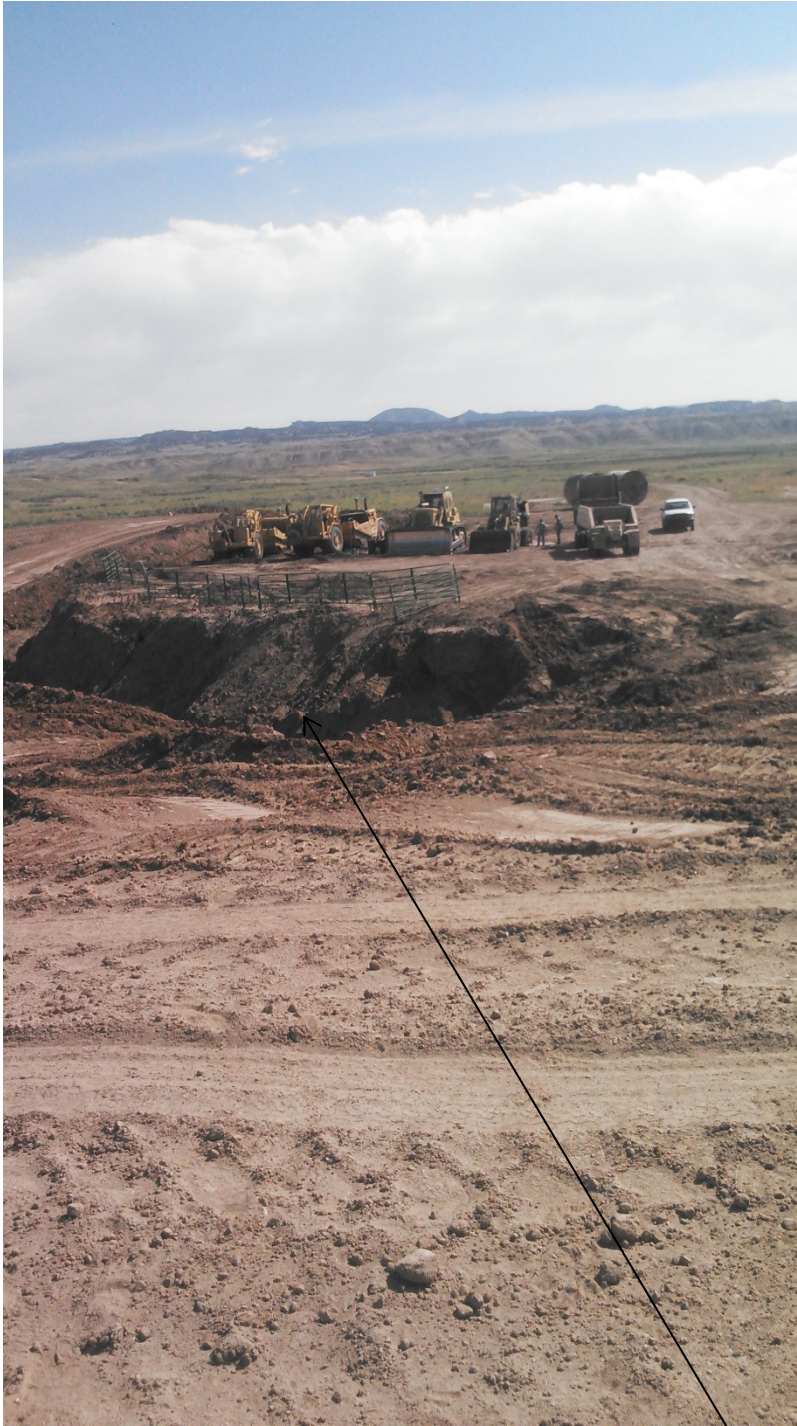
4/16/2015

This Picture is standing west facing east of pit excavation as benching on west side was in process

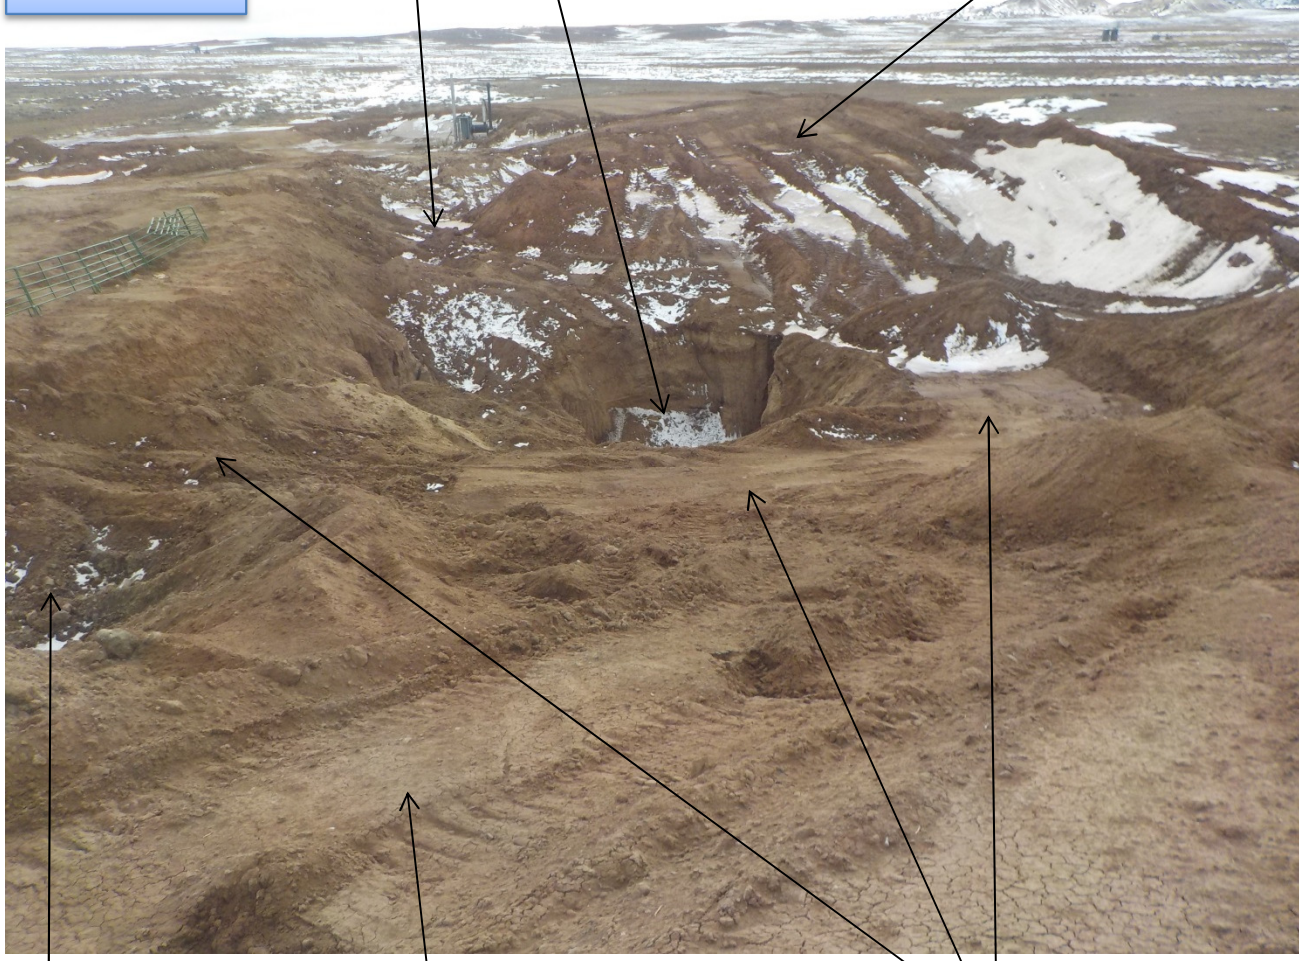
2/17/2016

This Picture is standing North Facing South

South Hole

Pit Bottom (Not visible)

Clean Spoil Pile

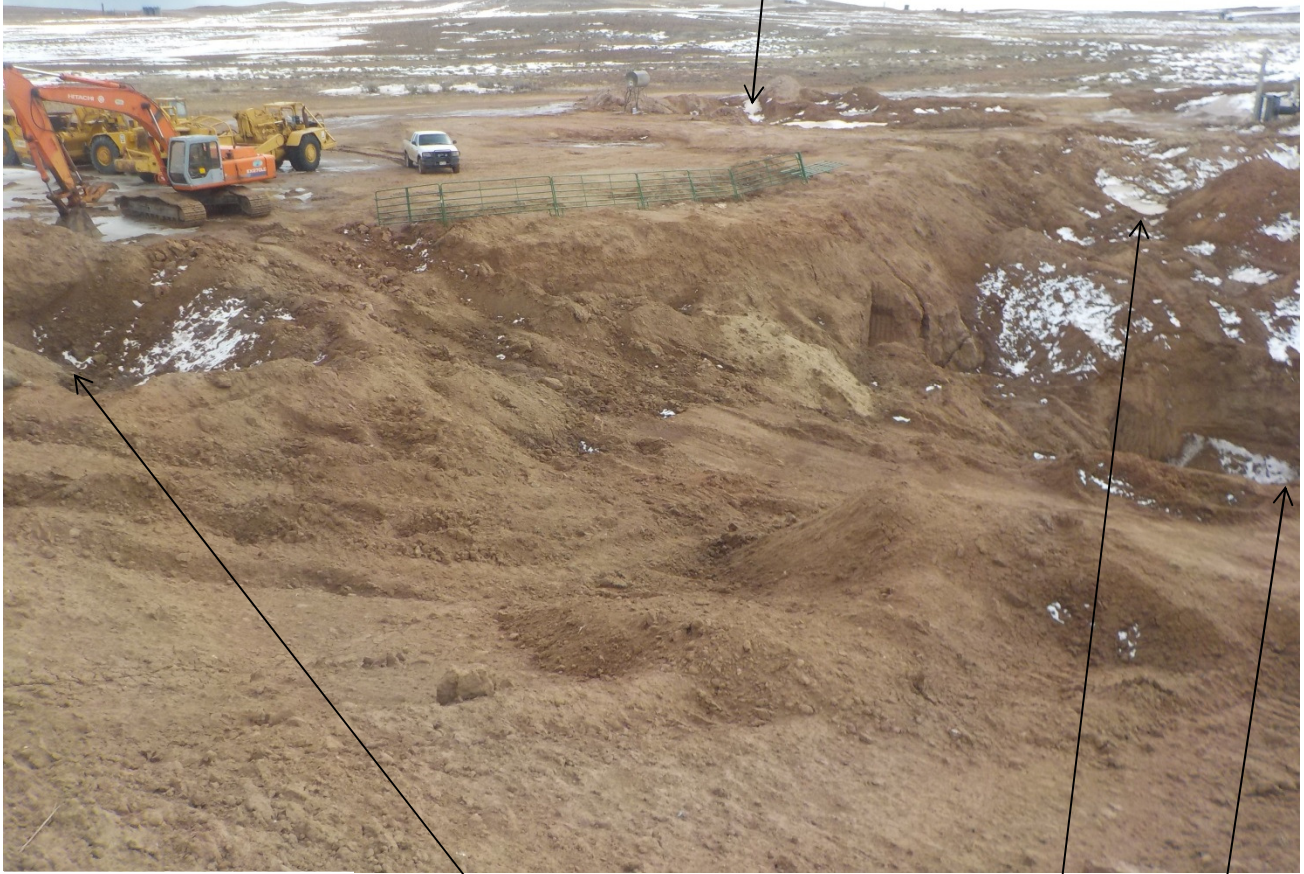
2/17/2016

North upper hole

Clean Spoil pile

Access road Benching

Tank Battery Excavation

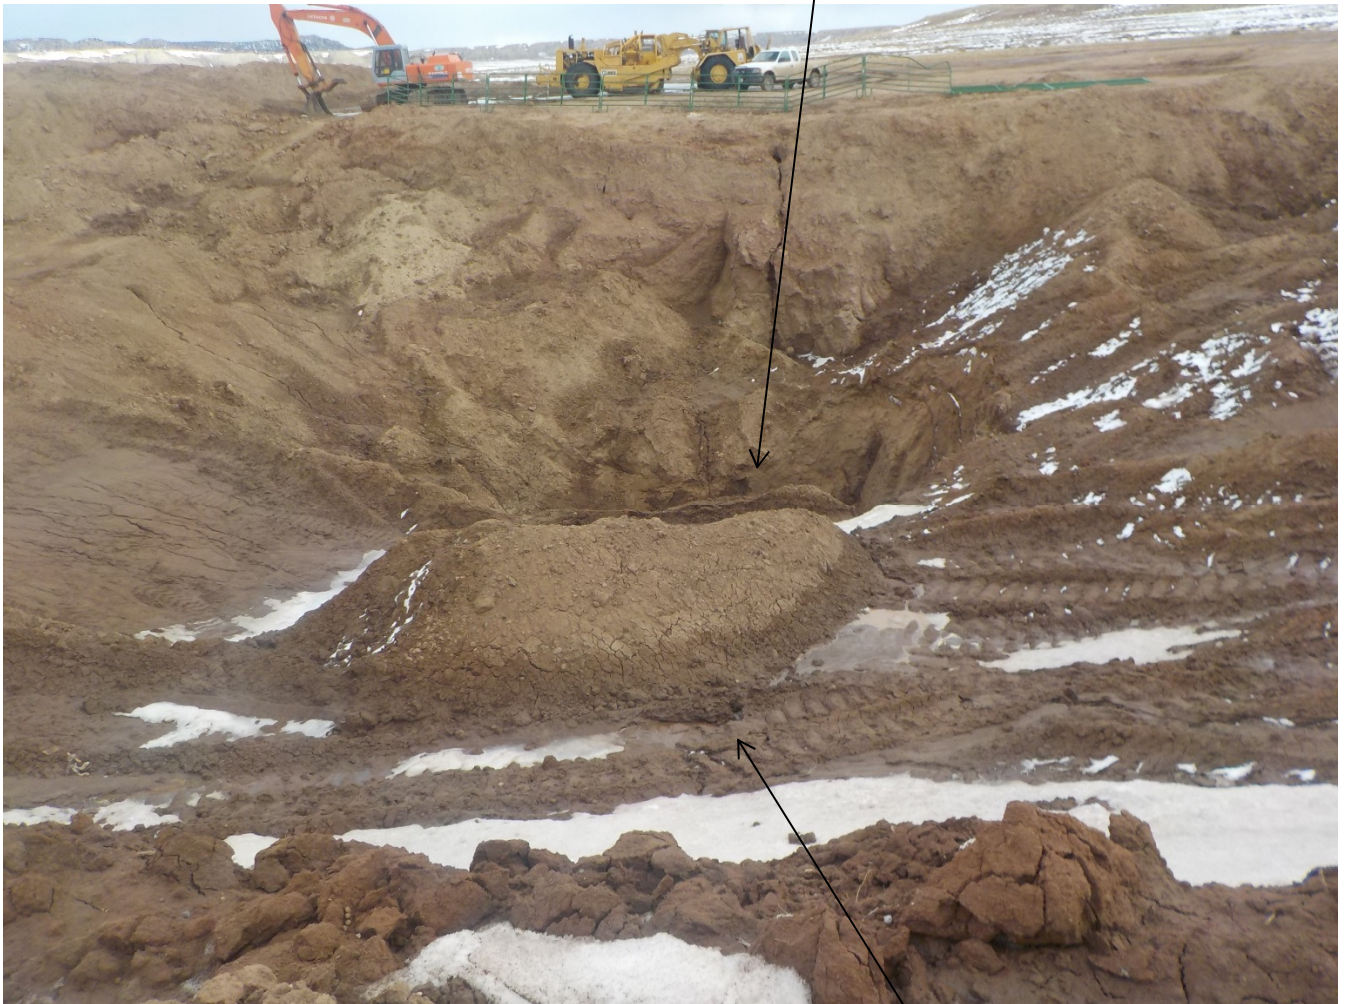
2/17/2016

This picture is standing on clean spoil pile to the North of pit excavation facing to the south east

North upper hole

South hole, Where contaminated pocket and trash was found

Pit Bottom (Not Visible)

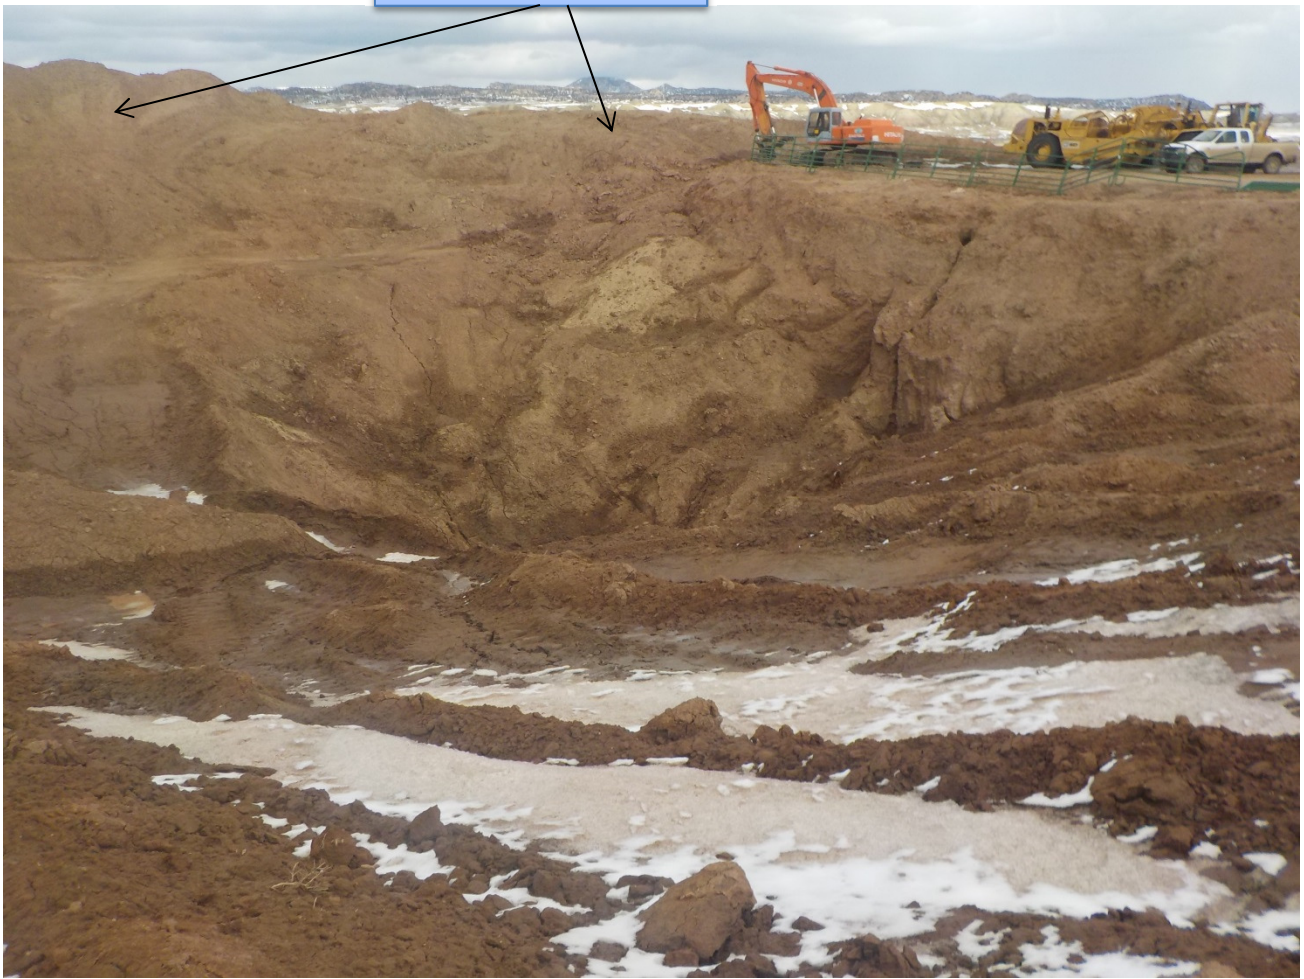
2/17/2016

Pit Bottom (not Visible)

This Picture is Standing on the west facing east. The bottom 20'-30' of the pit is not visible here.

This is an access road-bench area to mid-way down the pit. This is where soil from bottom with excavator working in pit bottom is placed and accessed with a loader and brought to surface and is loaded to trucks.

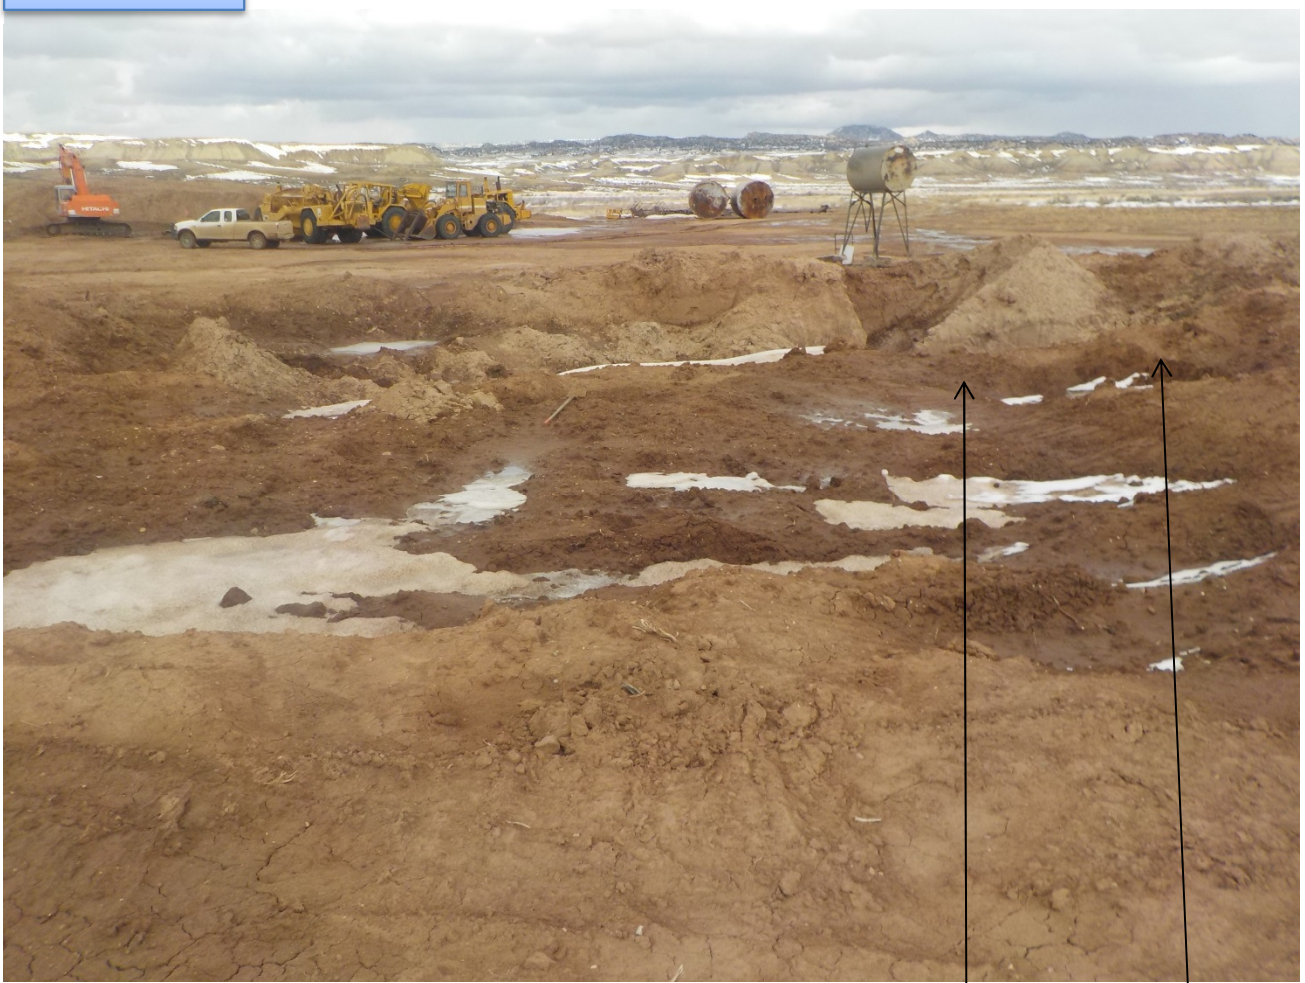
2/17/2016

Clean Soil Spoil pile

This is standing southwest facing northeast of the Pit Excavation. The bottom 20'-30' of the pit is not visible
