Photos from the Chivington pit closure project

Project: 8333
Document #: 2211853
Date: 03/09/2016

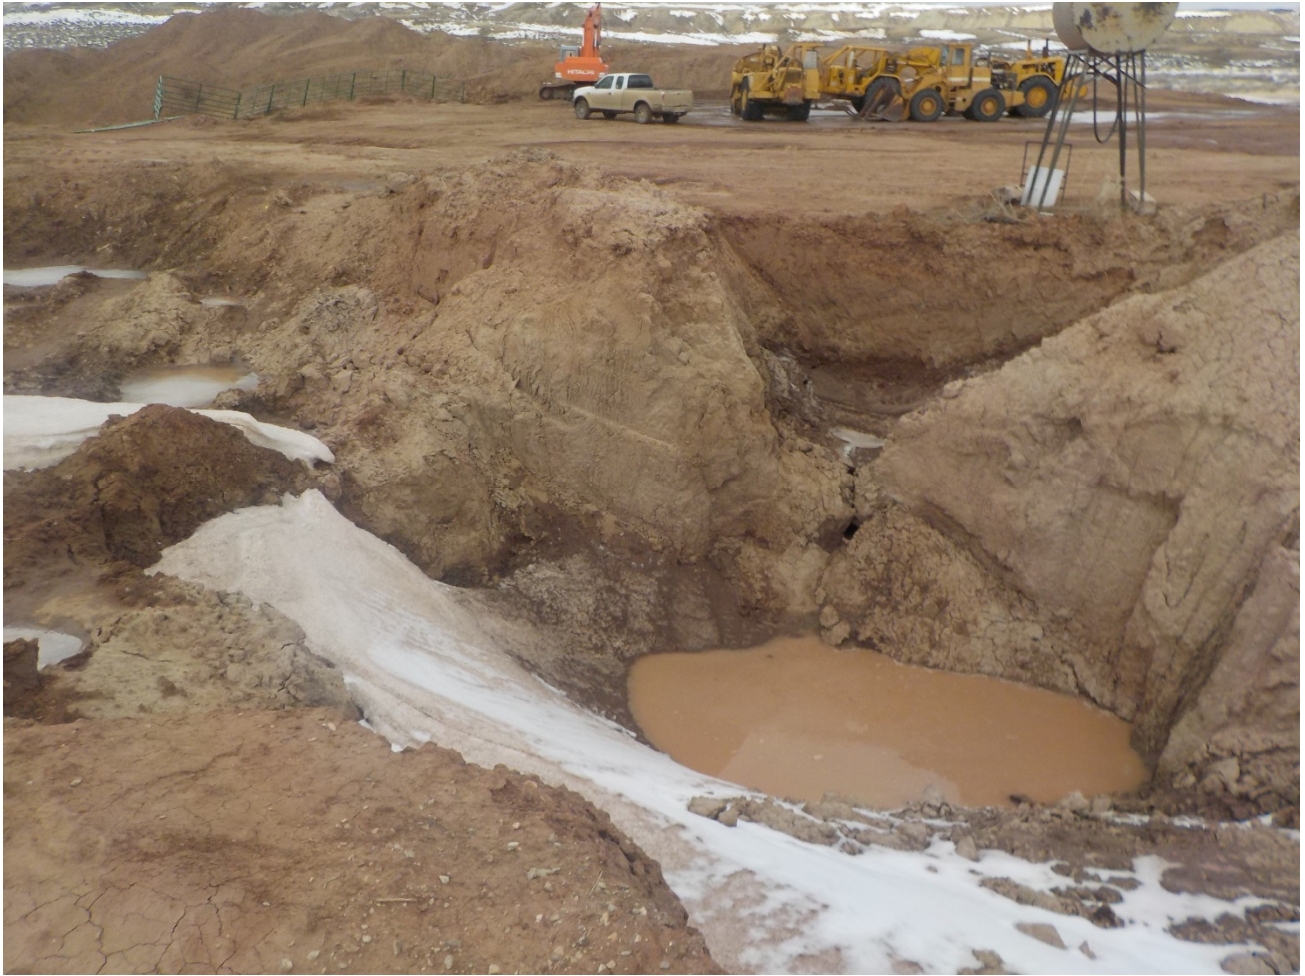
2/17/2016

This picture is of tank battery Excavation standing south west facing north east

Deeper section (bottom not visible)

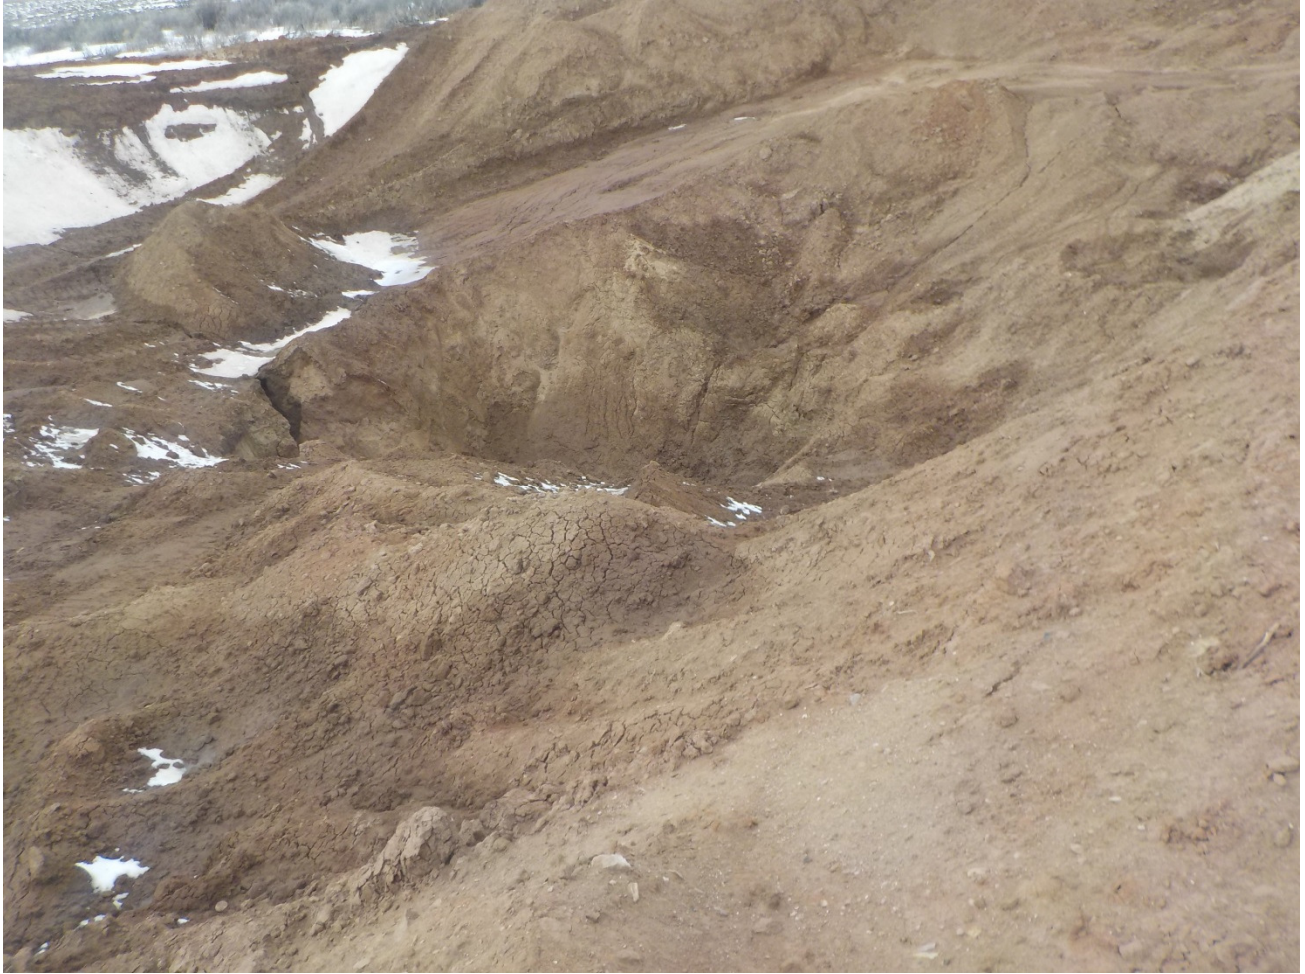
2/17/2016

This picture is of the tank battery excavation to the southeast. This is facing to the north. The standing water in the pit is storm water as most of the snow had melted. The pits had trapped a large amount of drifting snow over the winter. This came from the snow-melt from drifts trapped in the pit

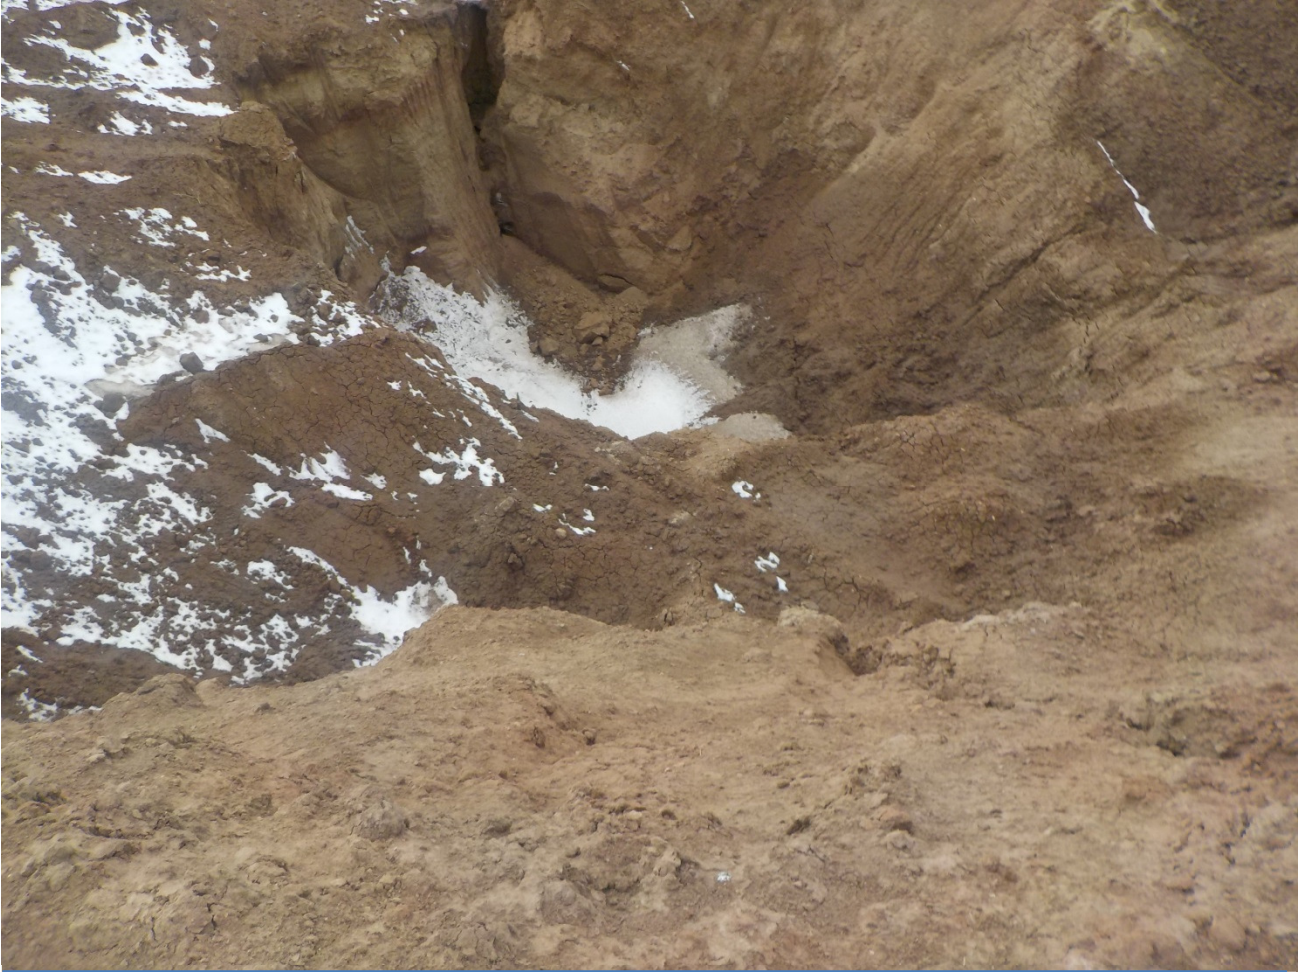
2/17/2016

This Picture is facing north. The center of the picture is the north upper hole where the pocket of contamination was found.
