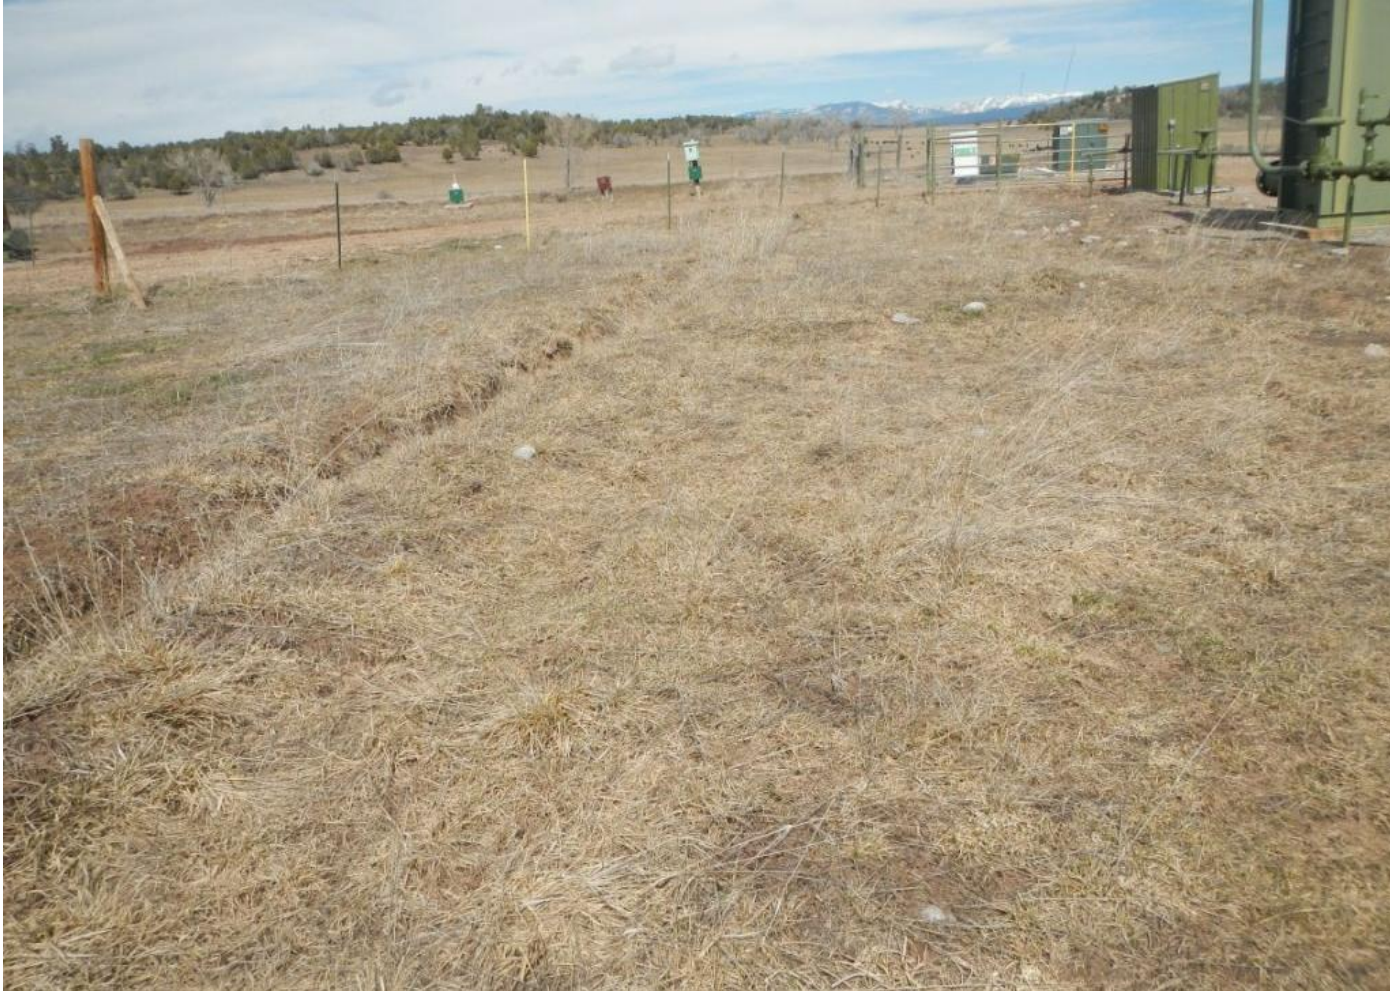
Photo 1. View of the western portion of the project area from the southwestern corner facing northward. Revegetation is comprised of smooth brome (*Bromus inermis*) and western wheatgrass (*Pascopyron smithii*).

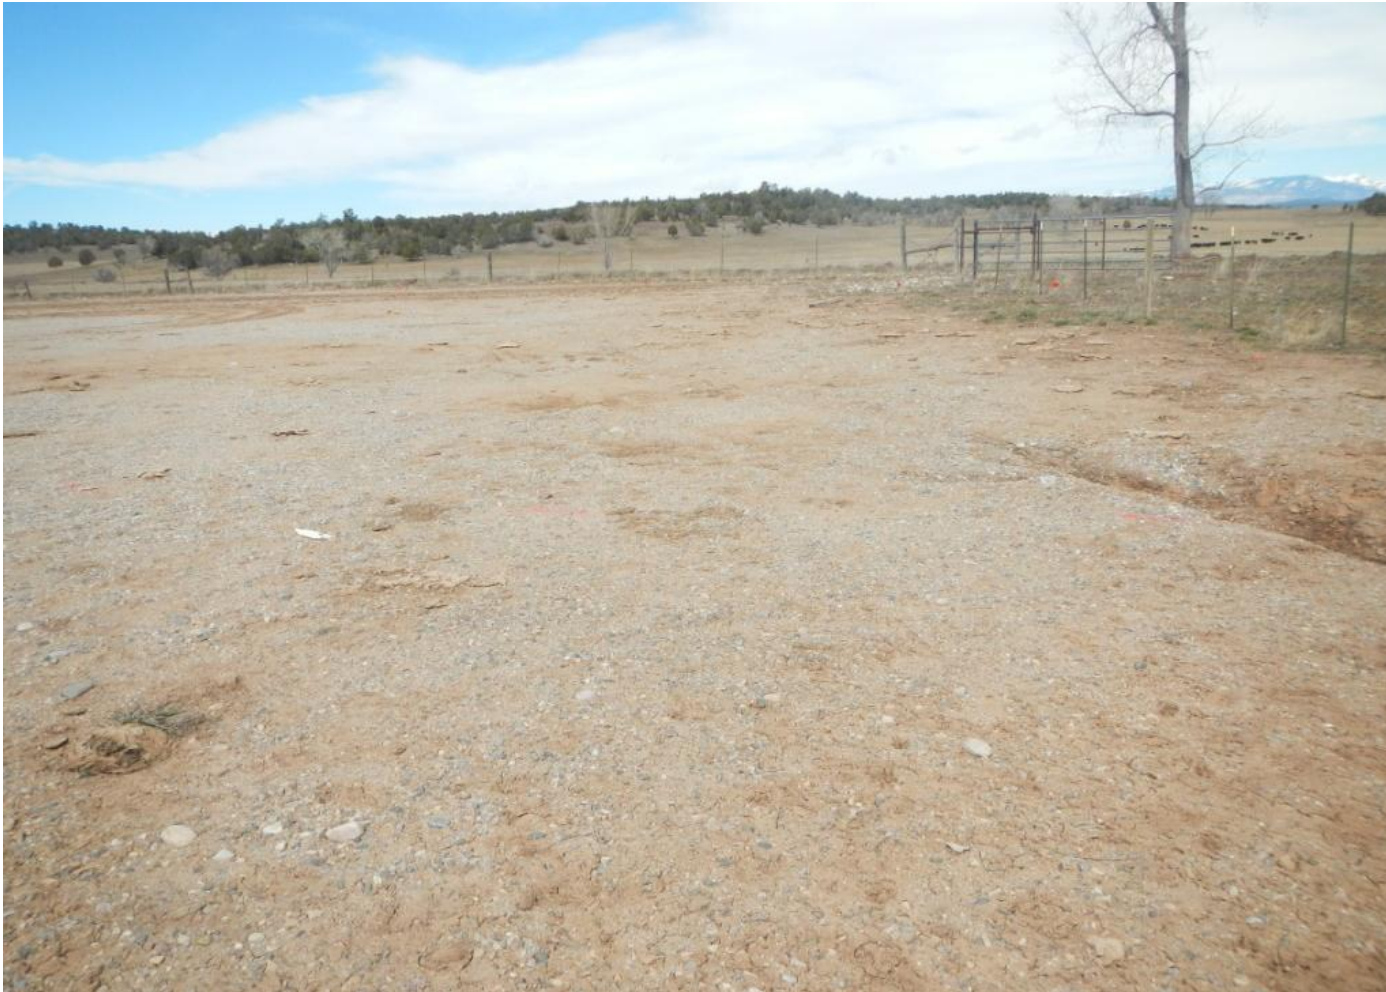
Photo 3. View of the eastern portion of the project area from the southeastern corner facing northward. This portion of the project area does not appear necessary for production and needs revegetation.

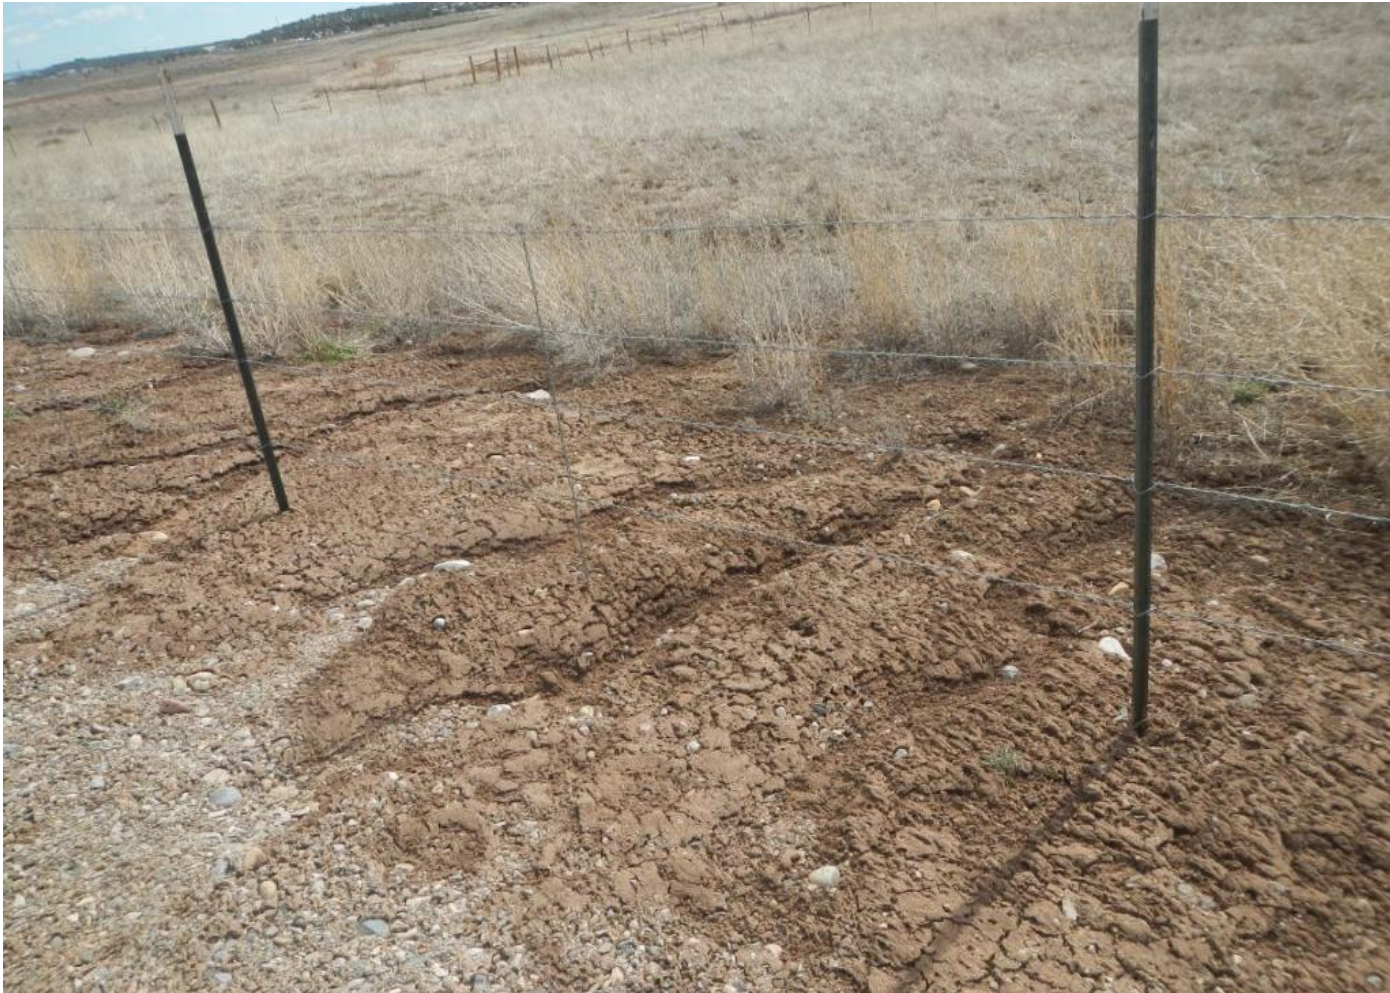
Photo 4. View of rill erosion occurring within the southern portion of the project area.
