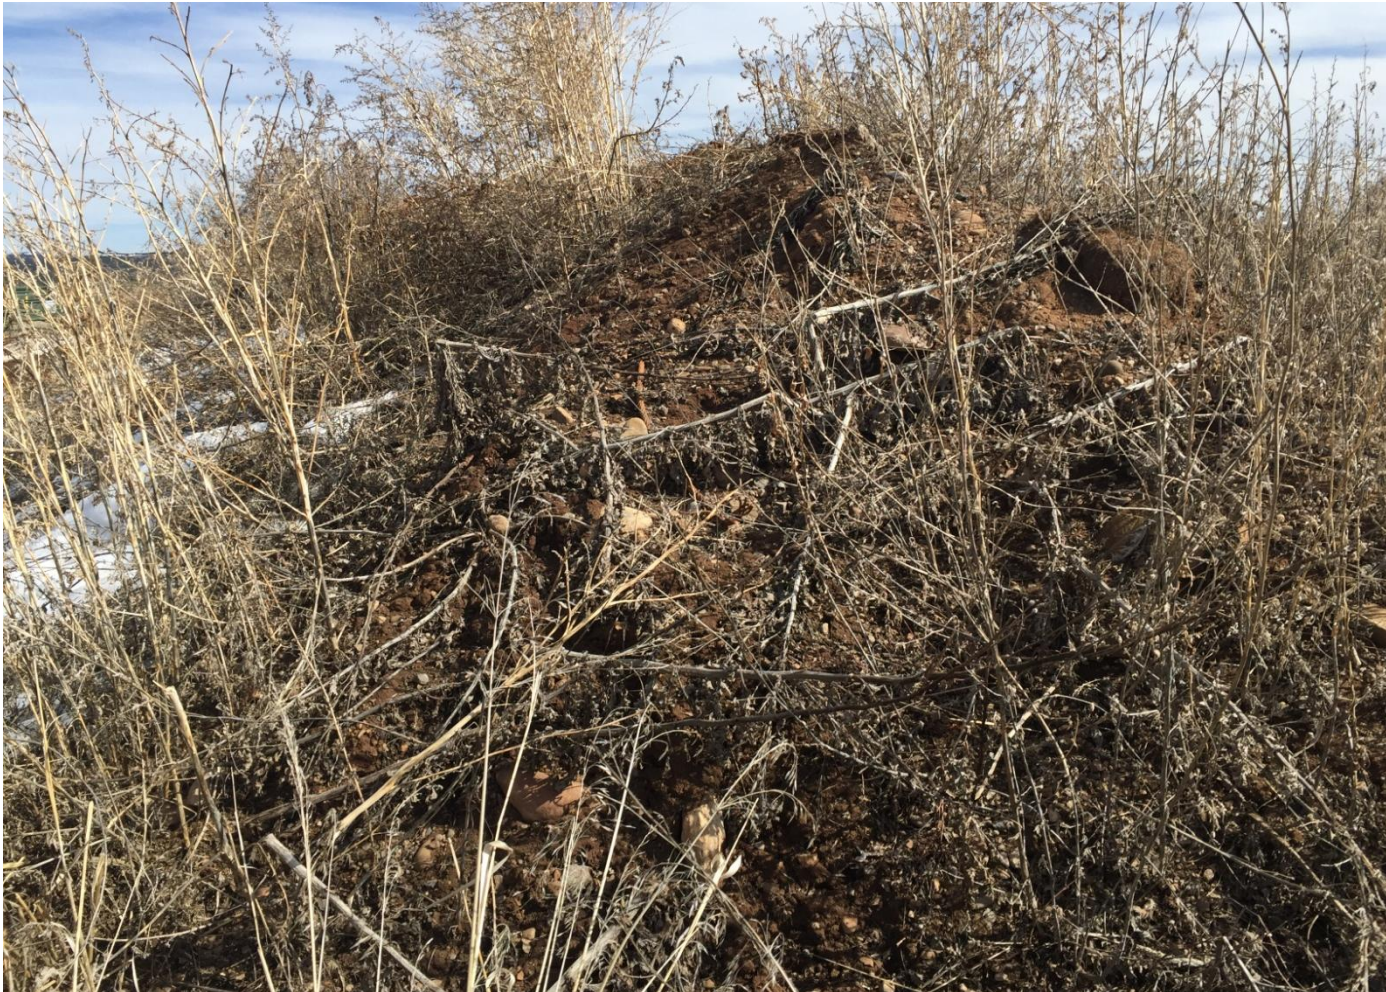
Photo 1. View of Canada thistle (*Cirsium arvense*) and kochia (*Kochia scoparia*) infestation on soil stockpile along southern portion of the project area. Weeds need to be controlled at the appropriate time in 2016 but no later than seedhead maturity. Kochia debris needs to be removed.

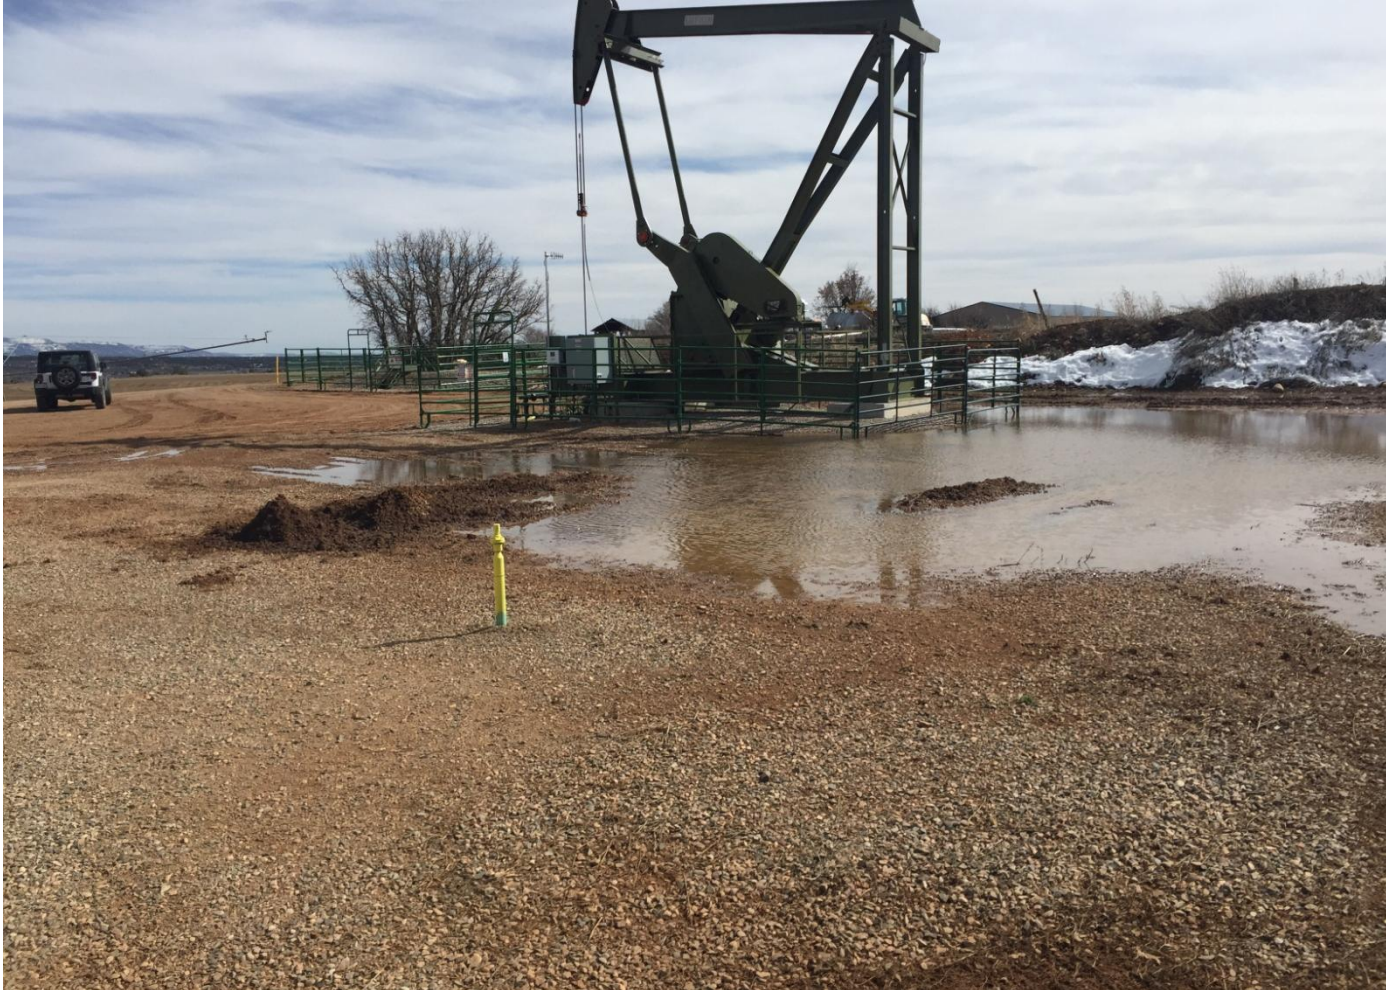
Photo 3. View of the project area from the northwestern corner facing center. Ponding water does not appear to be snowmelt as it is also present in aerial photos from August and October 2015.
