**MARATHON OIL COMPANY  
NOTICE OF COMPLETION REPORT FOR  
INTERIM RECLAMATION OF  
596-19C**

*January 20, 2012*

**InterTech Environmental & Engineering, LLC  
743 Horizon Court, Suite 110  
Grand Junction, Colorado 81506**

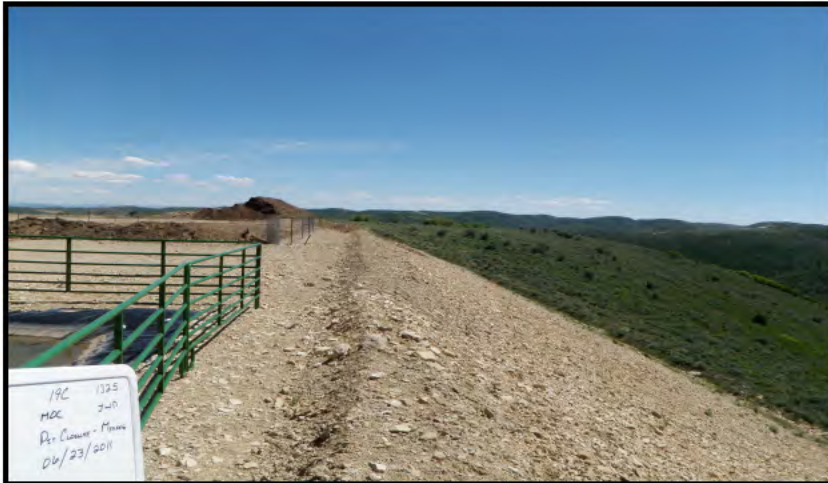
Photo 1 – 596-19C reserve pit containing drill cuttings.

This report covers the activities associated with the closure of the on-site reserve pit at Marathon Oil Company's 596-19C well pad. At the time of the initial site visit, the pit contained what appeared to be drill cuttings in an unlined pit (Photo 1, Appendix A).

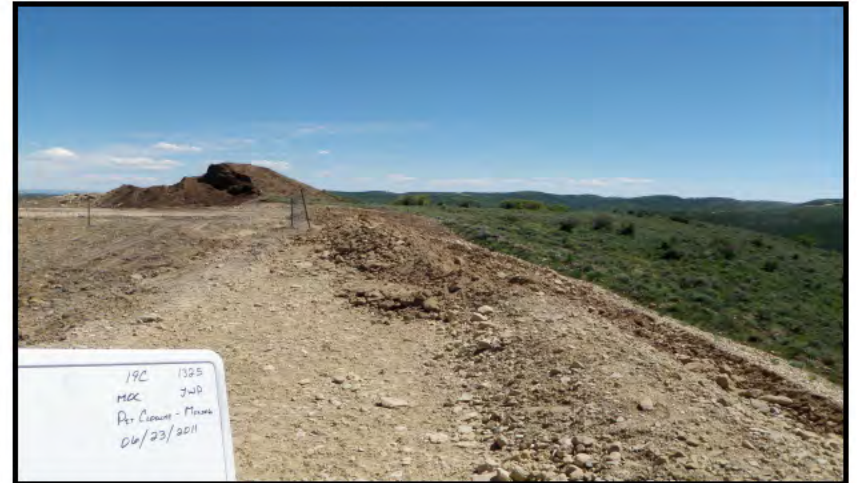
Photo 2 – Reserve pit and slope where material was harvested for clean mix material.

The mixing of pit contents with clean soil occurred inside of the pit. Native soil was obtained from portions of the pad slated for removal during re-contouring activities necessary for interim reclamation. A haul truck was used to transport the soil from the pad's southwest corner to the edge of the pit where it could be used as clean material for mixing with the pit's contents (Photo 2). After a pile of clean soil had been established on the pad, the clean soil was systematically added to the cuttings inside of the pit using an excavator and bulldozer to turn and mix the materials (Photos 3 and 4).

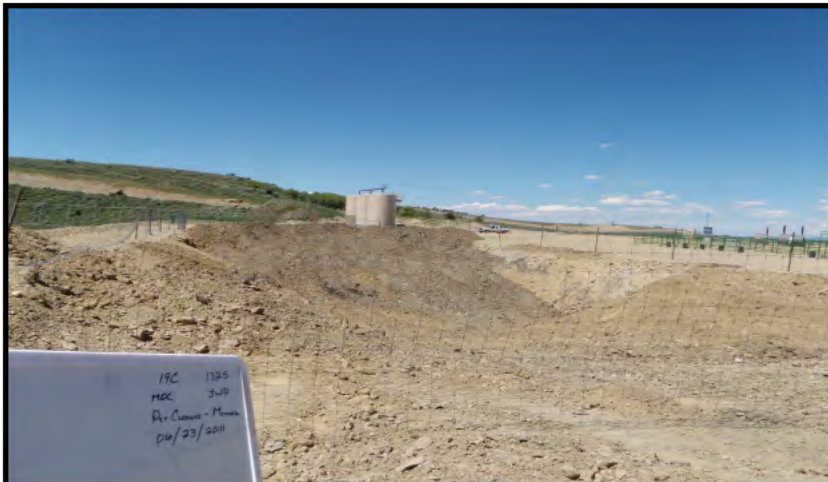
Photo 3 – Material in reserve pit after initial mixing.

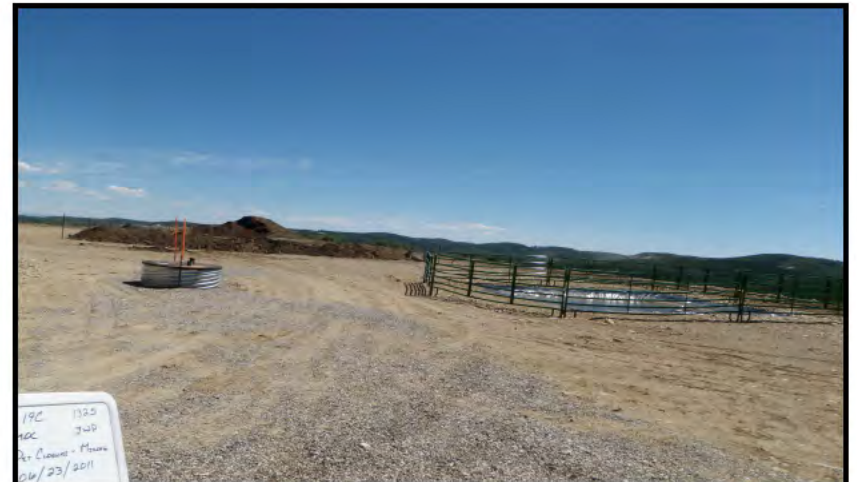
Photo 4 – Material in reserve pit after initial mixing.

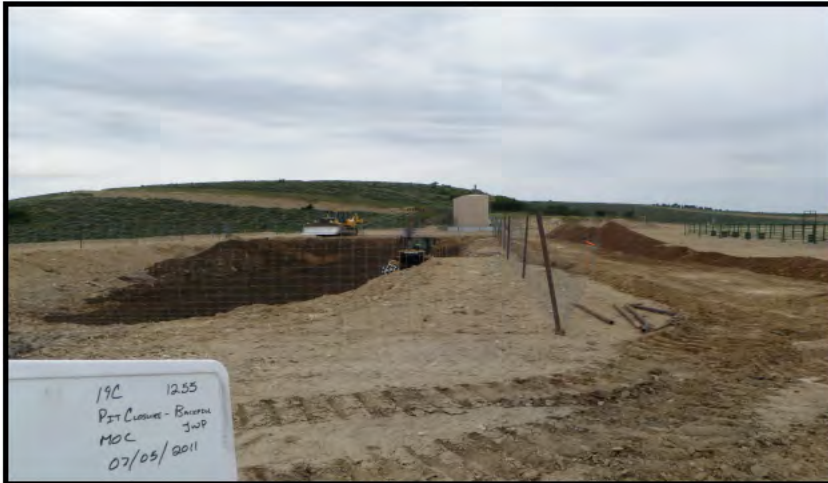
Photo 5 – Compactor and D8 rolling material while backfilling to achieve homogenous mixture.

Backfilling of the excavation was achieved by placing the 0.75:1 mixture of clean soil and cuttings back into the excavation (Photos 6 and 7). The mixed material was placed load-by-load into the excavation with each load being thoroughly compacted using the tracks of a dozer and a sheep's foot compactor. This process continued until the excavation was completely filled.

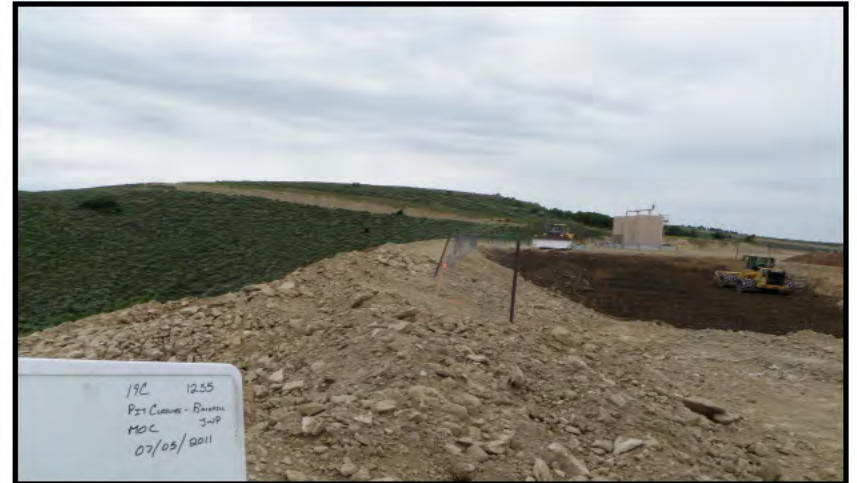
Photo 6 – Pit during backfilling operations.

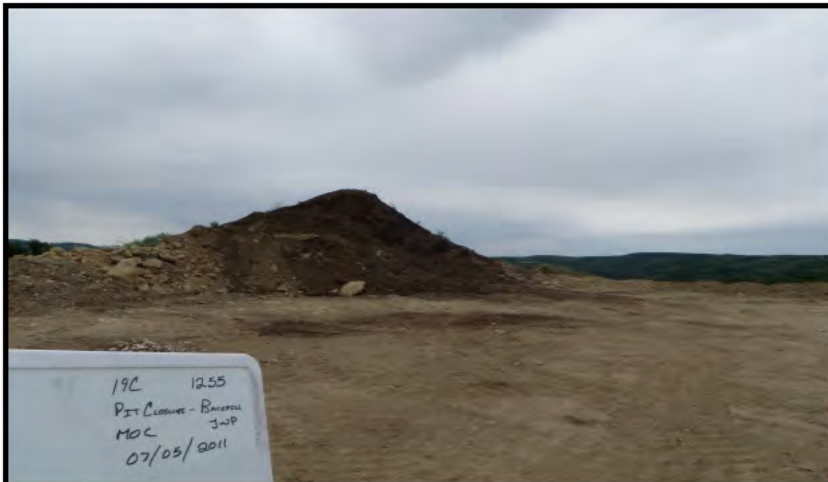
Photo 7 – Well pad during backfilling operations.

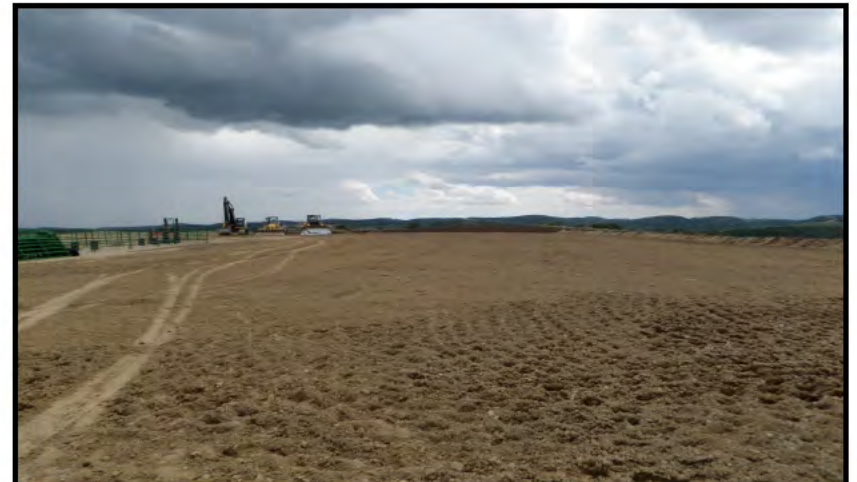
Photo 8 – Well pad after pit closure and reclamation.

Once the excavation had been backfilled, areas of the well pad no longer required for production were roughly graded to their original contour (Photo 8). These re-contoured areas were then top-soiled, thereby mitigating the potential effects of physical parameters on reclamation success. Backfilling and re-contouring operations concluded on July 8, 2011.

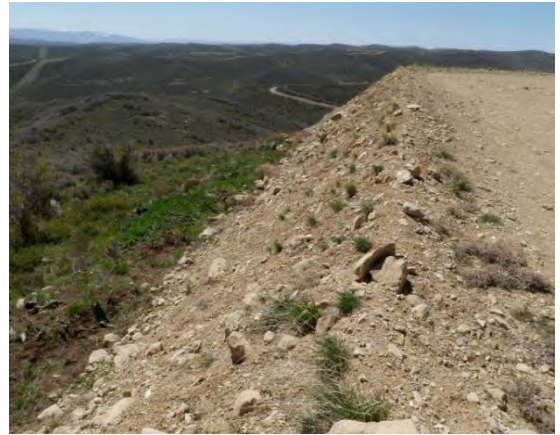
Eastern fill slope

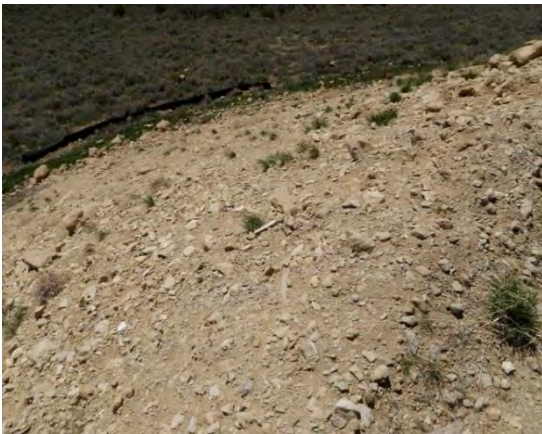
Southeast corner fill slope

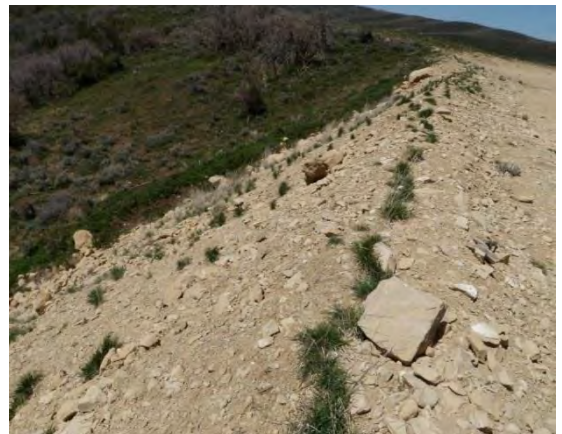
Southern fill slope

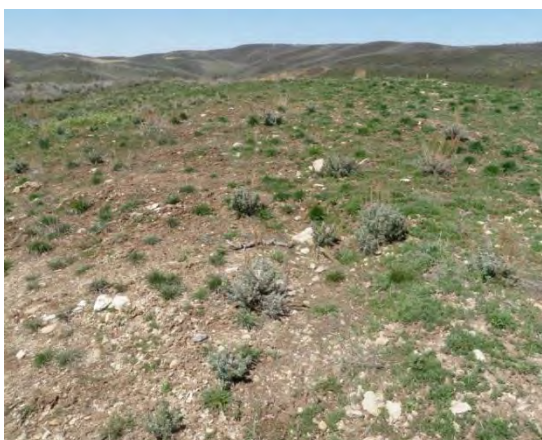
Reclaimed area on pad's southwestern corner

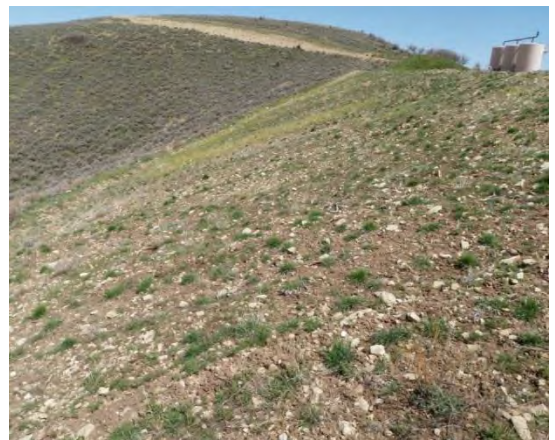
Western fill slope (1)

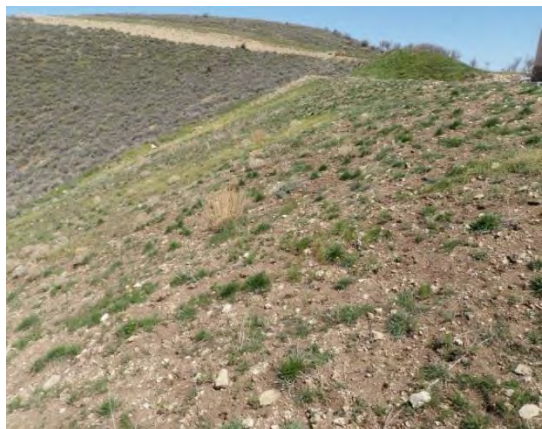
Western fill slope (2)

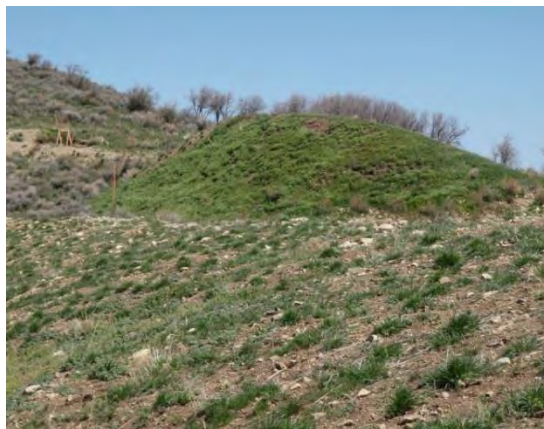
Top soil pile (1)

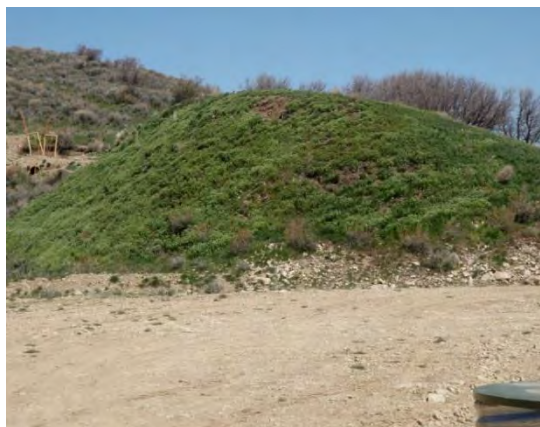
Top soil pile (2)
