Final Reclamation Inspection

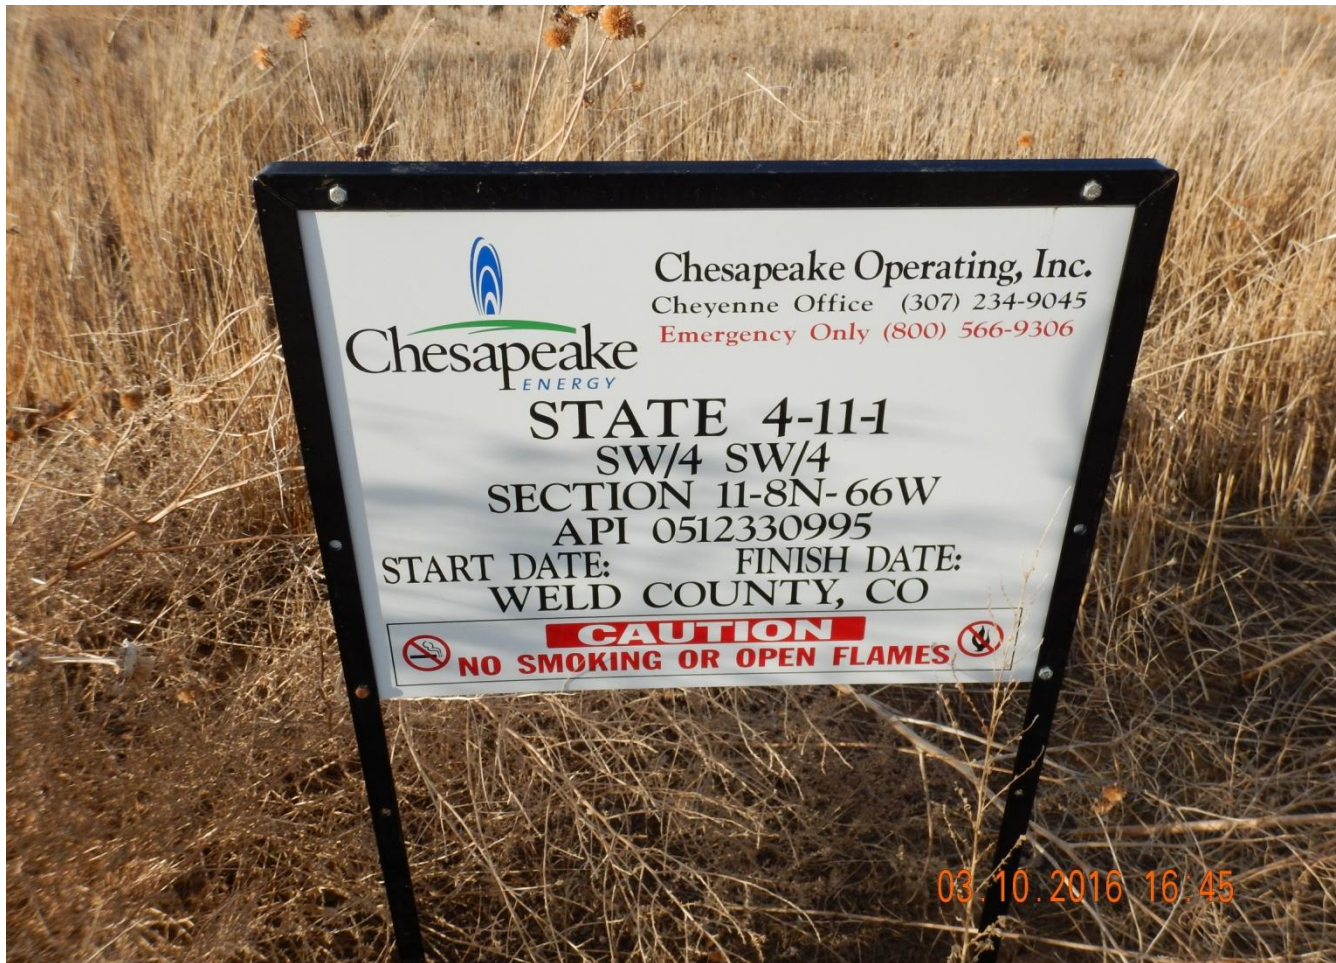
Photo 1. Photo taken of operator sign at entrance of location. Need to remove sign per Rule 603.f.

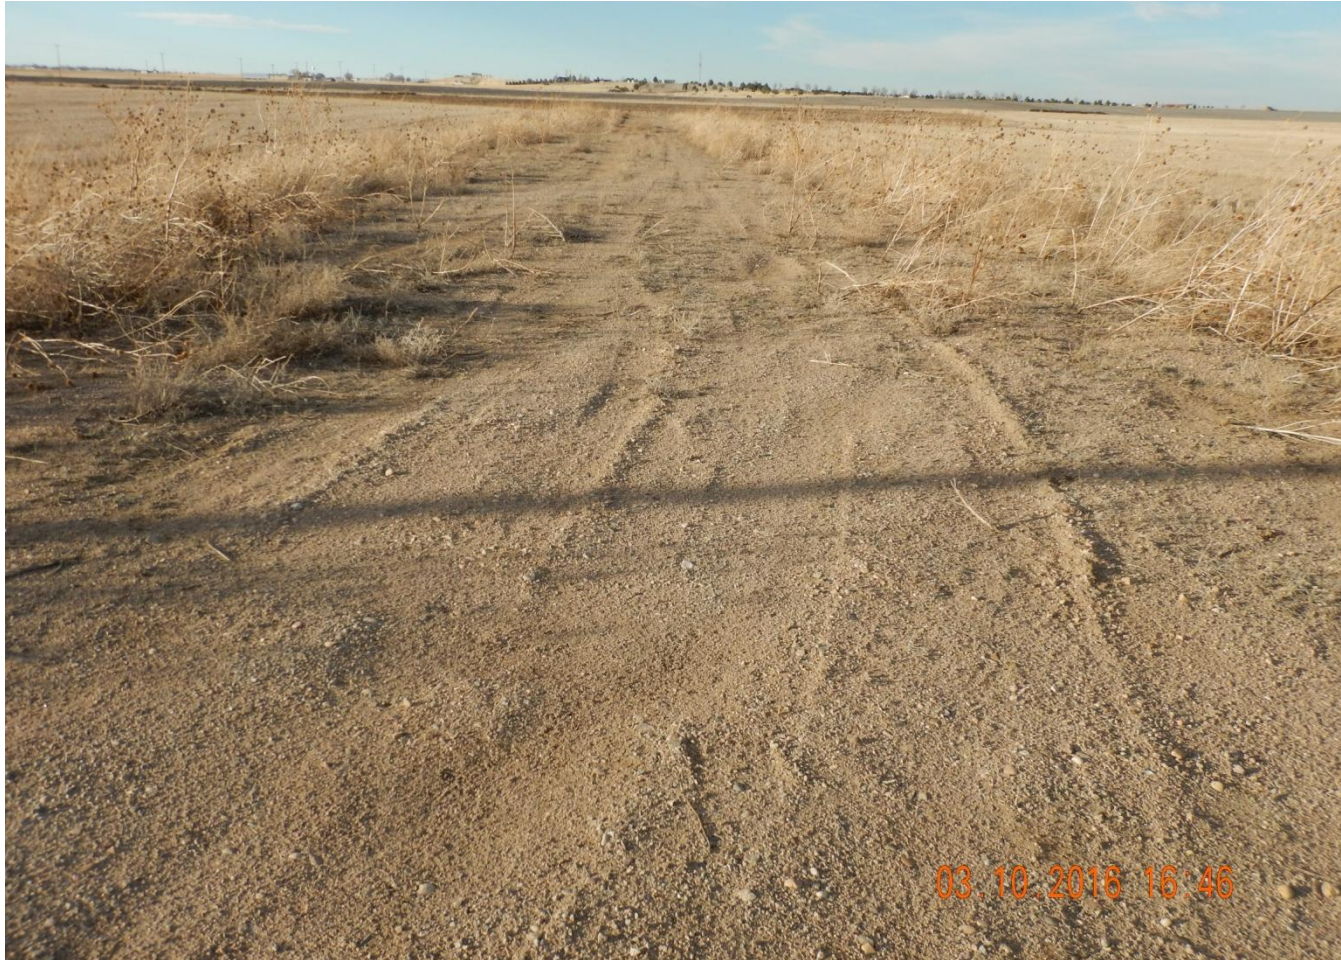
Photo 2. Photo taken from entrance of location, facing North towards location. Need to reclaim access road or provide documentation (SUA) stating this road doesn't need to be reclaimed.

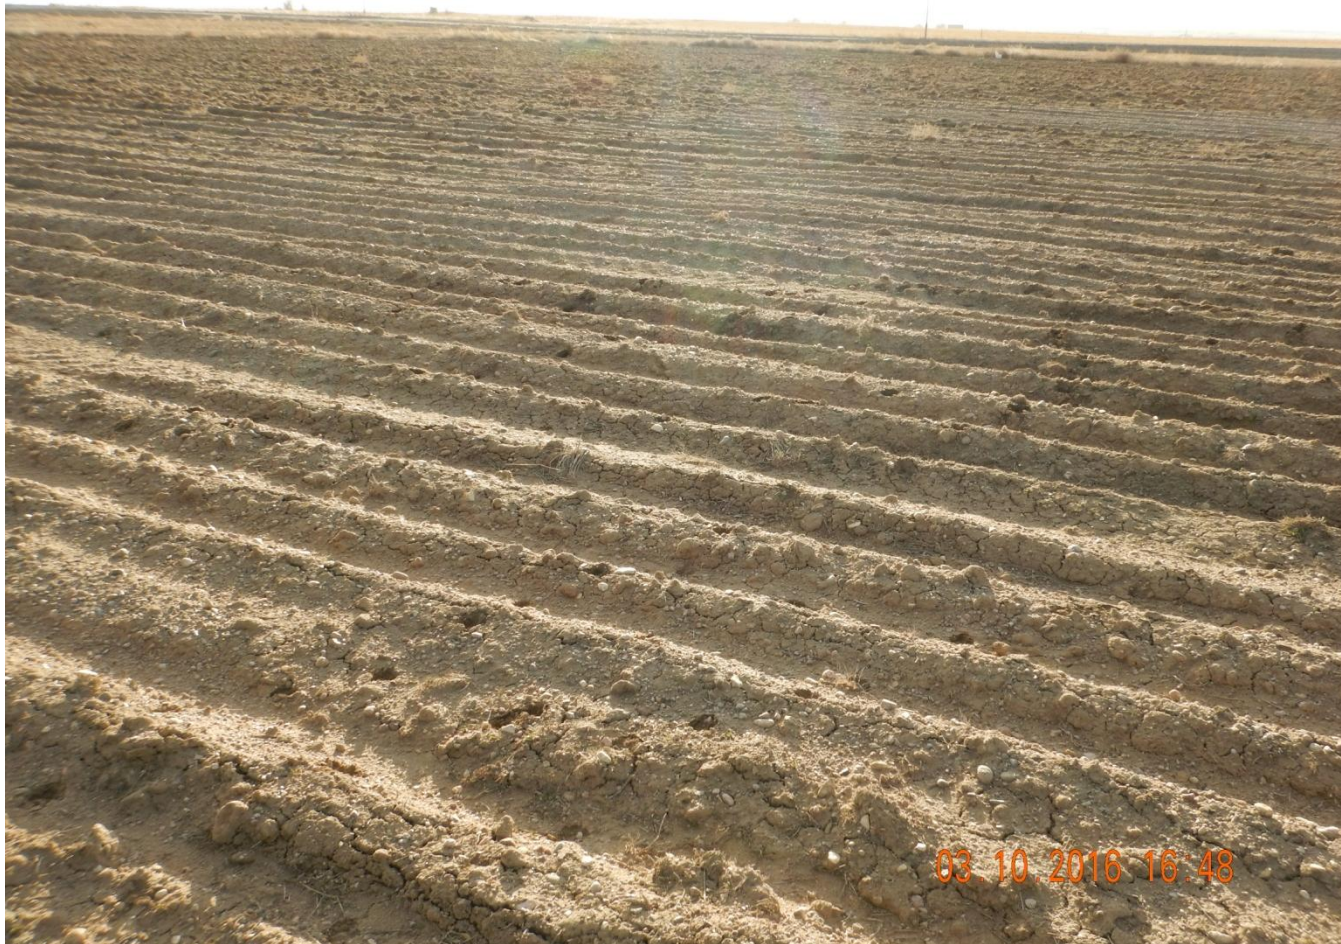
Photo 3. Photo taken from center of location, facing West. No evidence of wellbore at location. Need to come back during the crop growing season to evaluate proper vegetative per our reclamation regulations.

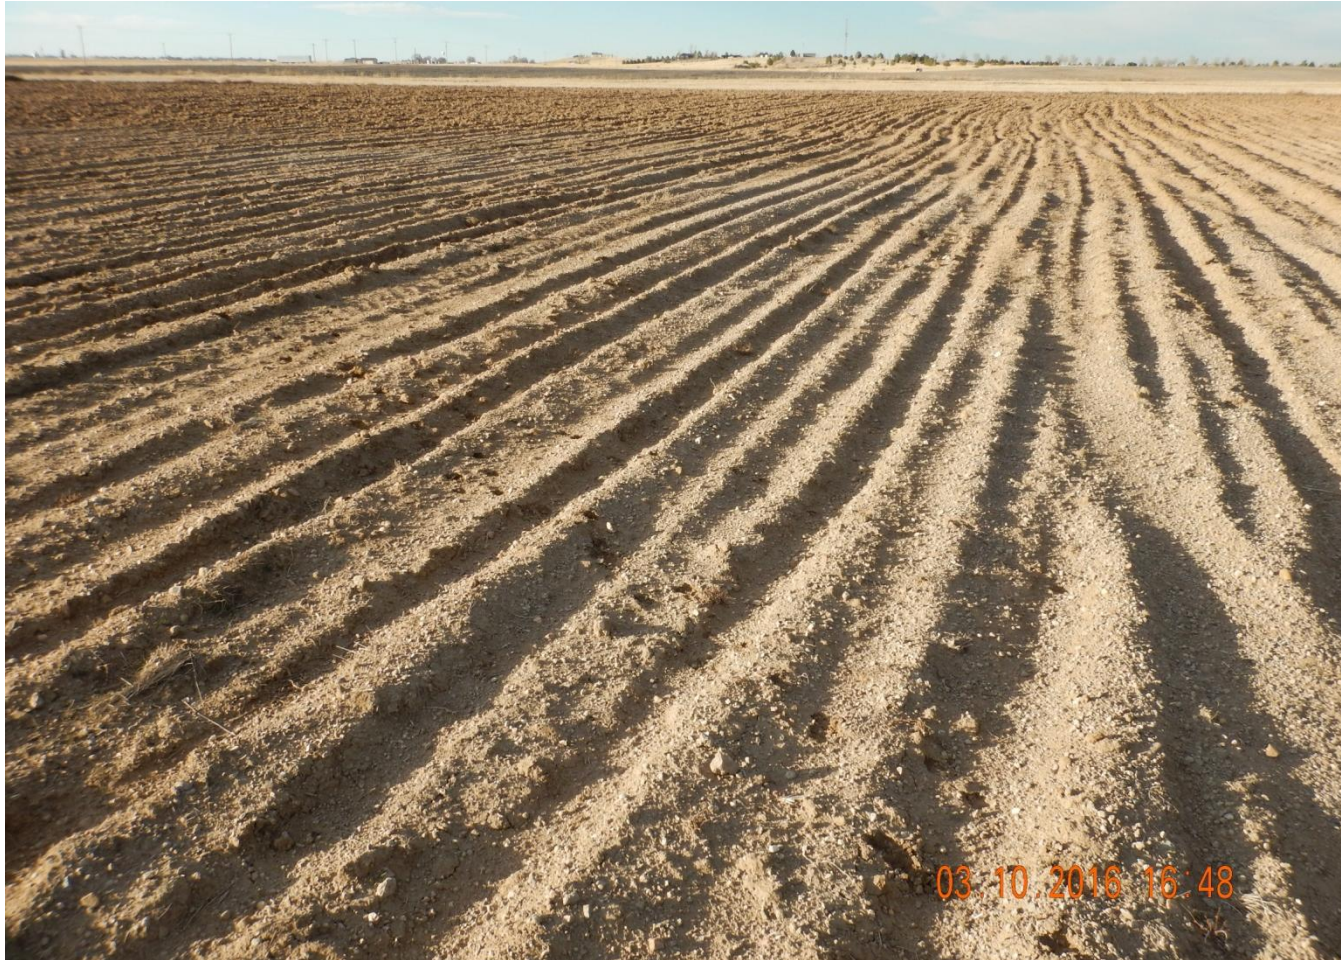
Photo 4. Photo taken from center of location, facing North. No evidence of wellbore at location. Need to come back during the crop growing season to evaluate proper vegetative per our reclamation regulations.

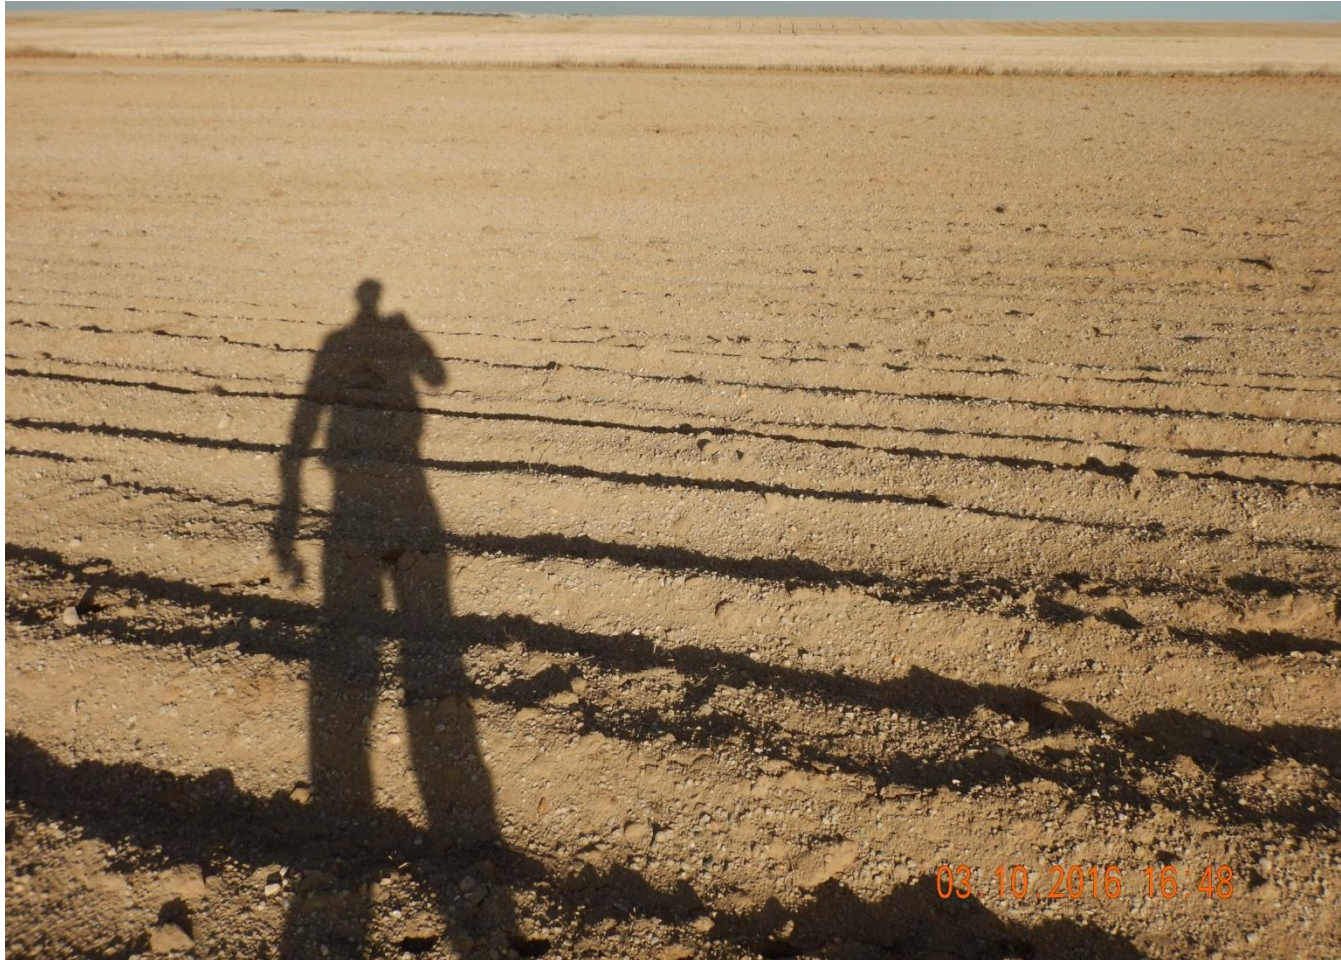
Photo 5. Photo taken from center of location, facing East. No evidence of wellbore at location. Need to come back during the crop growing season to evaluate proper vegetative per our reclamation regulations.

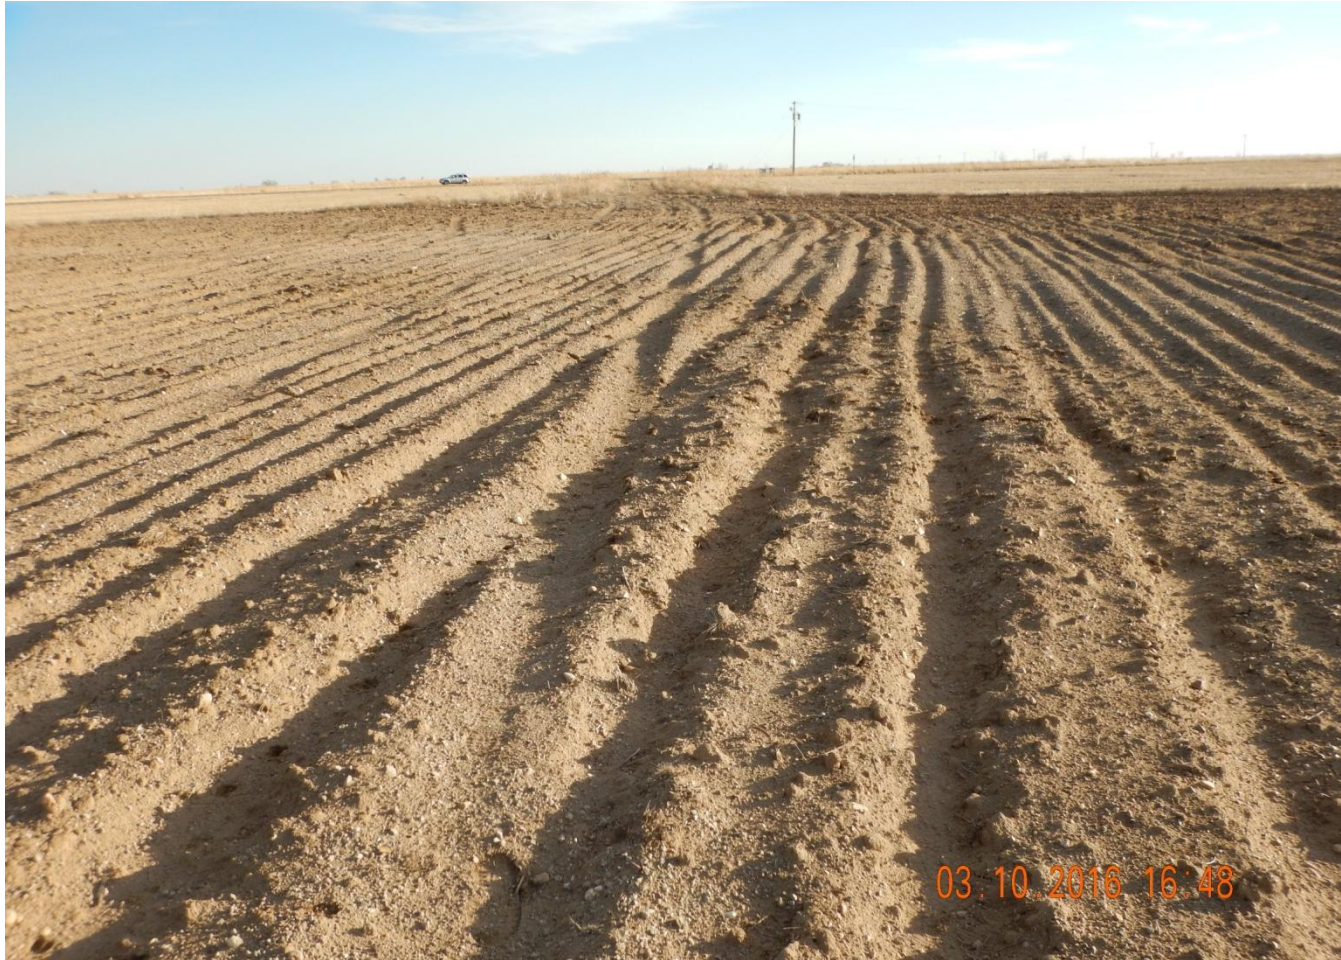
Photo 6. Photo taken from center of location, facing South. No evidence of wellbore at location. Need to come back during the crop growing season to evaluate proper vegetative per our reclamation regulations.
