Stormwater Inspection

3/28/2016

Operator: Grand Mesa Operating

Location ID: 443491

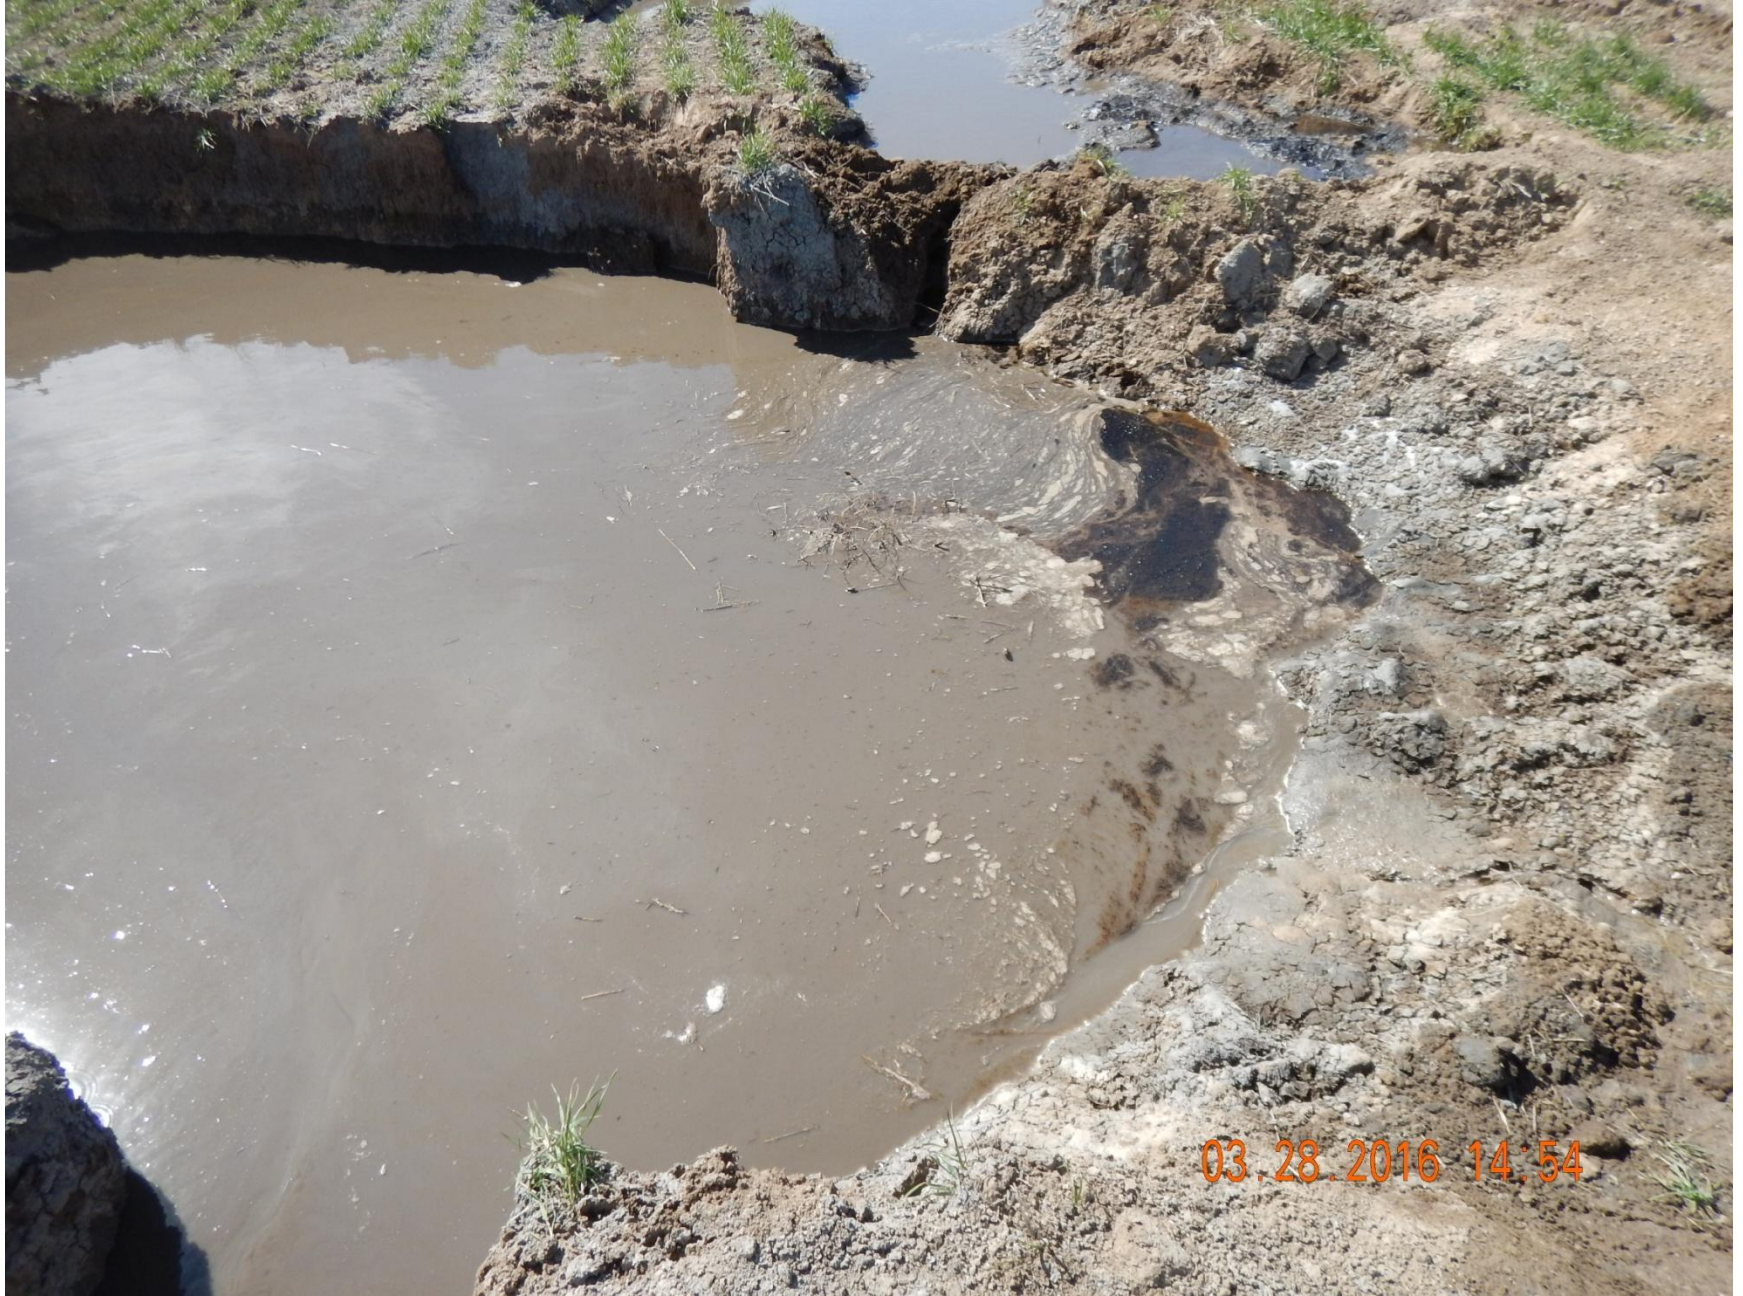
Figure 1: Photo taken from the pit on location. Photo shows oily substance on water. Likely hydraulic fluids from equipment.

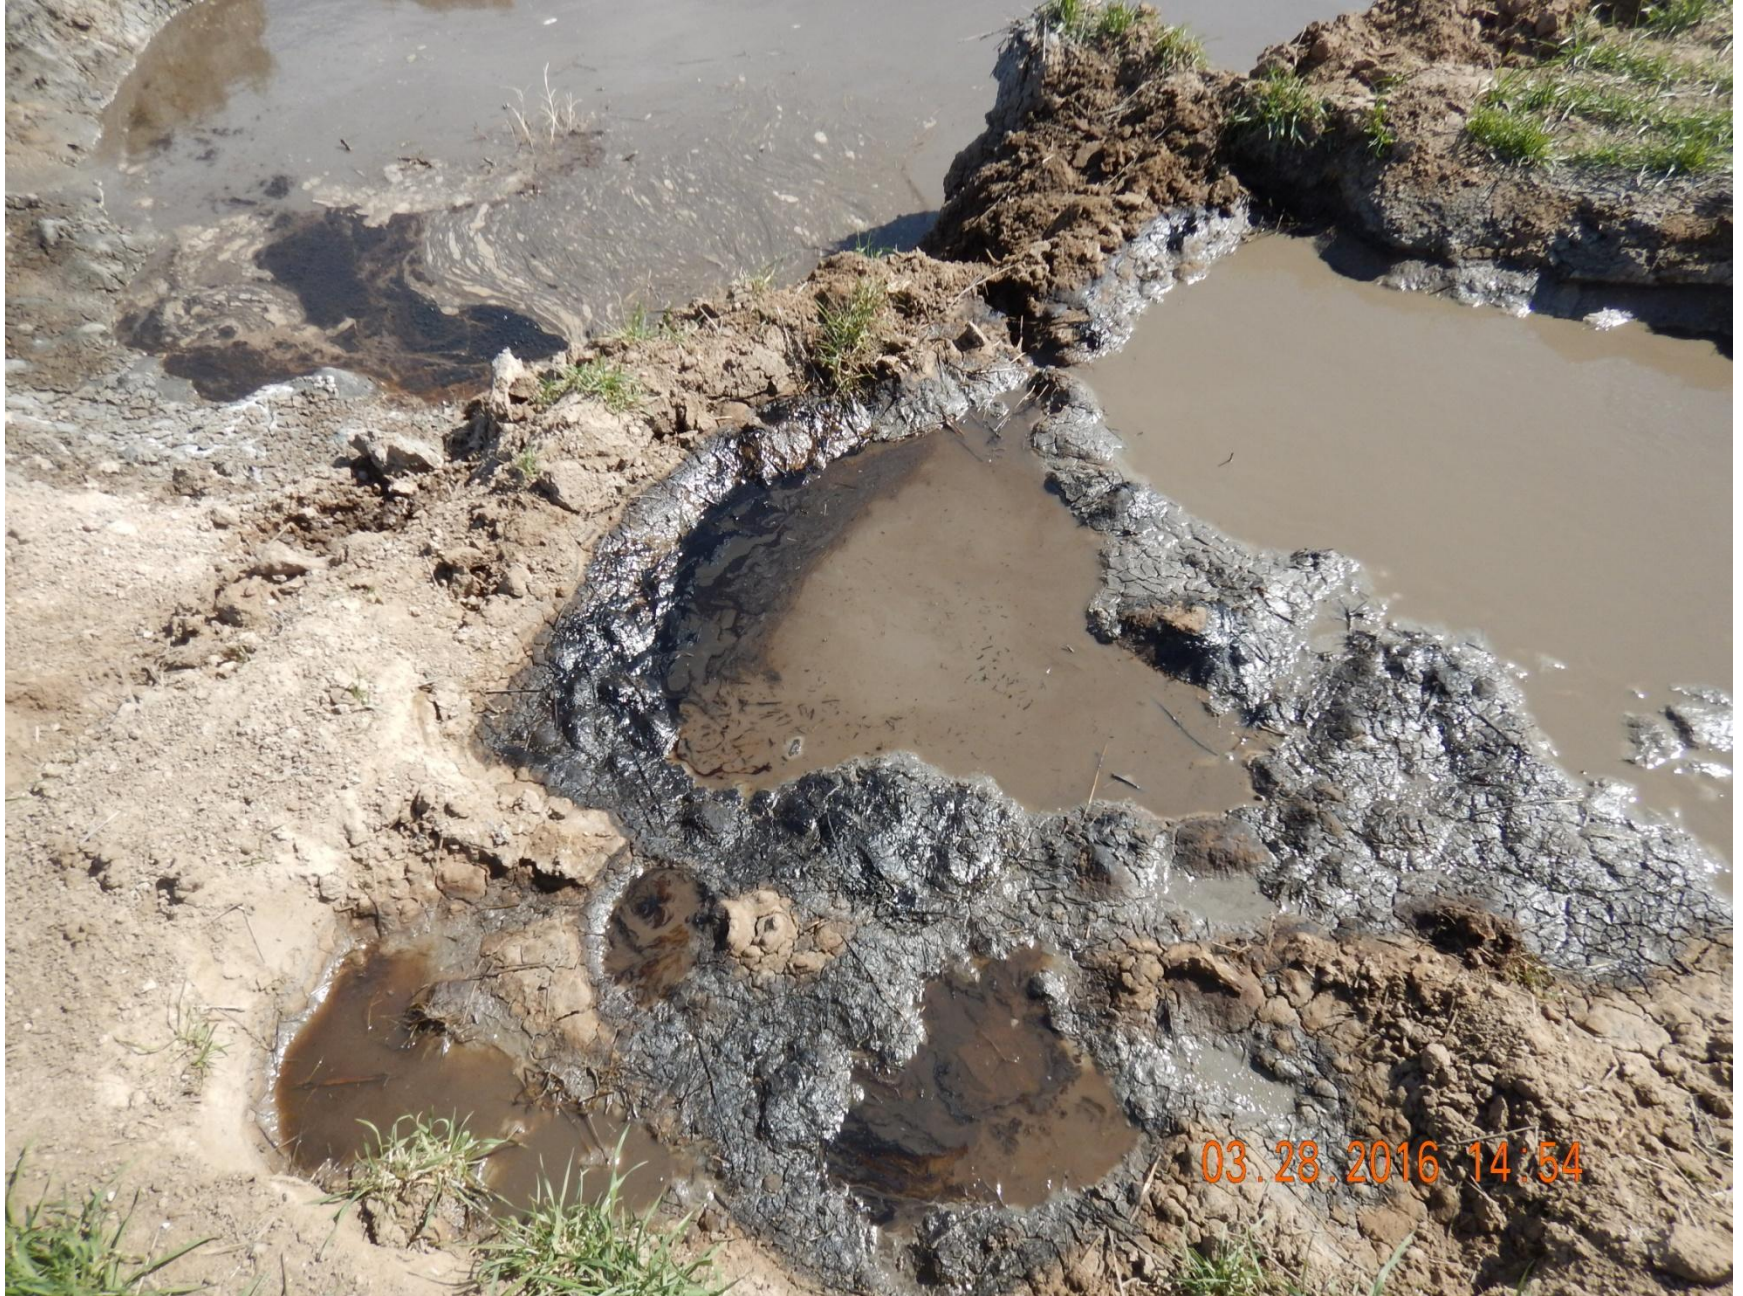
Figure 2: Photo taken from the pit on location. Photo shows oily substance on water and soil. Likely hydraulic fluids from equipment.

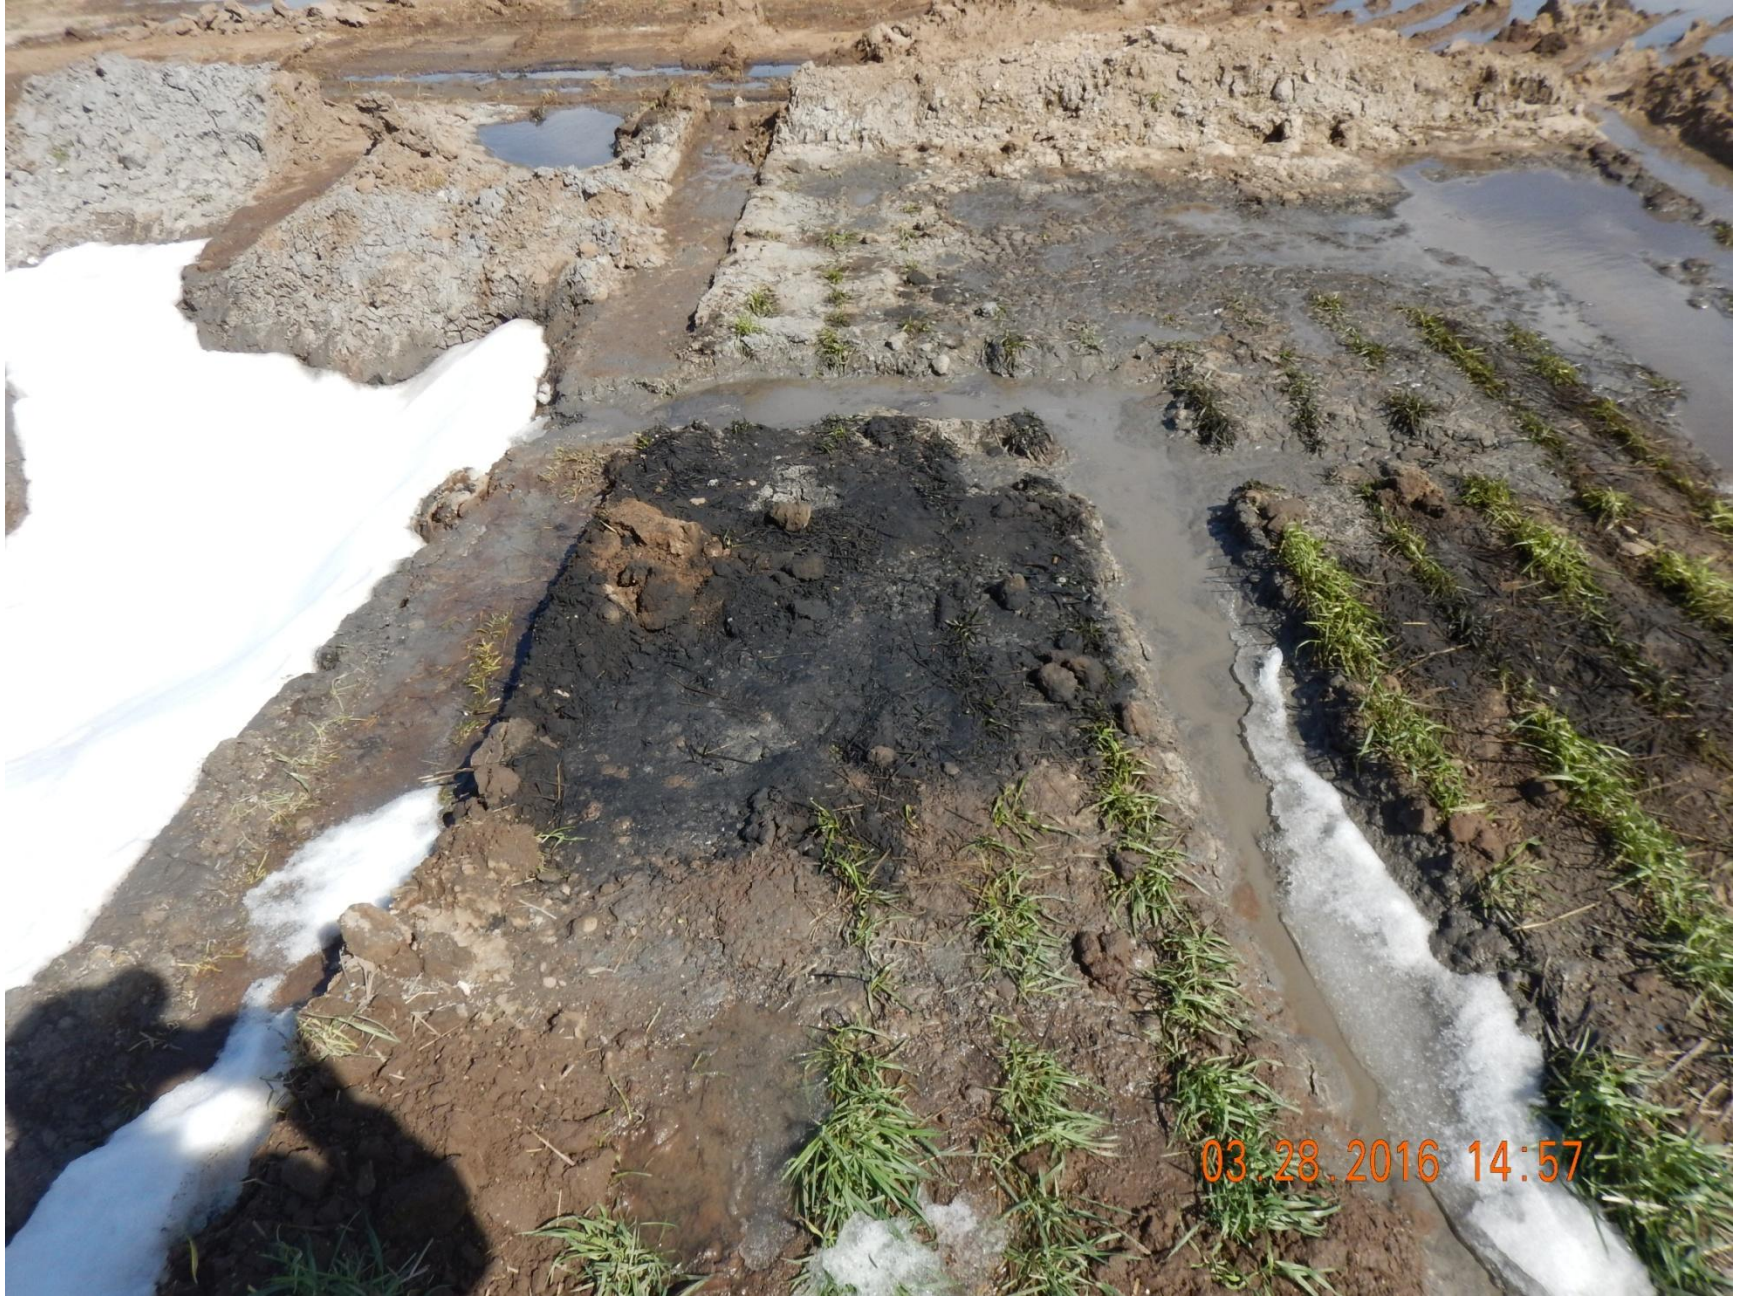
Figure 3: Photo taken east of the pits. Photo shows stained, contaminated soils.

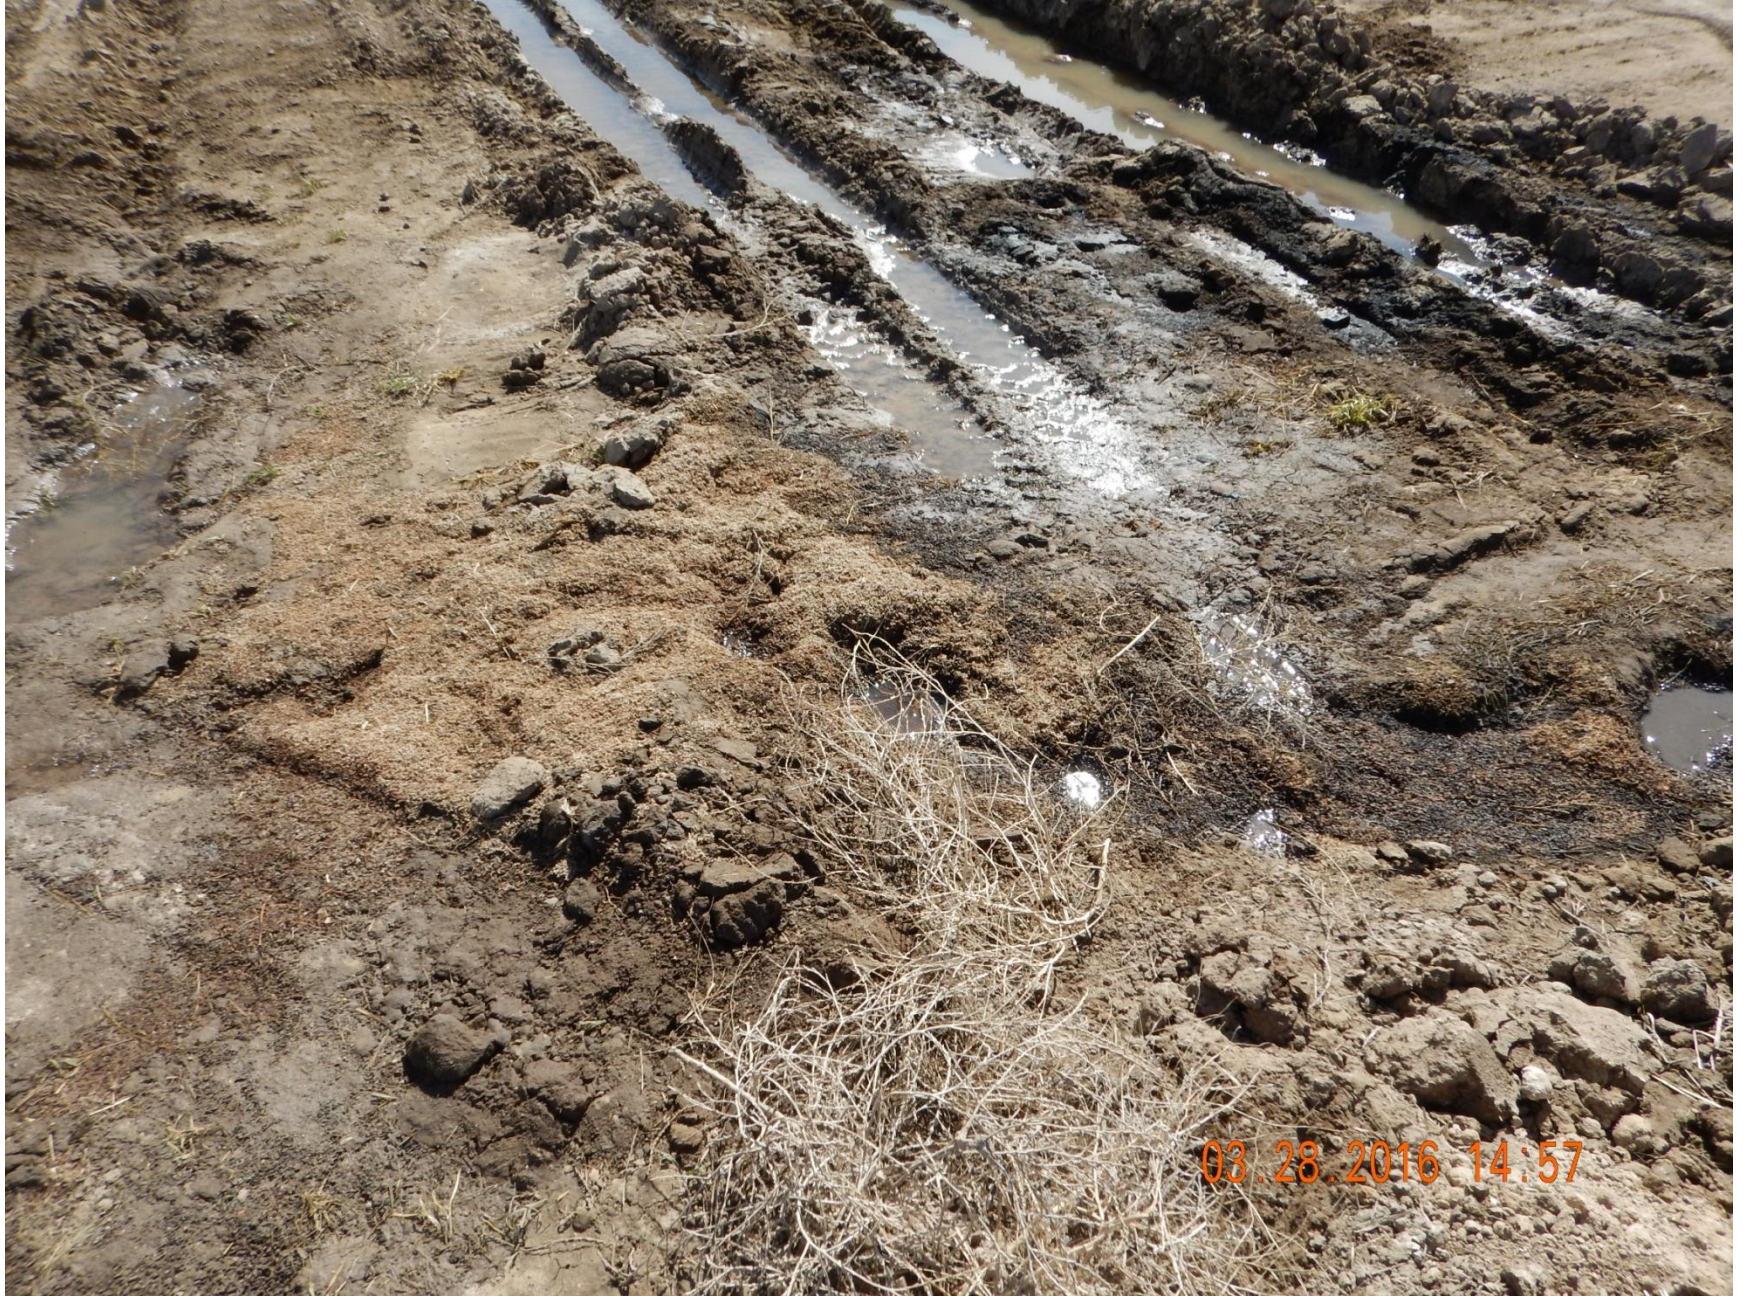
Figure 4: Photo taken east of the pits. Photo shows stained, contaminated soils.
