**MARATHON OIL COMPANY
NOTICE OF COMPLETION REPORT FOR
INTERIM RECLAMATION OF
696-5C**

January 20, 2012

**InterTech Environmental & Engineering, LLC
743 Horizon Court, Suite 110
Grand Junction, Colorado 81506**

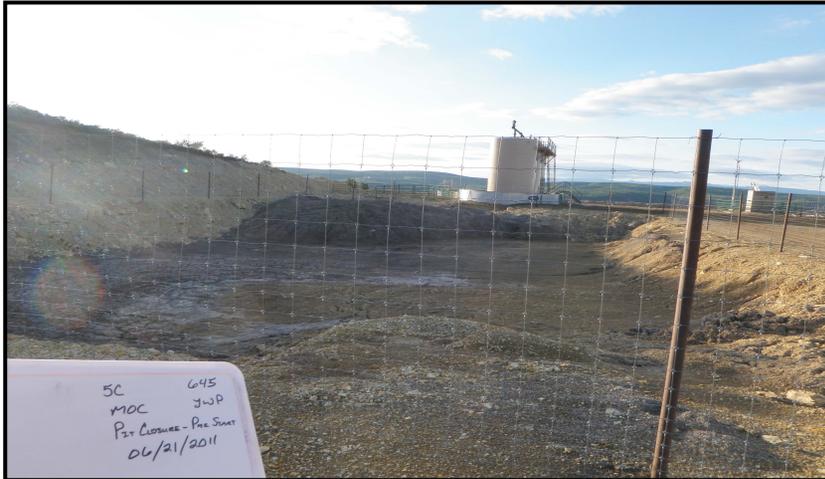
Photo 1 – 696-5C reserve pit containing drill cuttings.

This report covers the activities associated with the closure of the on-site reserve pit at Marathon Oil Company's 696-5C well pad. At the time of the initial site visit, the pit contained what appeared to be drill cuttings in an unlined pit (Photo 1, Appendix A).

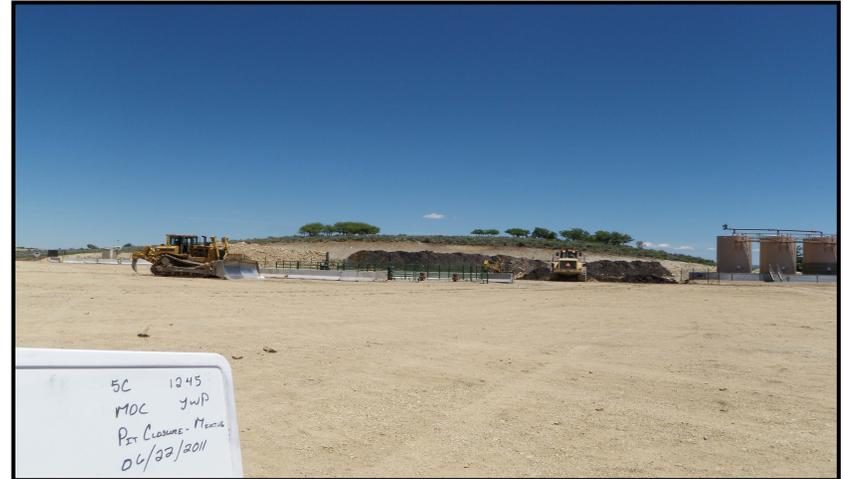
Photo 2 – Loader providing clean fill material from SW corner to track hoe for mixing.

The mixing of pit contents with clean soil occurred inside of the pit. Native soil was obtained from portions of the pad slated for removal during re-contouring activities necessary for interim reclamation. A bulldozer and front-end loader were used to push and carry the soil from the pad's southwest corner onto its interior surface where it could be used as clean material for mixing with the pit's contents (Photo 2). After a pile of clean soil had been established on the pad, the clean soil was systematically added to the cuttings inside of the pit using an excavator to turn and mix the materials (Photos 3 and 4).

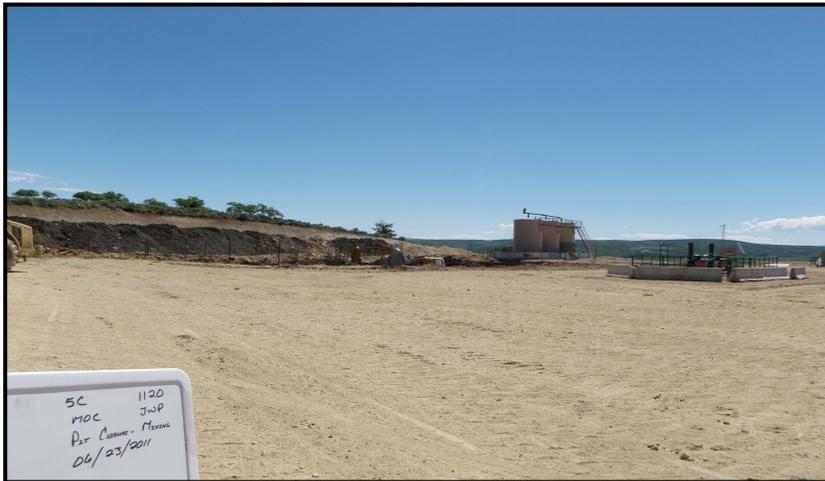
Photo 3 – Track hoe mixing pit contents with clean material within pit.

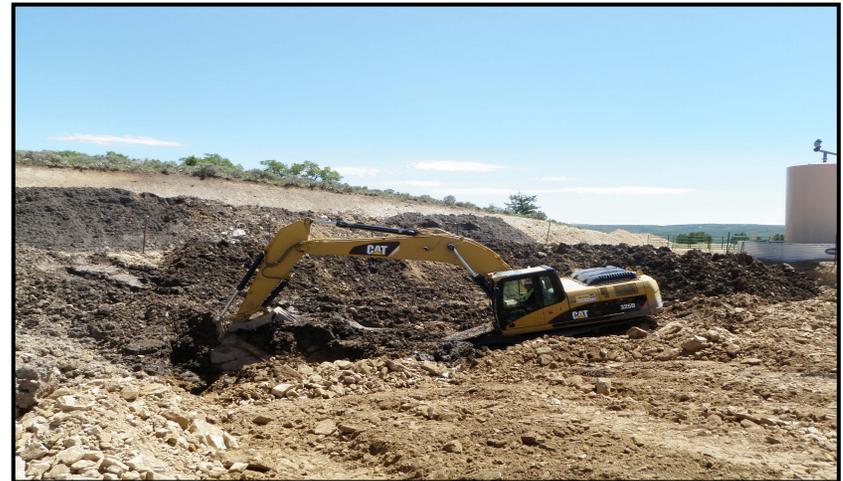
Photo 4 – Track hoe mixing pit contents with clean material within pit.

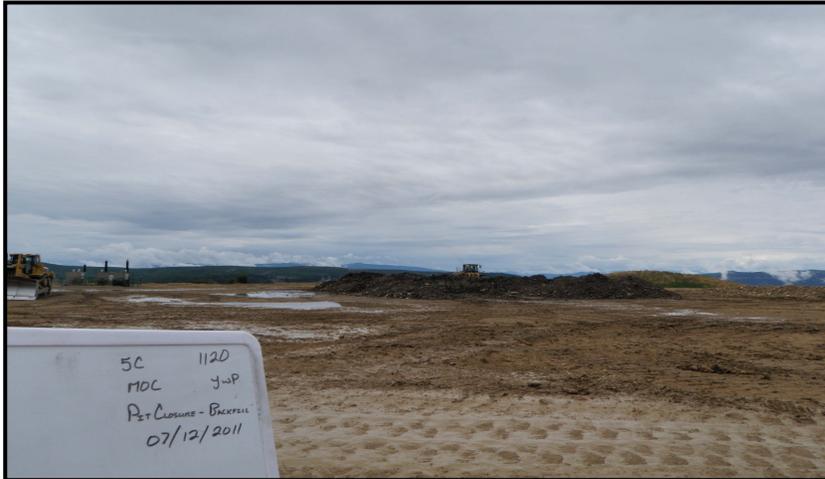
5C 1120
MOC JWP
PIT Closure - Backfill
07/12/2011

Photo 5 – Front end loader rolling material to achieve homogenous mixture.

The mixing was performed within the pit in order to dry and solidify the pit material, as well as to dilute the concentrations of its COGCC Table 910-1 constituents. The mixed material was then placed on the drilling pad where a bulldozer and a front-end loader continued the mixing process by combining additional clean soil with the extracted material and rolling the two together to reach a dry, homogenous mixture (Photo 5). Samples of the mixed soil were collected for laboratory analysis. These samples were tested only for the constituents that previously exceeded COGCC Table 910-1 limits. The final mixing ratio of clean soil to pit material was 2:1. The resulting analytical data indicated that the constituent concentrations of

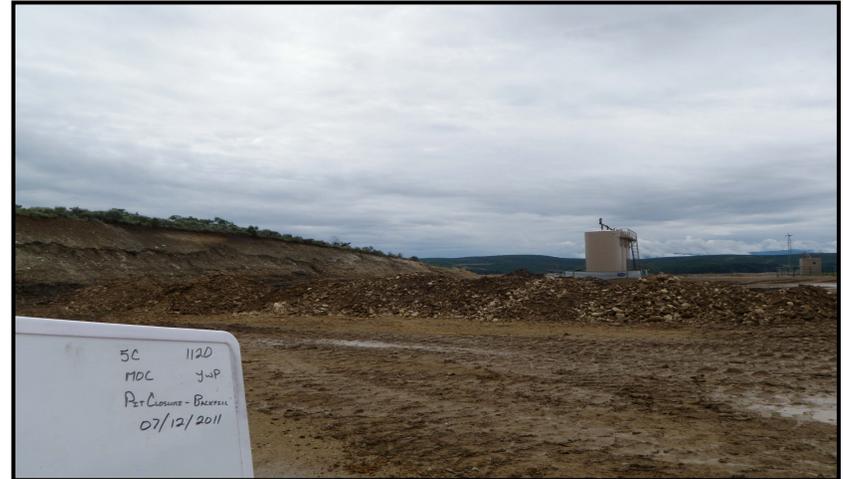
5C 1120
MOC JWP
PIT Closure - Backfill
07/12/2011

Photo 6 – Pit during backfilling operations.

Backfilling of the excavation was achieved by placing the 2:1 mixture of clean soil and cuttings back into the excavation (Photos 6 and 7). The mixed material was placed load-by-load into the excavation with each load being thoroughly compacted using the tracks of a dozer. This process continued until the excavation was completely filled.

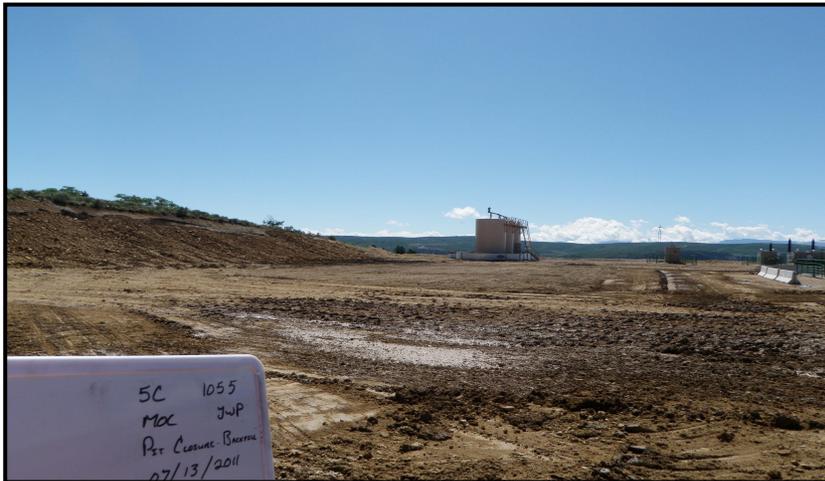
5C 1055
MOC JWP
PIT Closure - Backfill
07/13/2011

Photo 7 – Pit during backfilling operations.

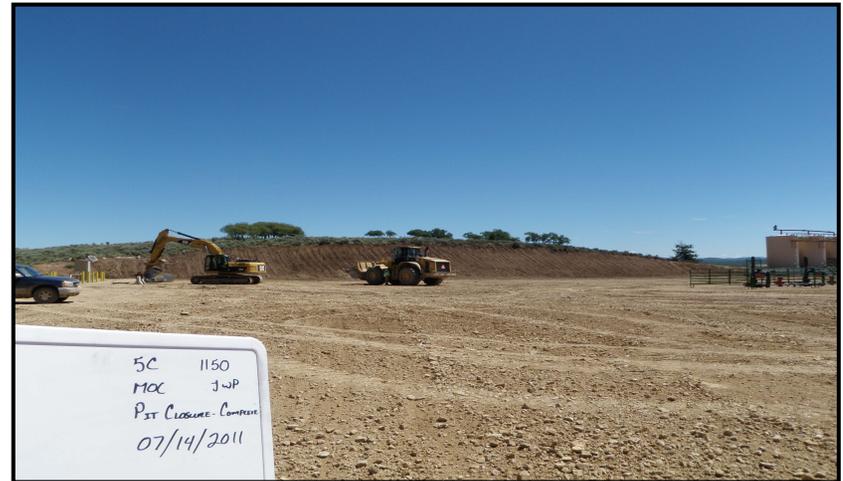
5C 1150
MOC JWP
PIT Closure - Complete
07/14/2011

Photo 8 – Well pad after pit closure and reclamation.

Once the excavation had been backfilled, areas of the well pad no longer required for production were roughly graded to their original contour (Photo 8). These re-contoured areas were then top-soiled, thereby mitigating the potential effects of physical parameters on reclamation success. Backfilling and re-contouring operations concluded on July 14, 2011.
