**MARATHON OIL COMPANY  
NOTICE OF COMPLETION REPORT FOR  
INTERIM RECLAMATION OF  
596-29C**

*January 20, 2012*

**InterTech Environmental & Engineering, LLC  
743 Horizon Court, Suite 110  
Grand Junction, Colorado 81506**

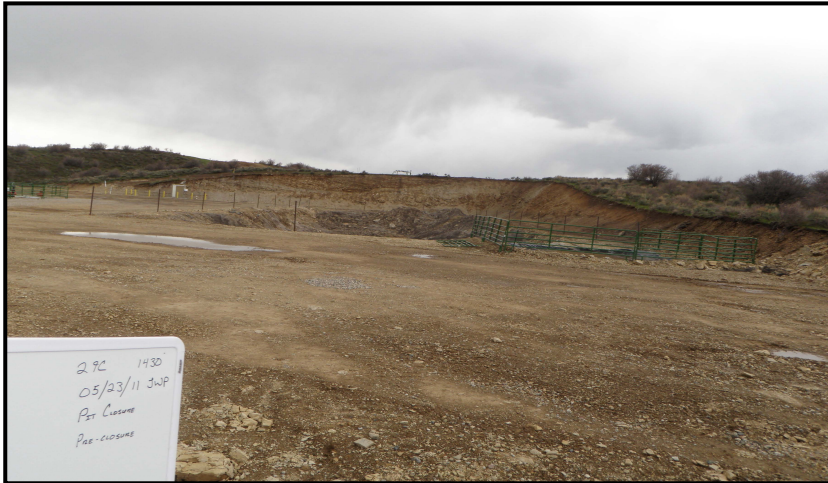
This report covers the activities associated with the closure of the on-site reserve pit at Marathon Oil Company's 596-29C well pad. At the time of the initial site visit, the pit contained what appeared to be drill cuttings in an unlined pit (Photo 1, Appendix A).

Photo 1 – 596-29C reserve pit containing drill cuttings.

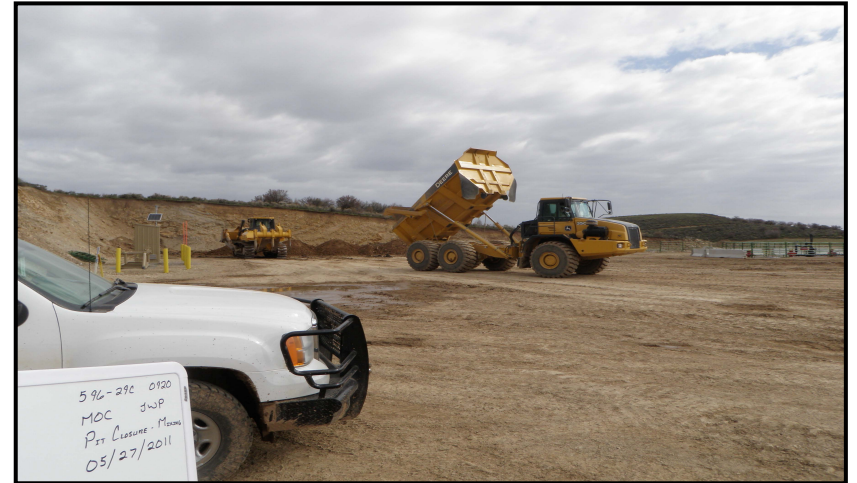
Photo 2 – Haul truck providing clean material for mixing.

The mixing of pit contents with clean soil occurred inside of the pit. Native soil was obtained from portions of the pad slated for removal during re-contouring activities necessary for interim reclamation. A haul truck was used to transport the soil from the pad's southeast corner to the edge of the pit where it could be used as clean material for mixing with the pit's contents (Photo 2). After a pile of clean soil had been established on the pad, the clean soil was systematically added to the cuttings inside of the pit using an excavator and bulldozer to turn and mix the materials (Photos 3 and 4).

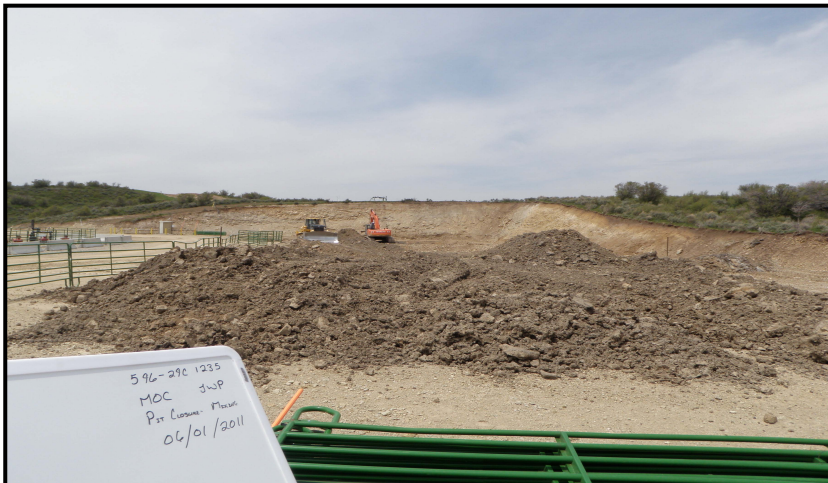
Photo 3 – Track hoe mixing pit contents with clean material within pit.

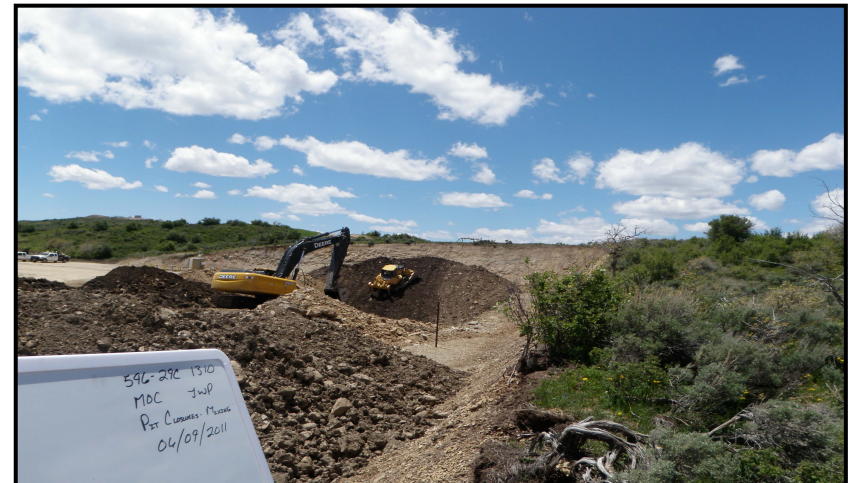
Photo 4 – D8 and track hoe mixing pit contents with clean material within pit.

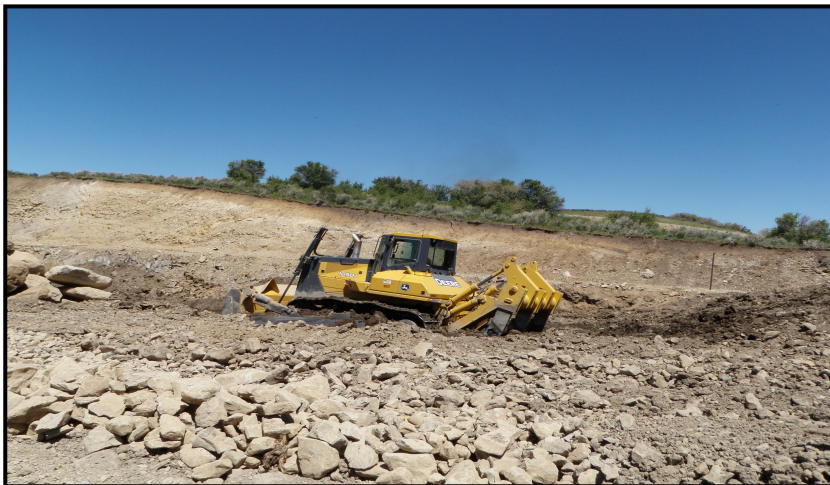
Photo 5 – Front end loader and D8 rolling material to achieve homogenous mixture.

The mixing was performed within the pit in order to dry and solidify the pit material, as well as to dilute the concentrations of its COGCC Table 910-1 constituents. The mixed material was then placed on the drilling pad where a bulldozer continued the mixing process by combining additional clean soil with the extracted material and rolling the two together to reach a dry, homogenous mixture (Photo 5). Samples of the mixed soil were collected for laboratory analysis. These samples were tested only for the constituents that previously exceeded COGCC Table 910-1 limits. The final mixing ratio of clean soil to pit material was 1.5:1. The resulting analytical data indicated that the constituent concentrations of the mixture were below COGCC Table 910-1 limits. The results further demonstrated that constituent concentrations were below CDPHE agricultural standards.

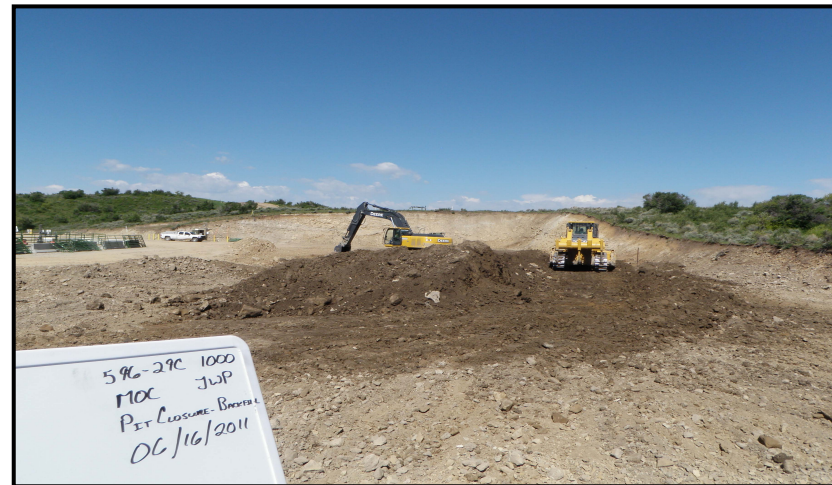
Photo 6 – Pit during backfilling operations.

Backfilling of the excavation was achieved by placing the 1.5:1 mixture of clean soil and cuttings back into the excavation (Photos 6 and 7). The mixed material was placed load-by-load into the excavation with each load being thoroughly compacted using the tracks of a dozer and a sheep's foot compactor. This process continued until the excavation was completely filled.

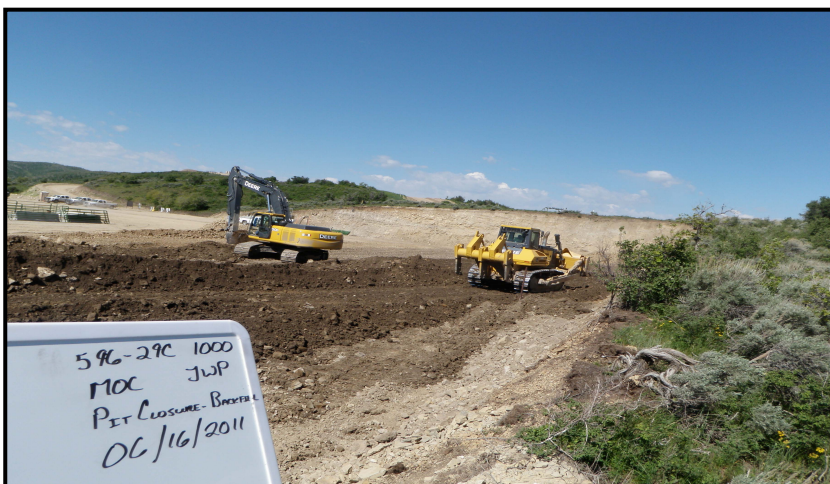
Photo 7 – Pit during backfilling operations.

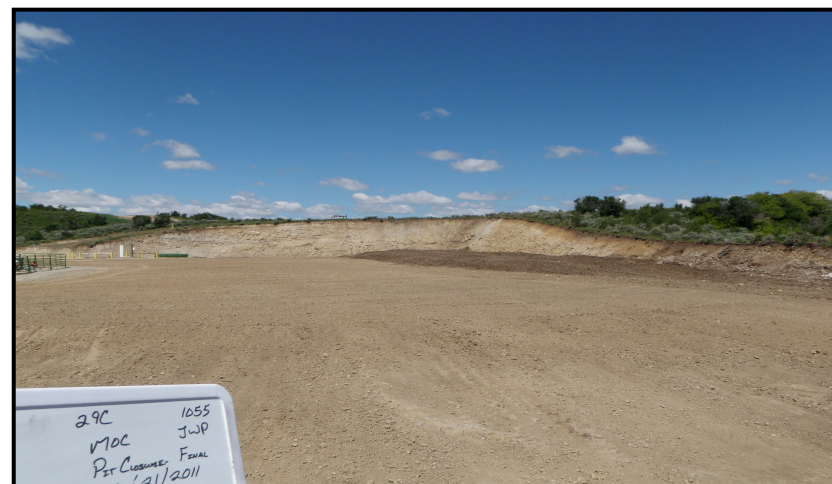
Photo 8 – Well pad after pit closure and reclamation.

Once the excavation had been backfilled, areas of the well pad no longer required for production were roughly graded to their original contour (Photo 8). These re-contoured areas were then top-soiled, thereby mitigating the potential effects of physical parameters on reclamation success. Backfilling and re-contouring operations concluded on June 21, 2011.

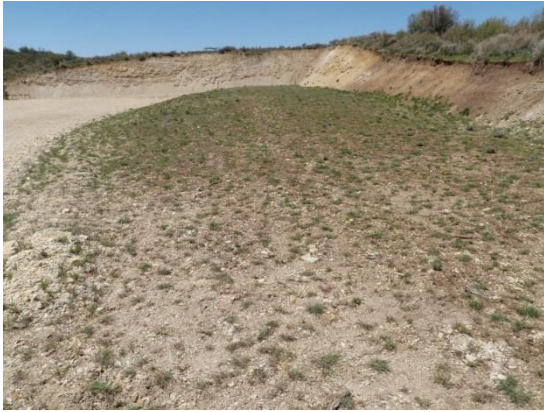
Former location of pit

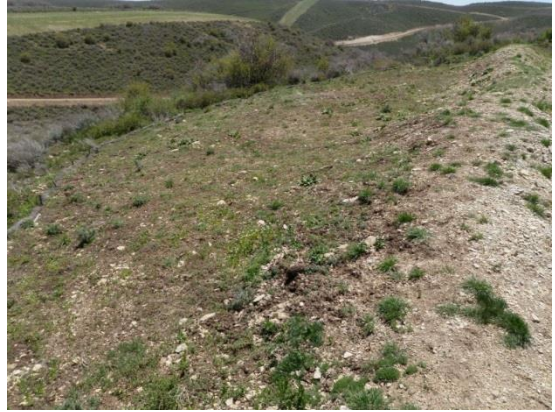
Eastern edge of pad

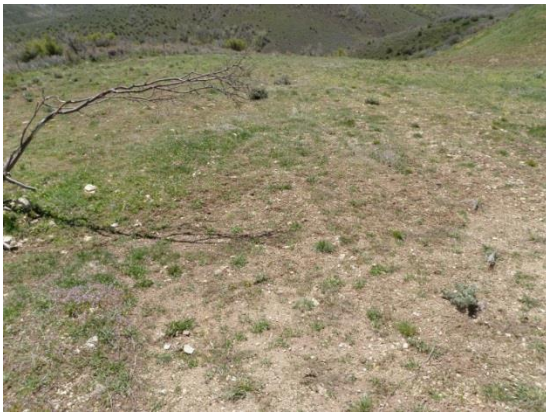
Southeast corner of pad

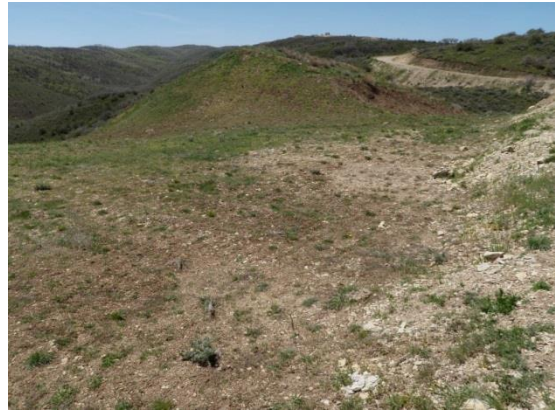
Southern edge of pad and top soil pile

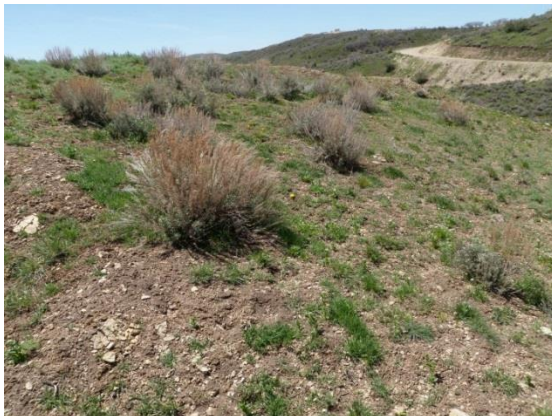
Top soil pile

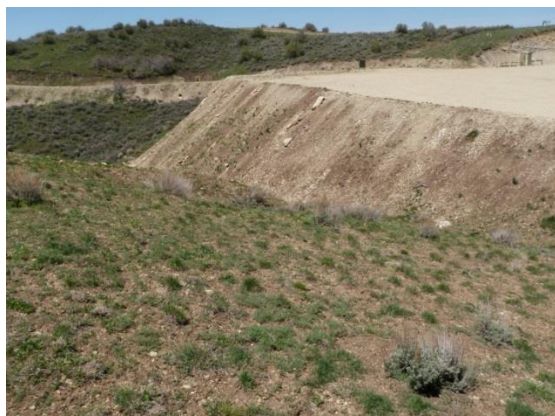
Reclaimed area and southern fill slope

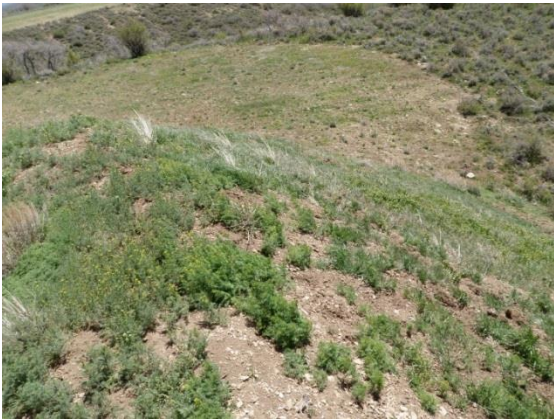
Top soil pile

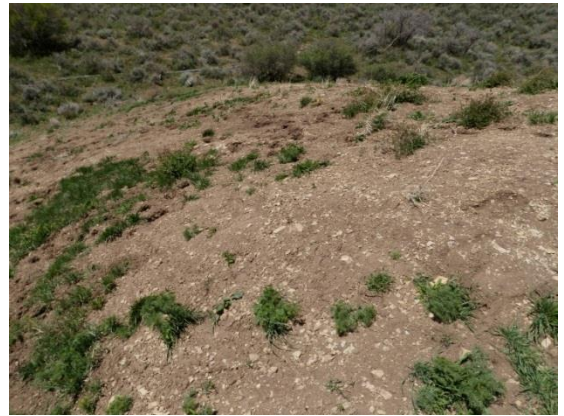
Top soil pile

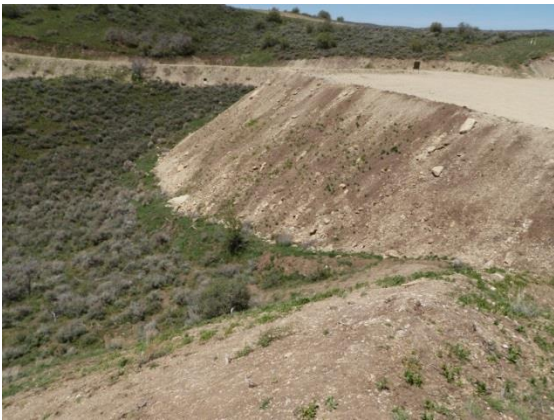
Southern fill slope

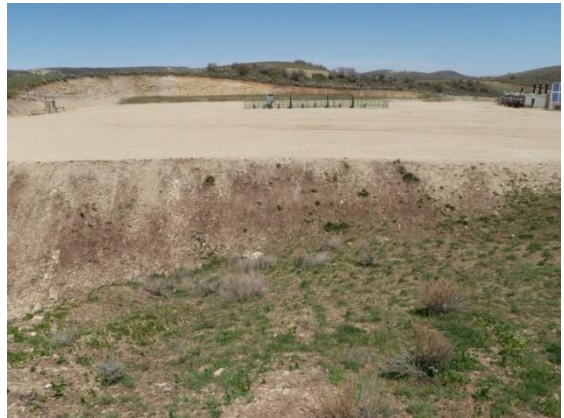
Looking north across pad

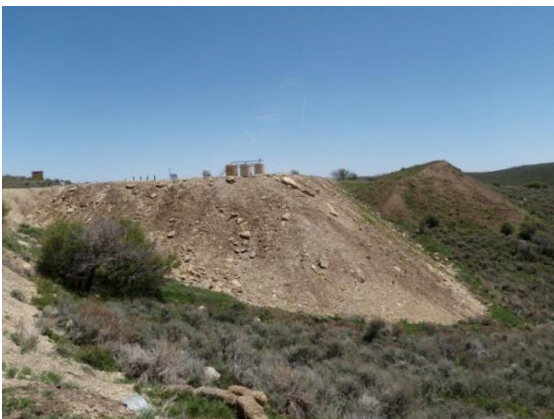
Southwest corner of pad
