## Final Reclamation Inspection

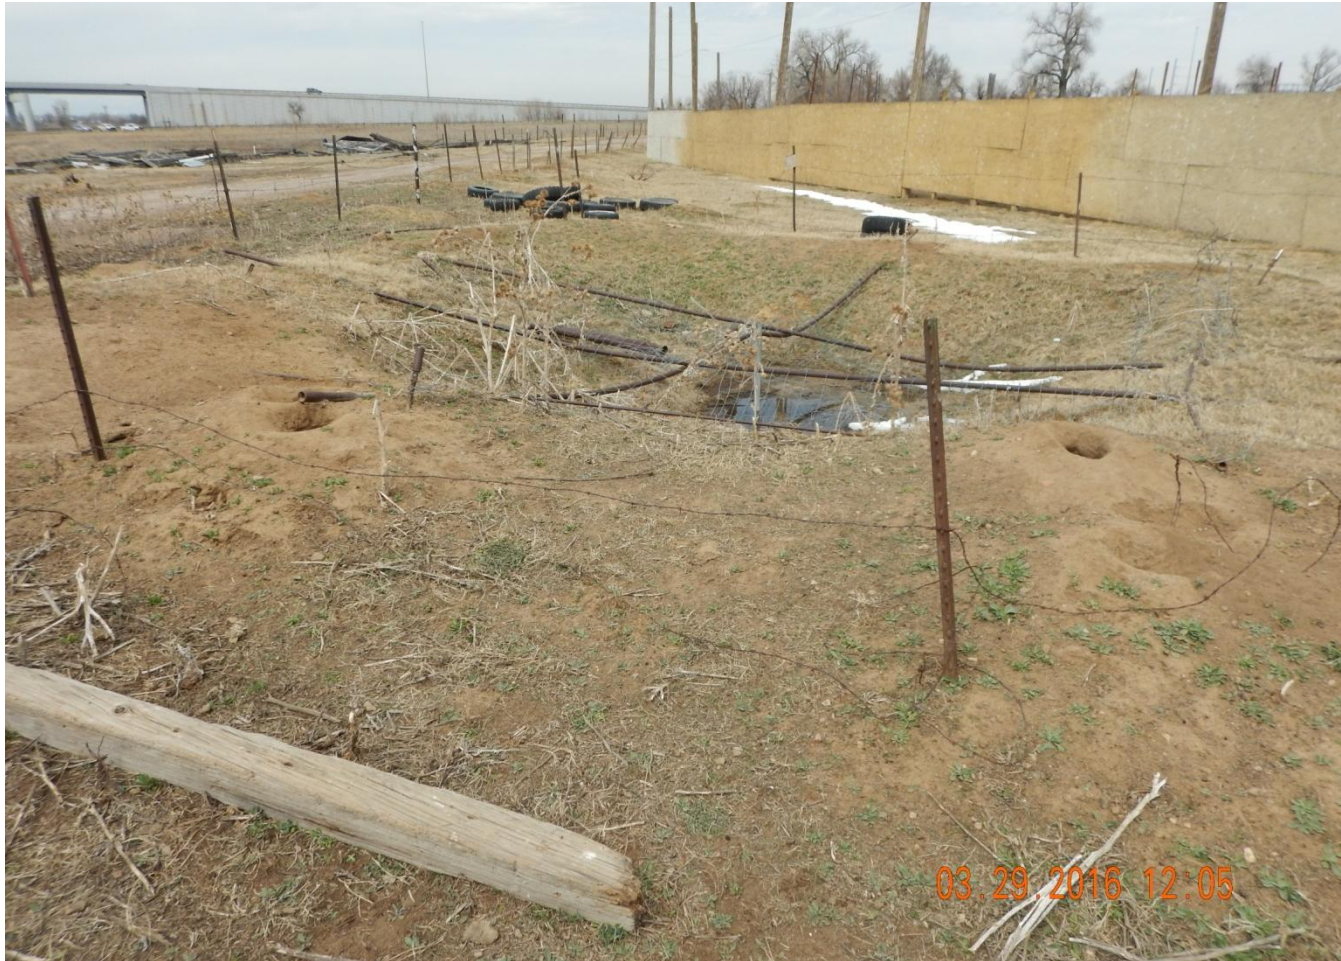
**Photo 1.** Photo taken of produced water pit west of 300 bbl tank. Pit needs to be backfilled and reclaimed per Rule 1004. Spread and infestation of a Colorado List B noxious weed (Bull thistle- *Cirsium vulgare*) exists throughout the location, along the lease road, and spreading onto adjacent lands needs to be controlled per Rule 1004.

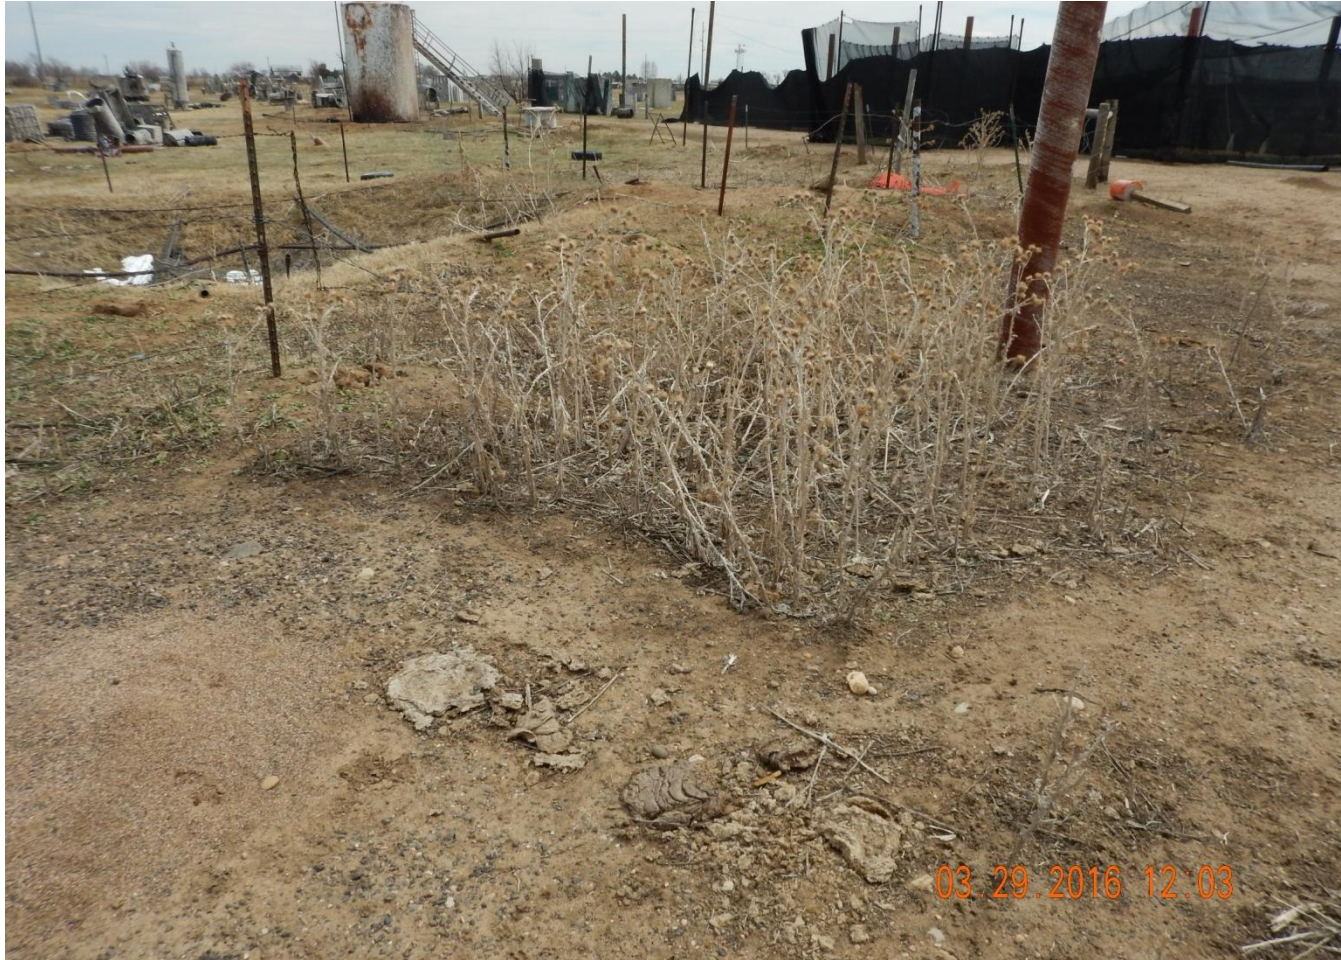
**Photo 2.** Photo taken of bull thistle infestation west of produced water, facing East towards 300 bbl tank. Need to control noxious weeds per Rule 1004.

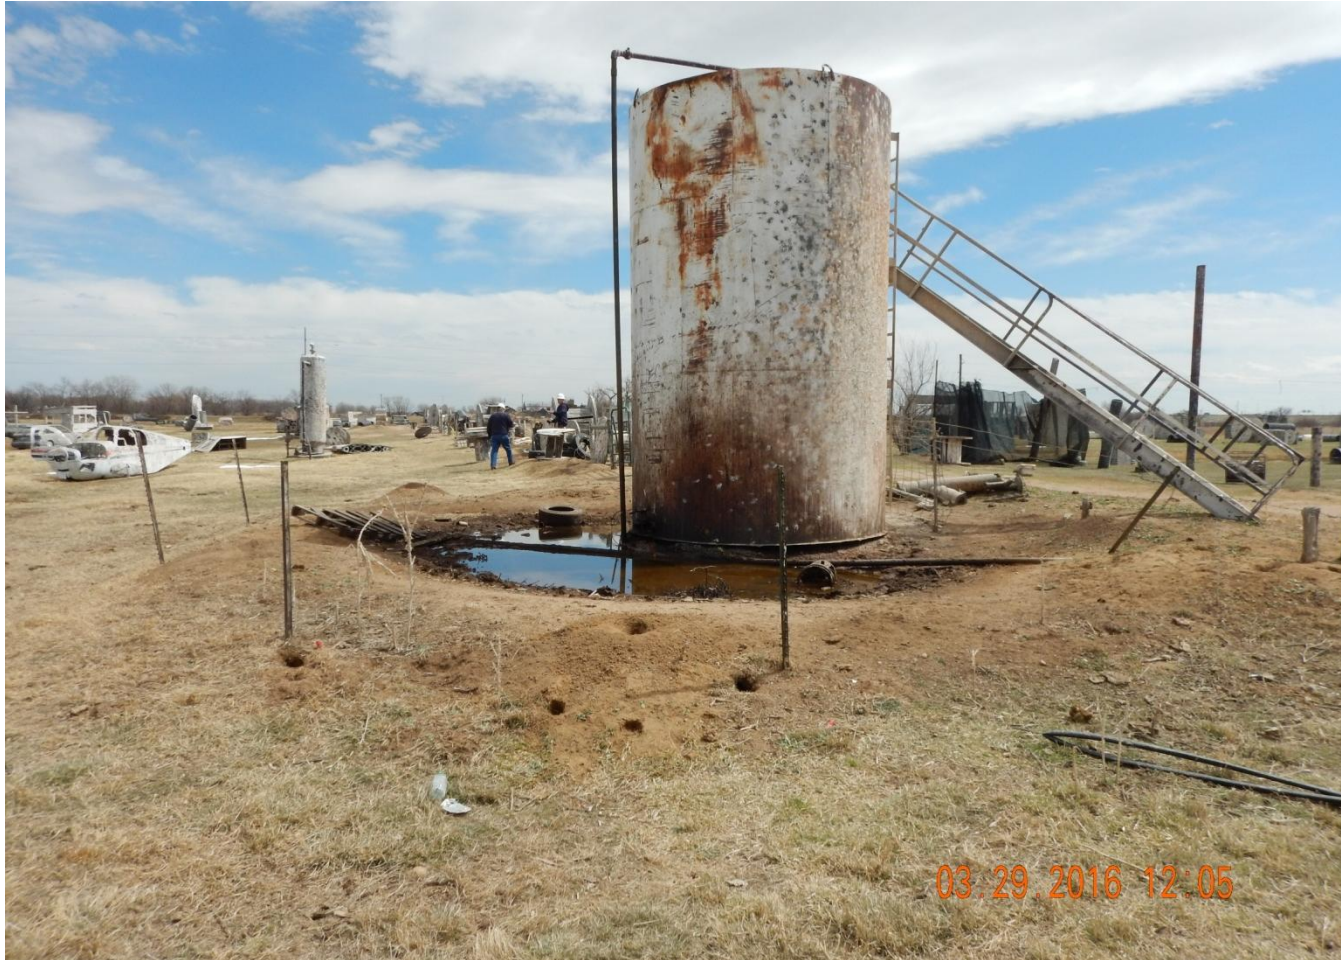
**Photo 3.** Photo taken of 300 bbl tank with pooled water and hydrocarbon odors. Need to remove all surface equipment within three months of plugging a well, backfill and reclaim area per Rule 1004.

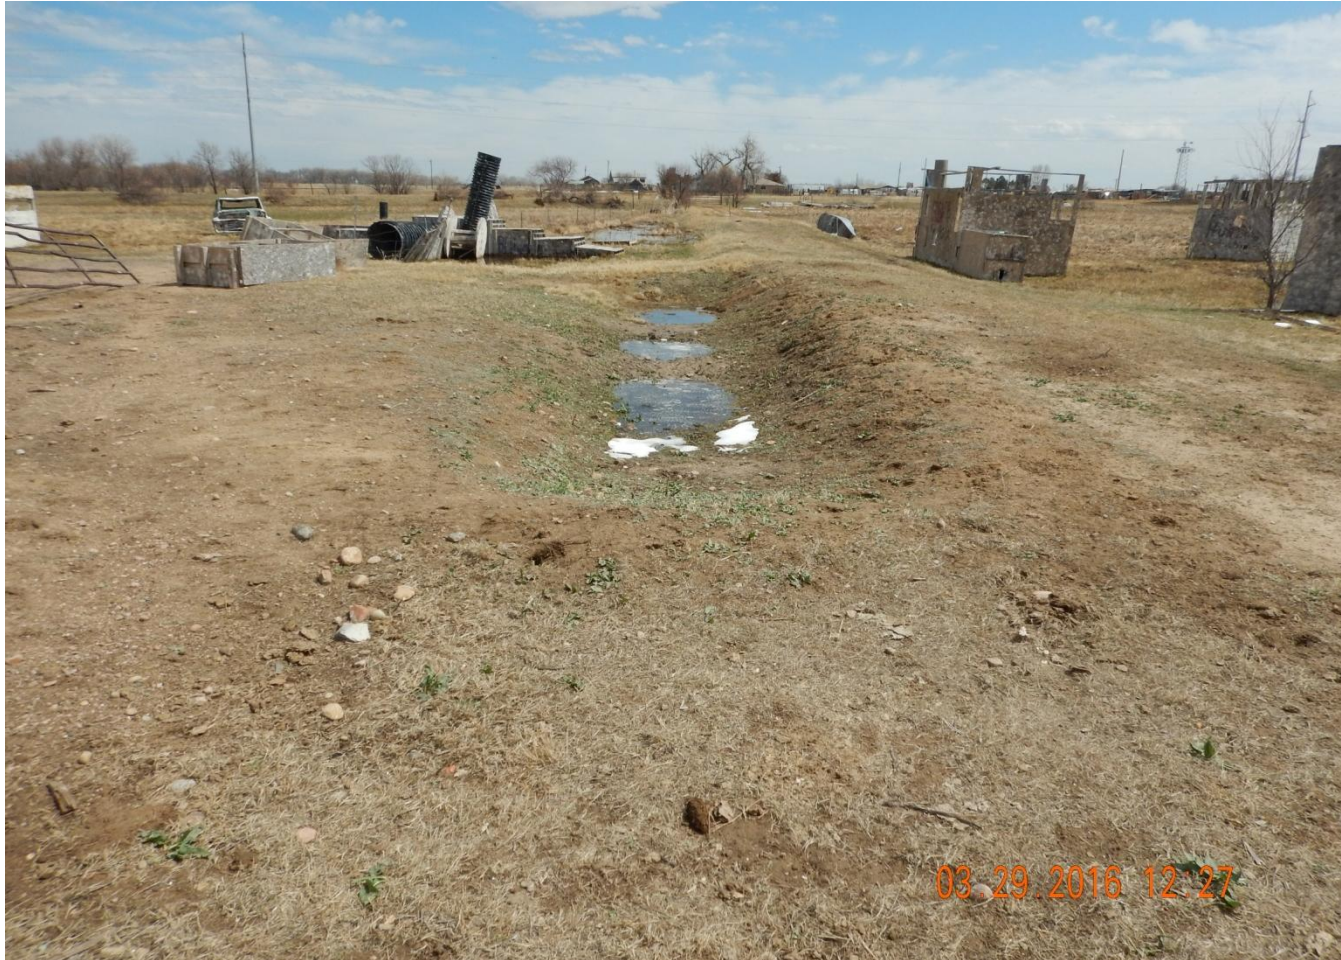
**Photo 4.** Photo taken east of 300 bbl tank of possible workover/plugging pit. Need to backfill and reclaim per Rule 1004.

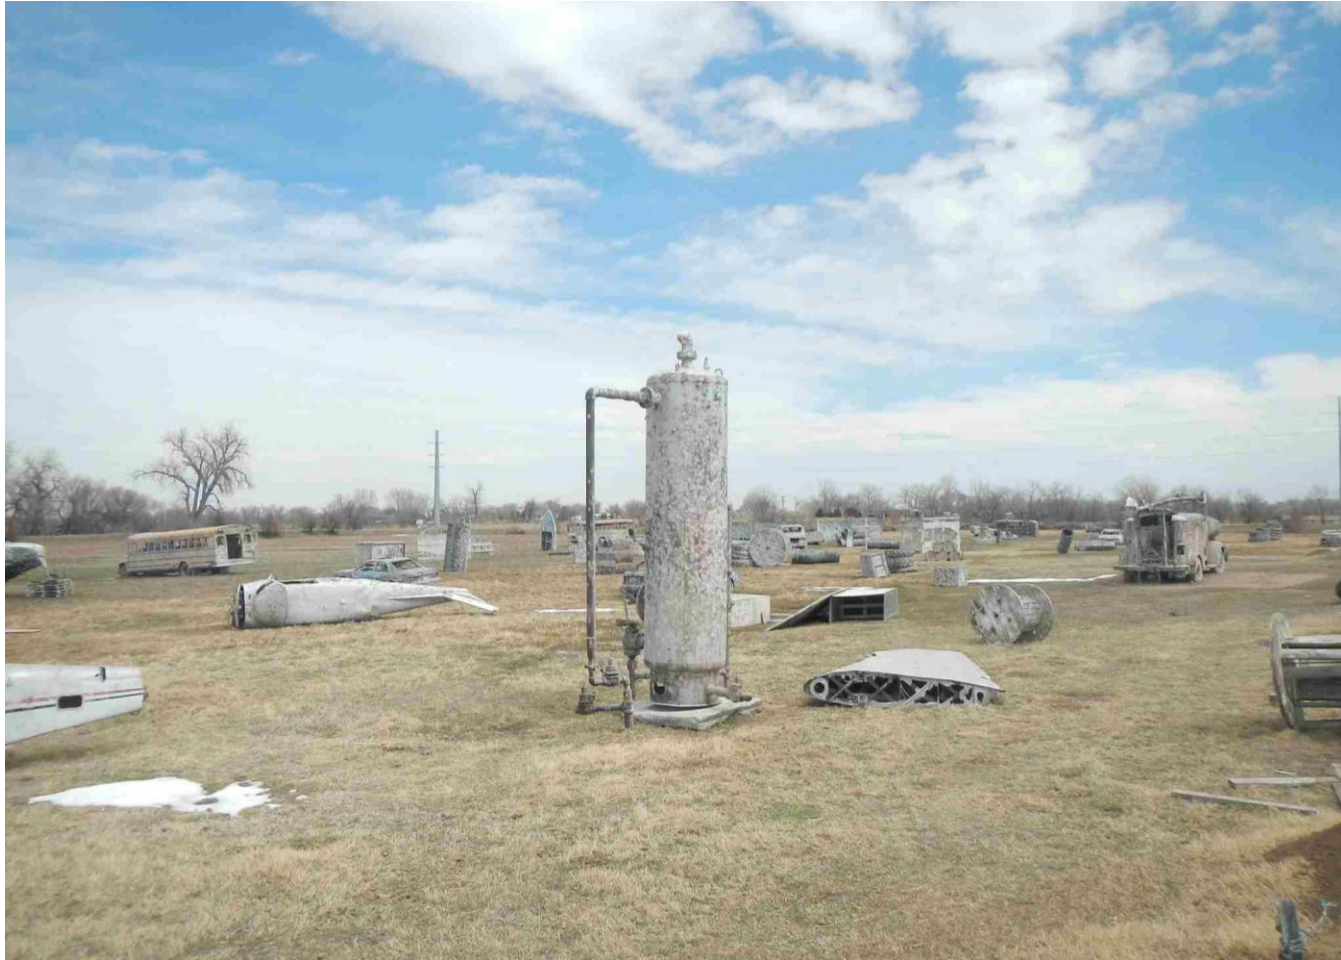
**Photo 5.** Photo taken of 2-phase separator, north of the 300 bbl tank. Need to remove all surface equipment within three months of plugging a well per Rule 1004.

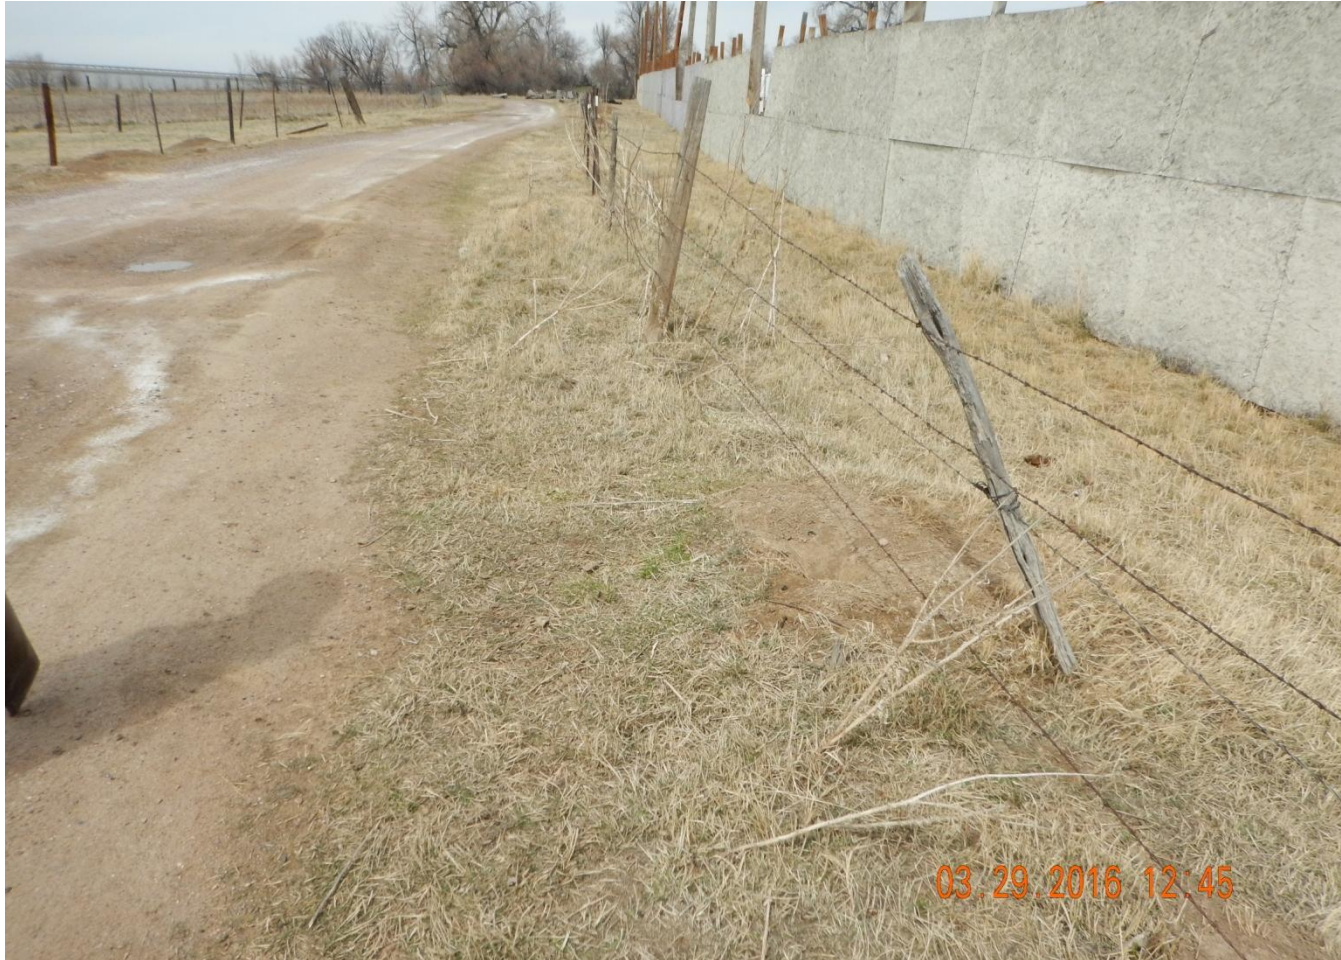
**Photo 6.** Photo taken northwest of produced water pit, facing North along lease road. All access roads to plugged and abandoned wells shall be closed, graded, and recontoured per Rule 1004.

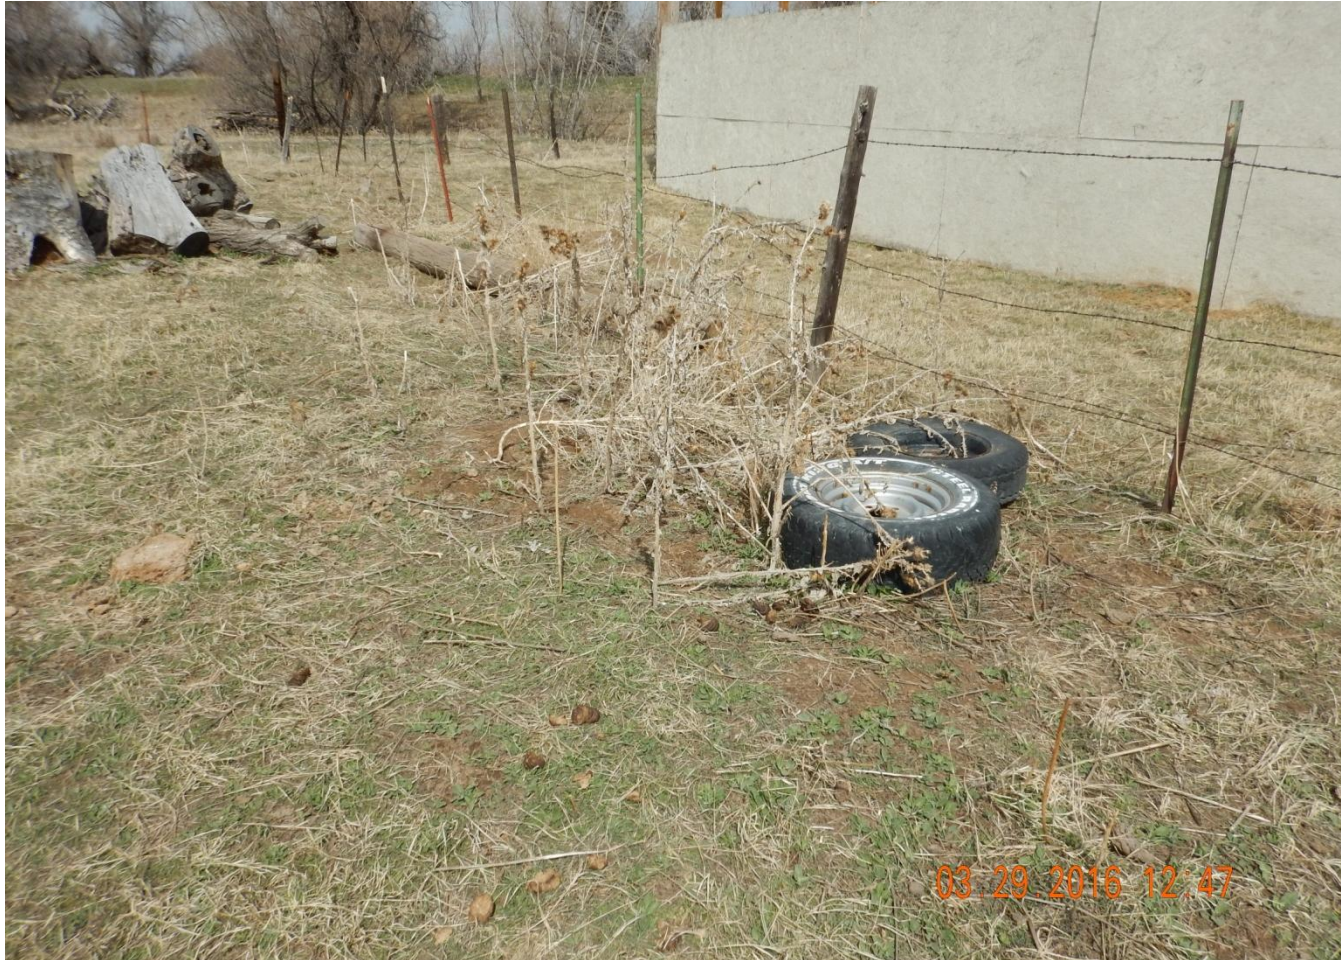
**Photo 7.** Photo taken from northeast corner of lease road, facing North. Need to control noxious weeds per Rule 1004.

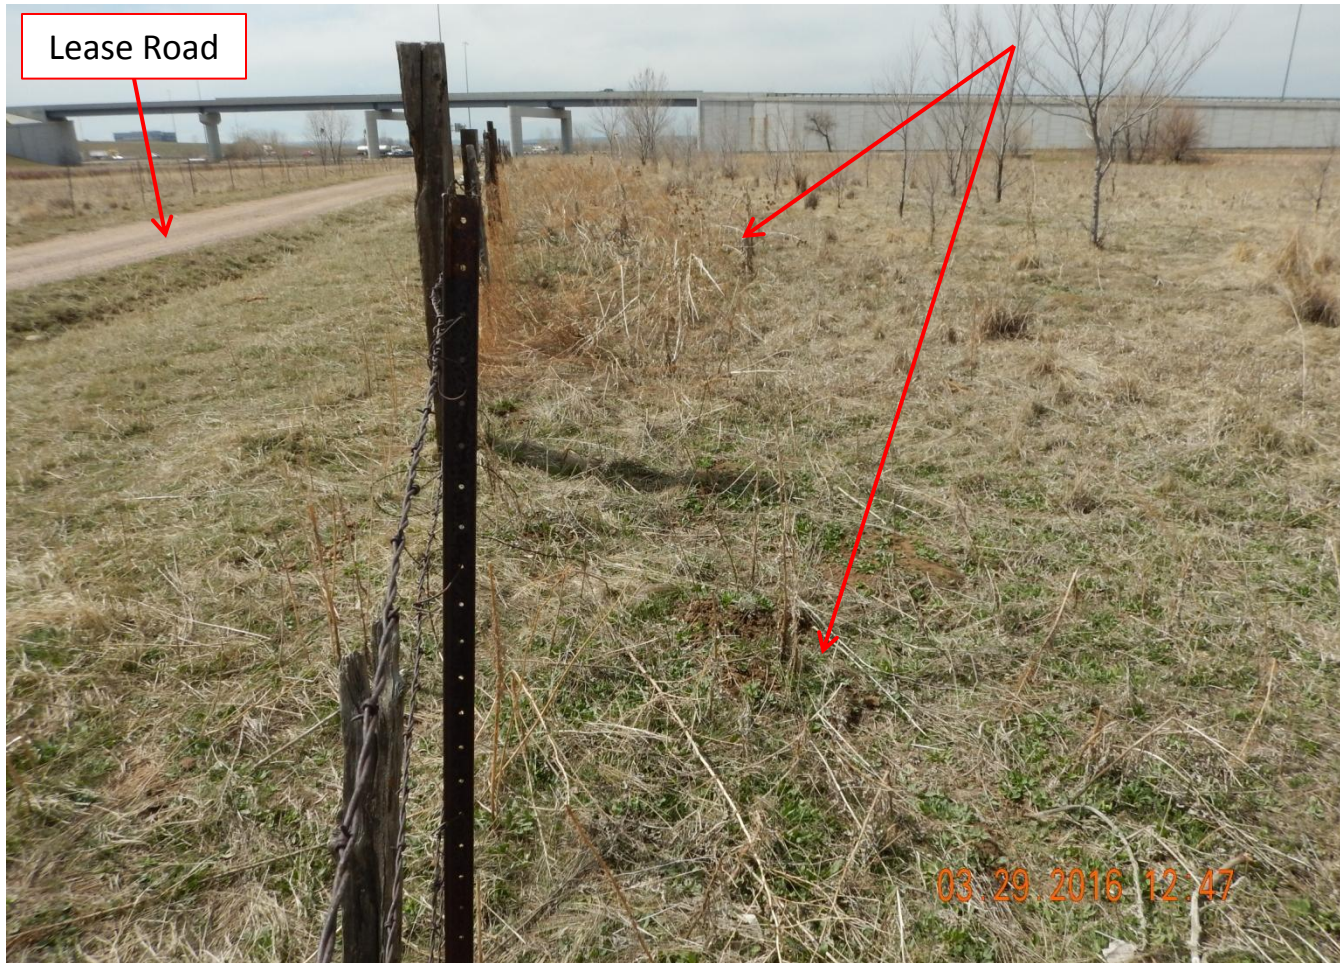
**Photo 8.** Photo taken from northeast corner of lease road, facing West. Under the Colorado Noxious Weed Act, noxious weeds must be prevented from spreading to surrounding lands. Bull thistle was observed throughout adjacent lands.
