Final Reclamation Inspection

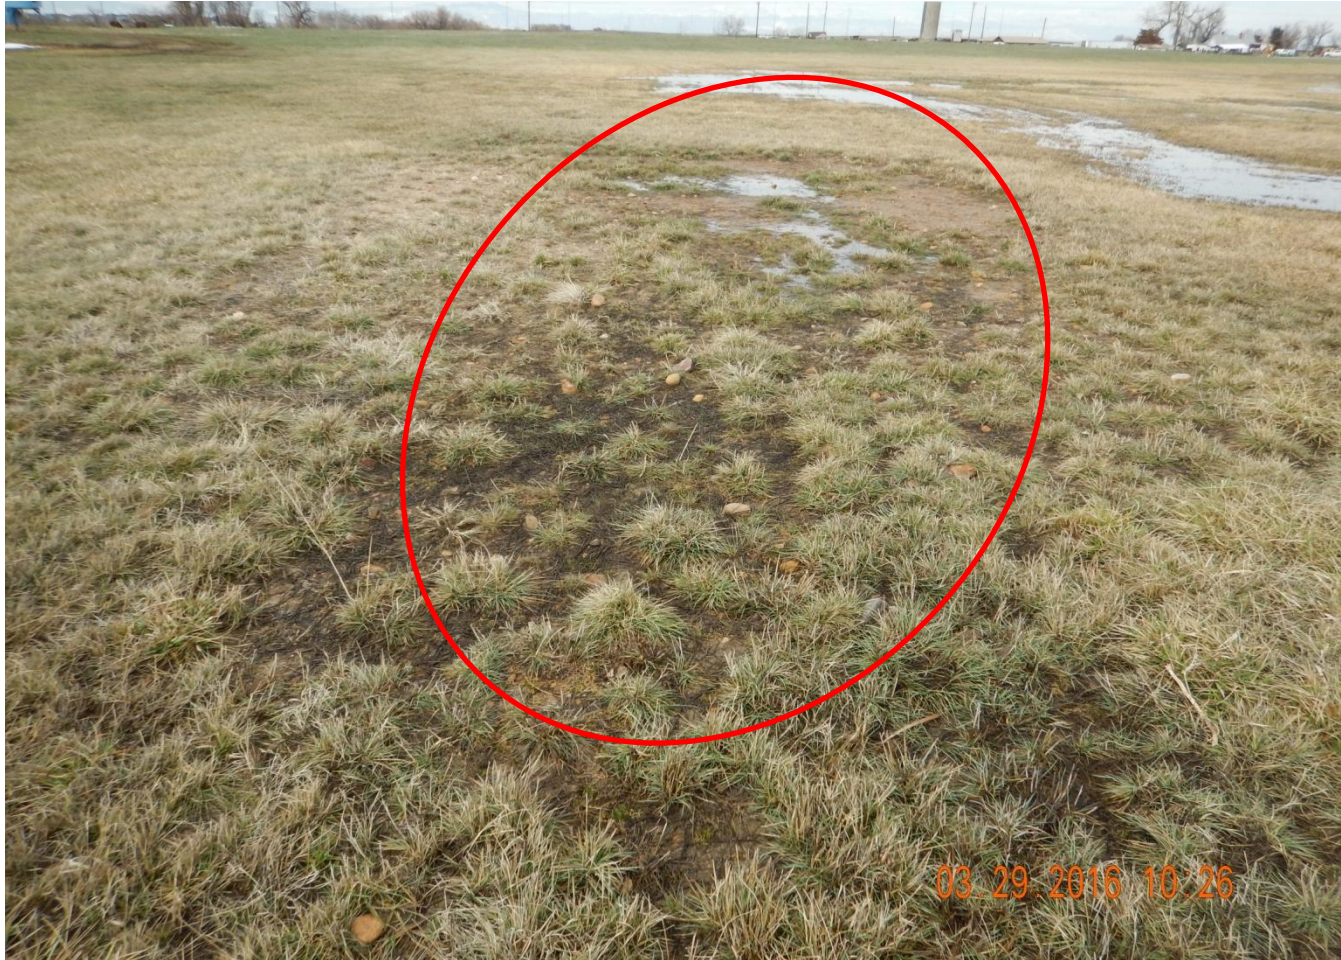
Photo 1. Photo taken from east of location, facing West. Gravel not removed and location does not reflect reference area vegetative cover per Rule 1004.

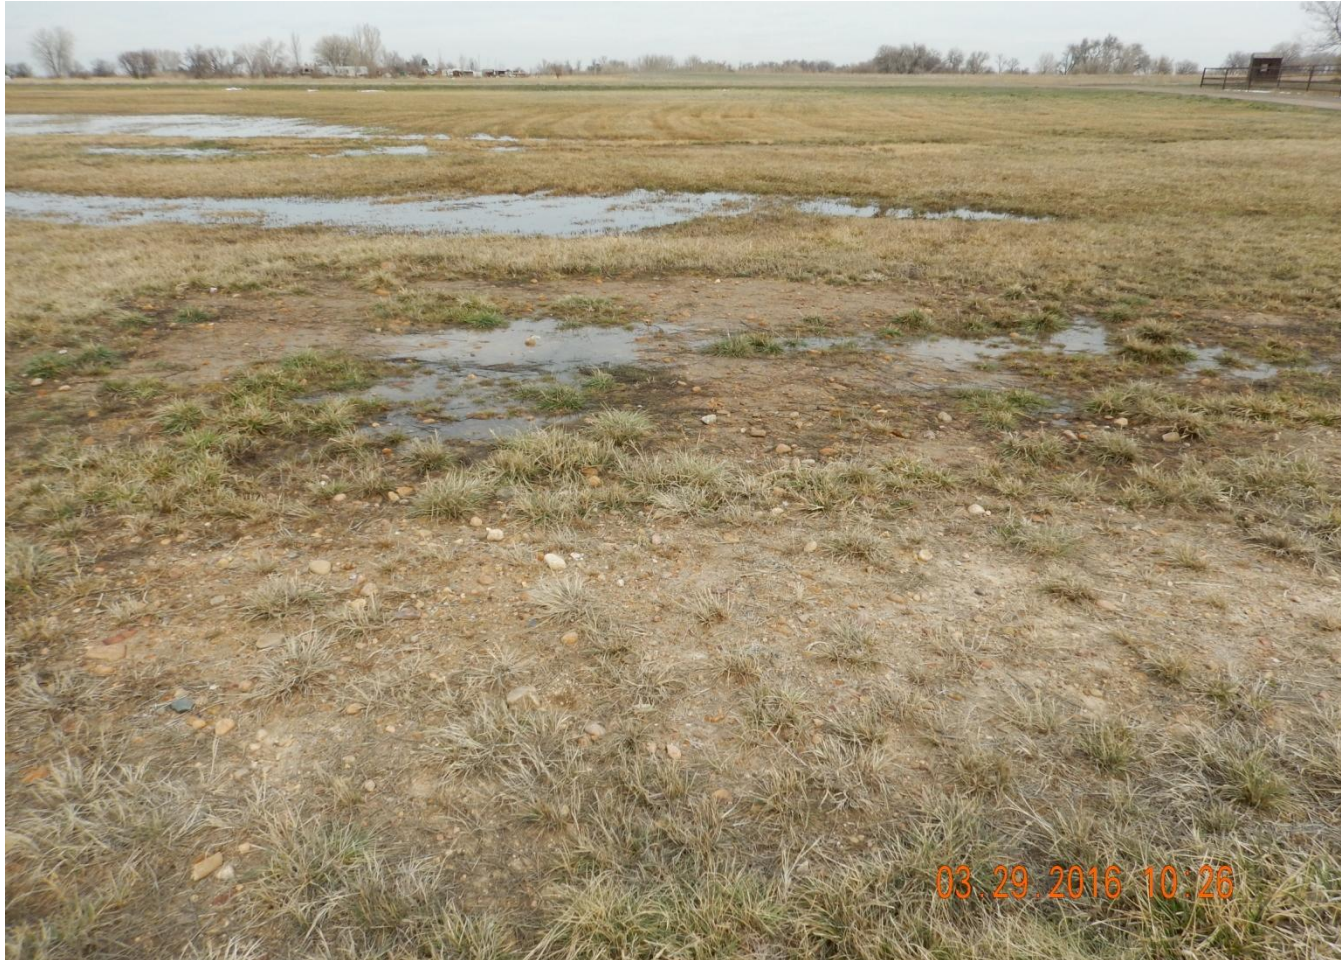
Photo 2. Photo taken from south of location, facing North. Gravel not removed and location does not reflect reference area vegetative cover per Rule 1004.

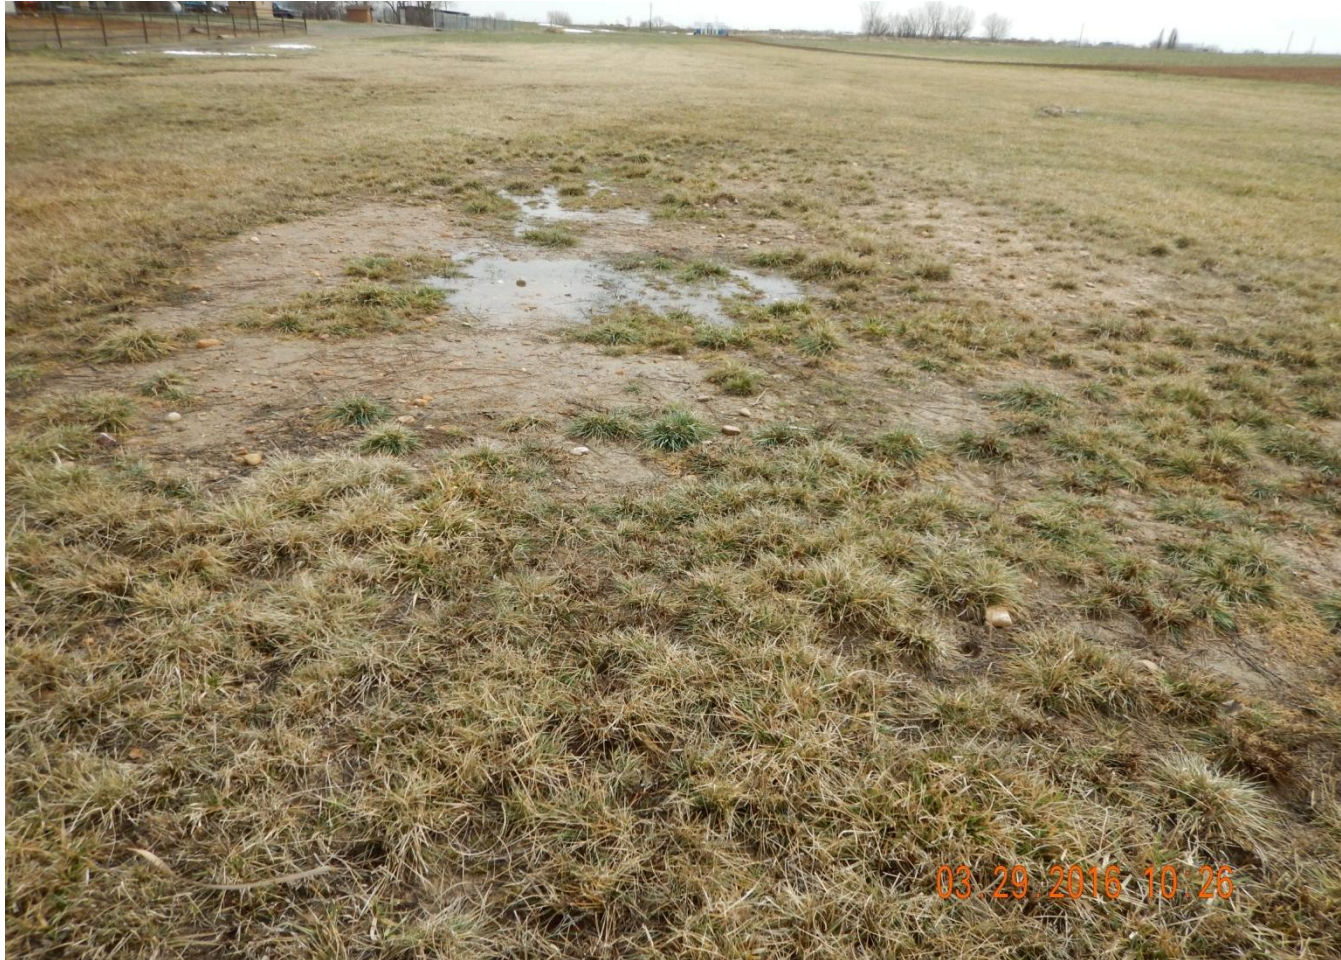
Photo 3. Photo taken from west of location, facing East. Gravel not removed and location does not reflect reference area vegetative cover per Rule 1004.

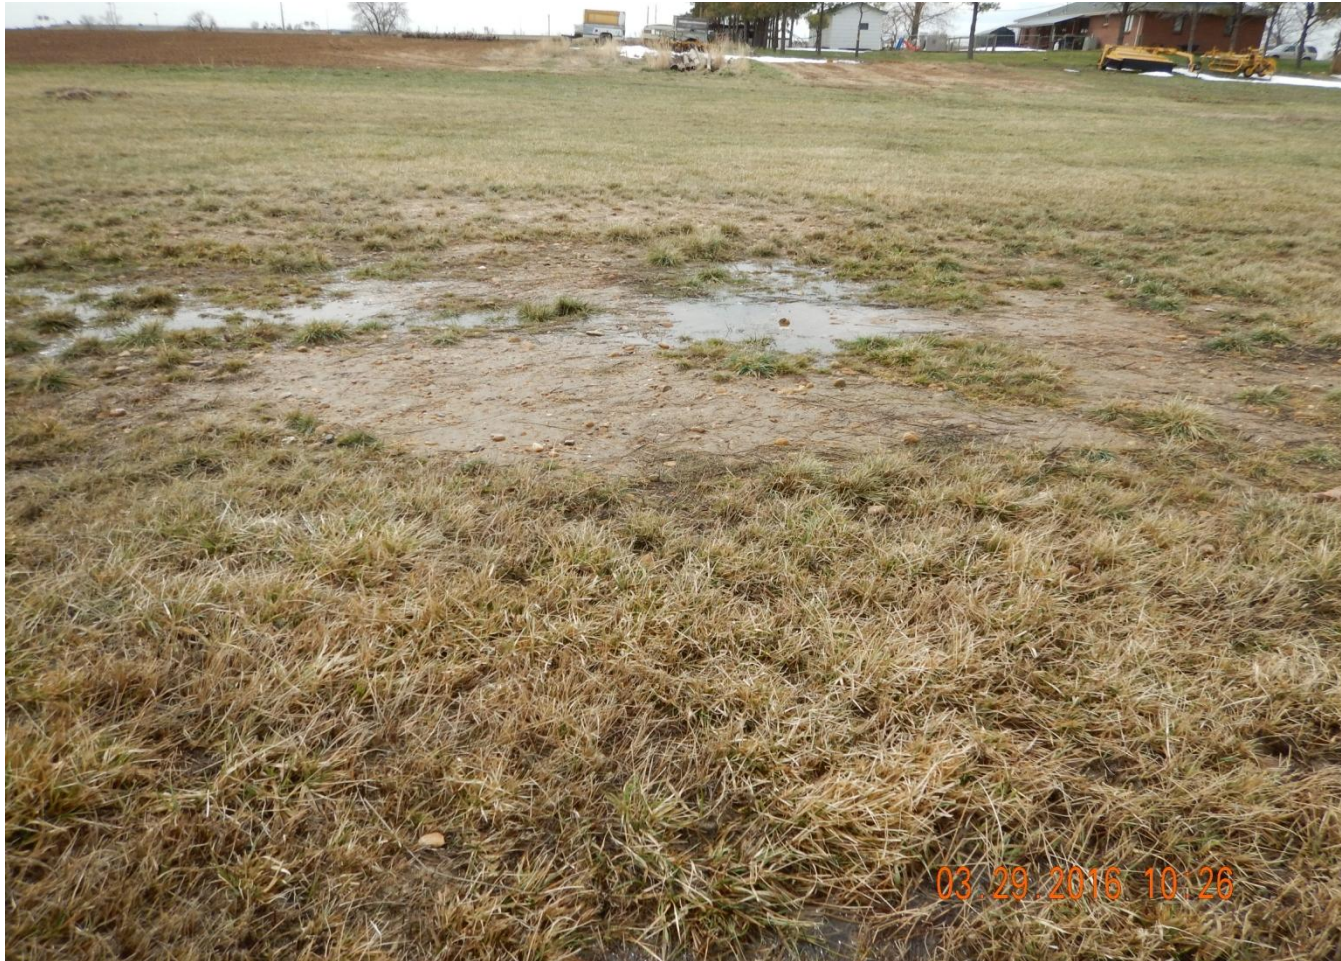
Photo 4. Photo taken from north of location, facing South. Gravel not removed and location does not reflect reference area vegetative cover per Rule 1004.

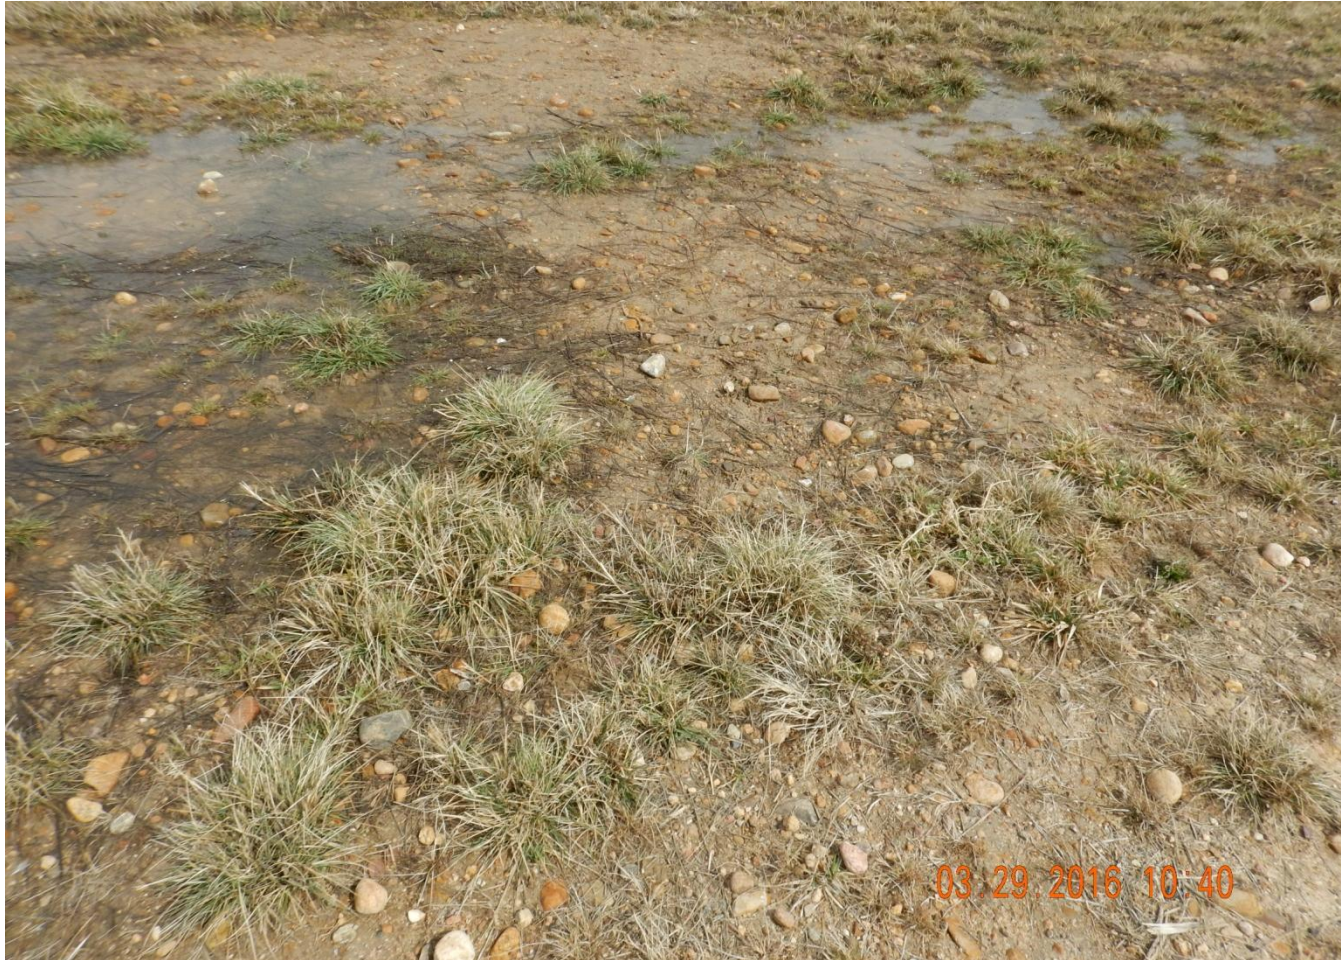
Photo 5. Photo taken from center of location. Gravel not removed and location does not reflect reference area vegetative cover per Rule 1004.

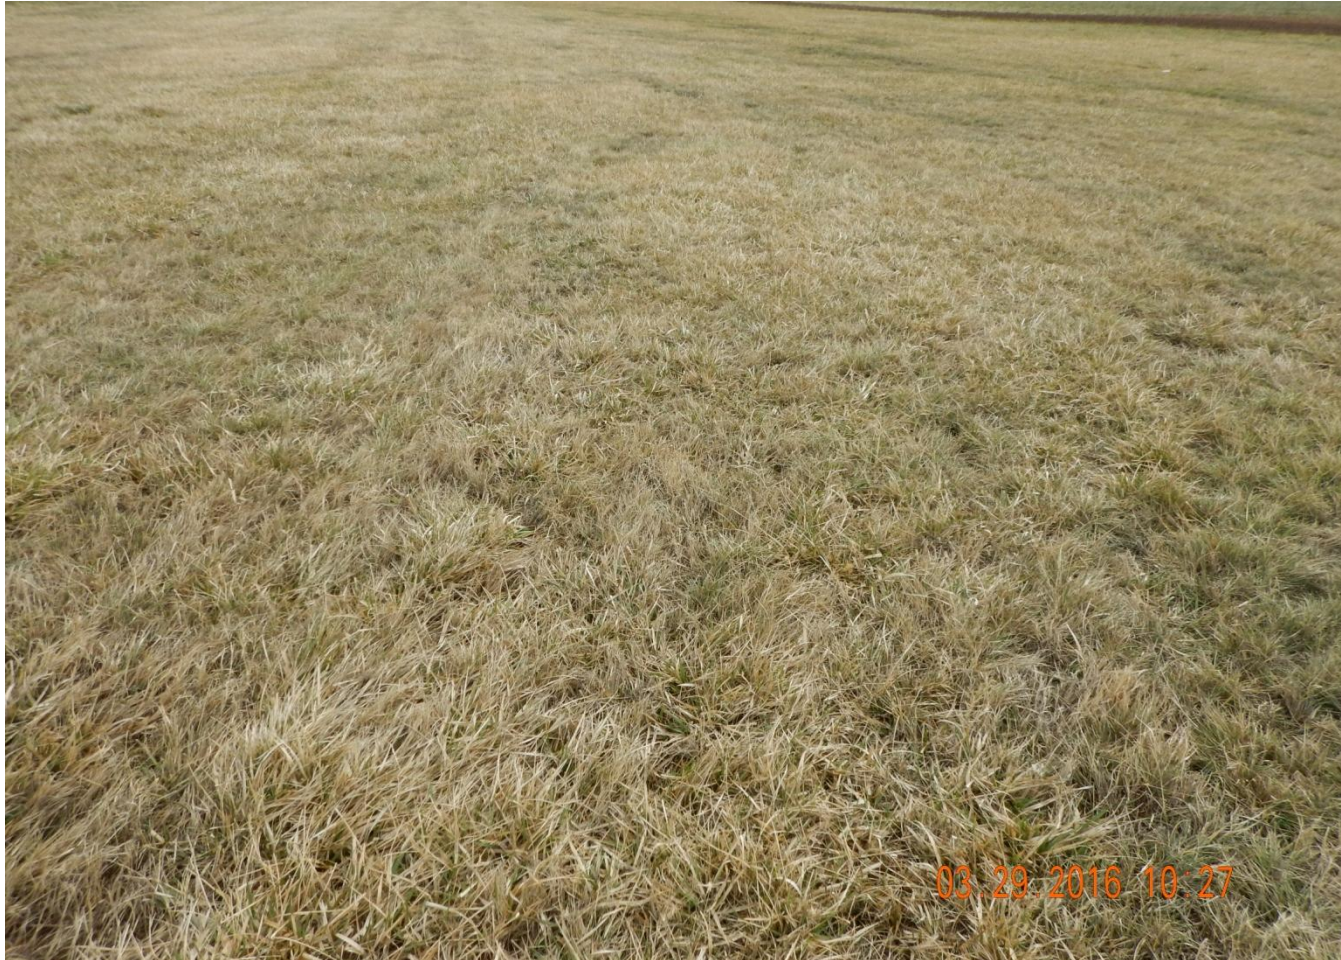
Photo 6. Photo taken from east of location, facing East. Reference area illustrates uniform vegetative cover.

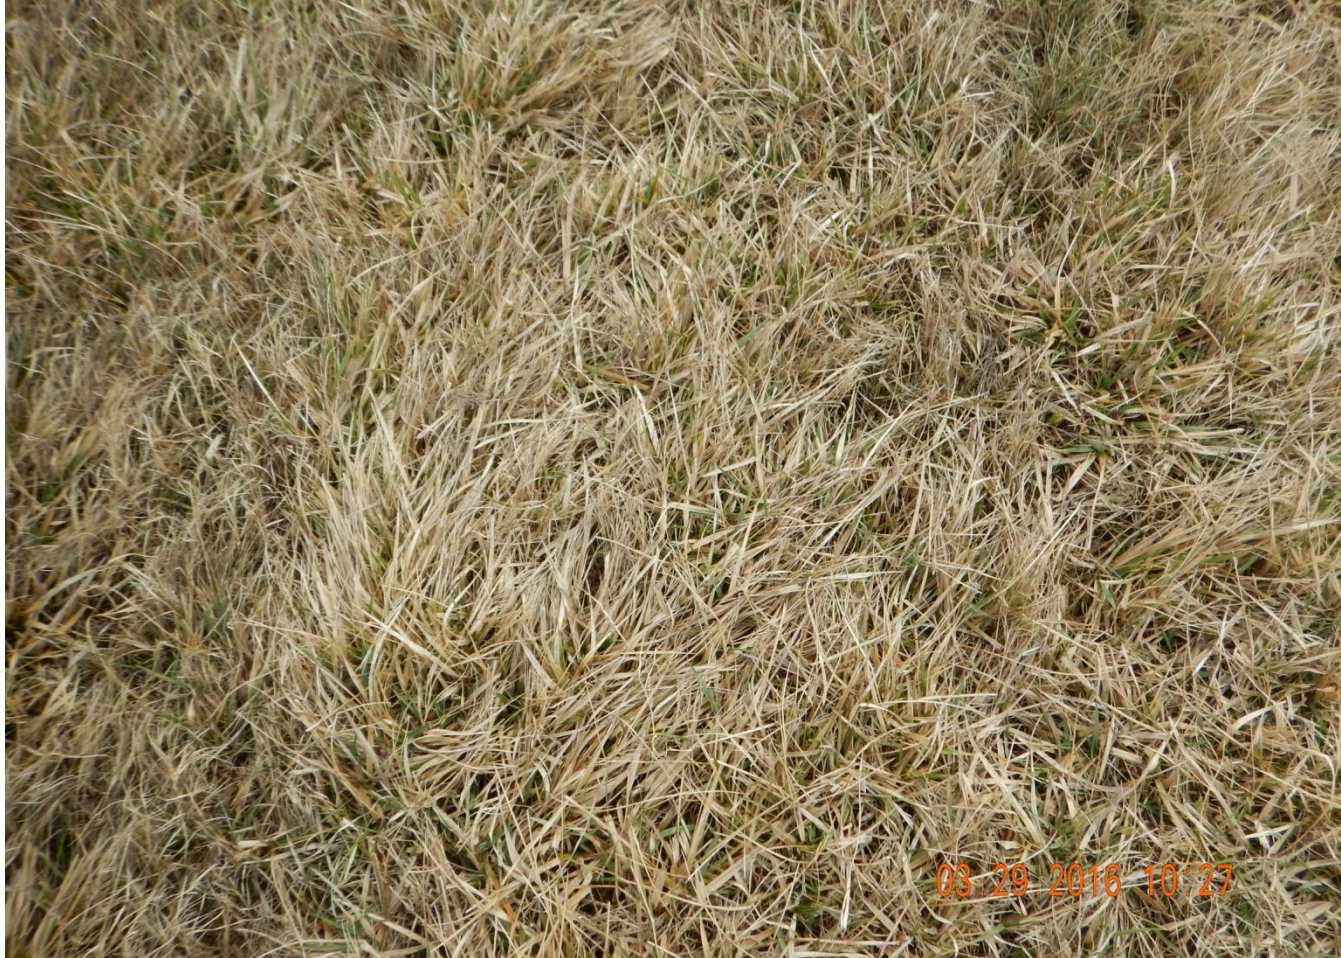
Photo 7. Photo taken from east of location, facing East. Reference area illustrates uniform vegetative cover.
