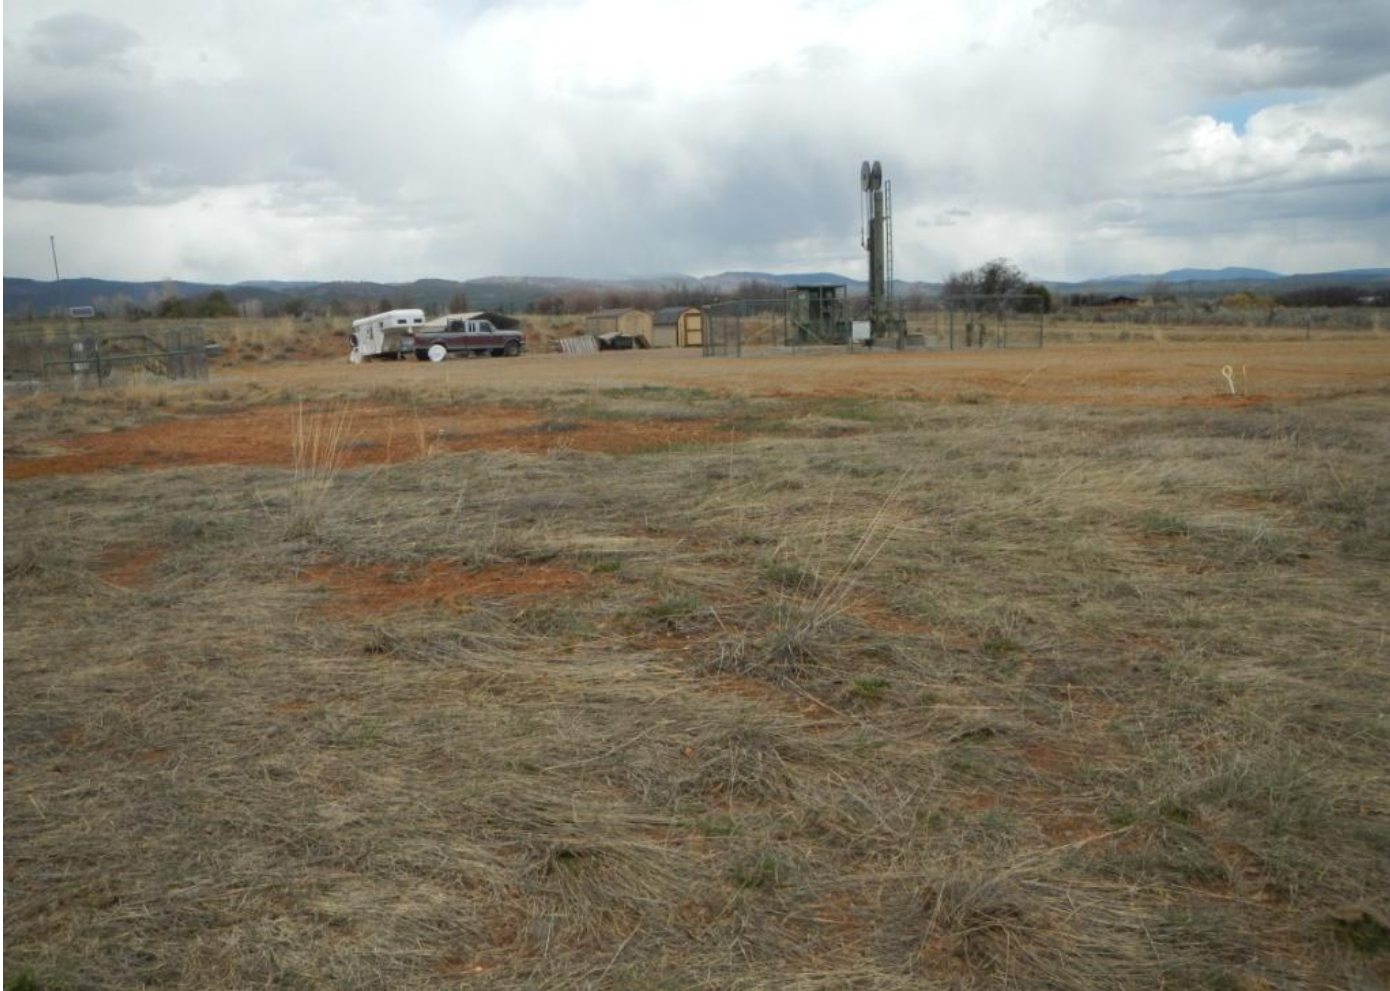
Photo 1. View of the project area from the southwestern corner facing center.

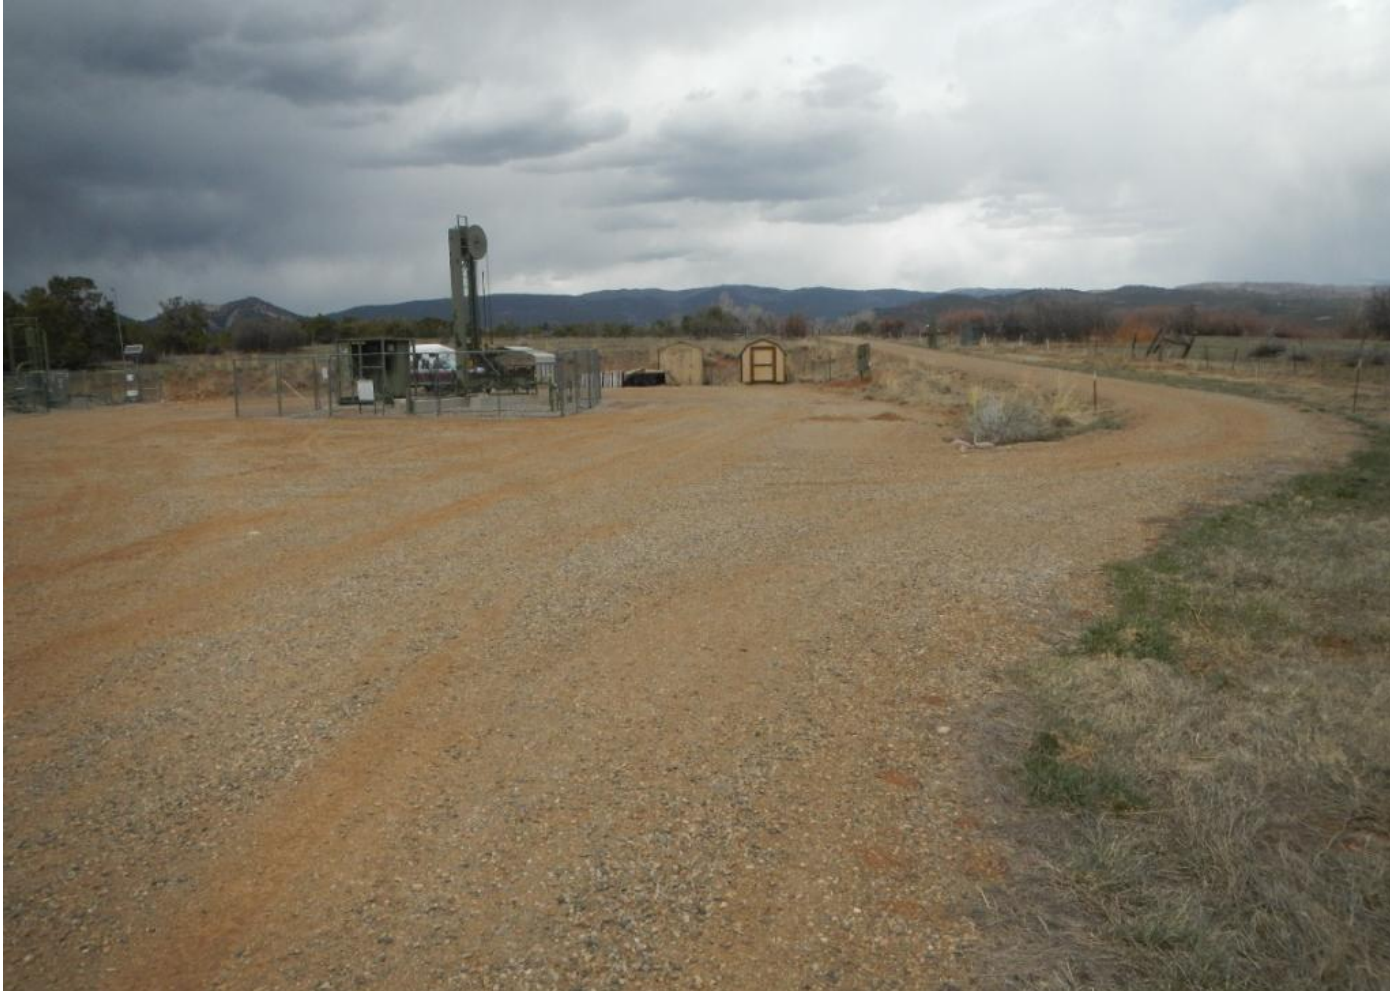
Photo 2. View of the eastern portion of the project area from the southeastern corner facing northward.

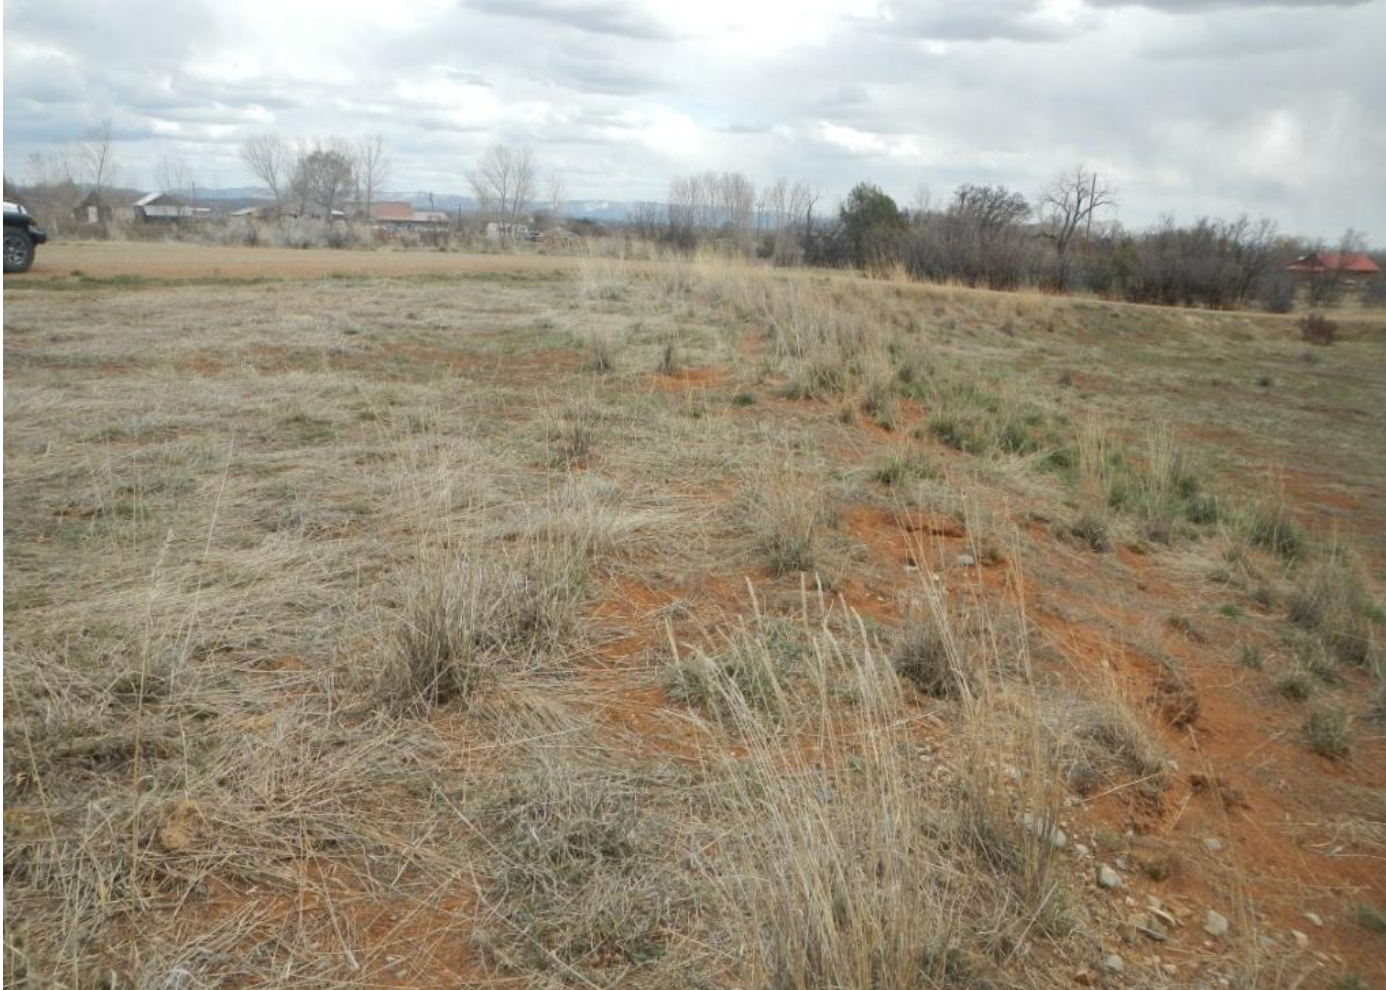
Photo 3. View of the southern portion of the project area from the southwestern corner facing eastward. Revegetation is progressing here and is largely comprised of crested wheatgrass (*Agropyron cristatum*), intermediate wheatgrass (*Thinopyron intermedium*), and western wheatgrass (*Pascopyrum smithii*).

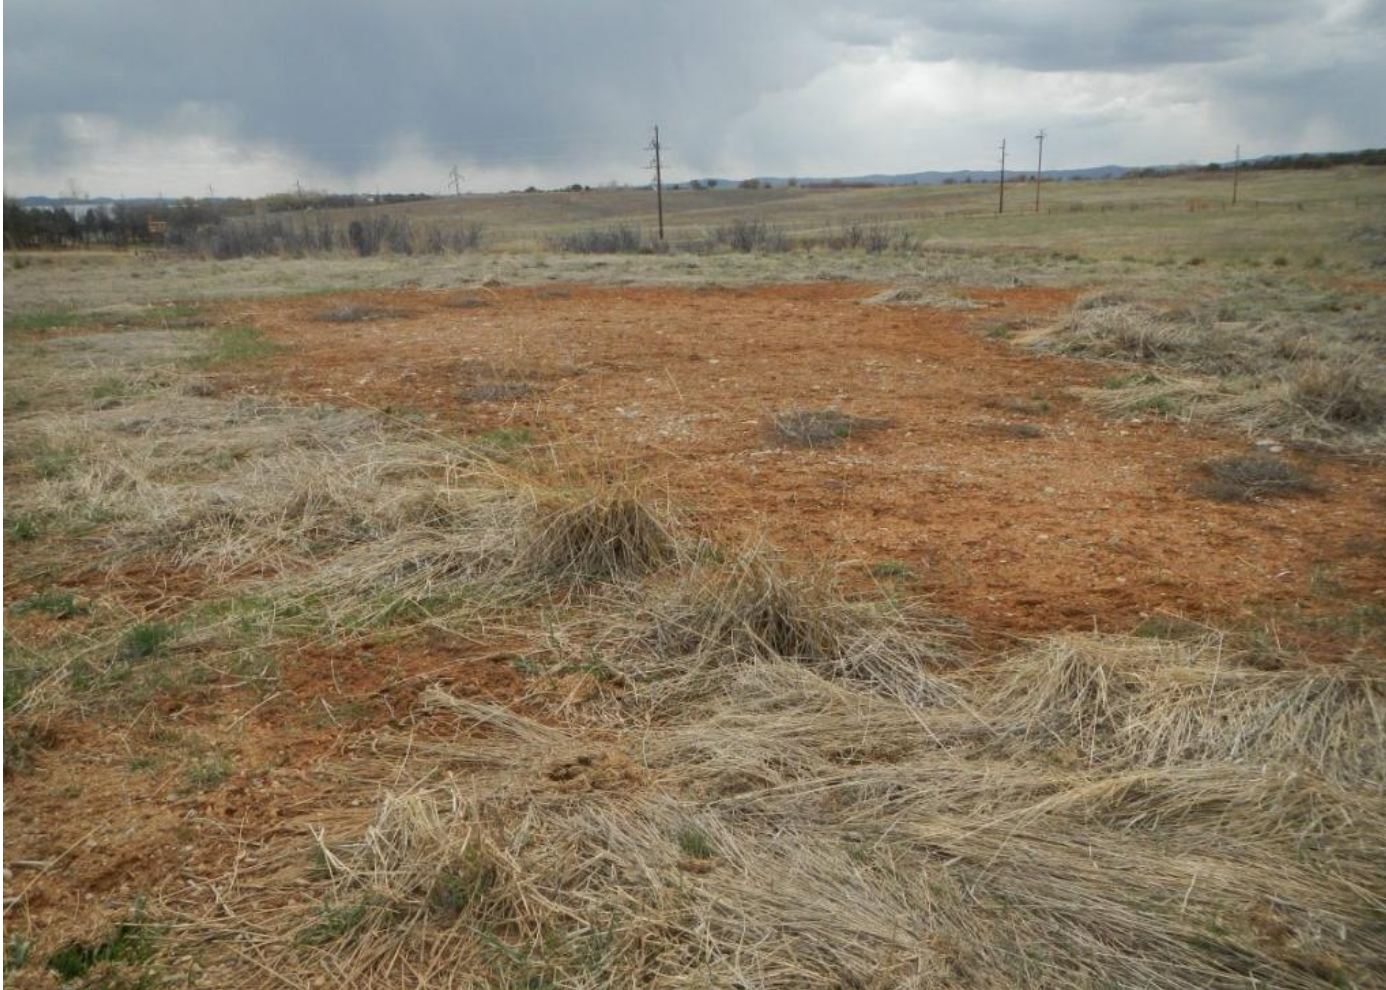
Photo 4. View of an approximately 50 foot long and 25 feet wide area in the western portion of the interim reclamation area that needs revegetation.

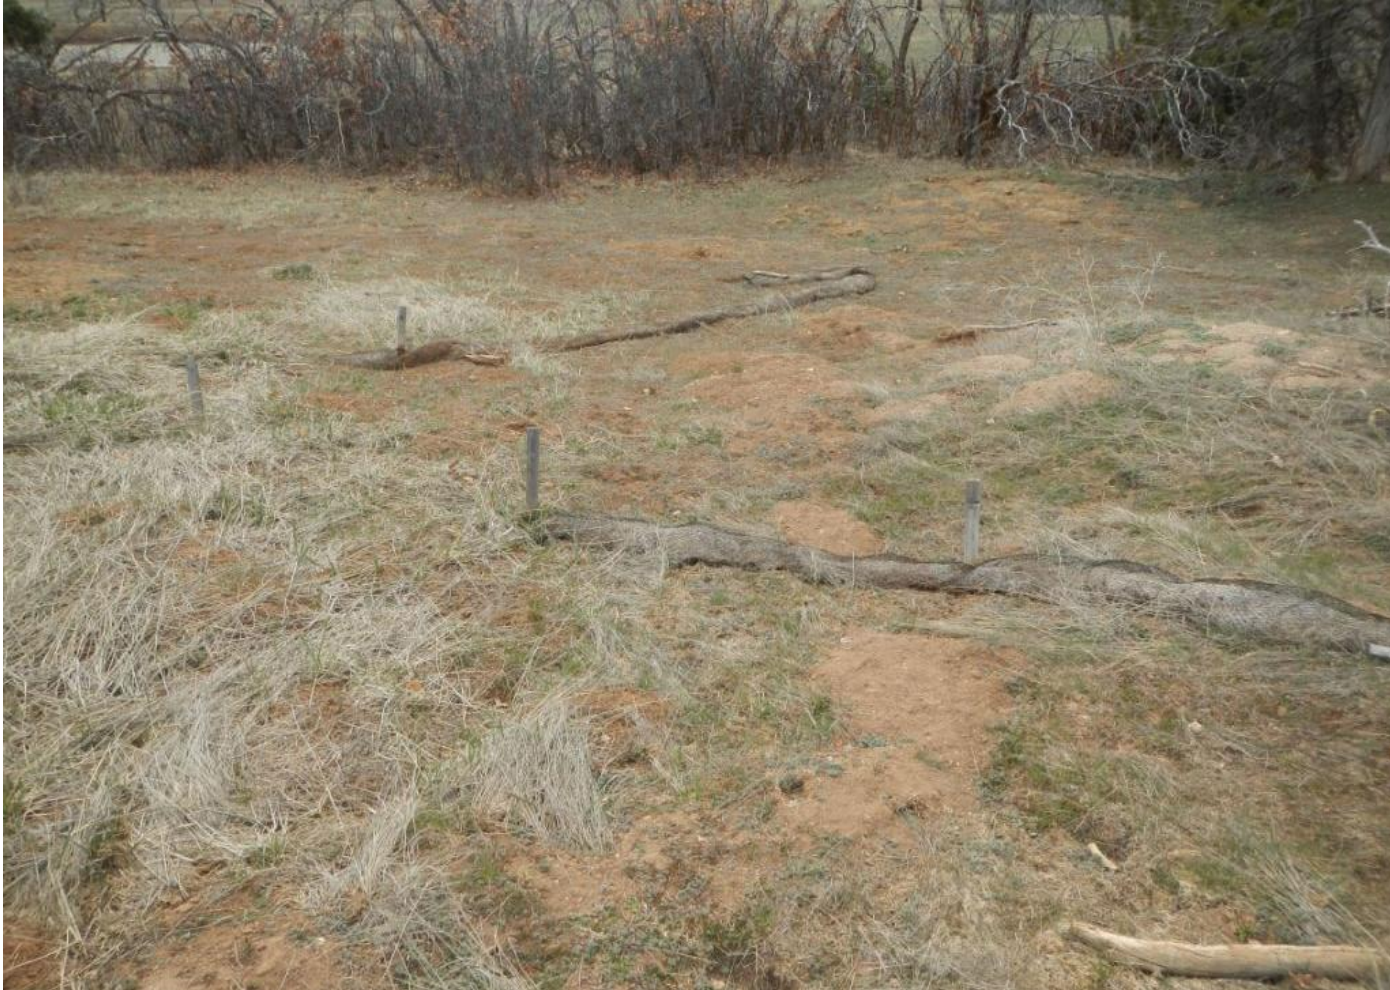
Photo 5. View of area in northwestern portion of the project area where wattles are no longer functioning.

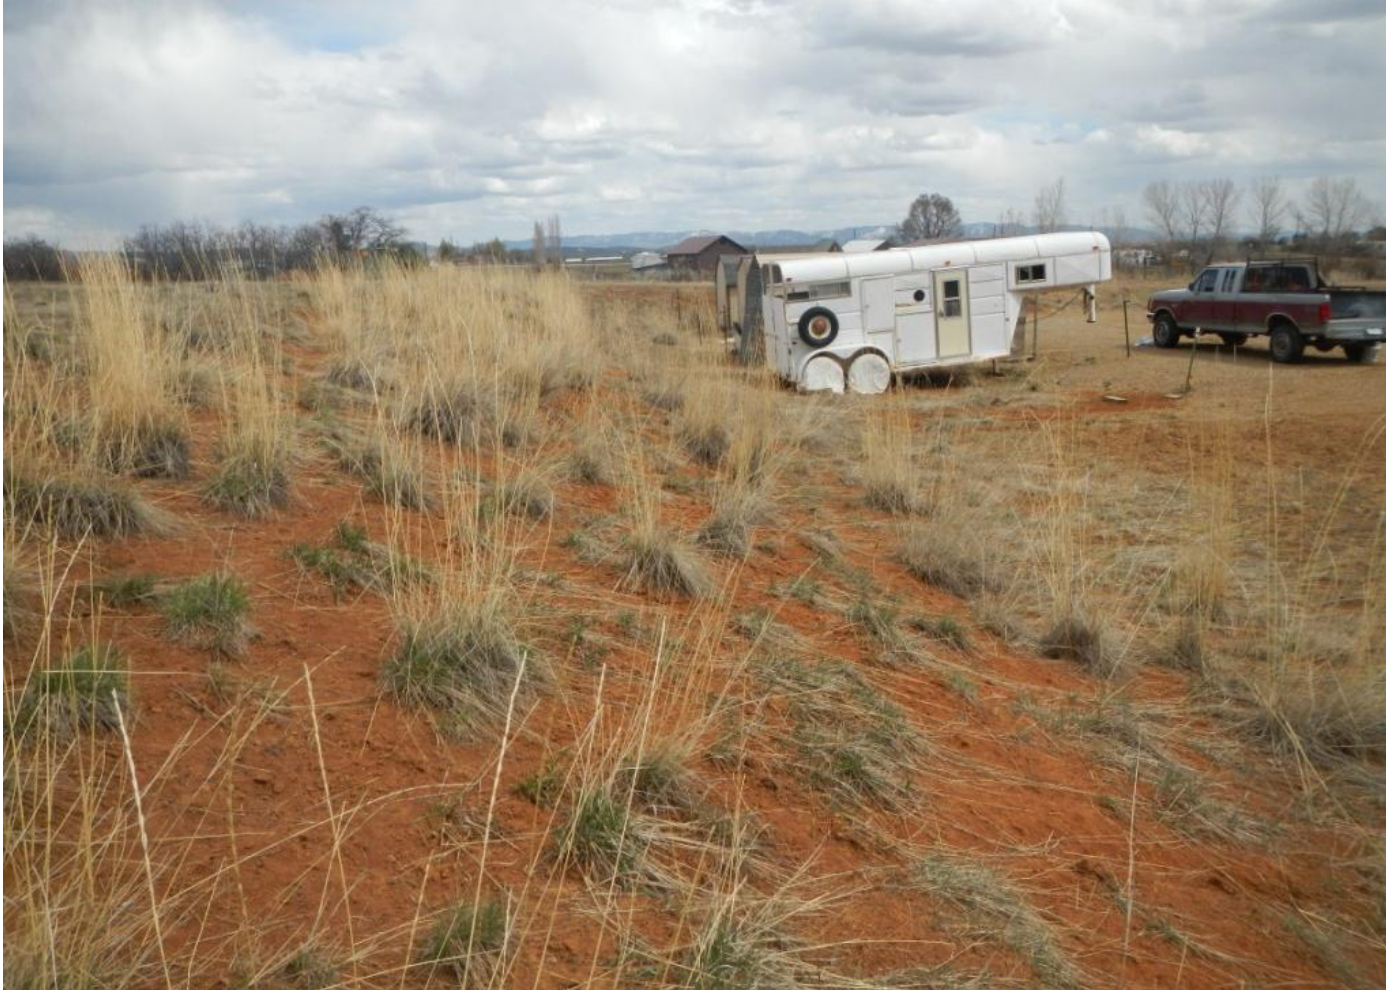
Photo 6. View of the northern portion of the project area from the northwestern corner facing eastward. Horsetrailer, sheds, vehicle, and other debris are being stored on the well pad.
