Final Reclamation Inspection

4/19/2016

Operator: Vista Operating

Location ID: 317420

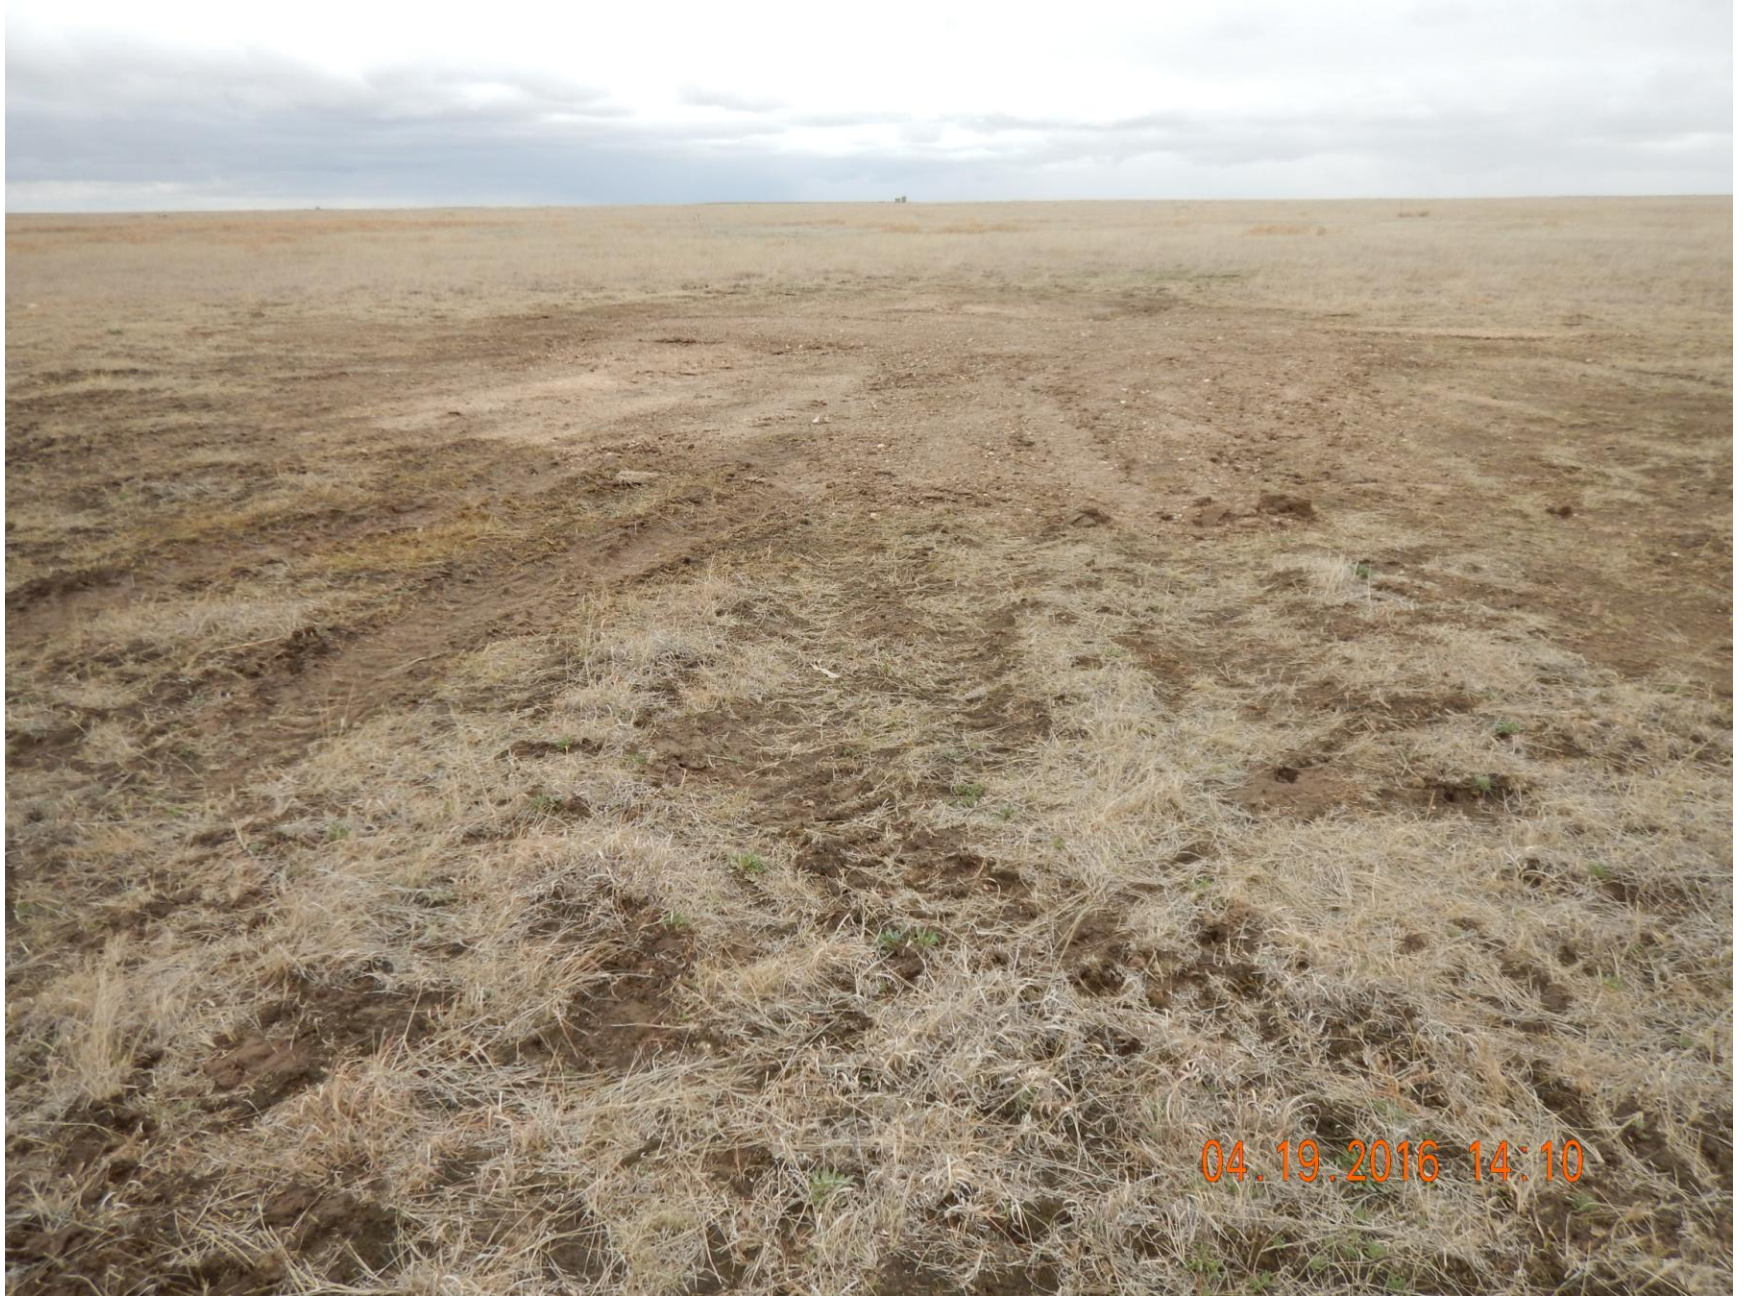
Figure 2: Photo taken from the west end of the pit location, facing east. Pit located north of well. Area appears to have had work done recently. Straw appears to have been spread over areas of the pit, not properly crimped. Unable to find evidence location has been seeded.

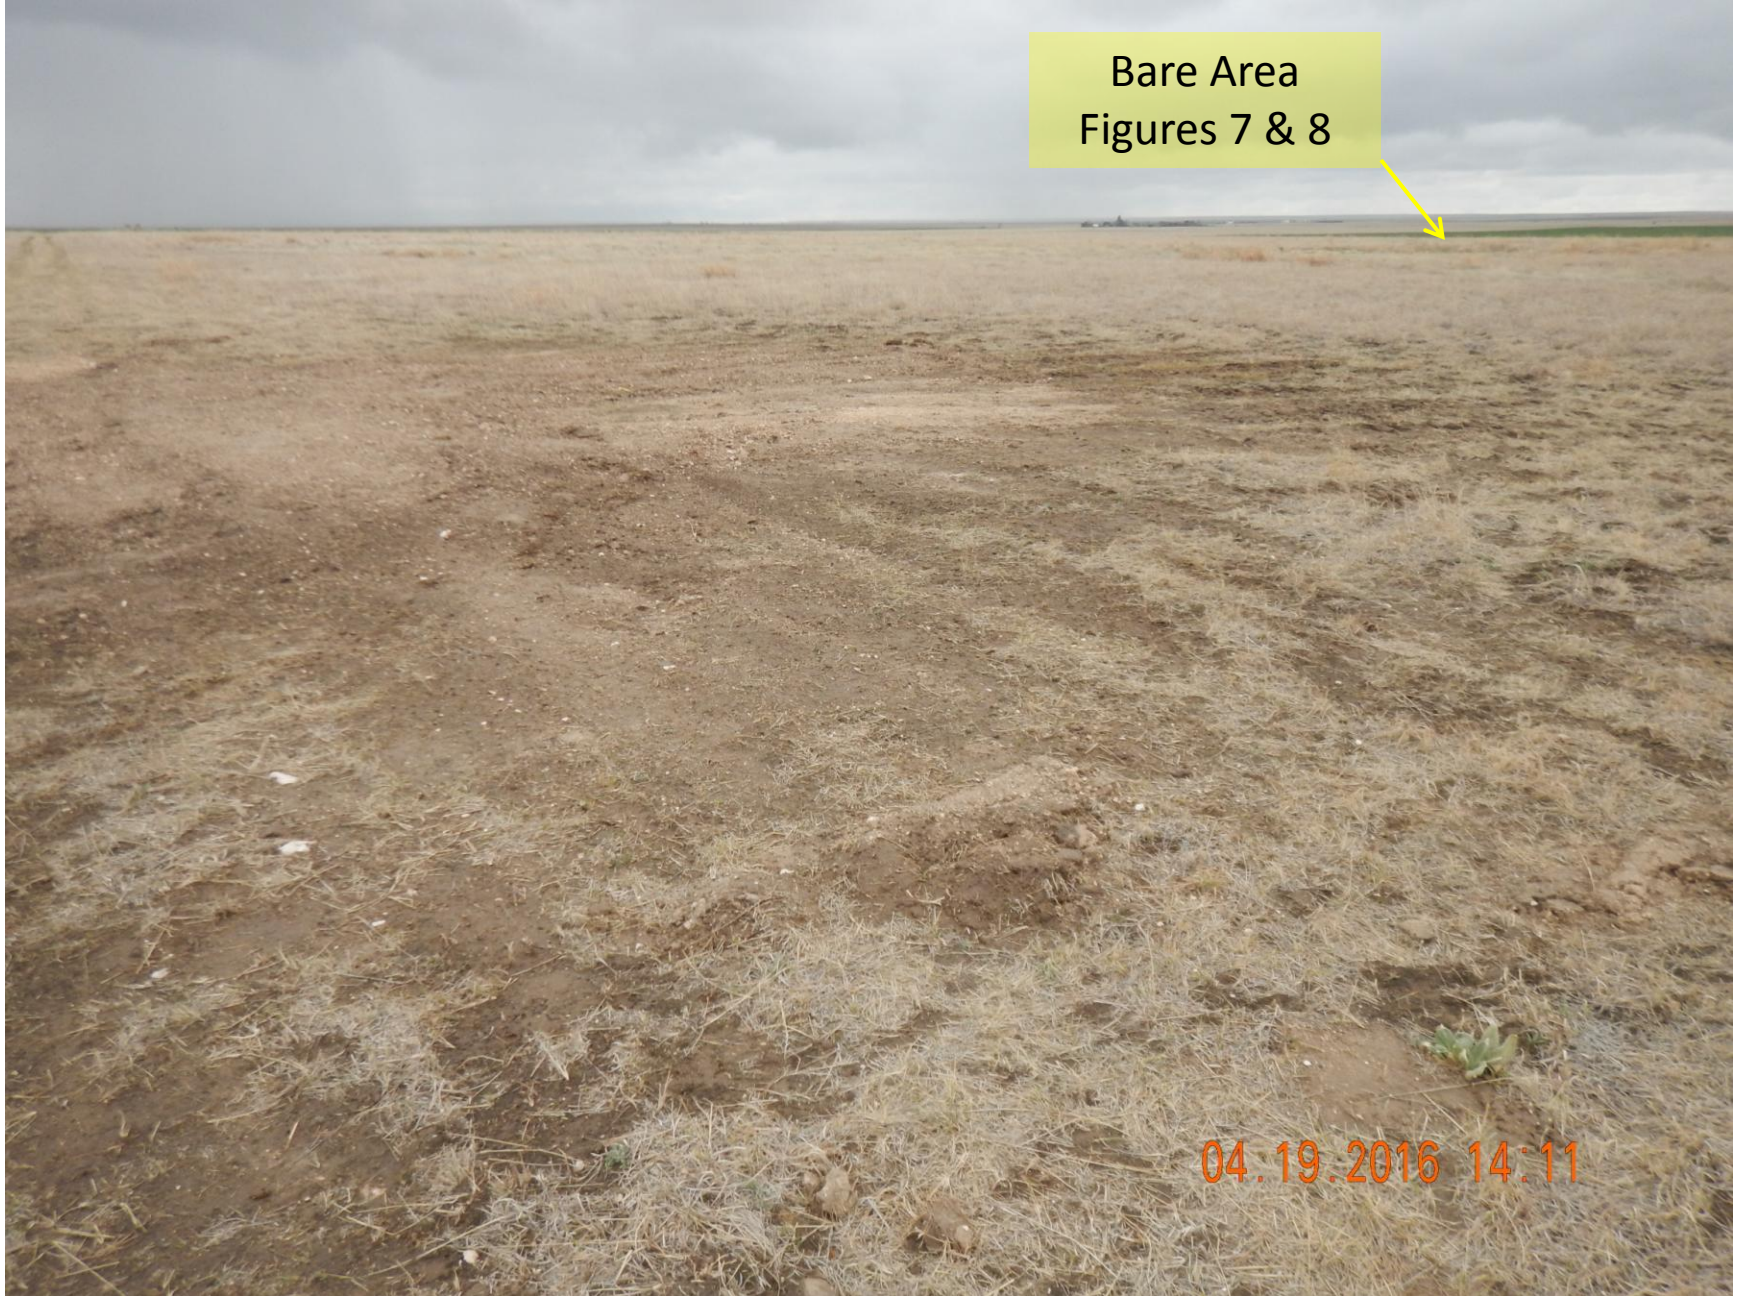
Bare Area
Figures 7 & 8

Figure 3: Photo taken from the north end of the location, facing southwest. Area appears to have had work done recently. Straw appears to have been spread over areas of the pit, not properly crimped. Unable to find evidence location has been seeded. Bare area identified in figures 7 and 8 top right of photo.

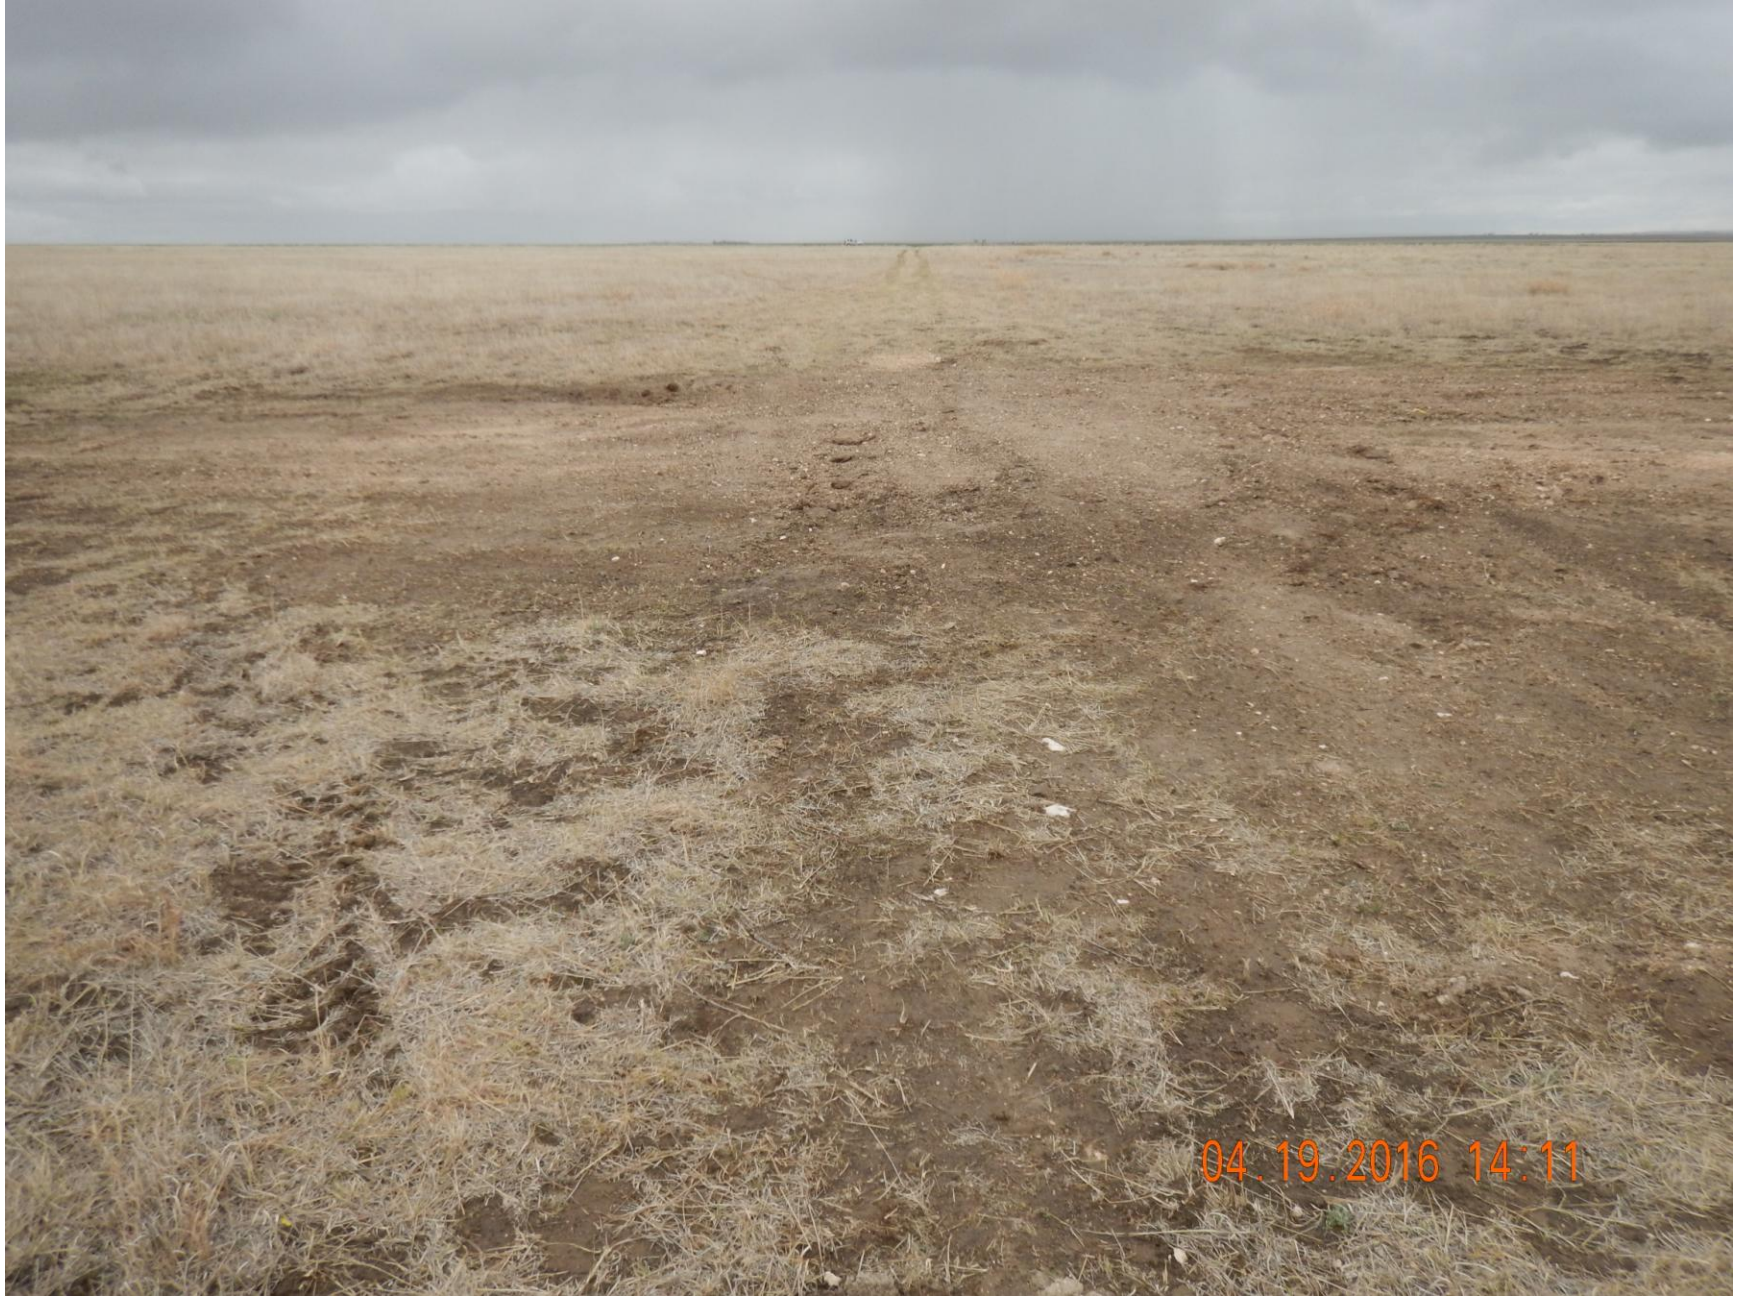
Figure 4: Photo taken from the north end of the location, facing south. Area appears to have had work done recently. Straw appears to have been spread over areas of the pit, not properly crimped. Unable to find evidence location has been seeded.

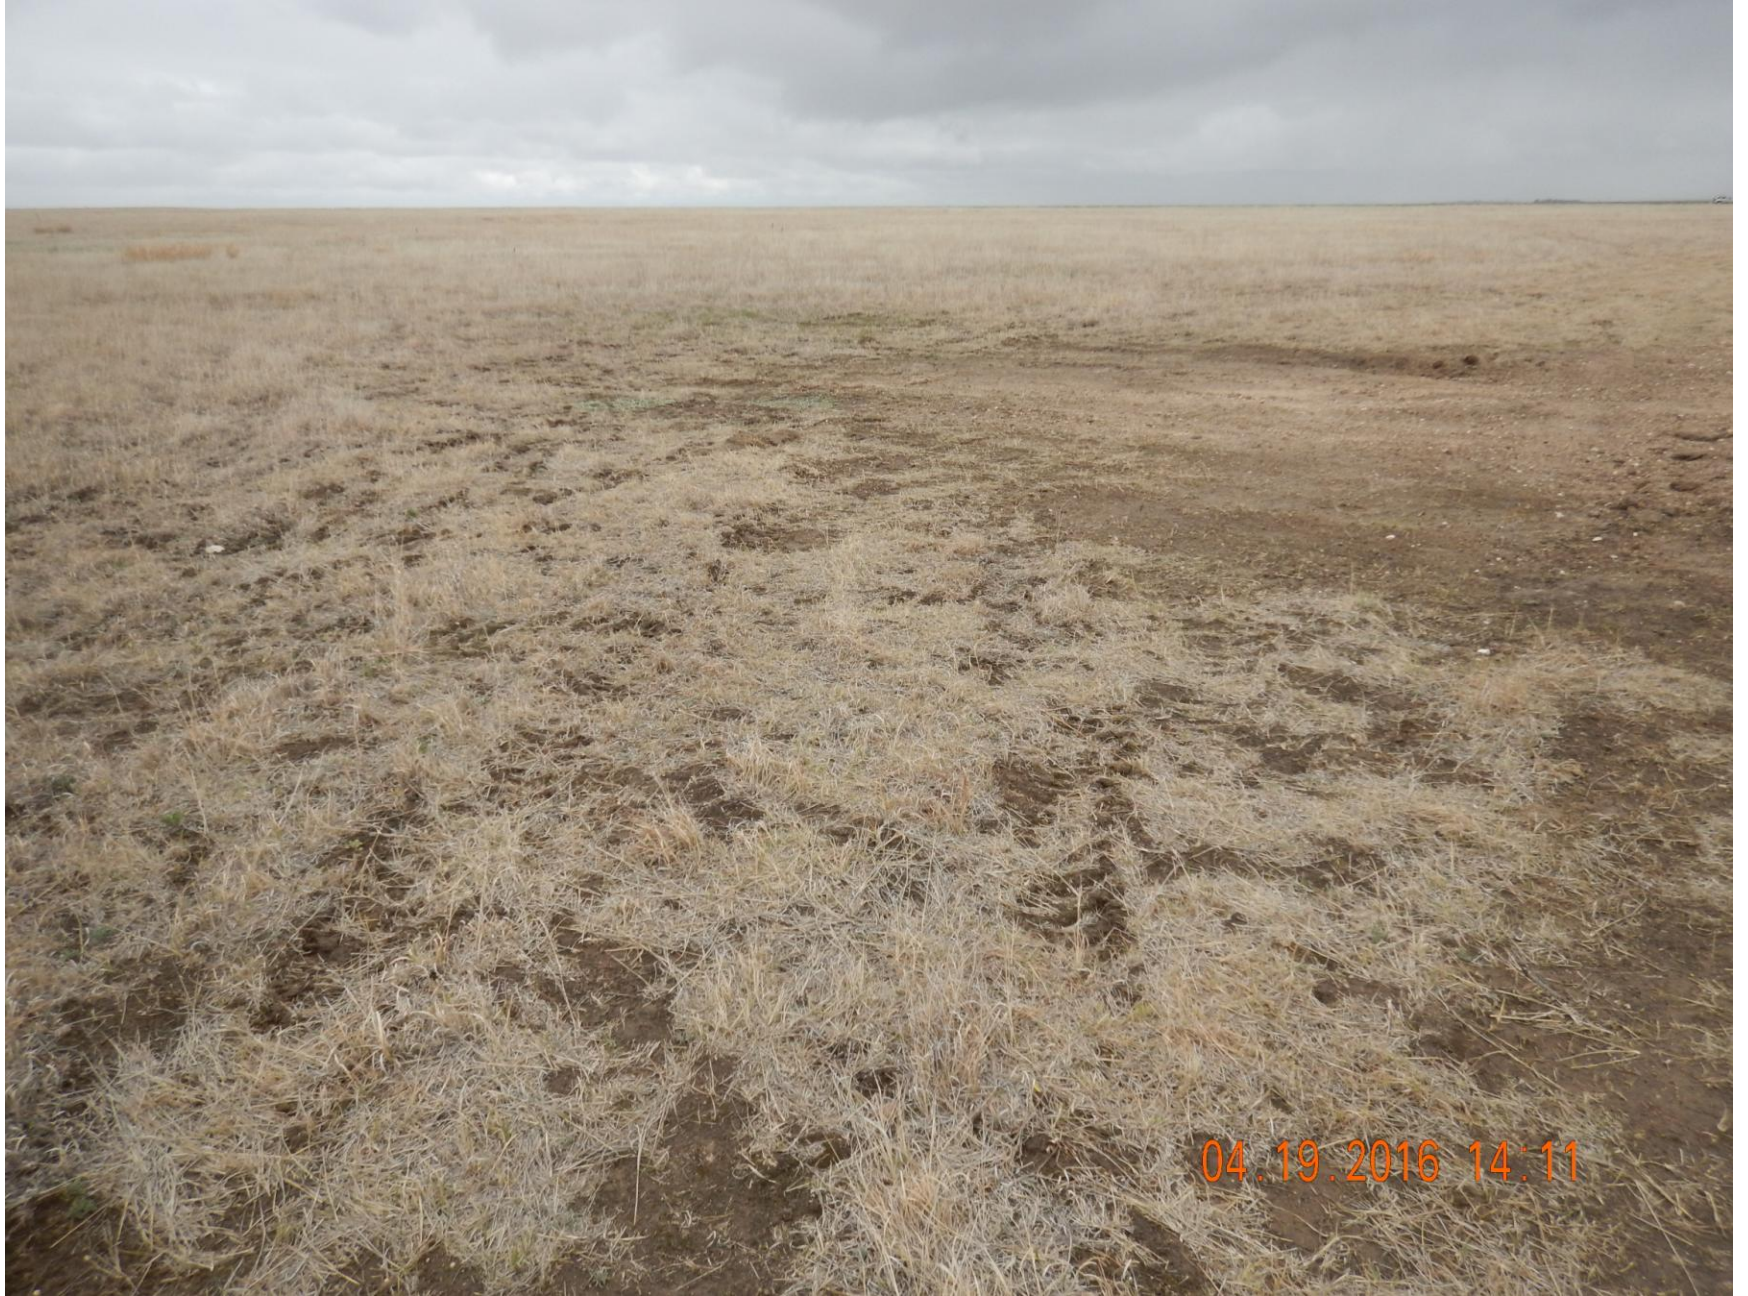
Figure 5: Photo taken from the north end of the location, facing southeast. Area appears to have had work done recently. Straw appears to have been spread over areas of the pit, not properly crimped. Unable to find evidence location has been seeded.

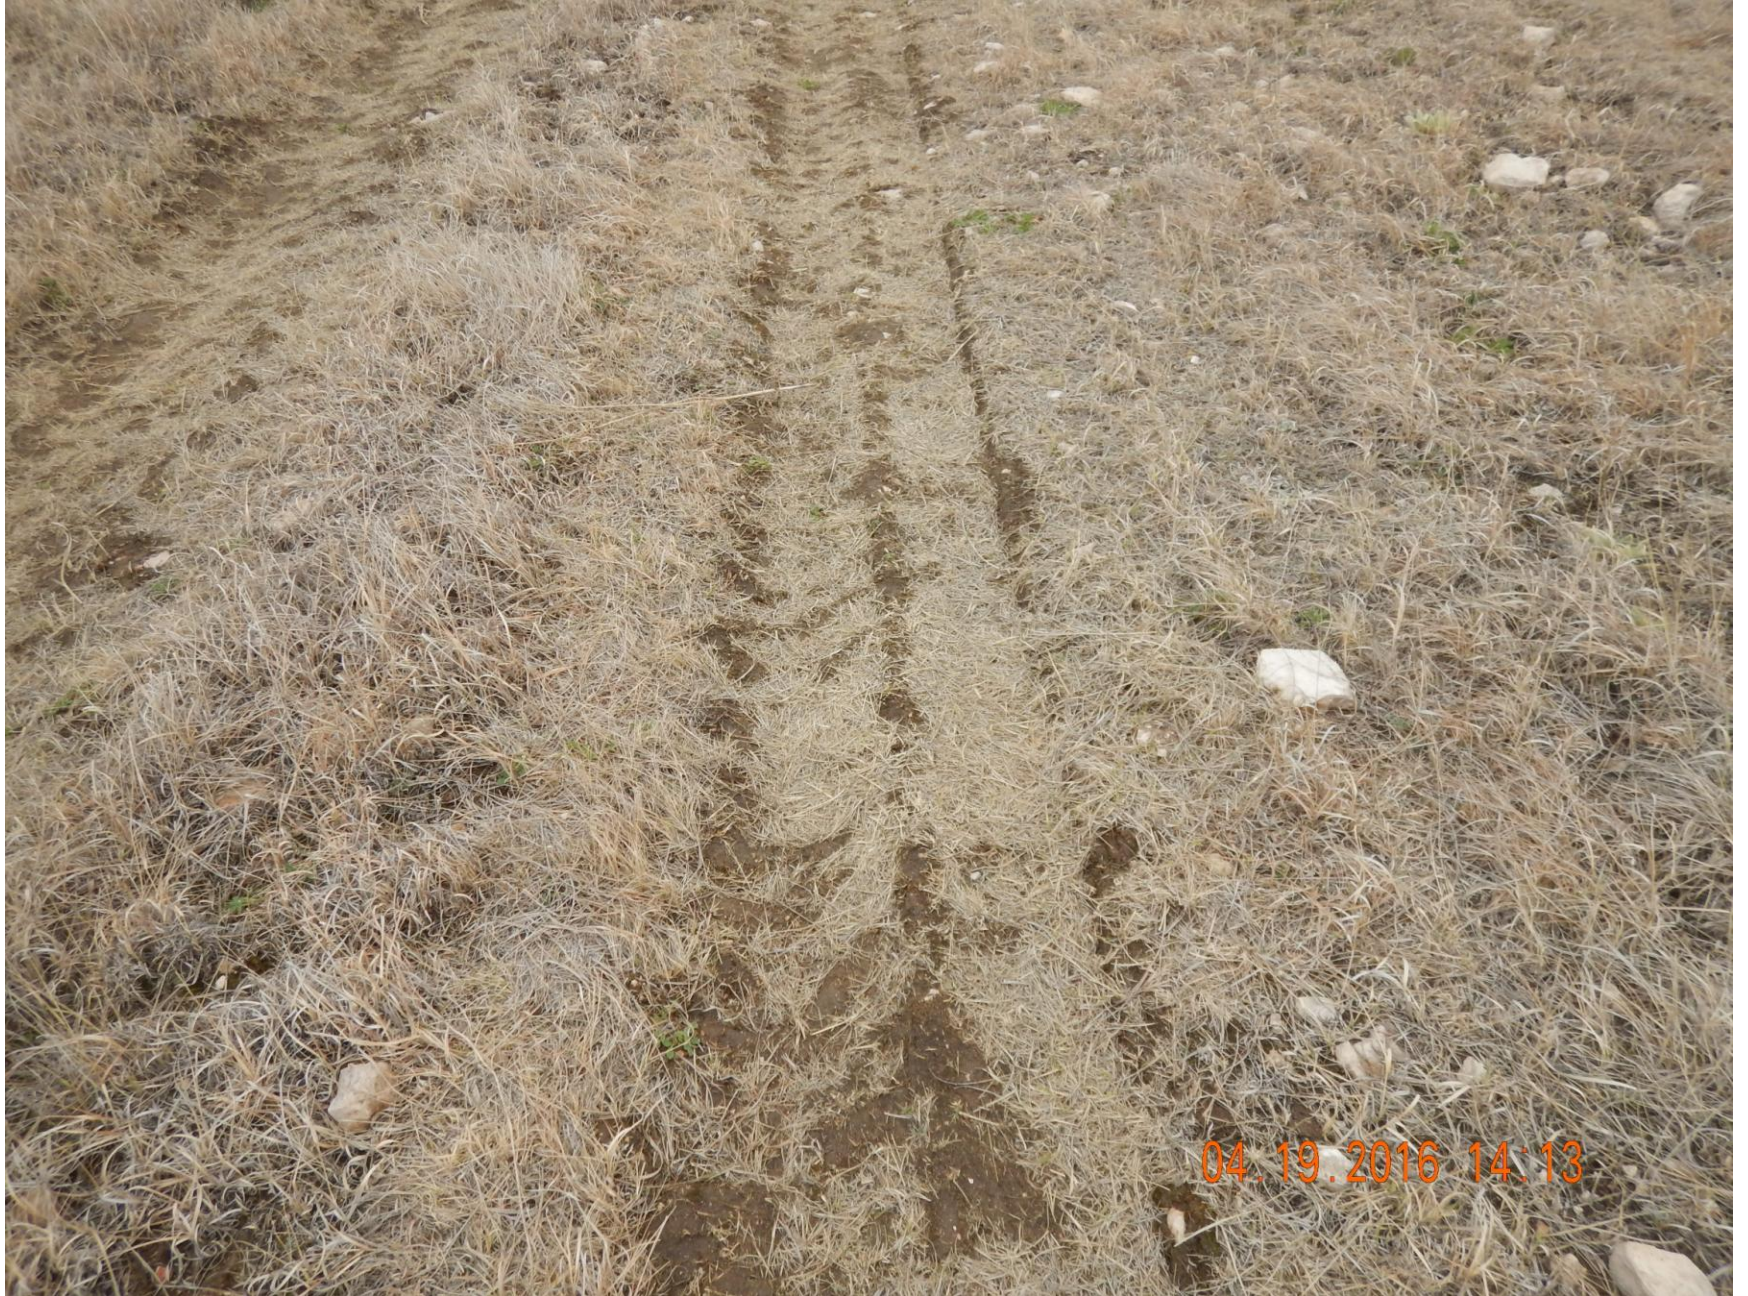
Figure 6: Photo taken of access road. Photo shows straw spread over access road.

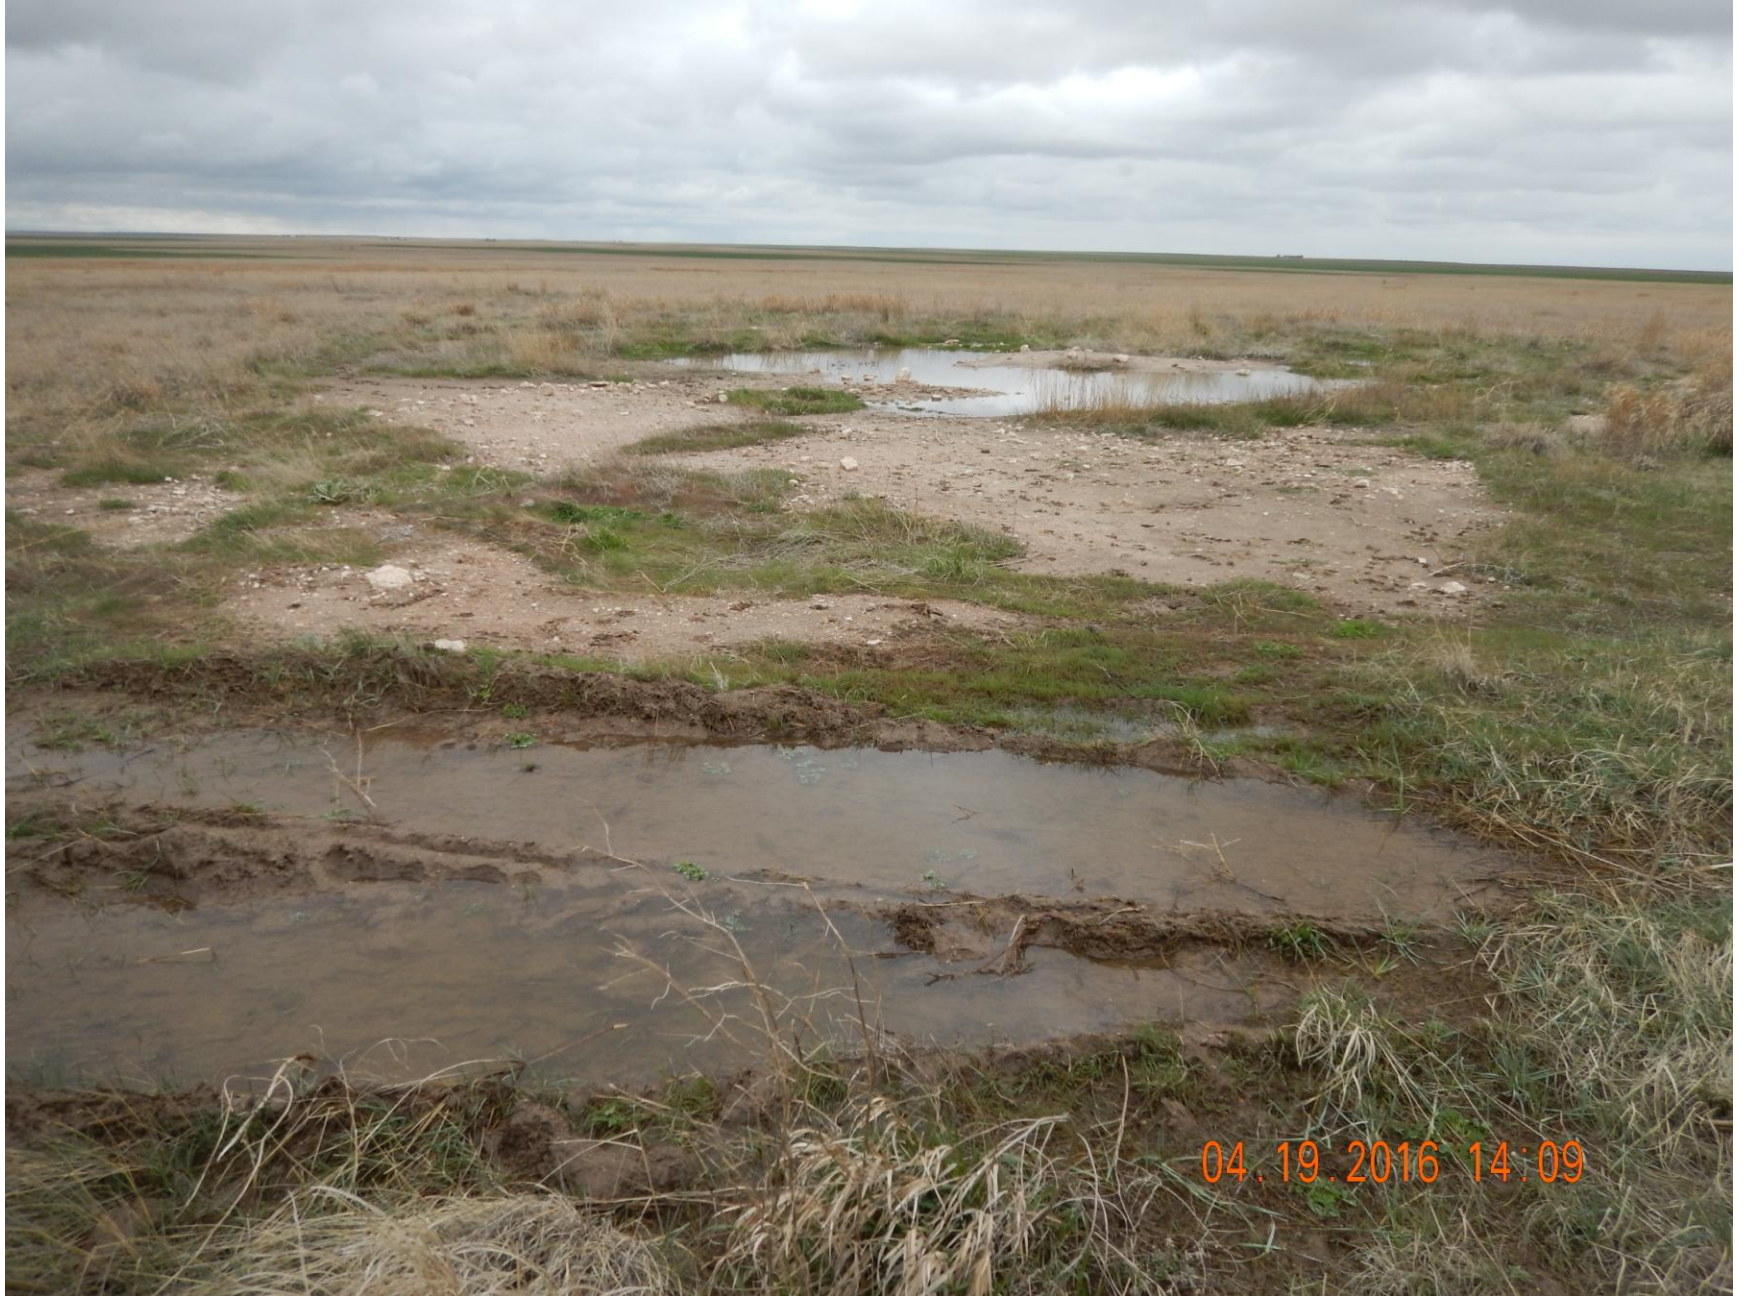
Figure 7: Photo taken from the west end of the location (identified in figure 3), facing southwest. Photo shows large area on location that remains unvegetated. Unlike pit, no work appears to have recently been done over this area. Area will need to be reclaimed.

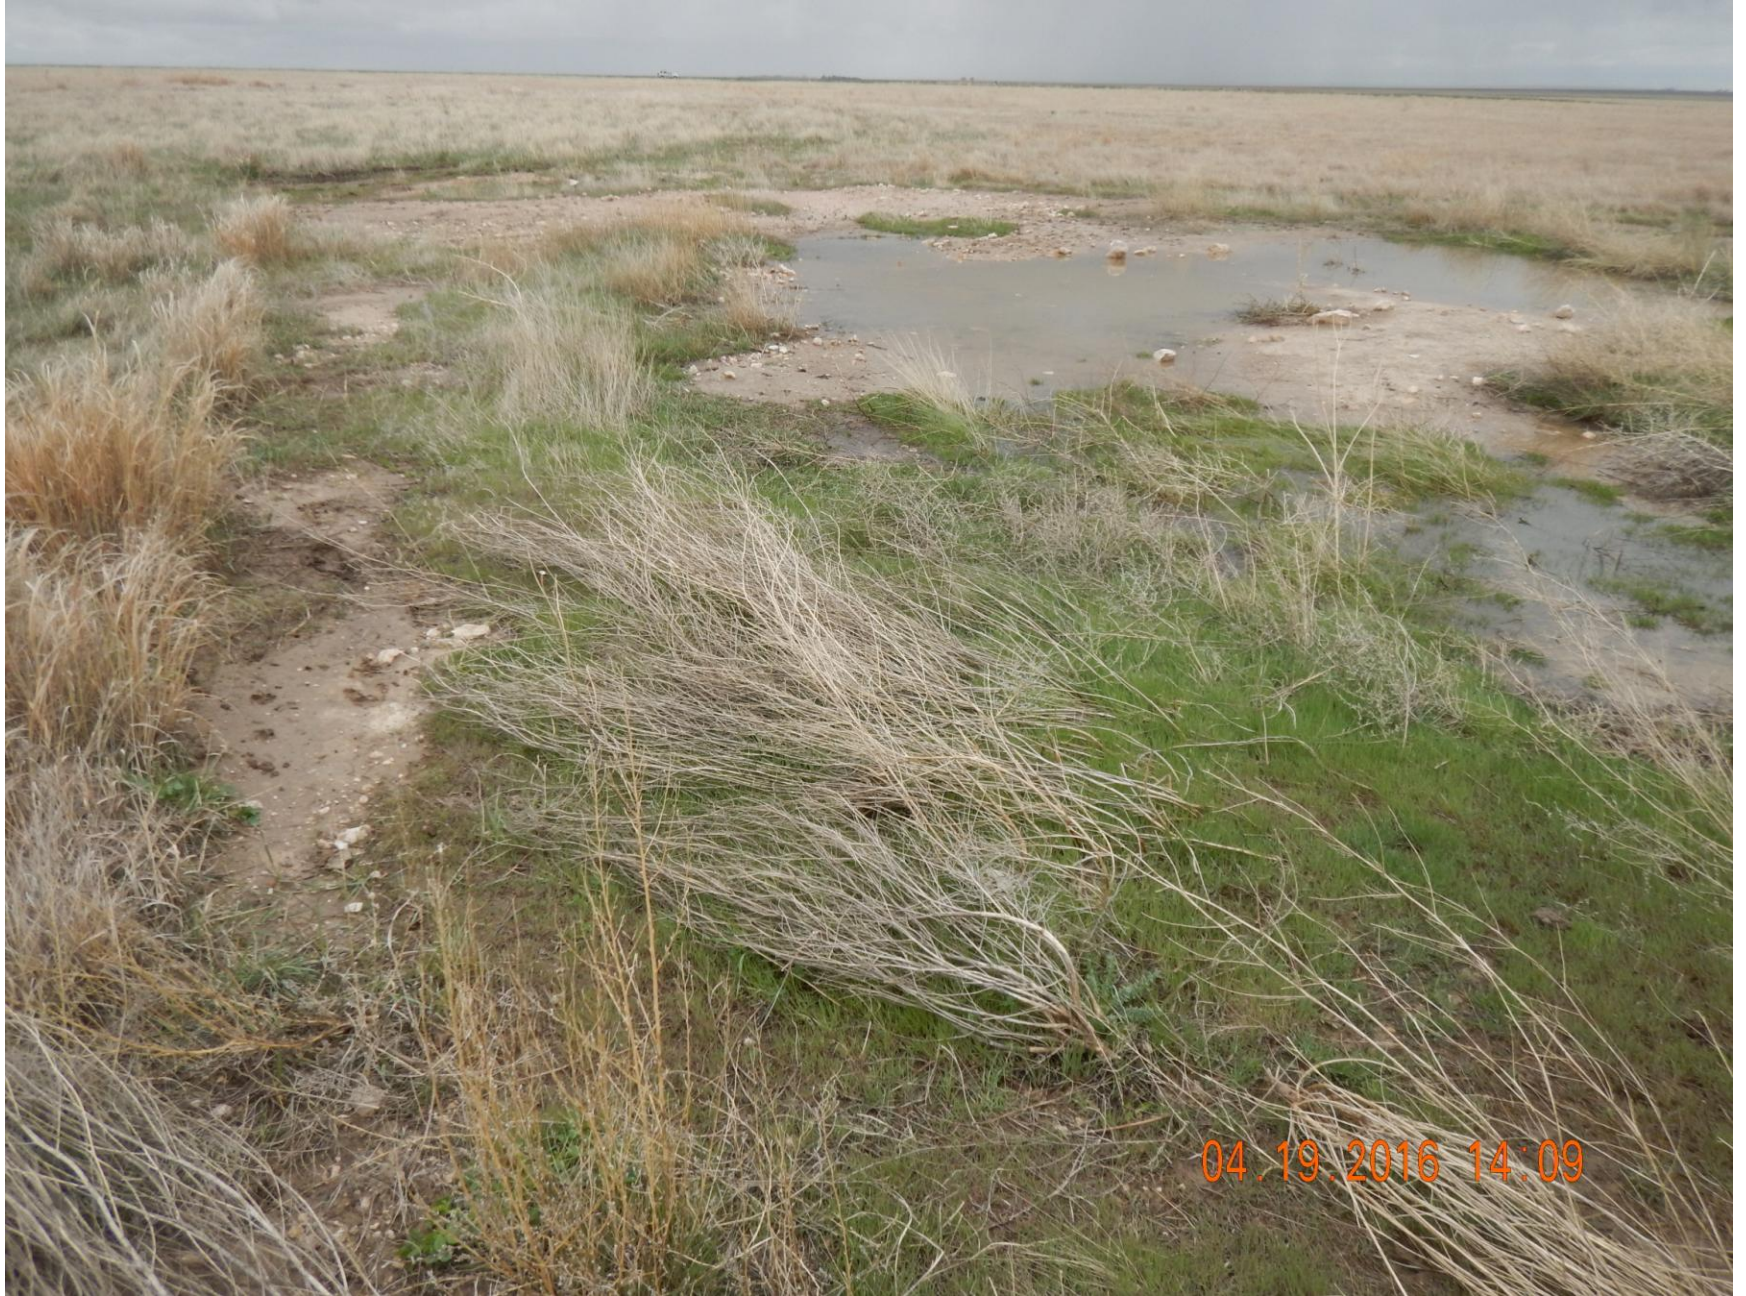
Figure 8: Photo taken from the west end of the location (identified in figure 3), facing southeast. Photo shows large area on location that remains unvegetated. Unlike pit, no work appears to have recently been done over this area. Area will need to be reclaimed.
