# Final Reclamation Inspection

Operator: Forestar Group inc

Location ID: 395653

Morgan County, CO

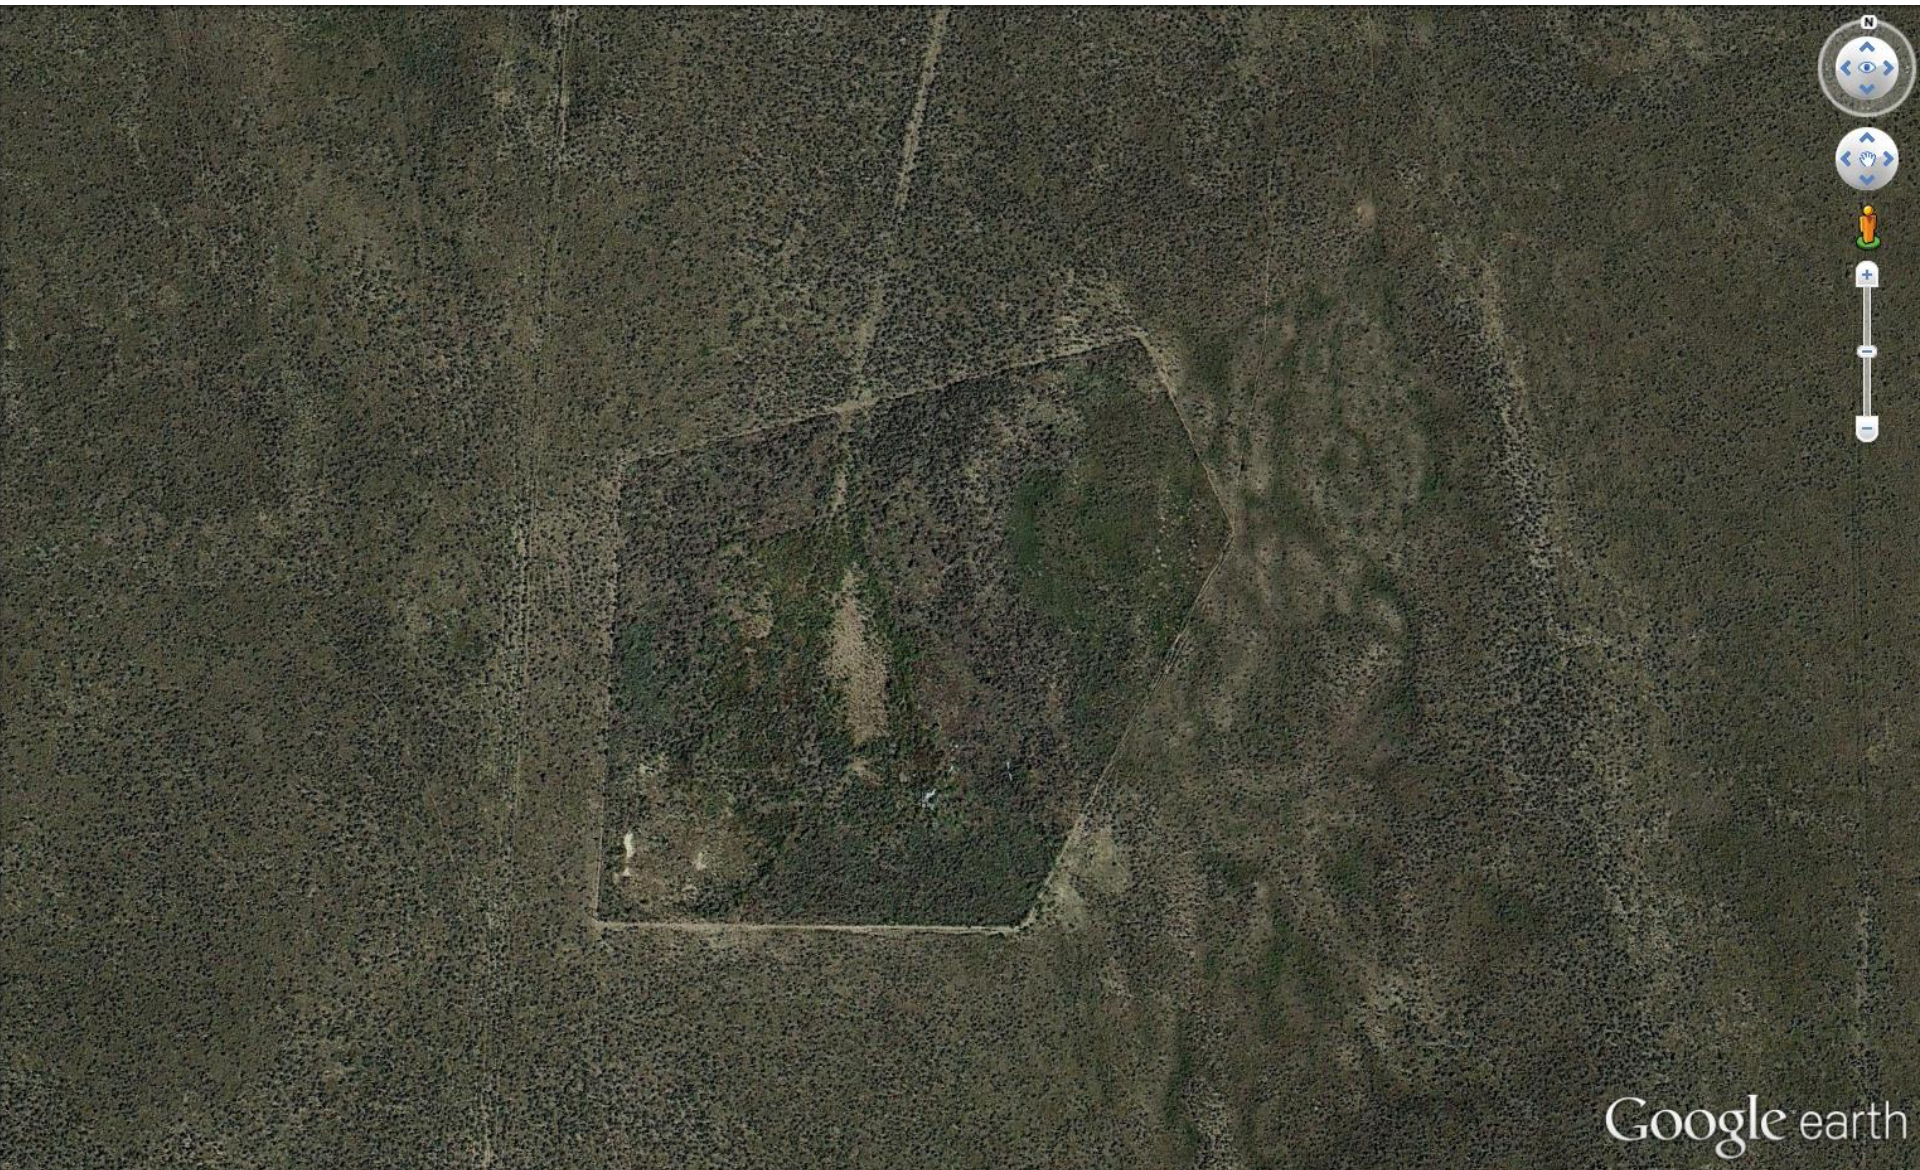
**Figure 1:** 2013 (most current) aerial imagery of location. Image is to provide overview of location. Location is approximately 4.5 acres in size.

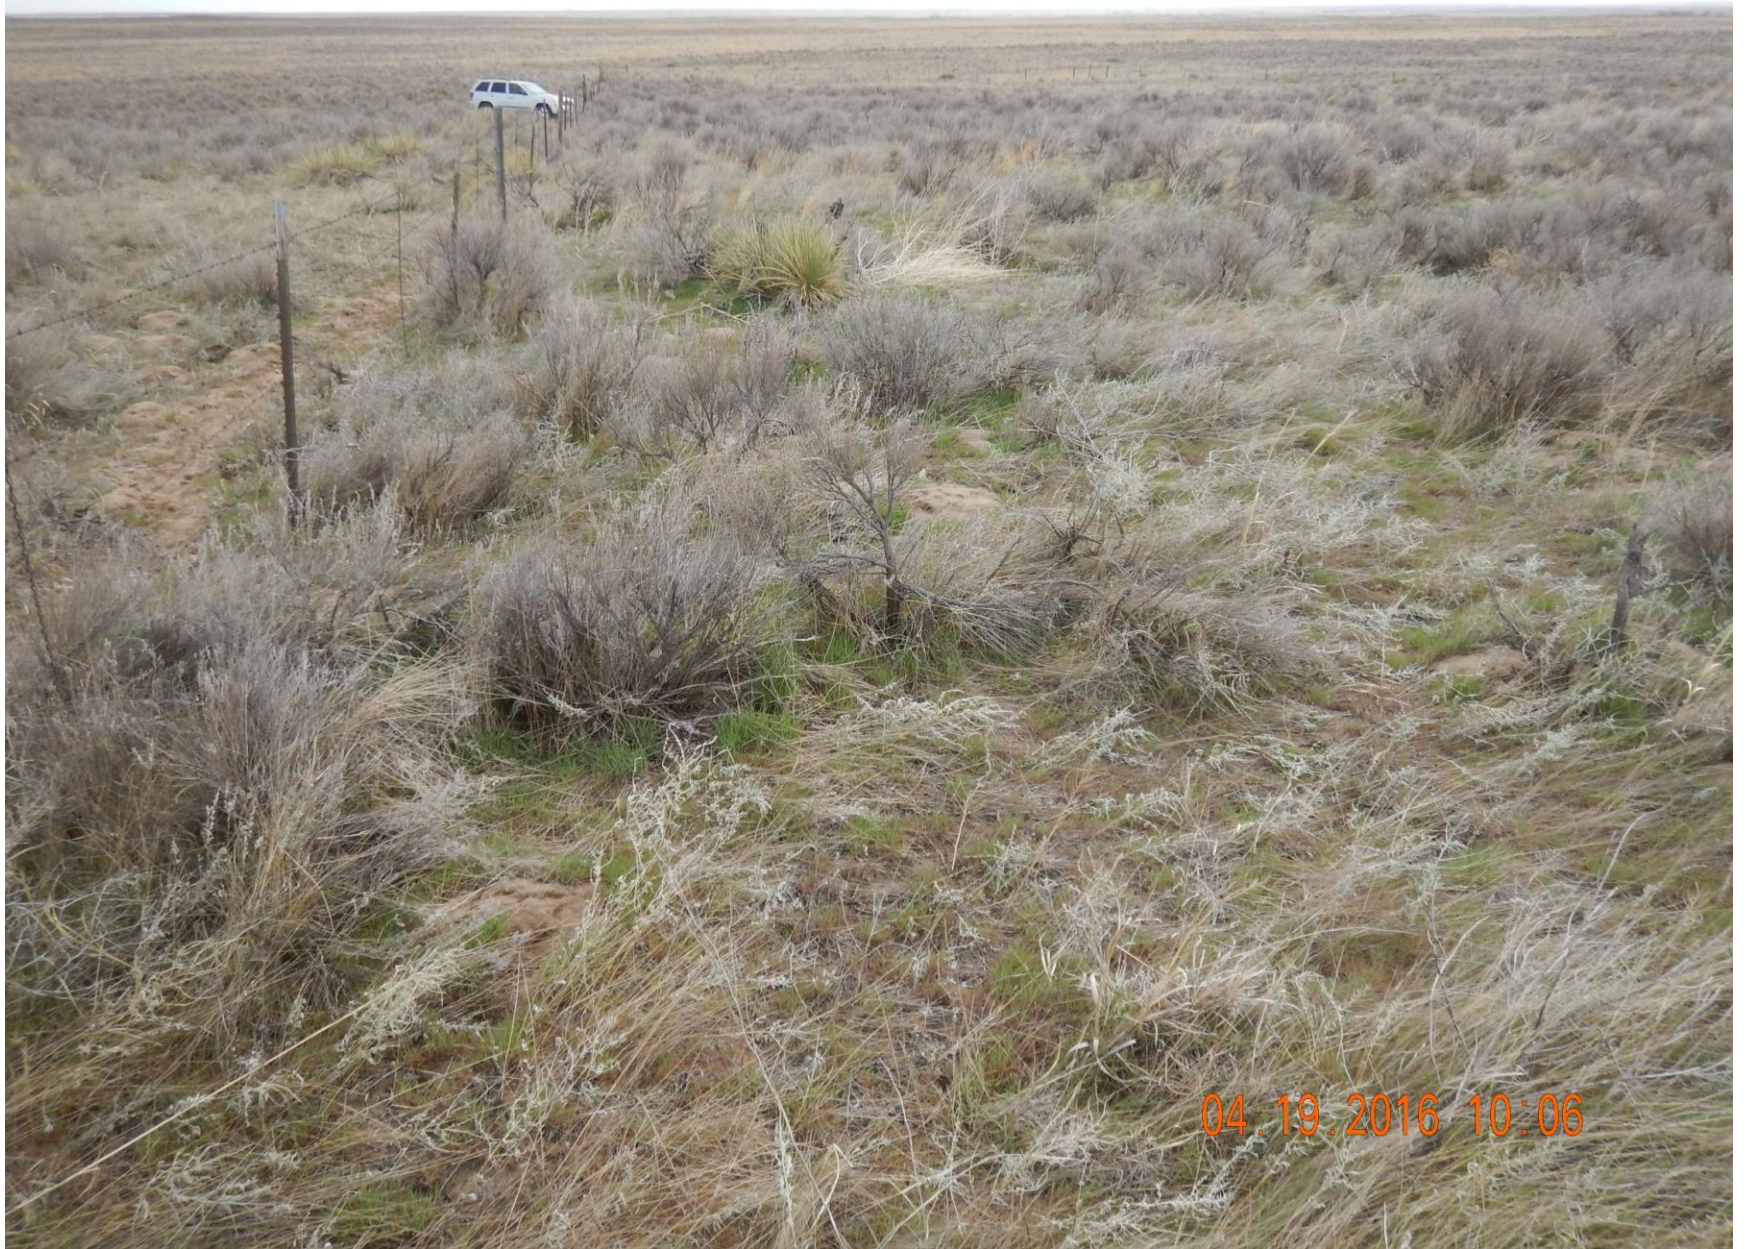
**Figure 2:** Photo taken from the northwest corner of the location, facing east. Photo shows vegetation on the location.

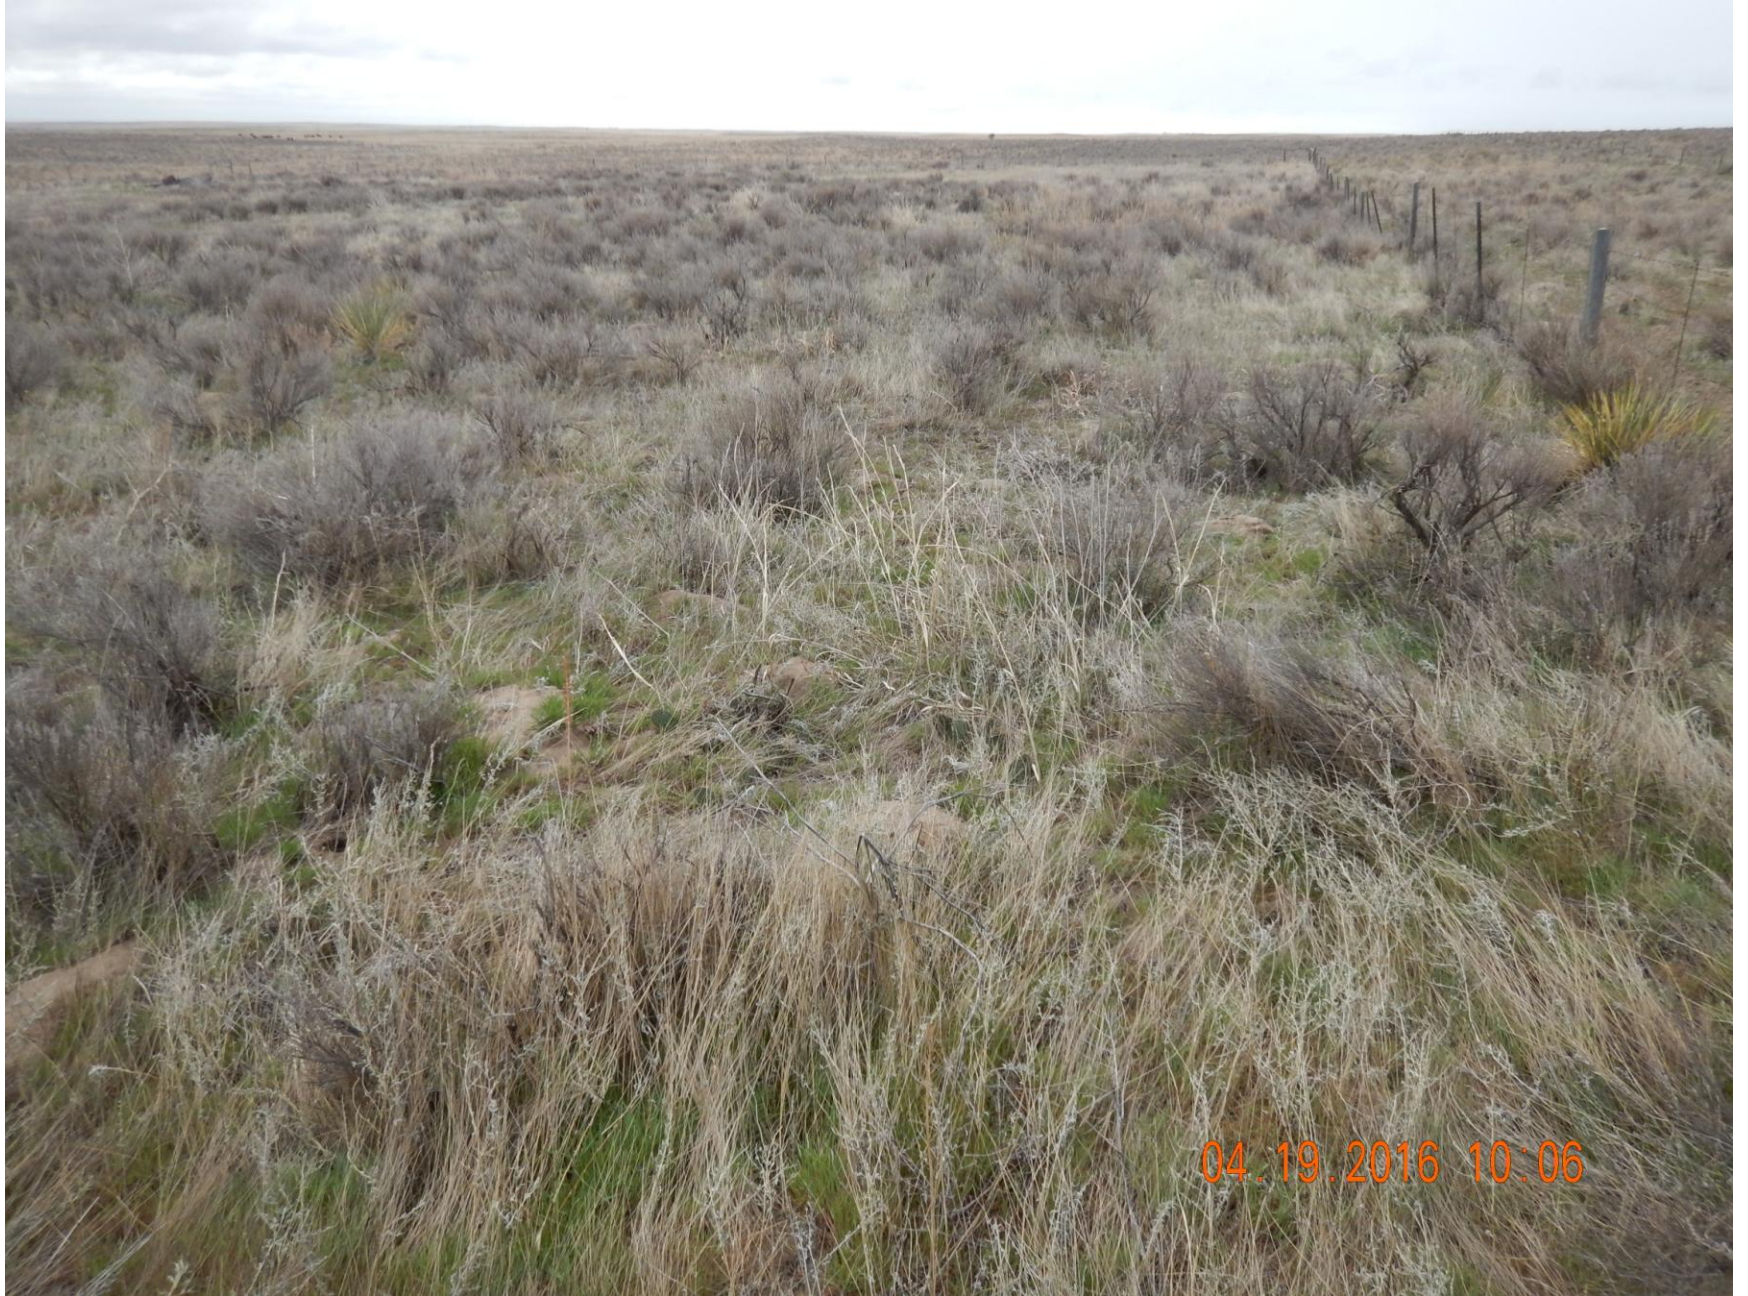
**Figure 3:** Photo taken from the northwest corner of the location, facing south. Photo shows vegetation on the location.

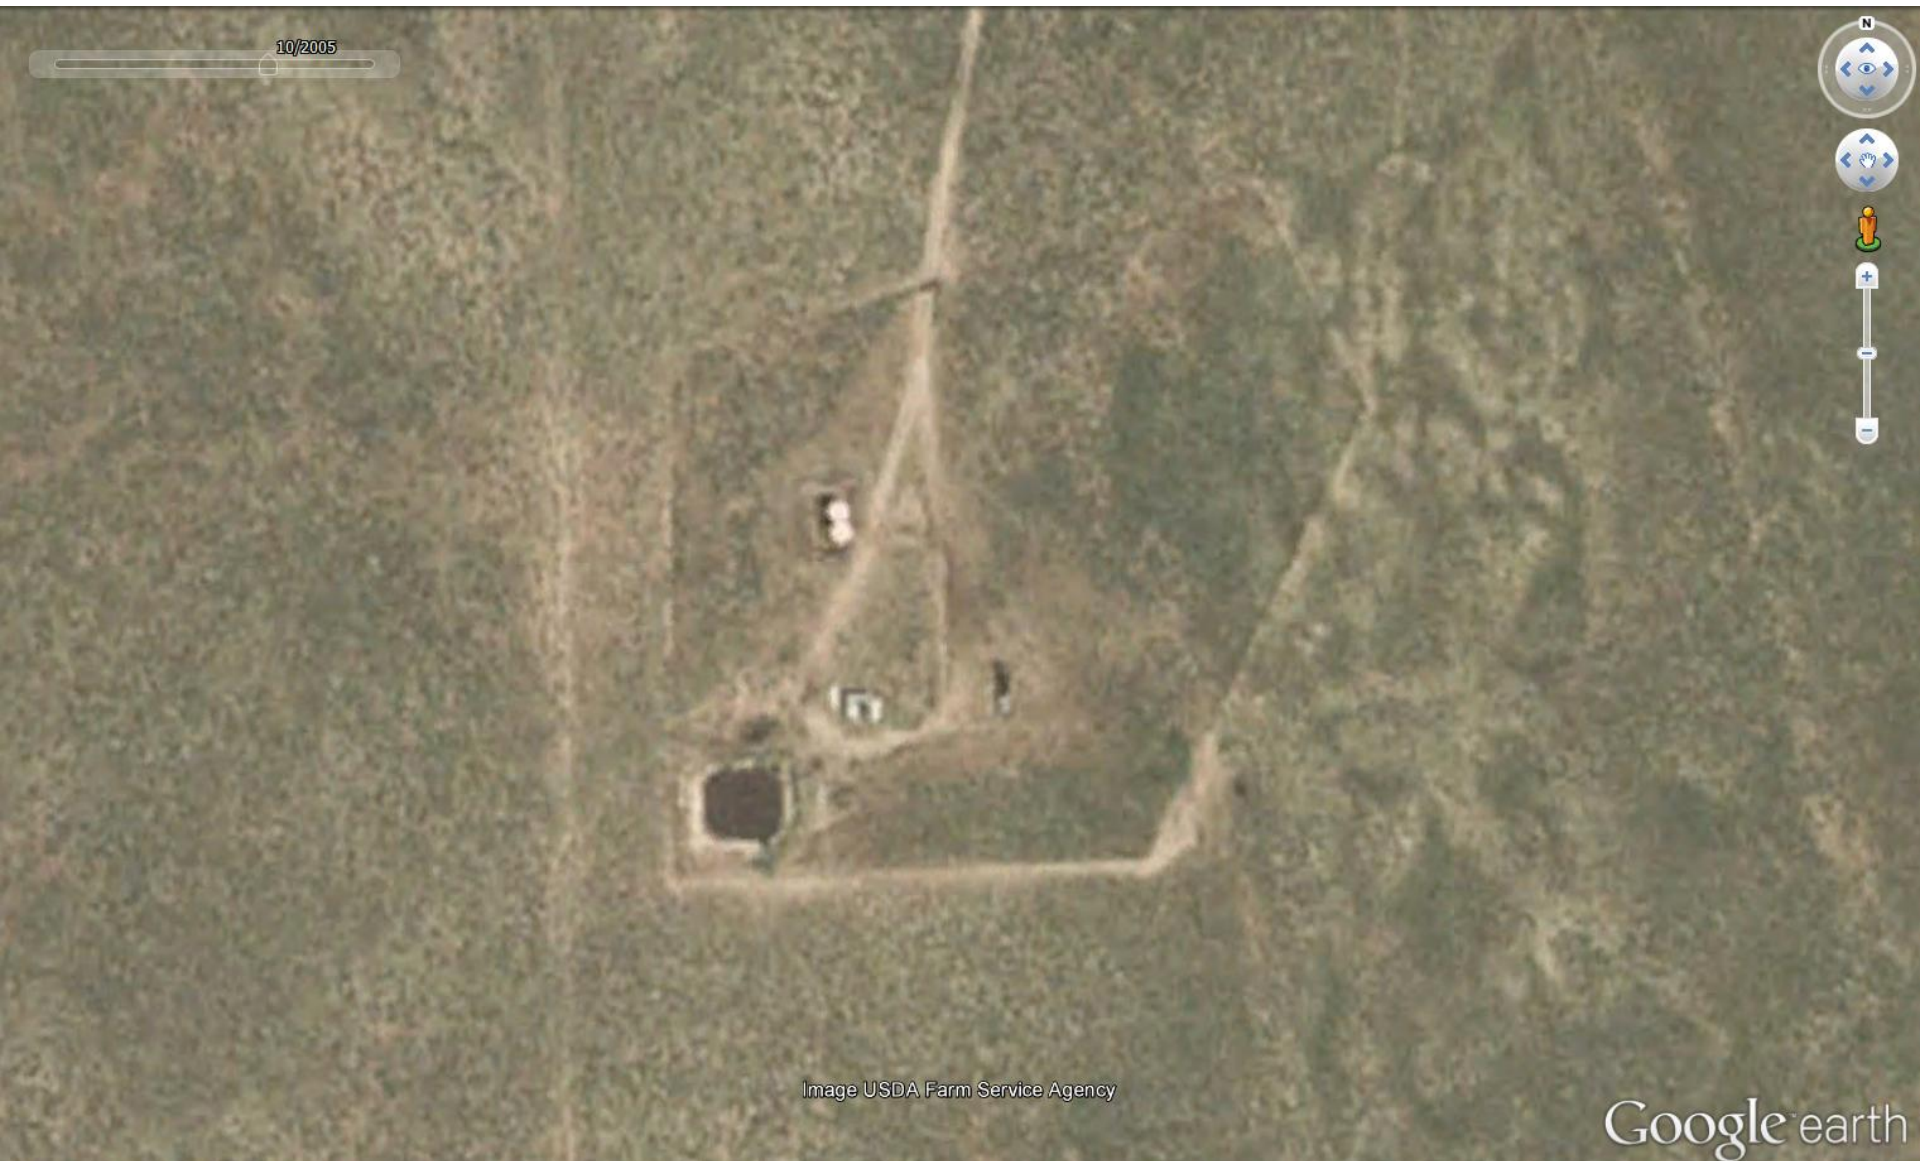
**Figure 4:** 2005 aerial imagery of location. Image shows where production facilities and pit's location within the production area. Please note pit is found in the southwest corner of the location.

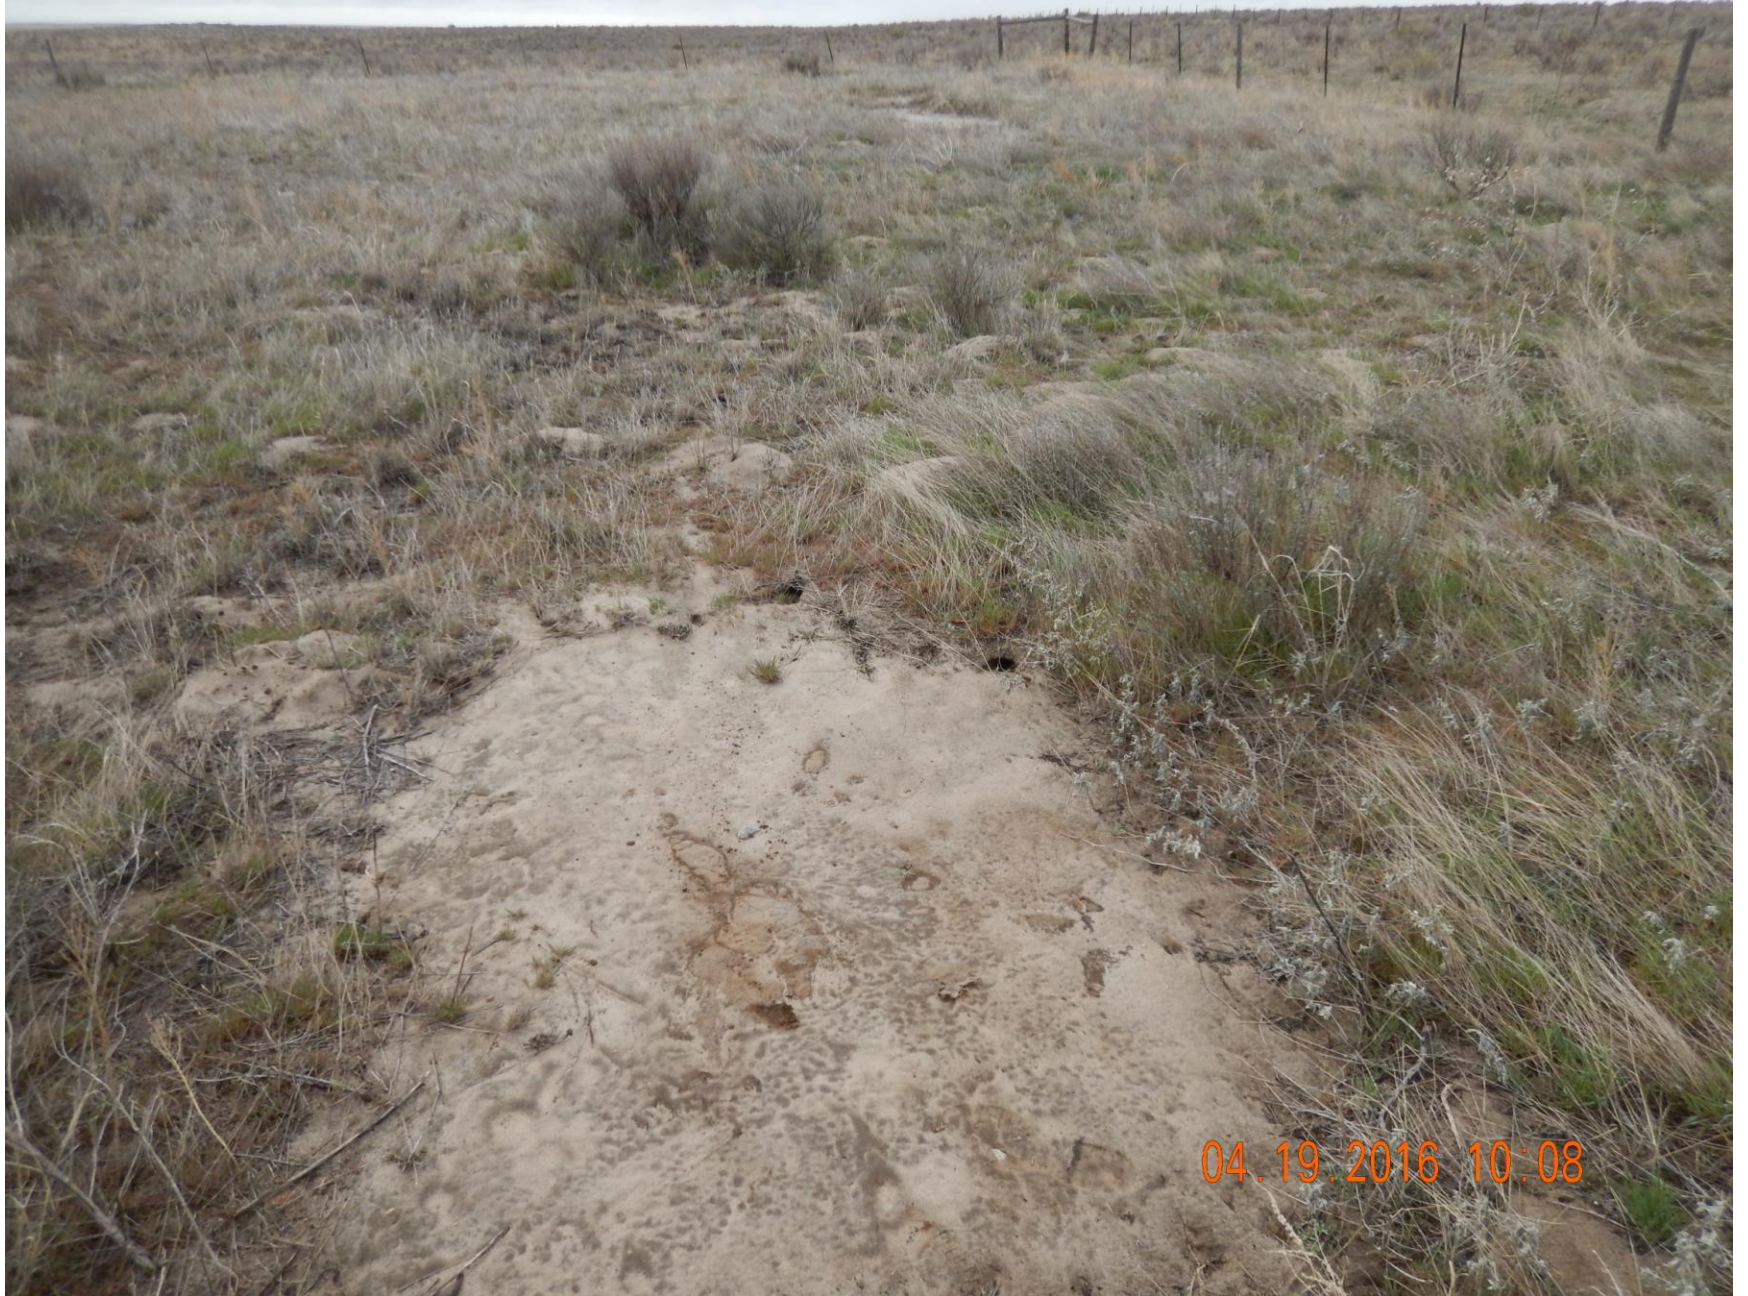
**Figure 5:** Photo taken on the west end of the location, facing south. Photo shows unvegetated areas on around the former pit location that appear to have stained soil.

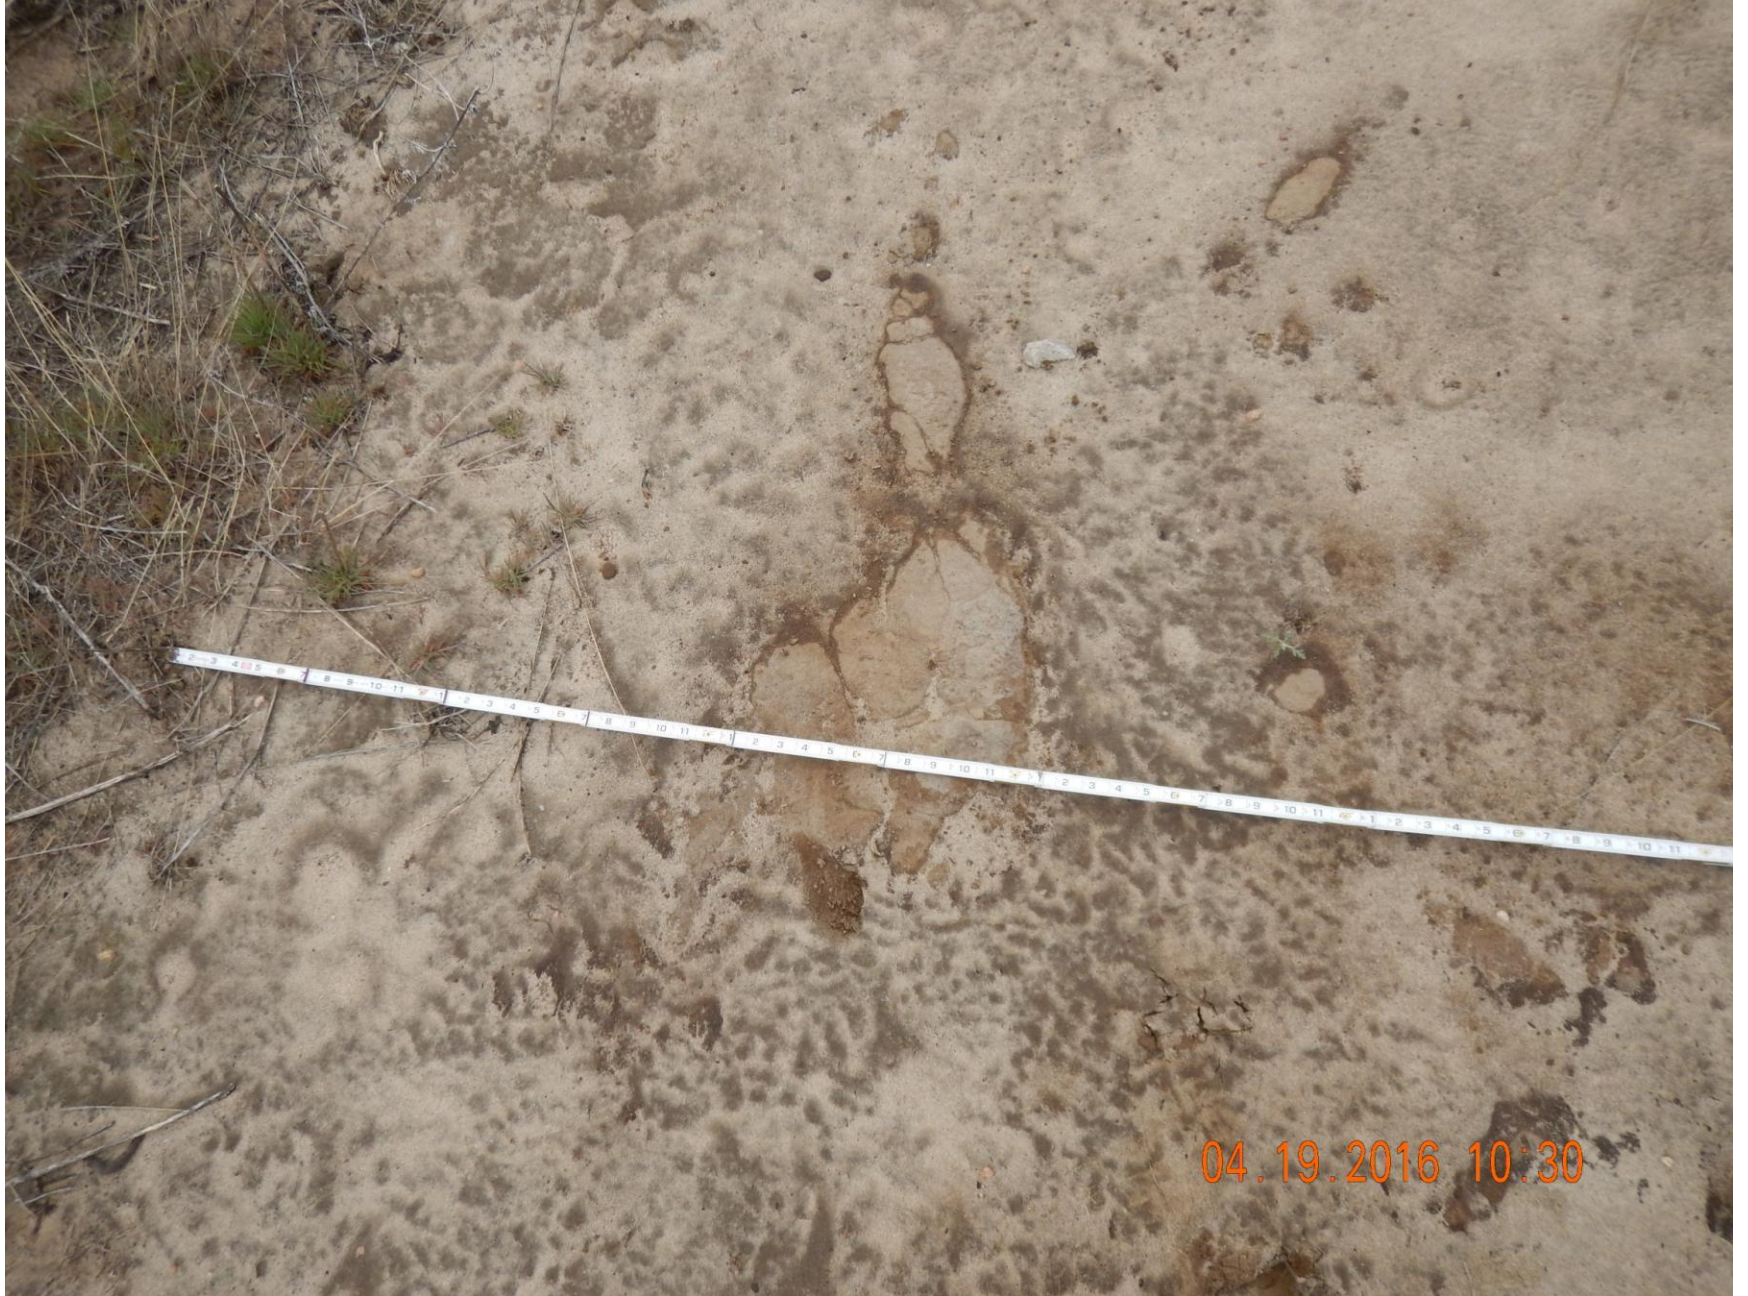
**Figure 6:** Photo taken on the west end of the location. Photo shows unvegetated areas on around the former pit location that appear to have stained soil. 6' measuring stick for reference.

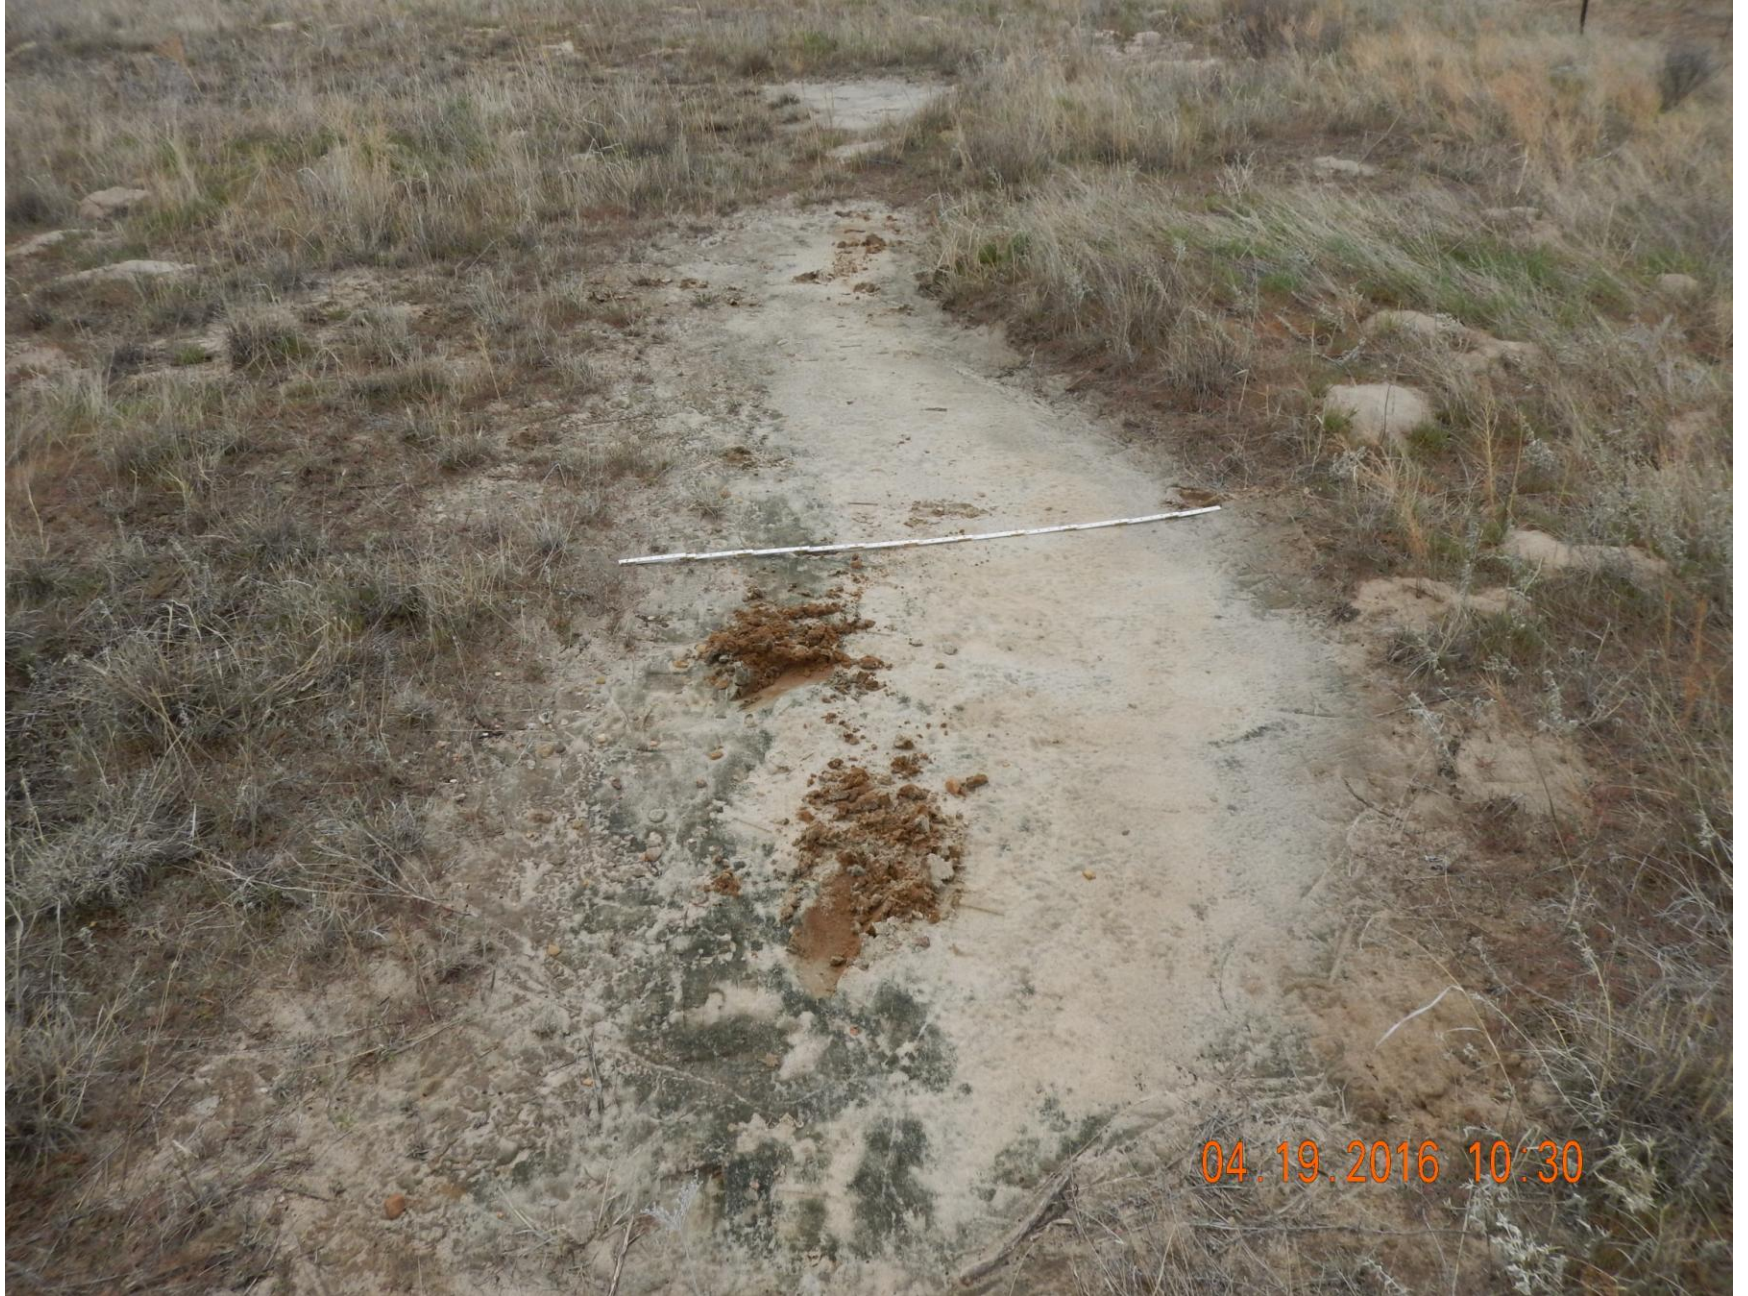
**Figure 7:** Photo taken on the west end of the location, facing south. Photo shows unvegetated areas on the former pit location that appear to have stained soil. 6' measuring stick for reference. Note inspector disturbed soil to view sub-surface.

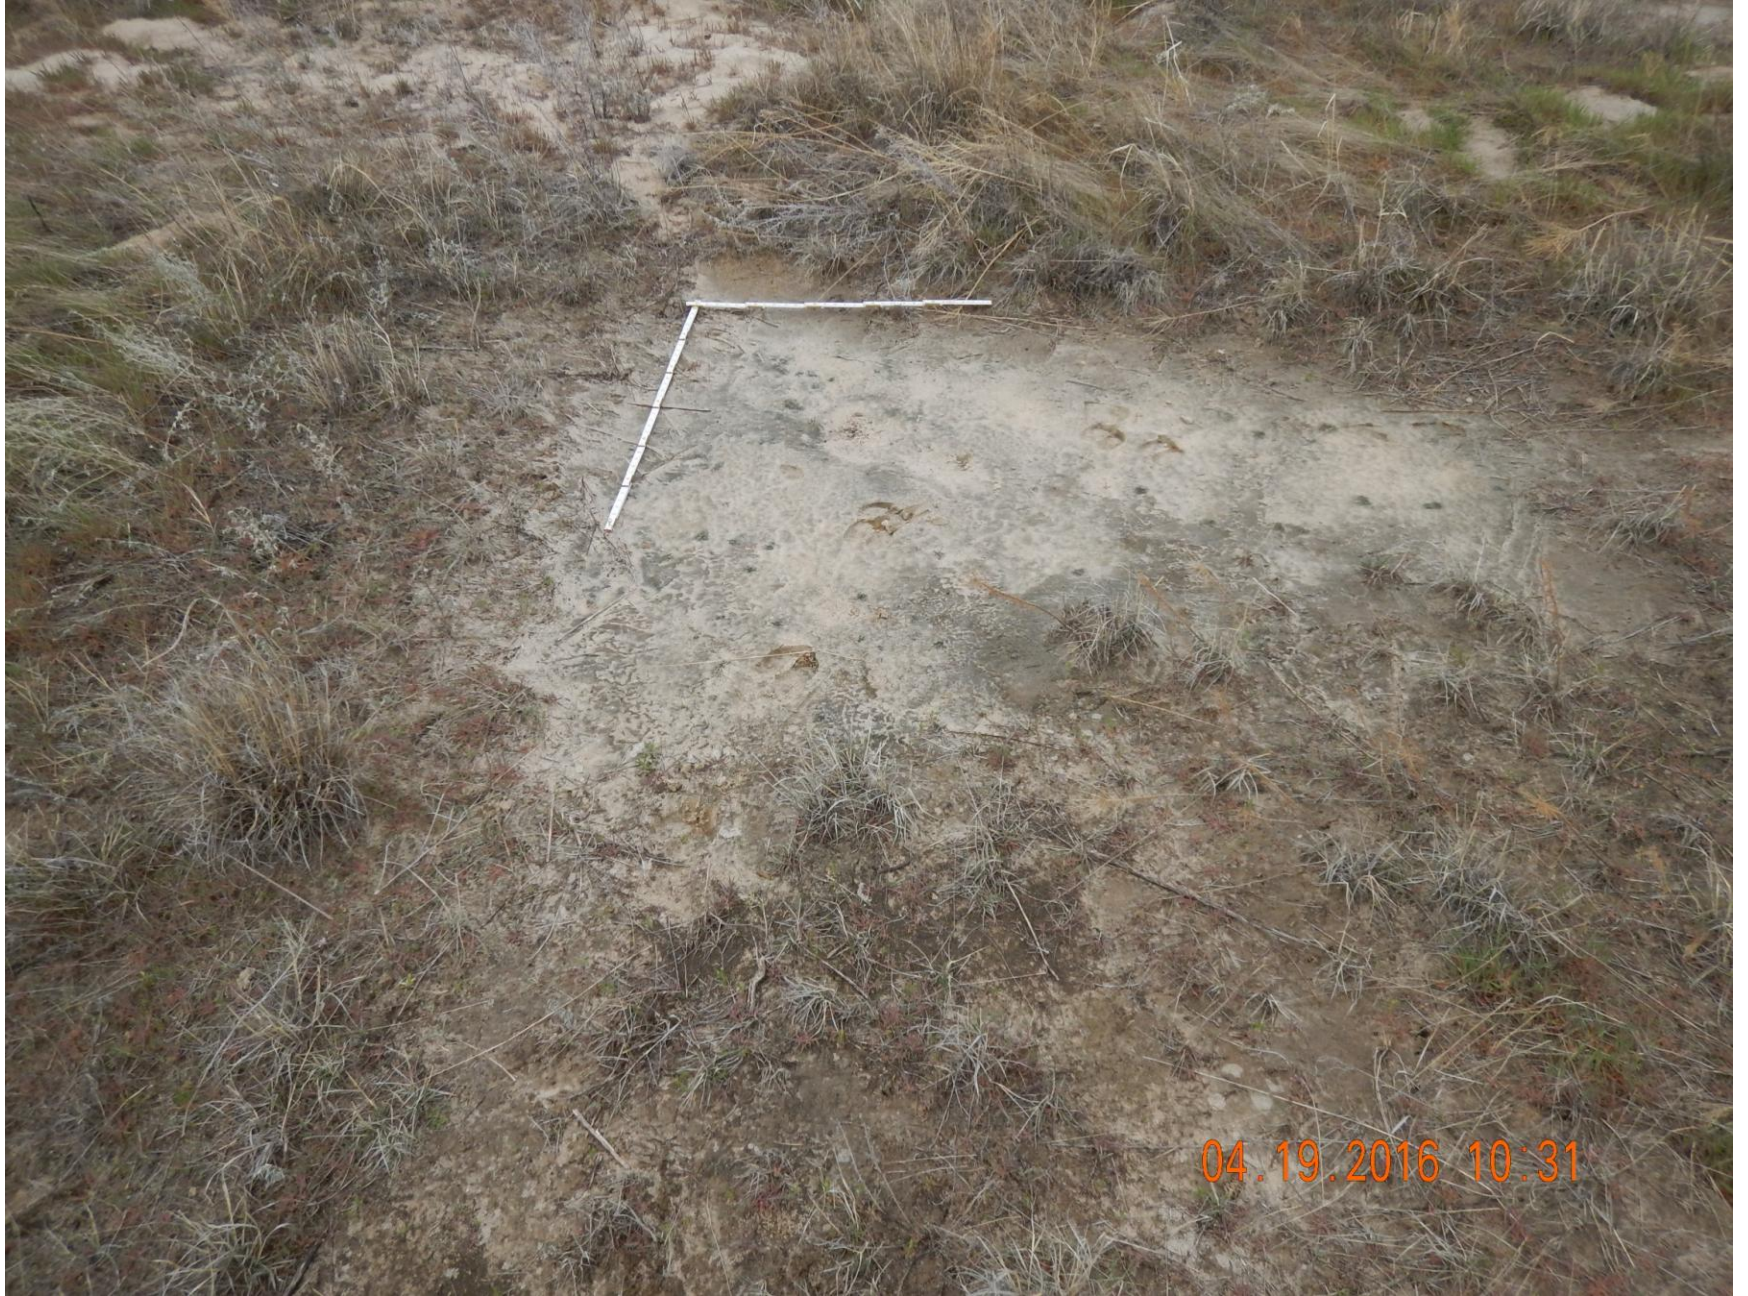
**Figure 8:** Photo taken on the southwest end of the location, facing west. Photo shows unvegetated areas on the former pit location. Would be the southwest corner of pit. 3.5'x2.5' measuring stick for reference.

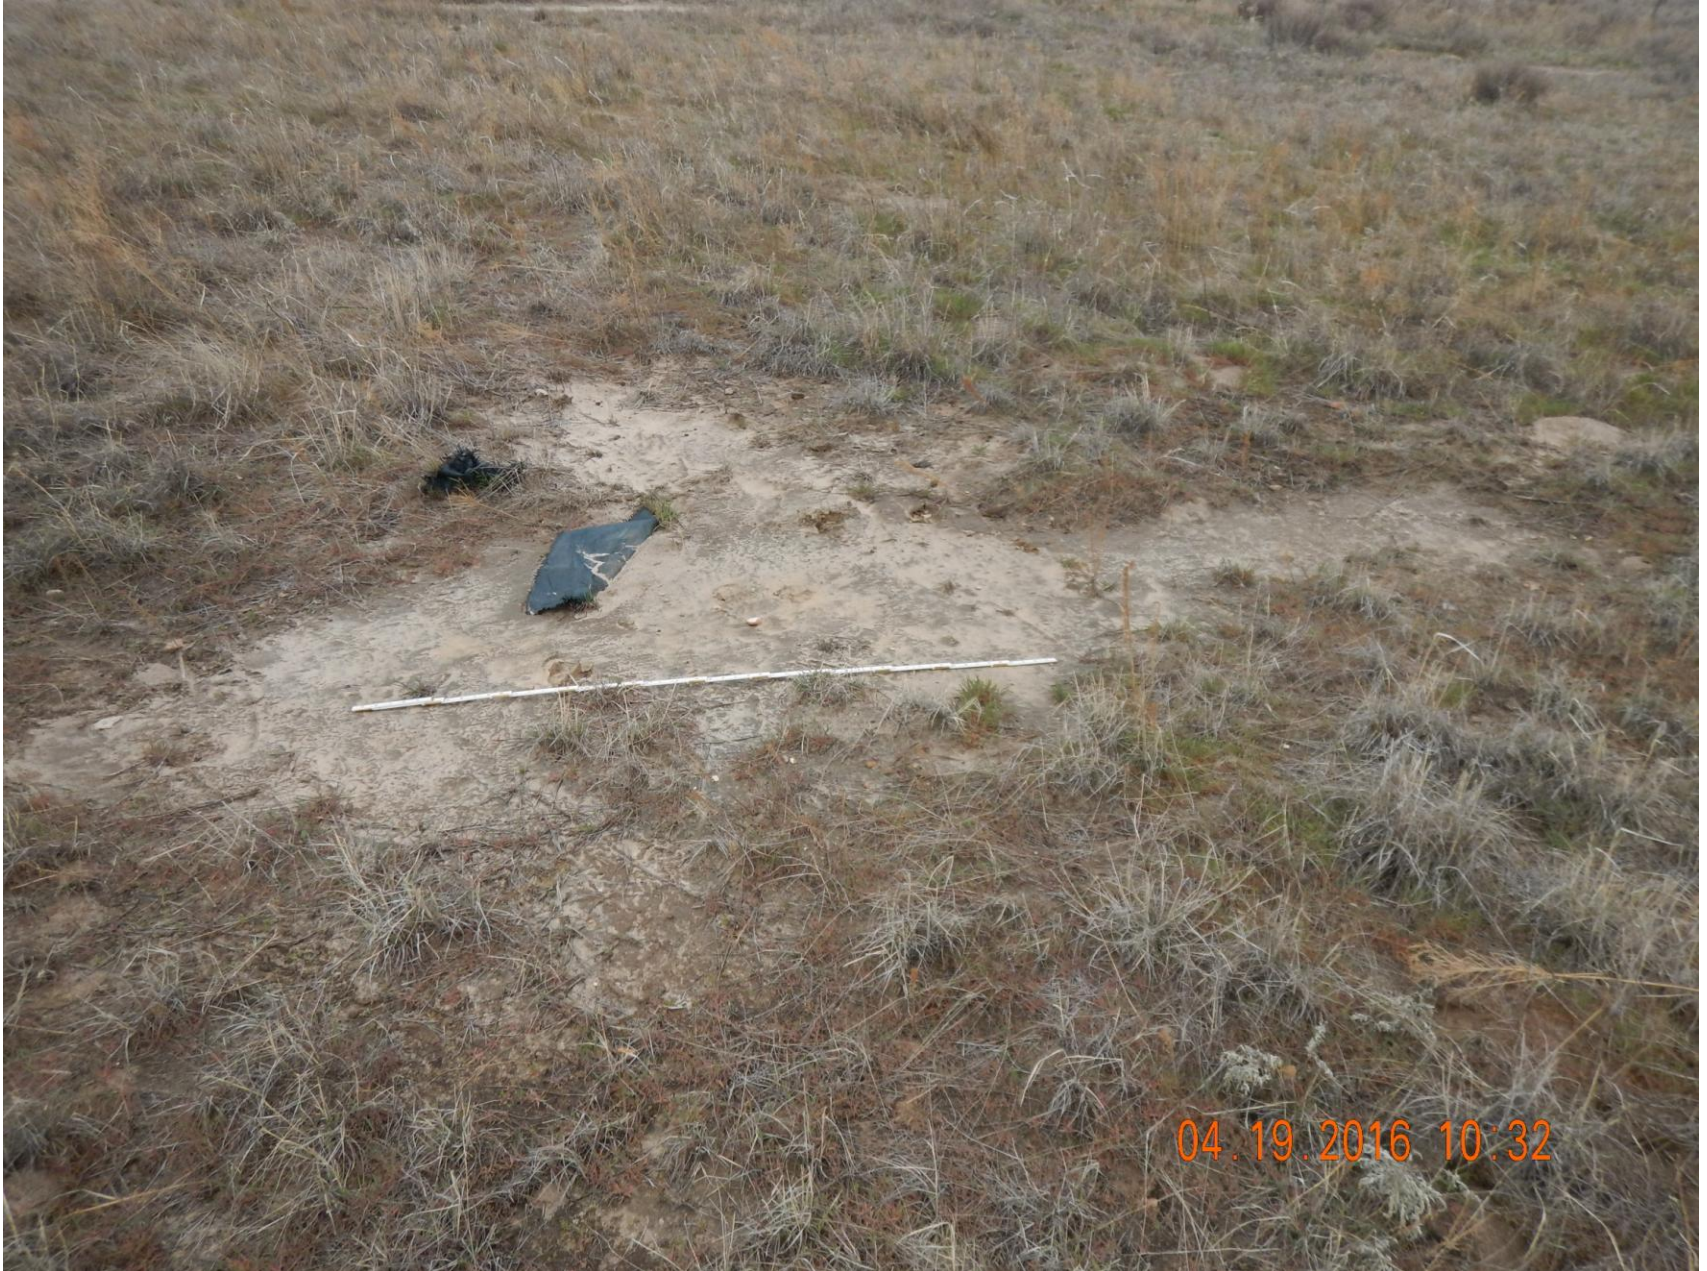
**Figure 9:** Photo taken on the southwest end of the location, facing west. Photo shows unvegetated areas on the former pit location.

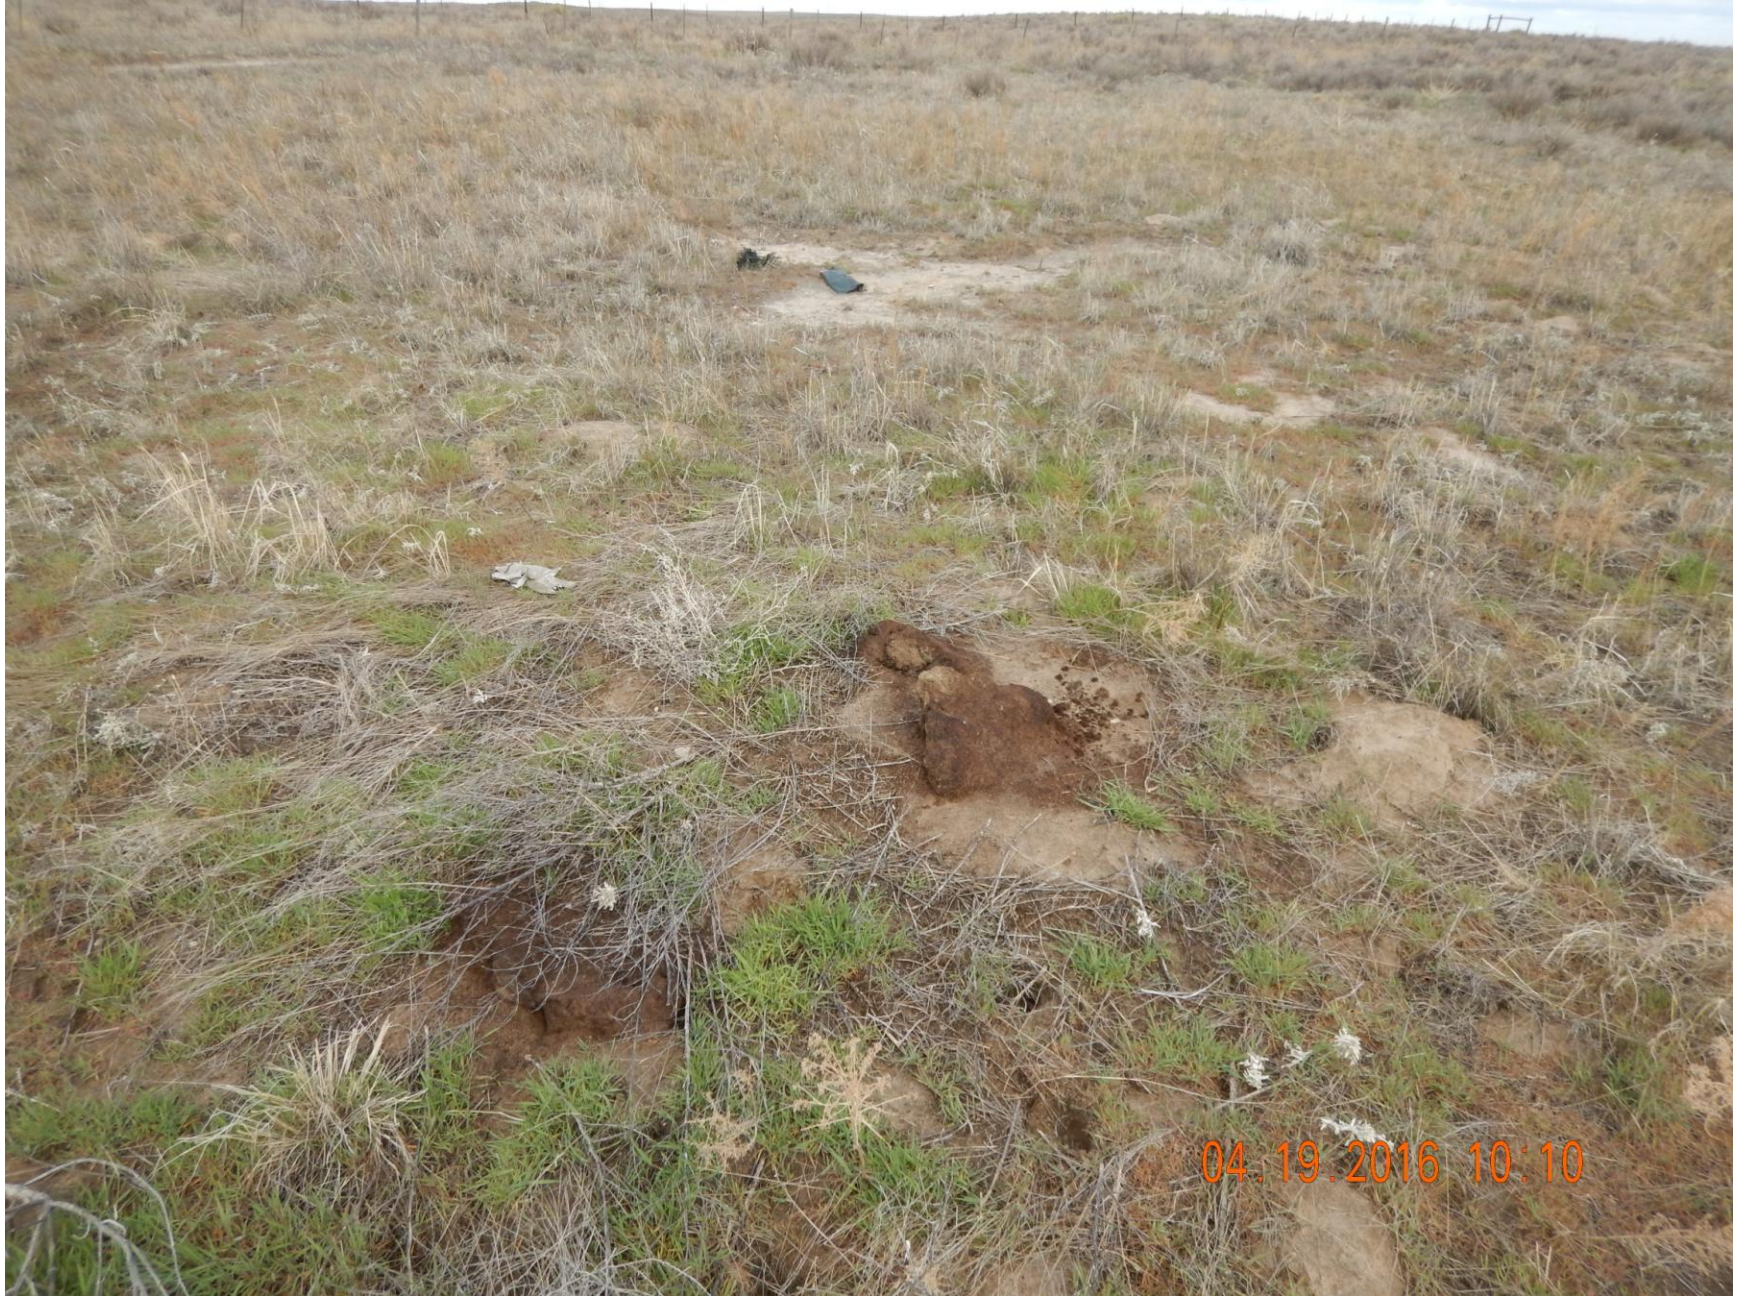
**Figure 10:** Photo taken from the southern end of the location (east end of the former pit location), facing west. Photo shows unvegetated areas on the former pit location that appear to have stained soil
